Monitoring of Harbor Improvements at St. Paul Harbor, St. Paul Island, Alaska

by *Robert R. Bottin, Jr., WES*
Kenneth J. Eisses, Alaska District

Final report

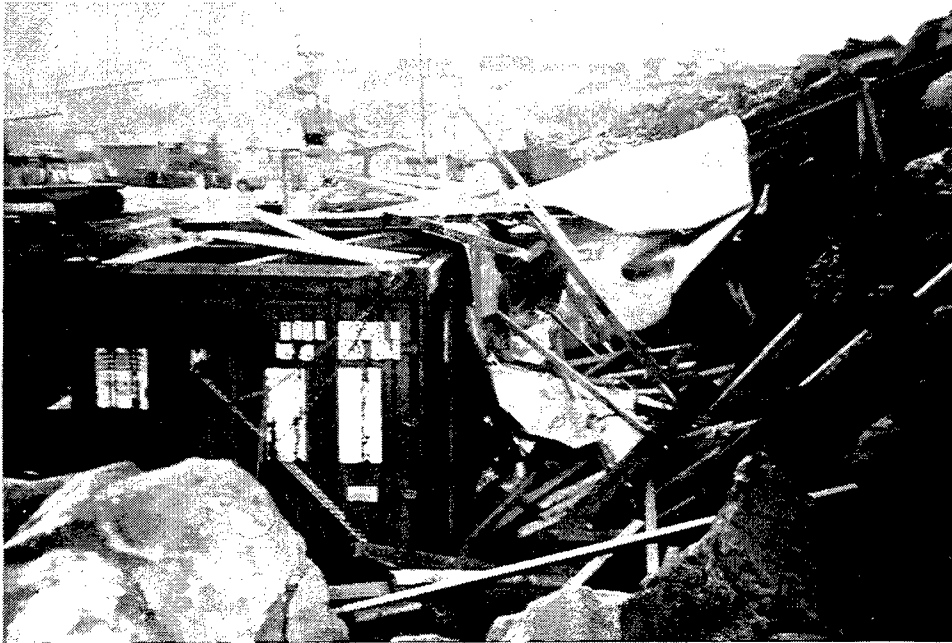
Figure 22. Collapsed apron resulting from 3 November 1994 storm

Wave overtopping rates of 1.7 l/sec/m (0.022 cfs/ft) were calculated from the container in the lee of the main breakwater during the 3-hr period prior to the collapse of the container apron on 3 November 1994. As mentioned previously, as much as 50 percent of the overtopping waves were not collected due to spray and "overshooting" of the container during the storm. Therefore, the actual rates are not quantifiable. It was also noted that significant volumes of water were reaching the road as a result of waves passing through the rubble-mound structure. These values could not be quantified with the equipment setup that was onsite. Waves passing through the structure and overtopping from this storm were obviously unacceptable since they resulted in washing out of the road in the lee of the breakwater. Since incident wave conditions were not known and overtopping rates could not be quantified for this storm event, no attempt was made to correlate overtopping results with the two-dimensional model study results or guidance provided in the *Shore Protection Manual*.

for 2.6-m (8.5-ft) waves indicate a runup value between 4.9 and 5.2 m (16 and 17 ft) would occur (based on *Shore Protection Manual* predictions); however, massive overtopping actually occurred that resulted in destruction of the apron. Local forecasts indicated winds of 50 knots and seas of 9.1 m (30 ft) on 3 November 1994. Based on these comparisons, the hindcast data appear to have under-estimated wave conditions at the site. As stated earlier, in general, trends indicated larger waves occurred with higher runup values and wave overtopping, but absolute values of the wave heights generated by the hindcast model appeared low.

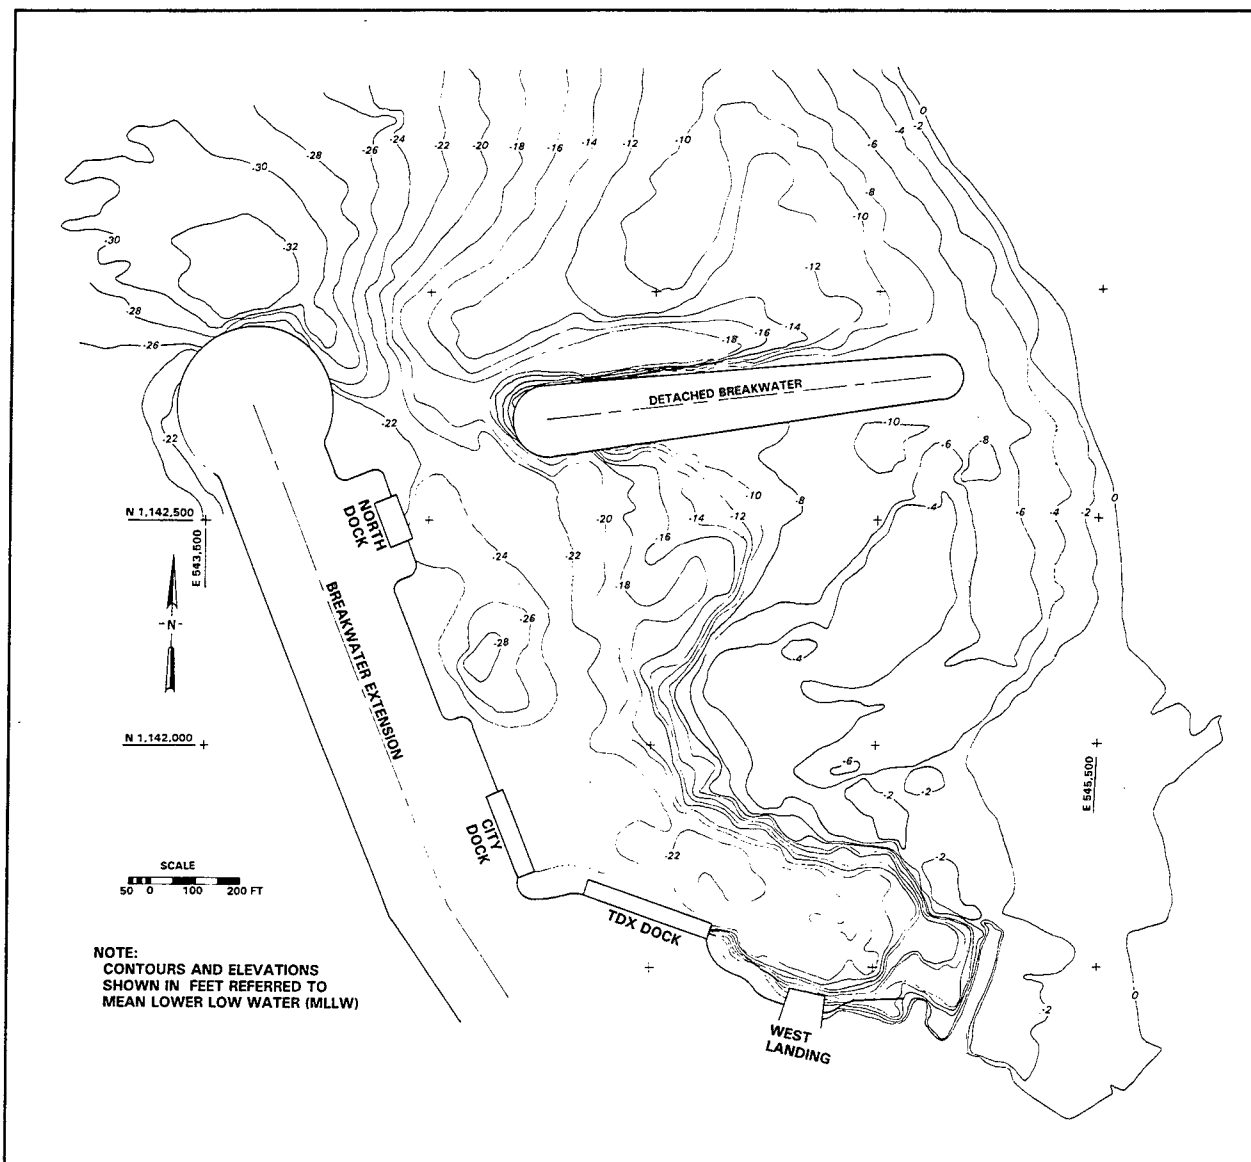
Bathymetric data obtained during the July 1995 survey are shown in Figure 27. The scour hole that had formed at the head of the structure in the August 1992 survey appears to have slightly filled in and shifted slightly west around the head of the structure. To this point, the scour hole has not impacted the stability of the head of the breakwater. The contours north of and adjacent to the detached breakwater are similar to the 1992 survey. To this point, the underwater spit has not had any negative impact on navigation. Local interests dredged an area inside the harbor

Figure 27. Bathymetry at St. Paul Harbor, July 1995

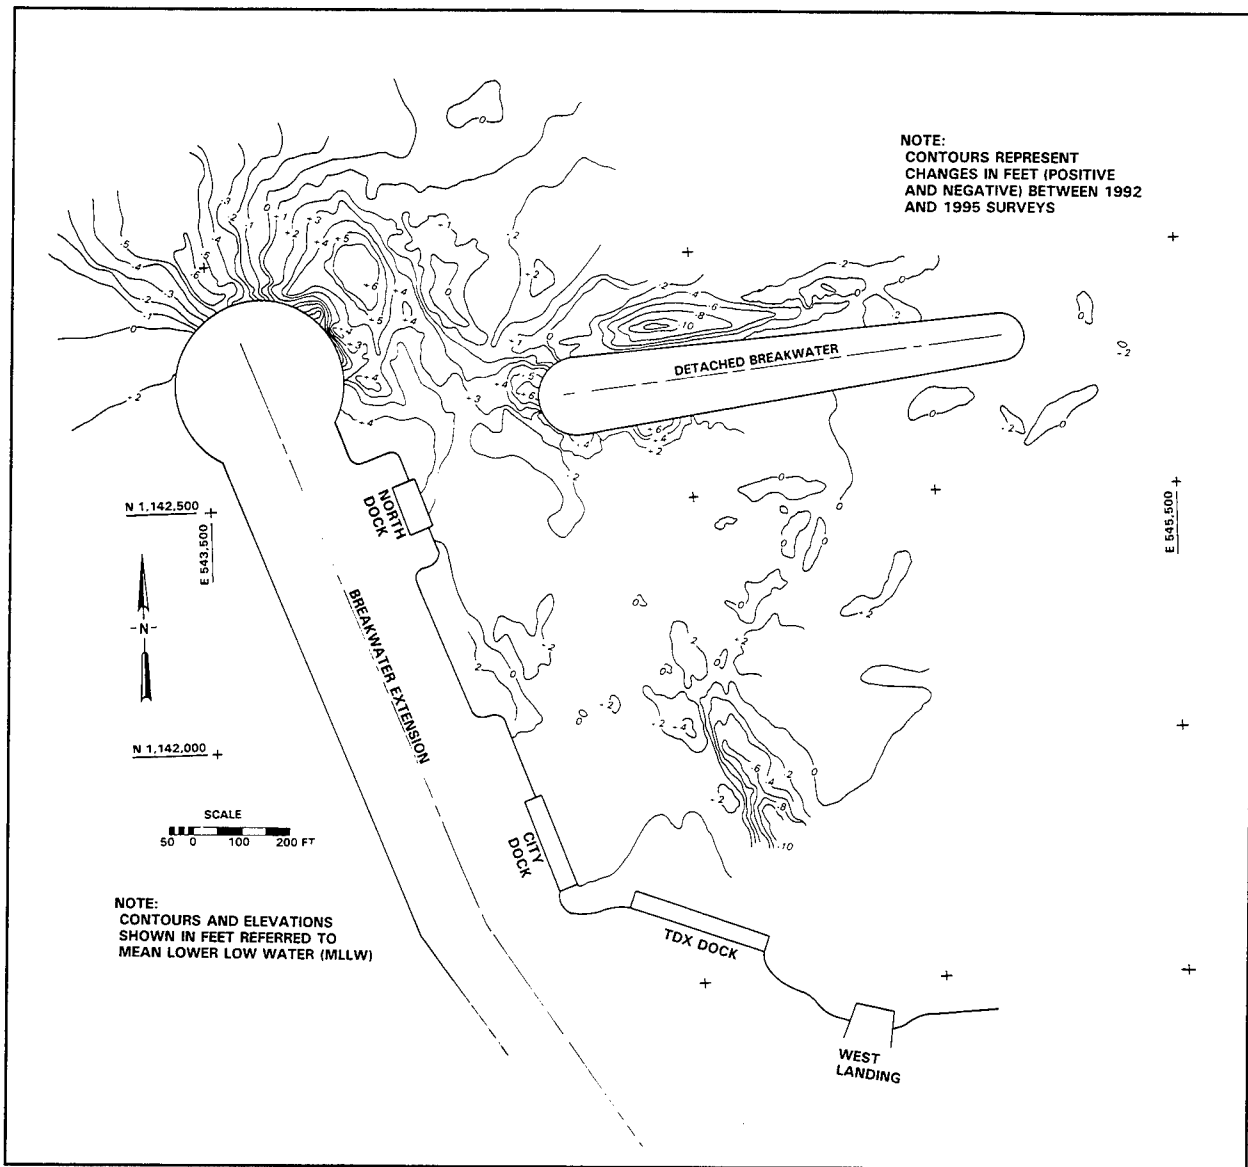
Contours of bathymetric changes that occurred between the August 1992 and July 1995 surveys are shown in Figure 28. The figure shows that the old (1992) scour hole location has filled in about 1.8 m (6 ft), with a 1.8-m (6-ft) cut at the new location to the west. The accretion immediately adjacent to the north side of the detached breakwater in 1992 had subsided by 3 m (10 ft). Not shown on the figure (due to lack of data in 1992), however, is a slight shift in the underwater spit north

of its old location with accretion observed. Accretion of 1.8 m (6 ft) had occurred at the seaward head of the detached breakwater. Cut and fill inside the harbor north of the TDX dock was probably related to the dredging operations at West Landing by local interests.

Figure 28. Contours of bathymetric changes between August 1992 and July 1995 surveys

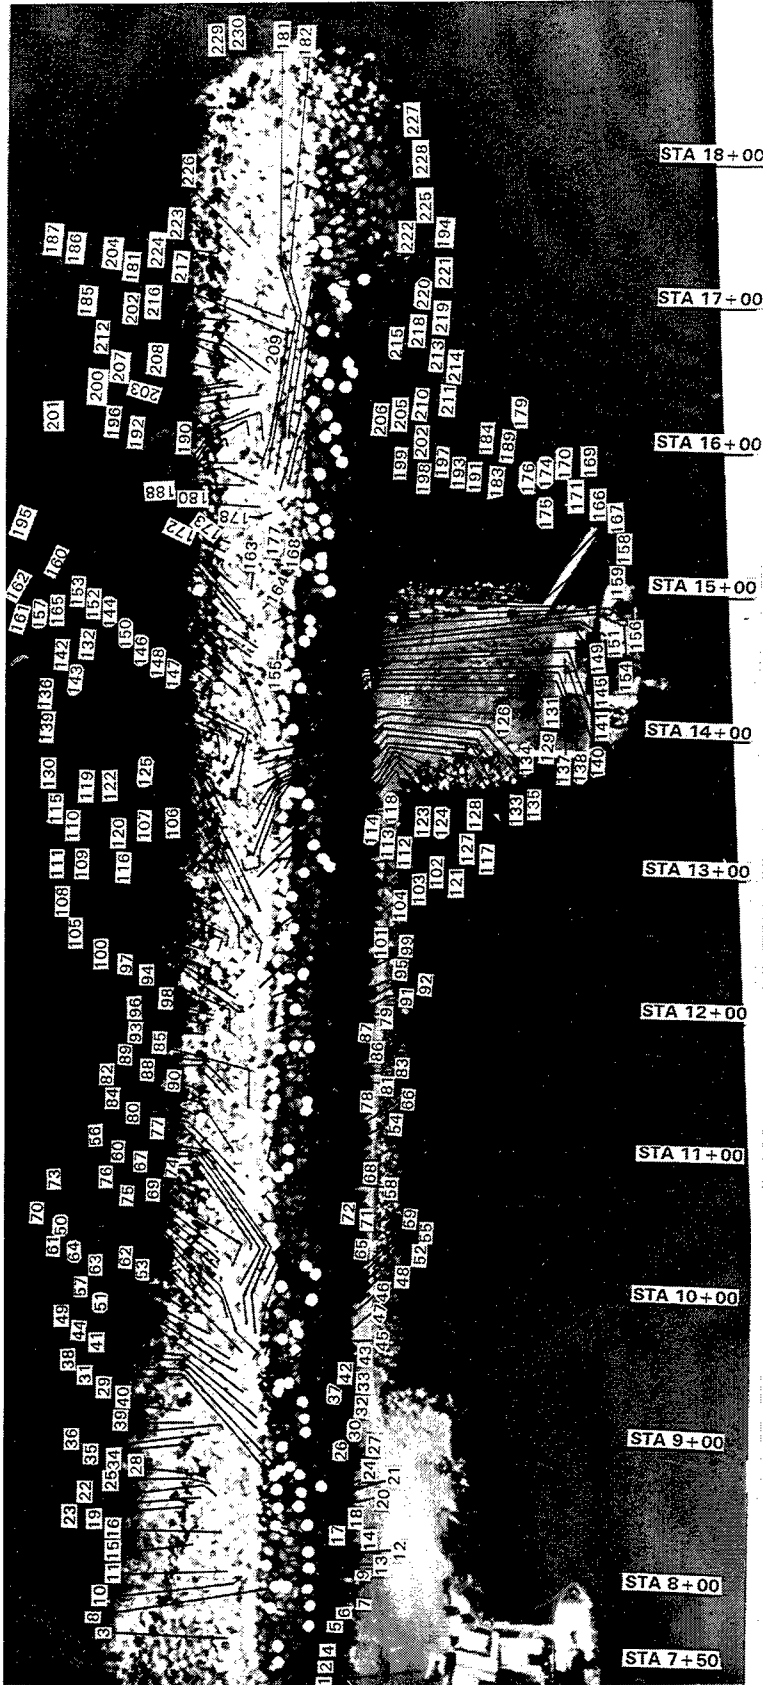
During the breakwater survey of June 1996, a total of 230 broken/cracked armor stones were identified on the main breakwater. Of the 230 stones, 54 were located on the crest, 105 on the seaward slope, and 71 on the harbor-side slope. The rate of breakage was slightly less for this survey than for previous years; however, the harbor master indicated that the 1995-96 winter was milder than normal. As of the June 1996 survey, the approximate locations of broken/cracked armor stones along the outer portion of the breakwater are shown in Figure 39, and detailed data obtained during the survey are presented in Table 5. Armor stone numbers identified in Figure 39 correspond to those listed in Table 5. As shown, only two broken armor units are located around the head of the structure. Armor stone for the breakwater head consisted of sound and durable granite from a quarry in Nome, AK. Shoreward of the breakwater head, broken stones were, generally, evenly distributed along the length of the structure. The survey showed that 49 percent of the broken stones were located on the shoreward half of the breakwater extension, and 51 percent on the outer half. About 23 percent of the observed broken stones were along the crest, 46 percent on the seaward slope, and 31 percent on the harbor-side

Figure 39. Approximate locations of broken/cracked armor stone on outer breakwater during June 1996 survey

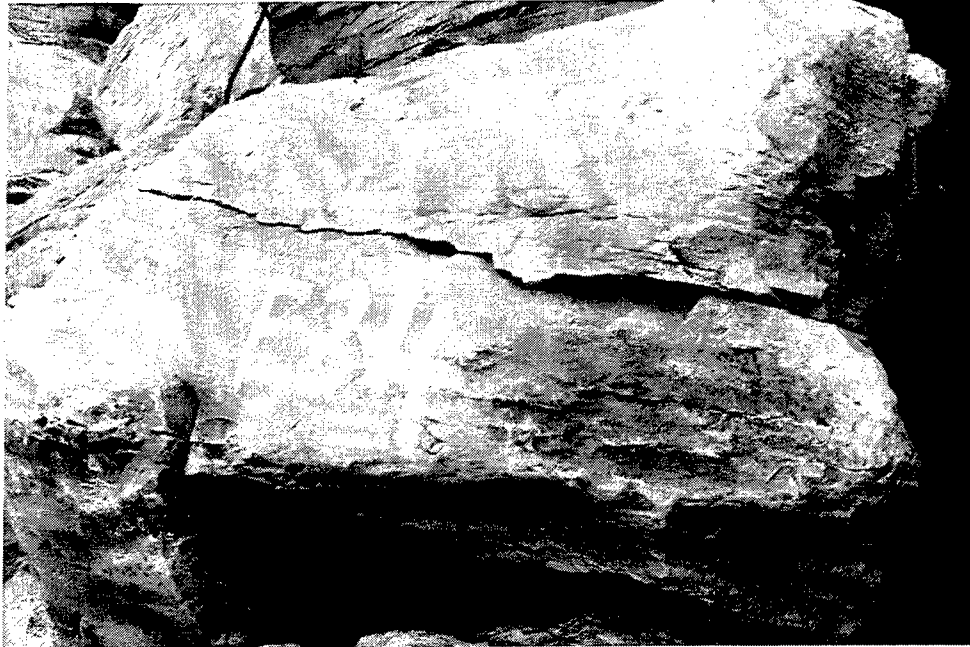
Figure 40. View of broken armor stone on St. Paul Harbor breakwater (station 10+21)

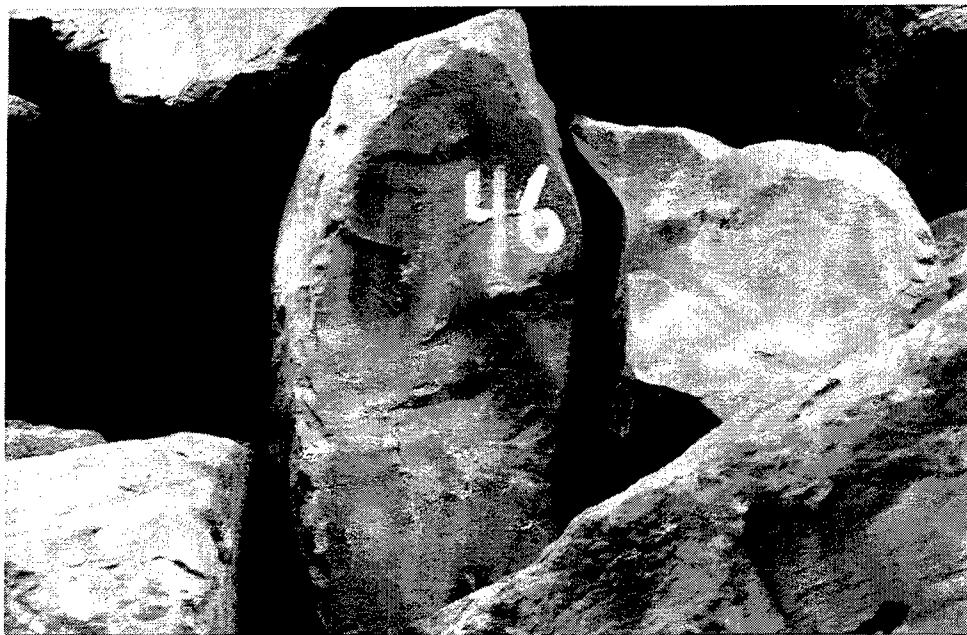
Figure 41. View of broken armor stone on St. Paul Harbor breakwater (station 11+78)

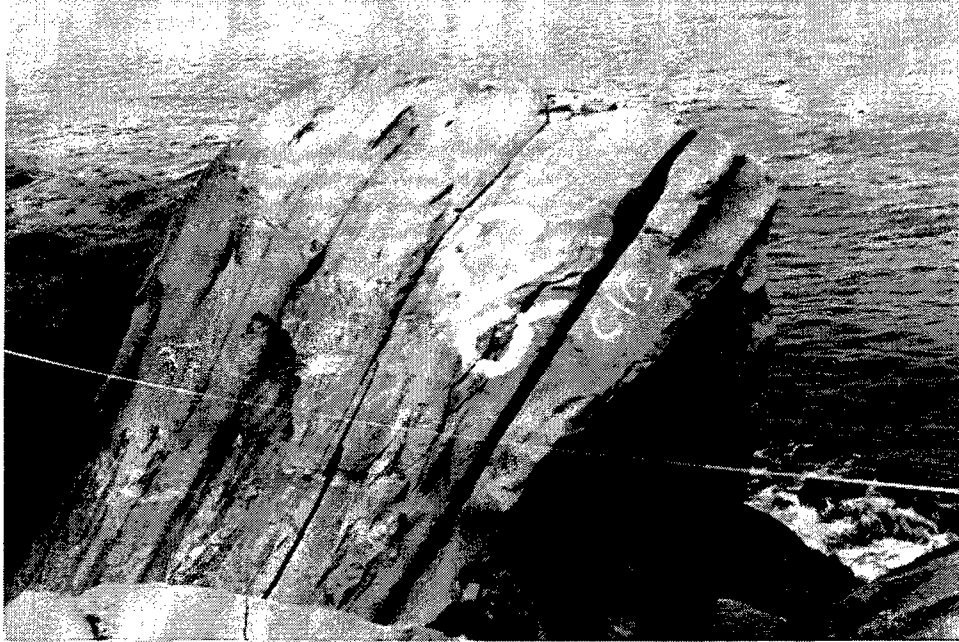
Figure 42. View of broken armor stone on St. Paul Harbor breakwater (station 11+87)

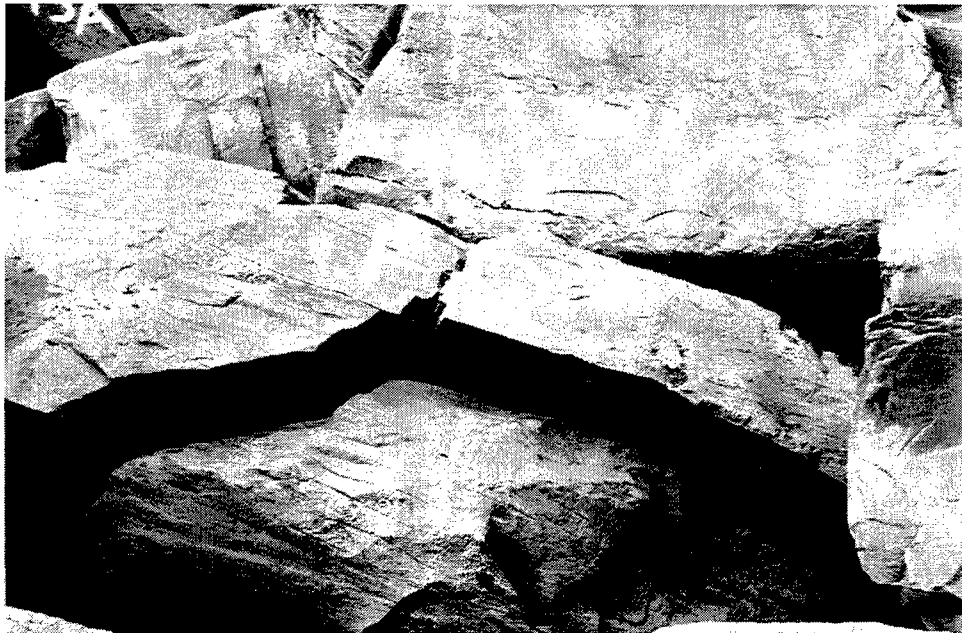
Figure 43. View of broken armor stone on St. Paul Harbor breakwater (station 17+34)
