Metallurgical Examination of
Failed Spiral Bevel Gear P196,
Part No. 145D6302

ARL-TR-1432

AUGUST 1997

Marc S. Pepi
Weapons & Materials Research Directorate

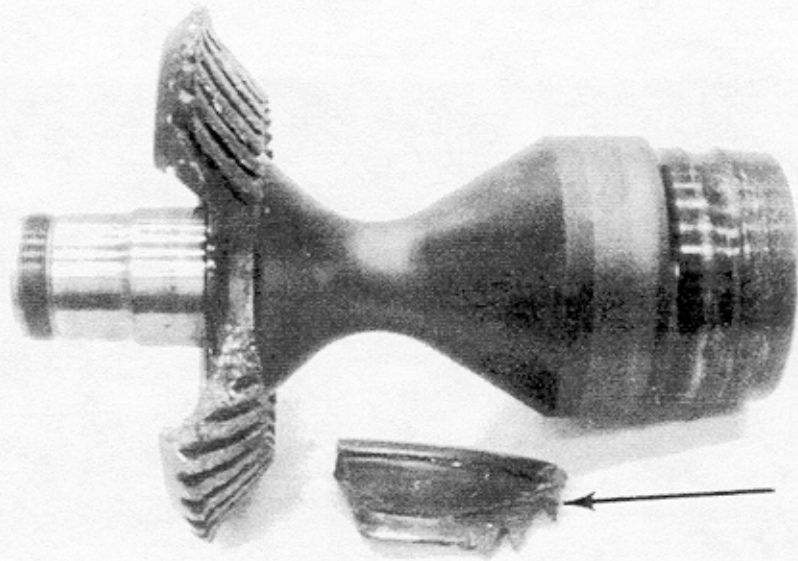
A spiral bevel transmission gear (see Figure 1, taken from the Boeing report) from a CH-47D Army cargo helicopter failed during a training flight at Fort Meade, Maryland, leading to an immediate landing. Inspection of the Number 2 engine transmission revealed that an eight-tooth segment (of a 35-tooth gear) had fractured and penetrated the transmission housing. The failed component (Part No. 145D6302) was fabricated from Vasco X-2M steel and carburized to a required case hardness of 59 to 64 hardness Rockwell "C" (HRC). The failed component was originally examined by Boeing Helicopters (refer to Boeing Report [Materials Engineering Laboratory Report {MELR}] No. 93-105, dated 15 December 1995) [1], and subsequently shipped to the U.S. Army Research Laboratory (ARL), Weapons and Materials Research Directorate, for analysis. The broken part was subject to visual examination/light optical microscopy, chemical analysis, metallography, hardness testing/case depth measurement, X-ray diffraction, scanning electron microscopy (SEM) and energy-dispersive spectroscopy (EDS).

Figure 1. Optical Macrograph of the Failed Spiral Bevel Gear and the Fractured Eight-tooth Segment (denoted by the arrow). (The photo was reproduced from the Boeing report and reduced 70%.)

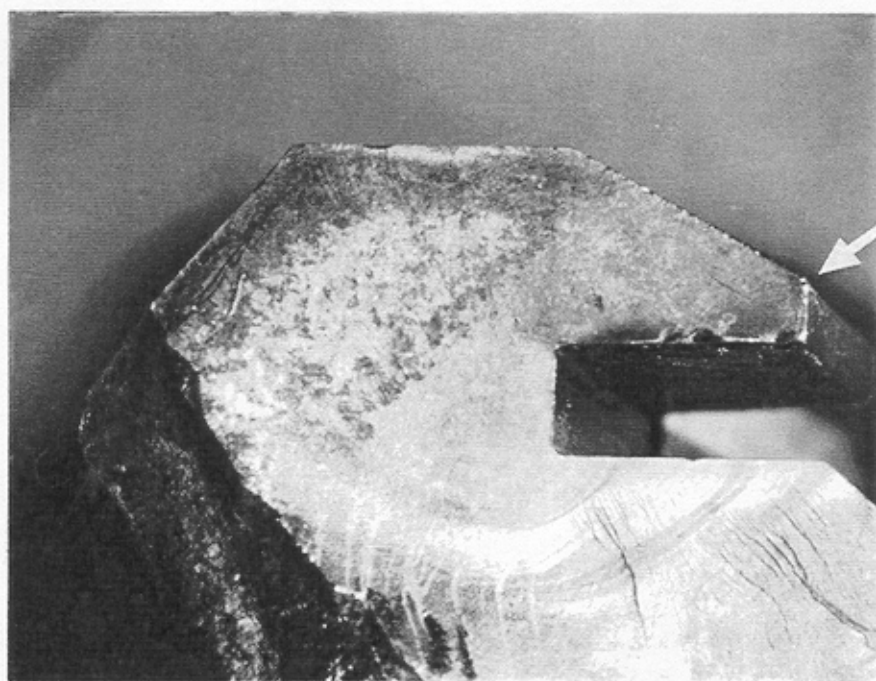
Visual examination and light optical microscopy of the fracture surfaces revealed characteristics consistent with a fatigue failure, including smoothness of fracture and beach marks (see Figure 2). The beach marks and radial lines on the fracture surface revealed that the origin was located in the damping ring groove portion of the gear at a darkened half-moon-shaped defect (see Figure 3). This region was located at the intersection of the 30° taper and the 7.125-inch diameter. The defect was oriented perpendicular to the direction of grinding, suggesting the possibility of a grinding crack. Further visual examination of the remaining component revealed small grinding cracks in the same area as the fracture origin.

Figure 2. Optical Micrograph of the Primary Fracture Surface Showing Evidence of Fatigue (beach marks). (Arrow denotes fracture origin; magnification 7.5x.)

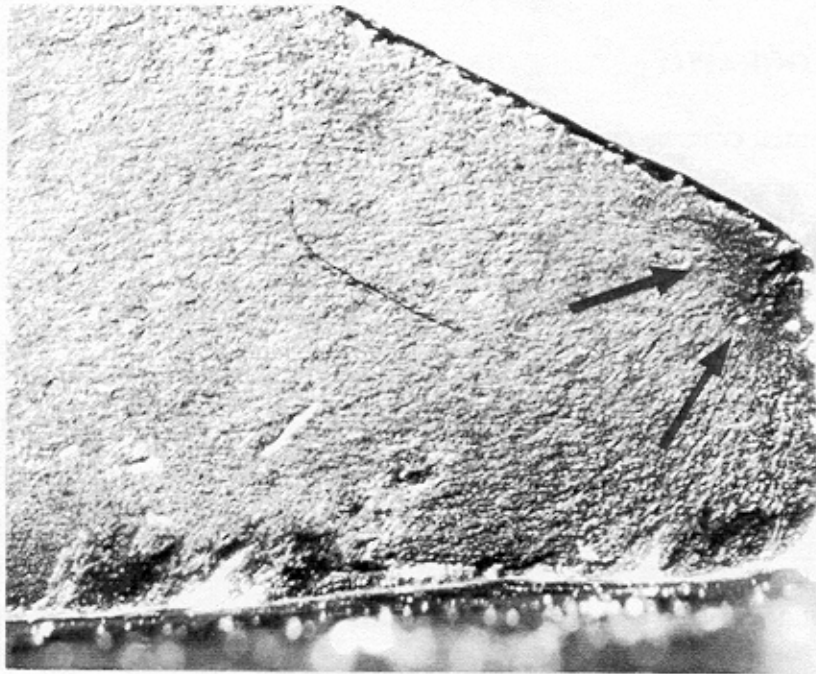
Figure 3. Magnified View of the Processing Defect Located at the Origin. (The grinding crack is denoted by arrows; magnification 40x.)

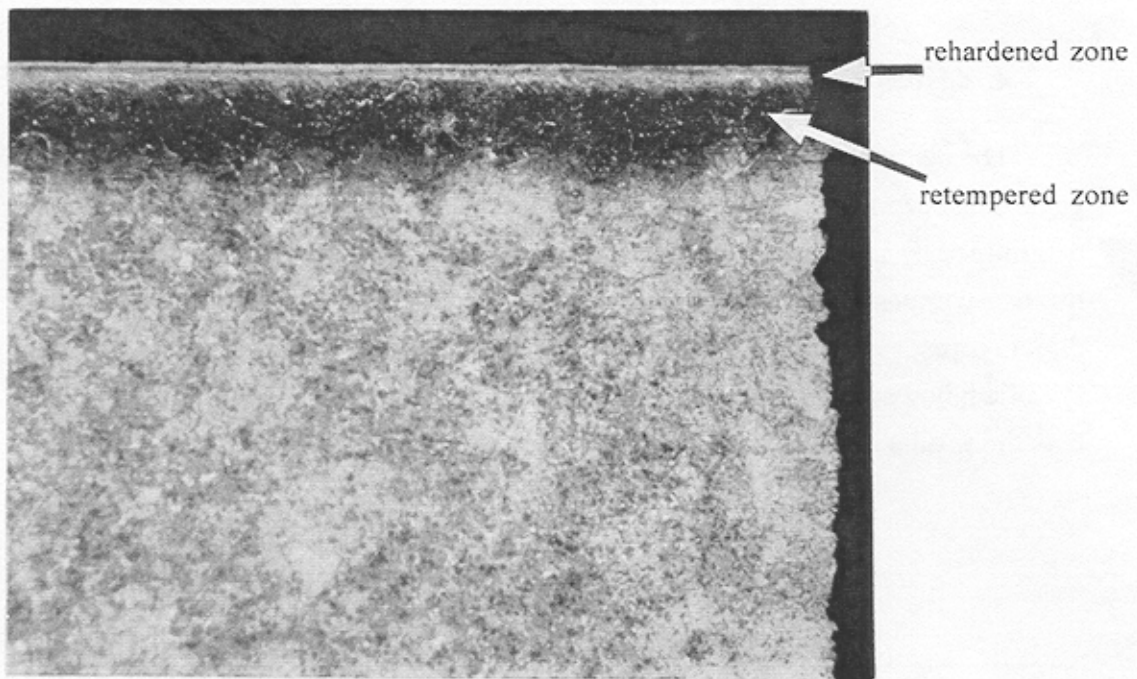
A circumferential cross section was taken through the origin to confirm that the pre-existing defect was a grinding crack. The sample was metallographically prepared and etched with Vilella's reagent (5 ml hydrochloric acid, 1 gram picric acid, and 100 ml ethanol). The sample showed evidence of rehardening (white region) and retempering (dark region) as shown in Figure 4. This pre-existing crack was oriented perpendicular to the direction of grinding, consistent with a grinding crack. Figure 5 is a montage showing the as-polished appearance of the fracture origin and several grinding cracks running parallel to the fracture plane. Figure 6 shows the same area after application of Vilella's reagent. Note that each grinding crack is contained within the grinding burn. Other grinding burns and grinding cracks were also noted adjacent to the fracture origin (see Figure 7). This burn was 0.43 inch away from the fracture origin. In addition, metallography revealed what appeared to be continuous carbide networks (CCNs) in the region of the gear that contained the origin (see Figure 8).

Figure 4. Metallographic Section Through the Origin. (Note the rehardened white layer and the retempered darkened layer caused by the grinding burn; Vilella's reagent; magnification 200x.)

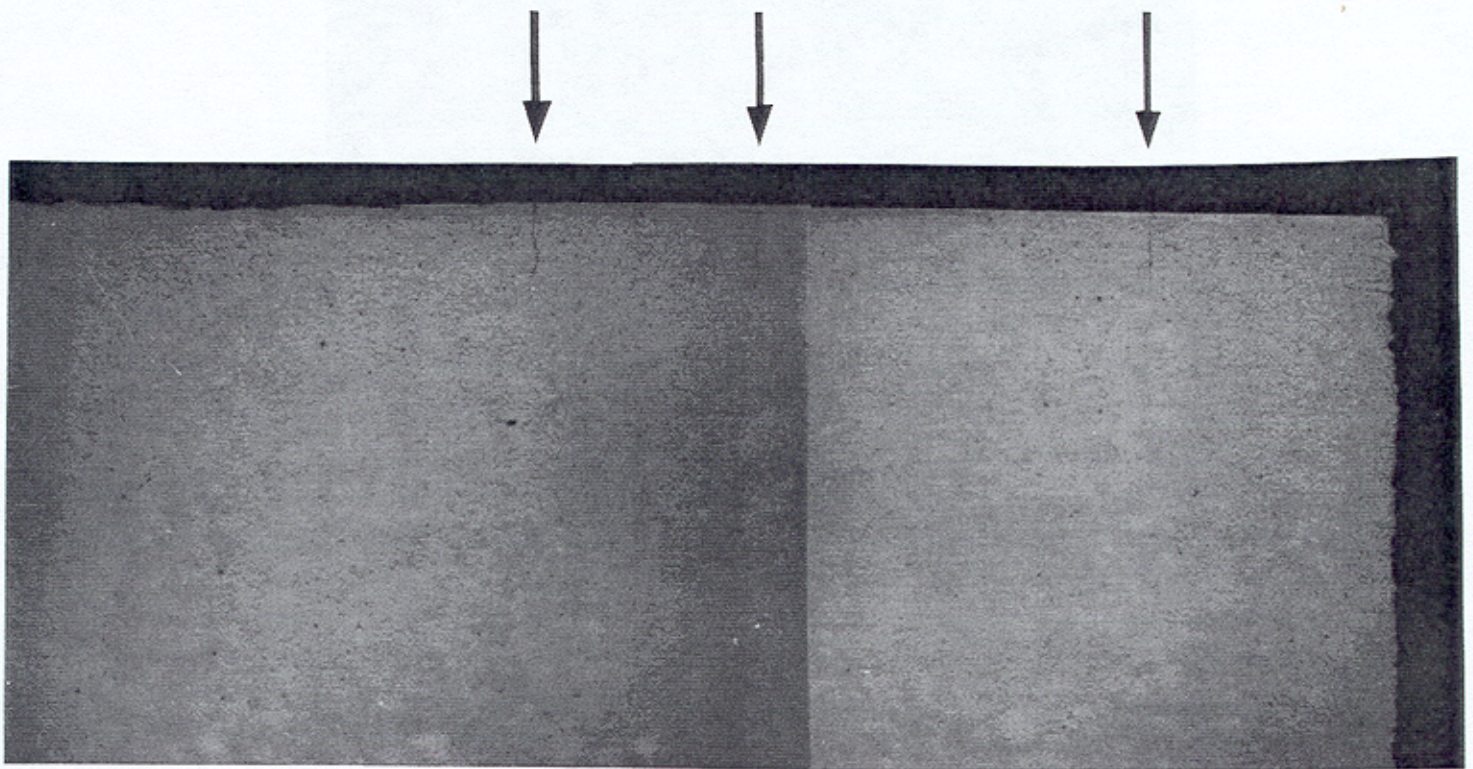
Figure 5. Montage of the Fracture Origin in the As-polished Condition. (Note the three additional grinding cracks [denoted by arrows] running parallel to the fracture plane; magnification 100x.)

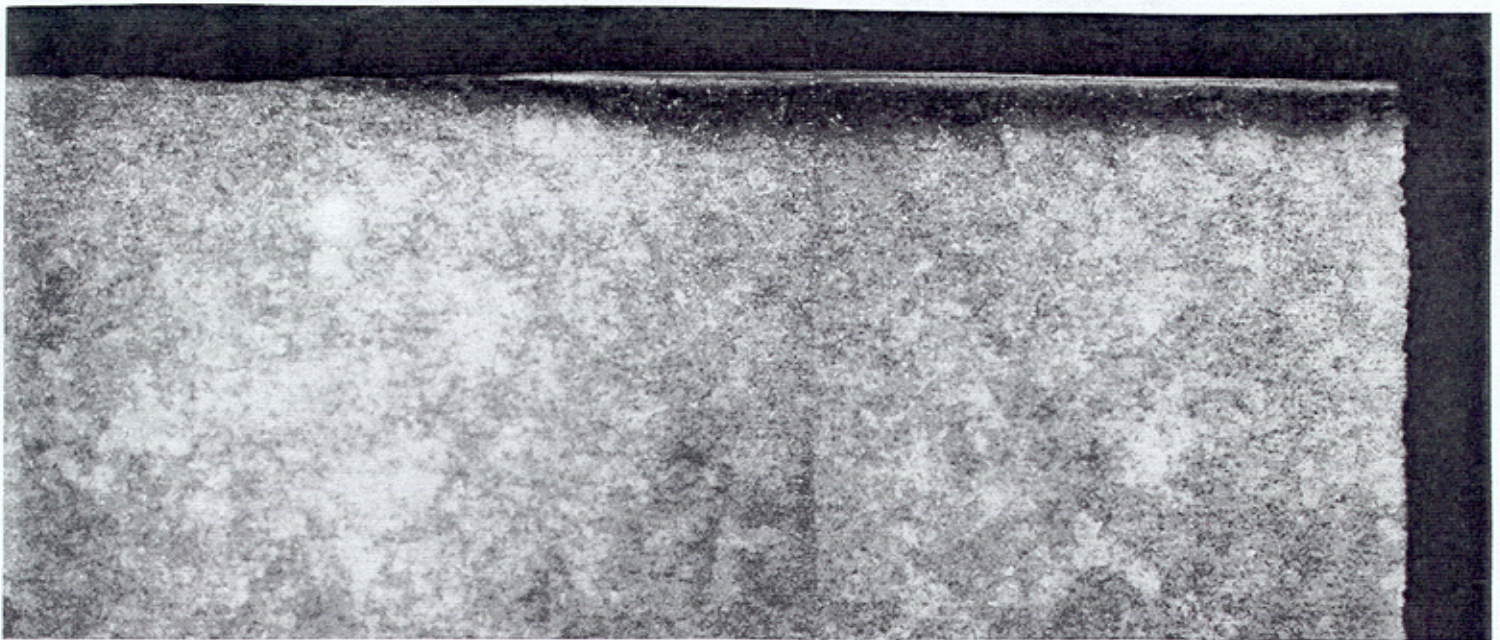
Figure 6. Montage of the Fracture Origin Shown in Figure 5, After Application of Vilella's Reagent. (Note that each crack is contained within the grinding burn; magnification 100x.)

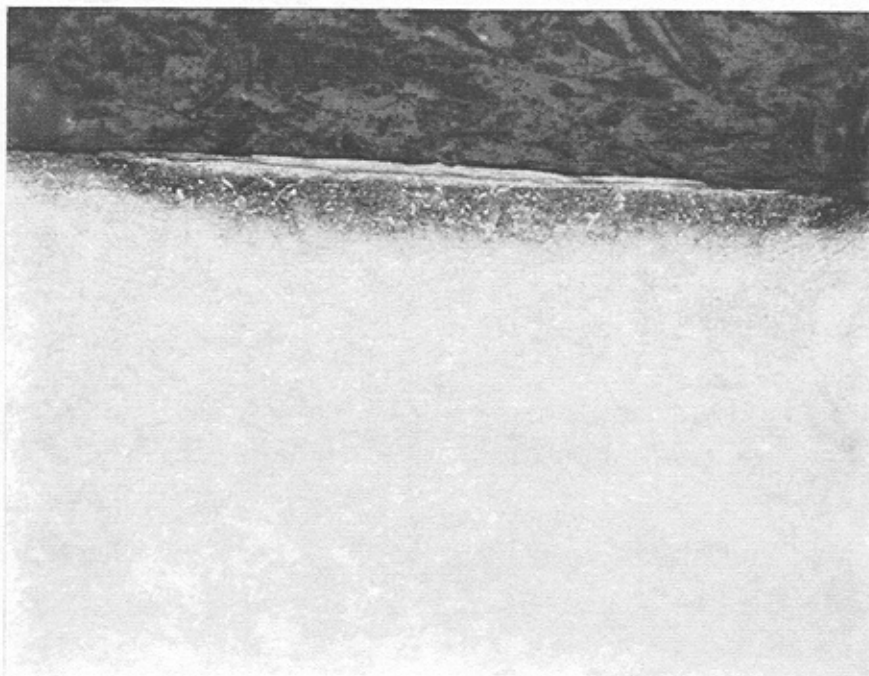
Figure 7. An Additional Grinding Burn Revealed Adjacent to the Fracture Origin, 0.43 Inch Away. (Note the white rehardened layer and the dark retempered layer; Vilella's reagent; magnification 150x.)

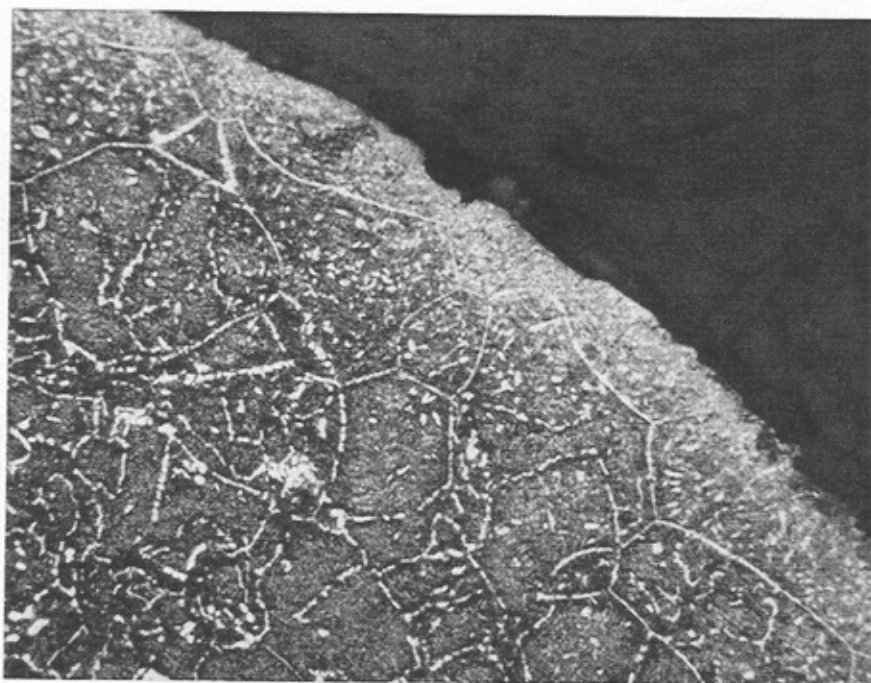
Figure 8. Metallographic Cross Section Through the Damping Ring Groove Region That was Double Carburized Inadvertently. (Note the carbide networks in the carburized case formed by this excess carbon; Vilella's reagent; magnification 400x.)

Metallography combined with microhardness testing of the damping ring groove area (fracture origin location) revealed a greater case depth than specified (see Hardness/Case Depth Measurement section for results). The core structure (see Figure 19) was consistent with the prior treatment (duplex structure of free ferrite within tempered martensite).

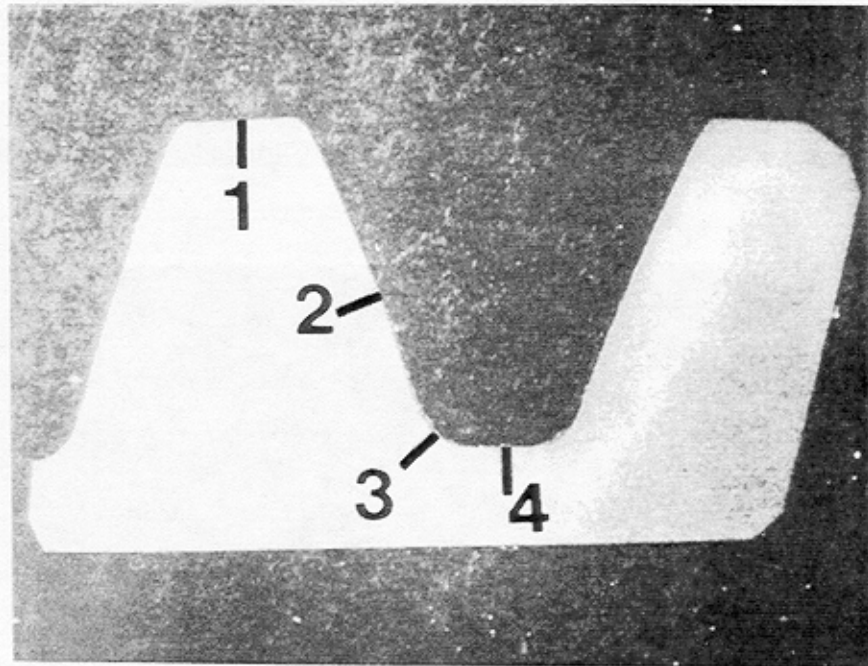
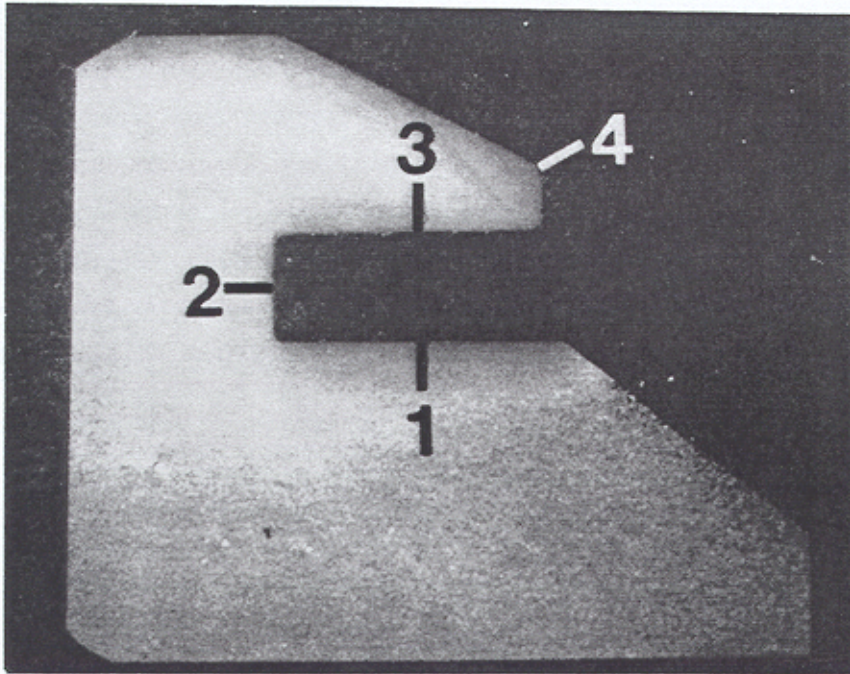
Representative damping ring and gear tooth metallographic samples were analyzed to determine the extent of carbide formation with respect to part geometry. Figures 9 and 10 highlight the areas examined for this investigation. Figures 11 through 14 show Areas 1 through 4, respectively, on the gear tooth sample. Note that carbide formation was heavier in Areas 1 and 2 (the locations with more surface area exposed to the carburization atmosphere). No carbide networks were noted in the areas of high stress (Areas 3 and 4). Figures 15 through 18 show Areas 1 through 4, respectively, of the damping ring groove sample. Note the heavy carbide formation in Area 4, with respect to Areas 1 through 3. The structure had the appearance of CCNs, which are unacceptable per Boeing Specification D210-10342-1 [3]. Also note that Area 4 is the point where the catastrophic failure originated.

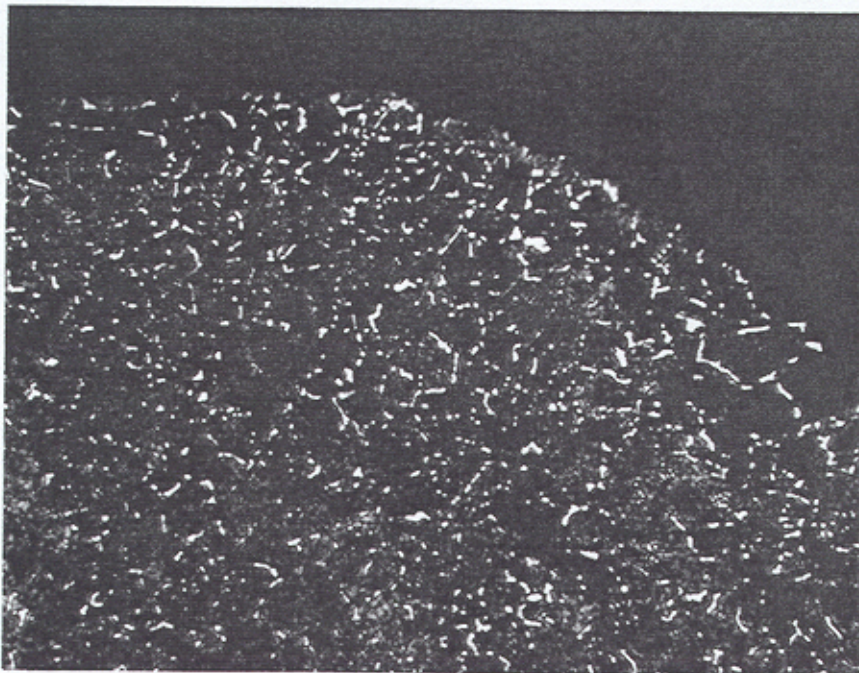
Figure 11. Micrograph of the Gear Tooth Metallographic Sample Showing the Case Microstructure Within Area 1 (Vilella's reagent; magnification 400x).

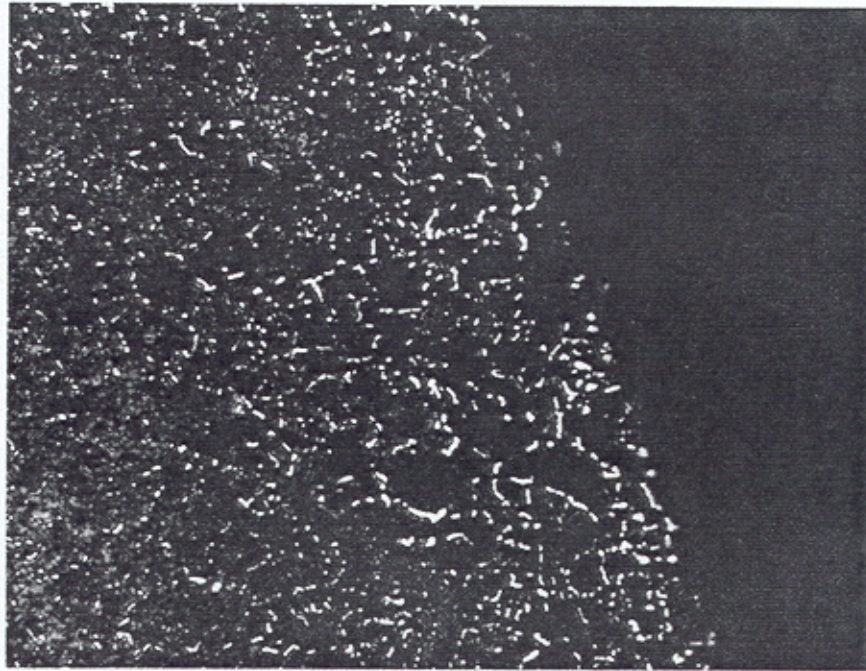
Figure 12. Micrograph of the Gear Tooth Metallographic Sample Showing the Case Microstructure Within Area 2 (Vilella's reagent; magnification 400x).

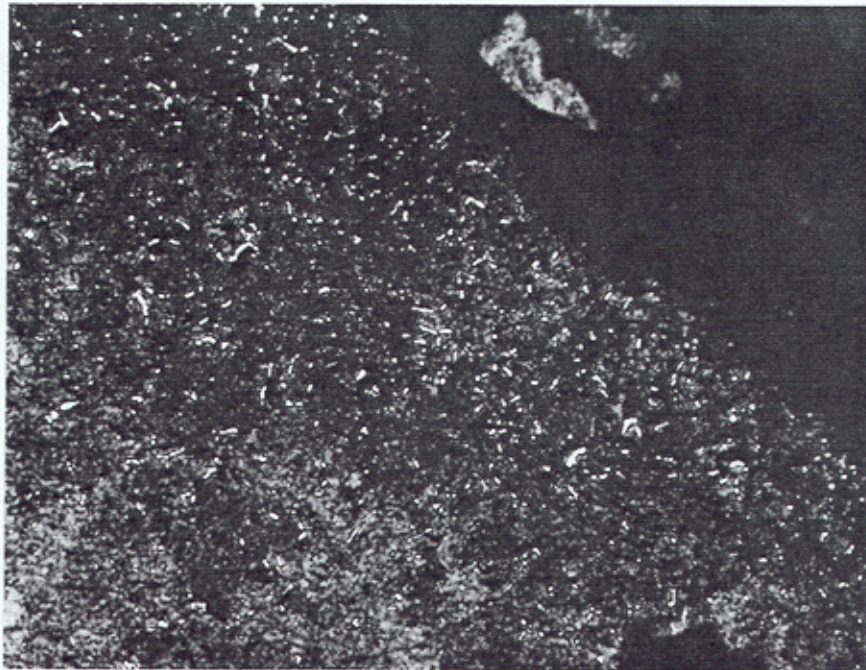
Figure 13. Micrograph of the Gear Tooth Metallographic Sample Showing the Case Microstructure Within Area 3 (Vilella's reagent; magnification 400x).

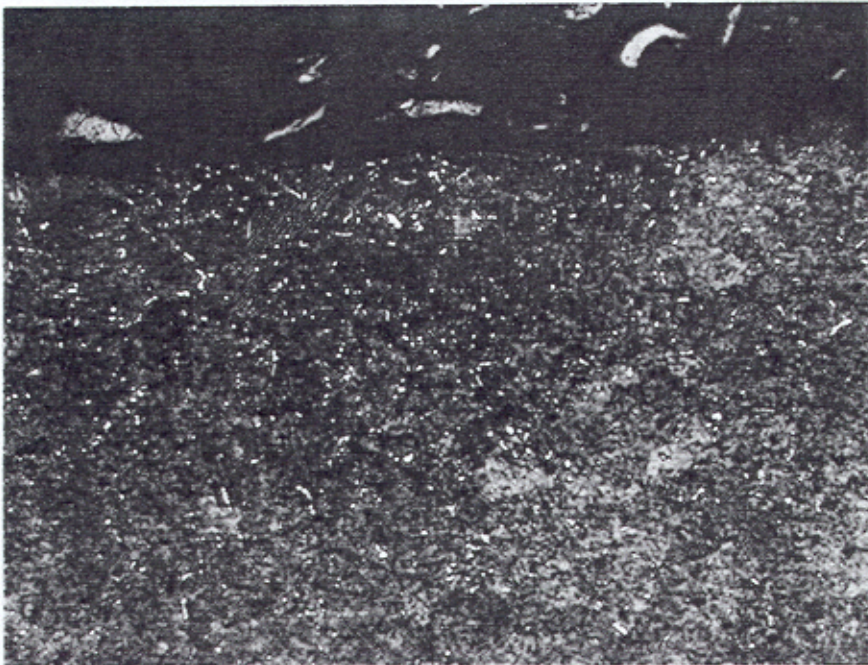
Figure 14. Micrograph of the Gear Tooth Metallographic Sample Showing the Case Microstructure Within Area 4 (Vilella's reagent; magnification 400x).

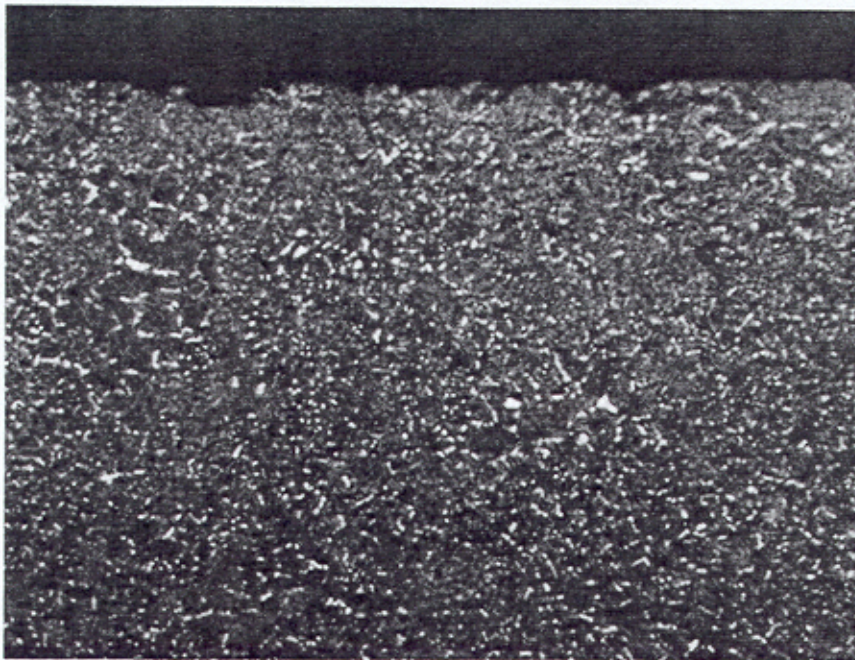
Figure 15. Micrograph of the Damping Ring Groove Metallographic Sample Showing the Case Microstructure Within Area 1 (Vilella's reagent; magnification 400x).

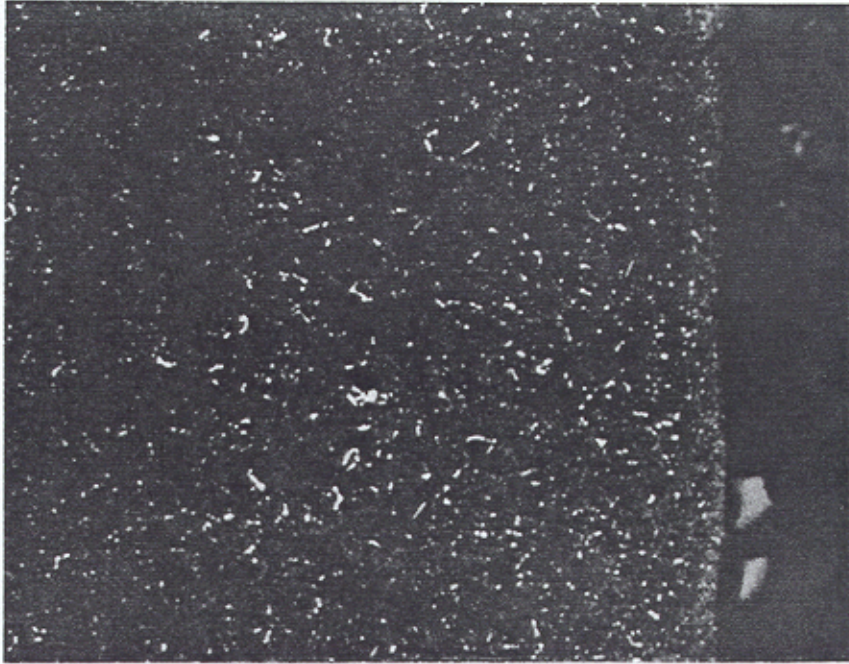
Figure 16. Micrograph of the Damping Ring Groove Metallographic Sample Showing the Case Microstructure Within Area 2 (Vilella's reagent; magnification 400x).

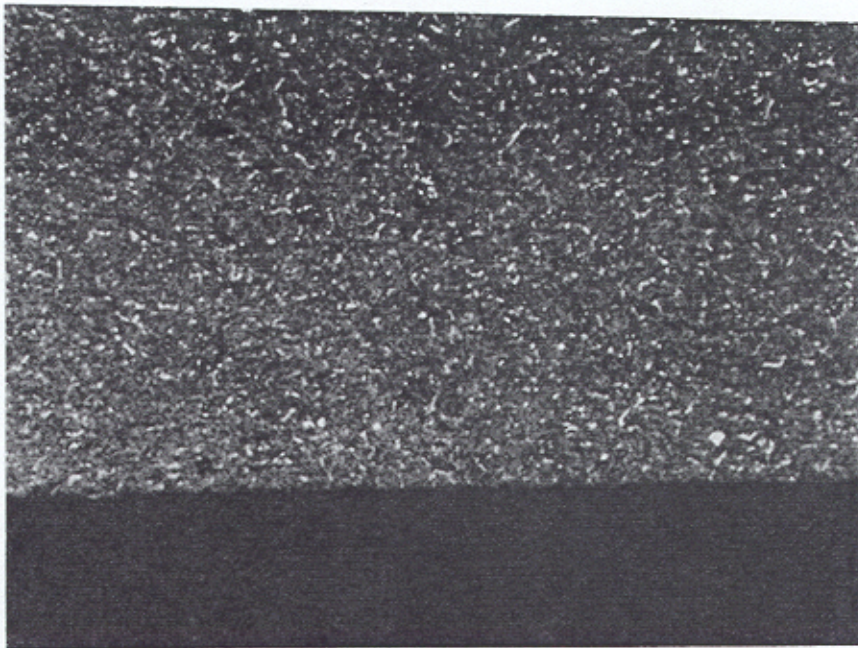
Figure 17. Micrograph of the Damping Ring Groove Metallographic Sample Showing the Case Microstructure Within Area 3 (Vilella's reagent; magnification 400x).

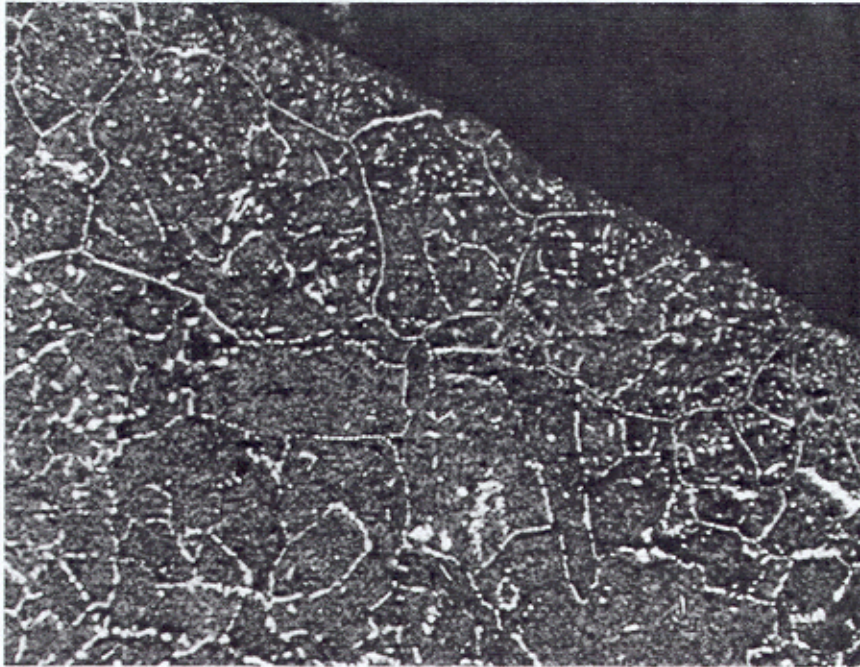
Figure 18. Micrograph of the Damping Ring Groove Metallographic Sample Showing the Case Microstructure Within Area 4 (Vilella's reagent; magnification 400x).

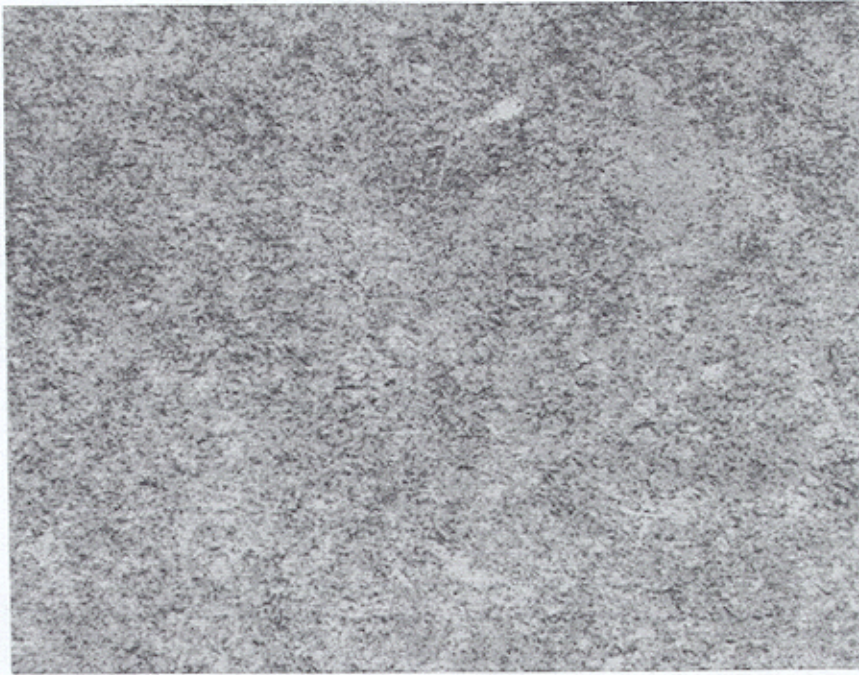
Figure 19. Micrograph of the Core Microstructure of the X-2M Steel Part. (The structure is consistent with the prior treatment; Vilella's reagent; magnification 200x.)

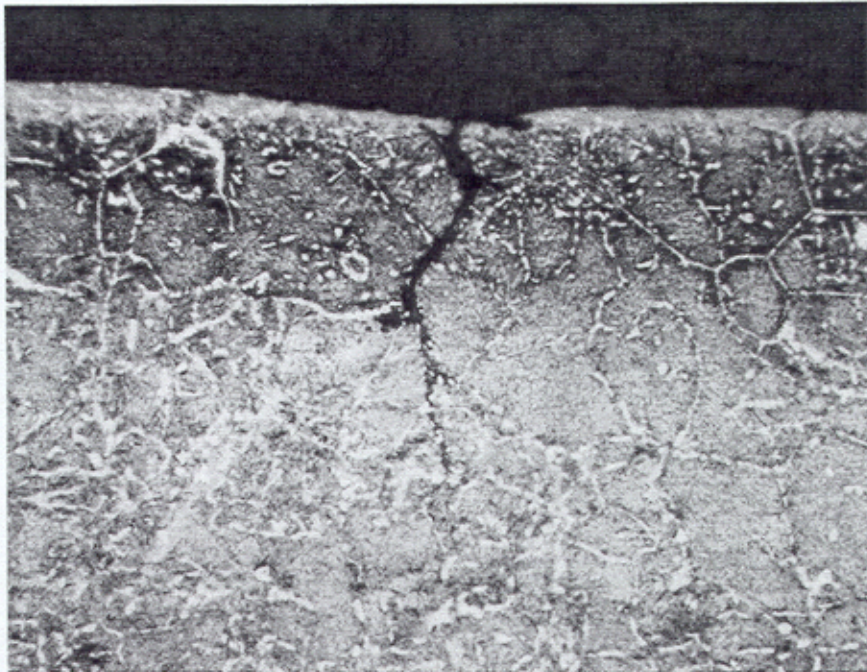
ARL examined a metallographic mount of spiral bevel gear P216, which Boeing had inadvertently included with the P196 gear parts when shipped to ARL. This sample was prepared and etched with Vilella's reagent by Boeing and exhibited the intergranular grinding crack shown in Figure 20. Although this part was not from the failed gear being investigated, and grinding cracks in this material have been known to travel in either an intergranular or transgranular direction, it served as an example of a grinding crack in X-2M steel following the path of a carbide network.

Figure 20. Micrograph of an Intergranular Crack Propagating Along a Carbide Network Noted in Gear P216. (This was not the failed gear being investigated, but this sample provided an example of a grinding crack following the path of a carbide network in X-2M steel; Vilella's reagent; magnification 400x.)

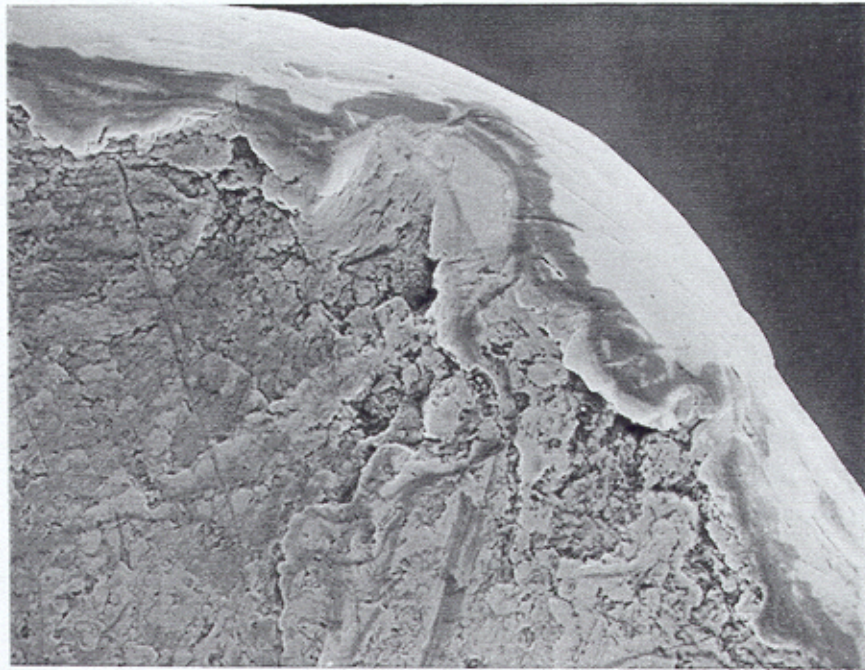
The length of fatigue crack propagation on the fractured part was approximately 1.65 inch, followed by a ductile overload region. The fracture origin was located at a defect within the damping ring groove region. The defect was "half moon" shaped and had a depth of approximately 0.005 inch and a length of approximately 0.015 inch. The defect contained a darkened film, which was considered evidence of a pre-existing crack opened to the surface during the black oxide treatment. Figure 21 shows a micrograph displaying the featureless origin in the backscatter mode. Figures 22 and 23 show a representative fatigue and overload morphology, respectively. The fatigue region was characterized by a transgranular morphology, while the overload region contained ductile dimples as the result of microvoid coalescence. Approximately

Figure 21. Scanning Electron Micrograph of the Fracture Origin. (Note the featureless morphology, common with fatigue fractures; magnification 350x.)

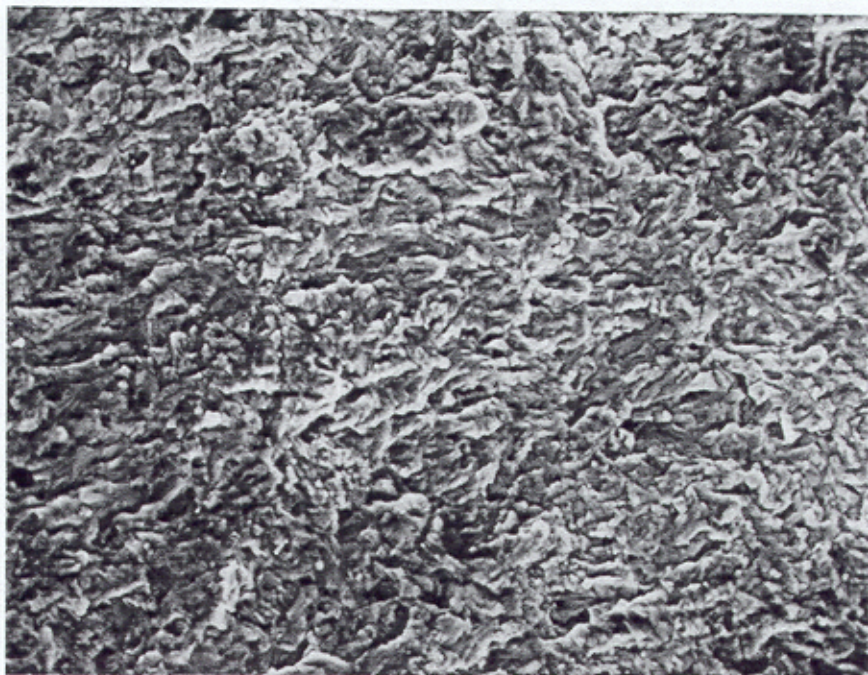
Figure 22. Scanning Electron Micrograph of the Fatigue Morphology, Predominant on the Primary Fracture Surface (magnification 1000x).

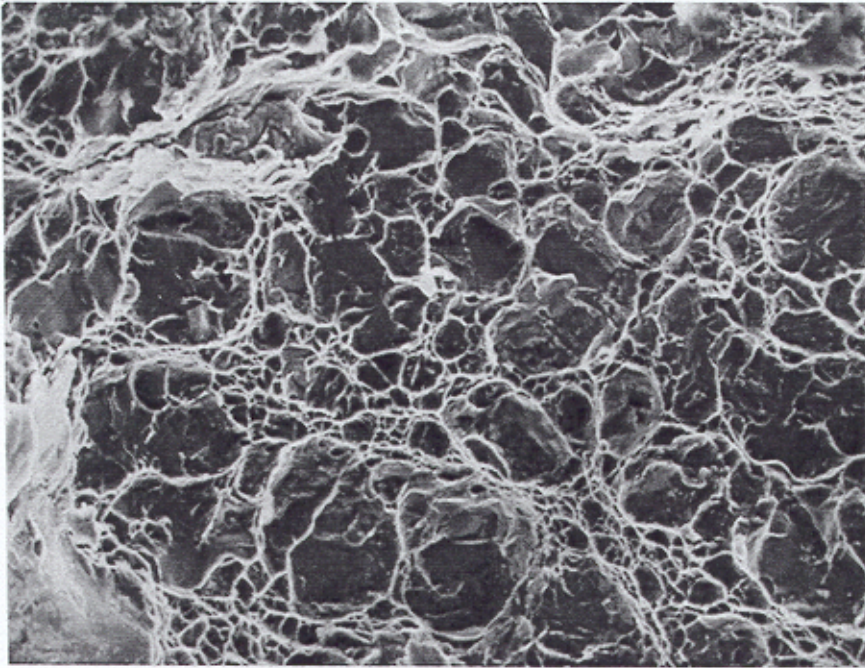
Figure 23. Scanning Electron Micrograph of the Overload Morphology. Noted on the Remaining Primary Fracture Surface (magnification 500x).

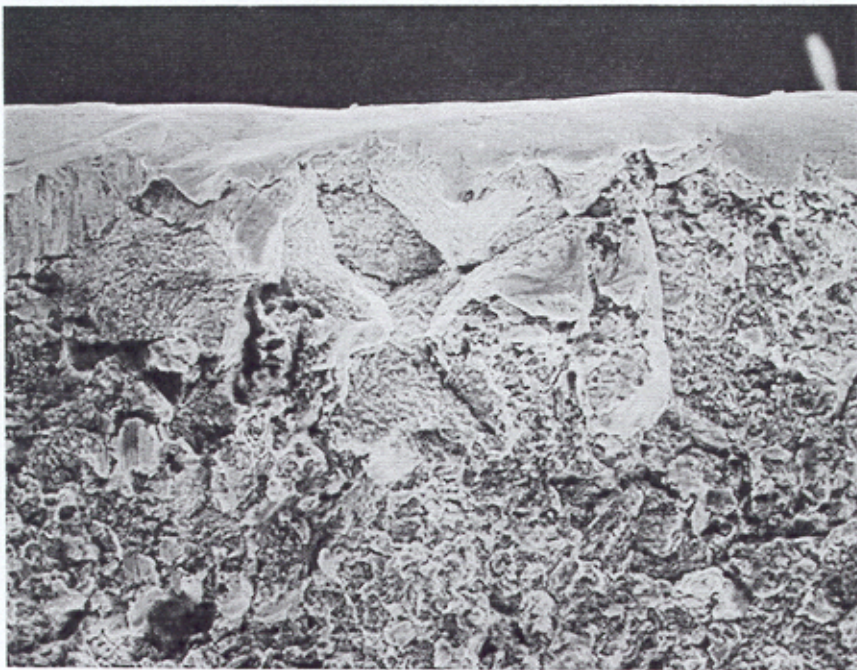
0.08 inch away from the origin along the 30° tapered surface, an intergranular morphology was noted, as shown in Figure 24. This was the region that displayed CCNs during metallographic examination, and it is believed the grinding crack responsible for this failure propagated along these networks.

Figure 24. Scanning Electron Micrograph of the Intergranular Morphology Noted Within the Carburized Case. Noted 0.08 Inch Away From the Primary Fracture Origin (magnification 400x).

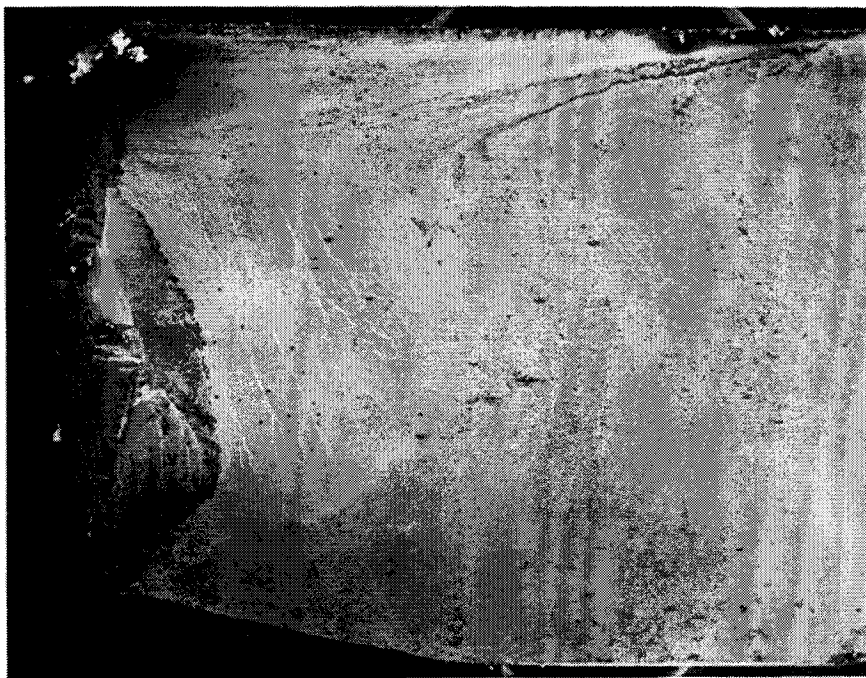
Further evidence of intergranular cracking was observed on a secondary fracture surface. The fracture was a section of the damping ring groove region (away from the origin), as the chamfer between the 30° taper and the 7.125-inch diameter was clearly recognizable. Fractographic examination of this "through crack" revealed an intergranular morphology within the carburized case, in a region similar to that of the fracture origin. Figure 25 shows a portion of the piece examined at low magnification, while Figure 26 shows the intergranular region within the carburized case of the part. Figure 27 shows the grains at higher magnification. Traversing toward the core of the specimen, a transgranular morphology consistent with fatigue in X-2M steel was evident (see Figure 28). Within the center of the specimen, an overload morphology (as shown in Figure 29) was predominant. The intergranular zone measured approximately 0.001 inch deep. The fatigue zone measured 0.008 inch into the core from the end of the intergranular region, and the overload zone measured 0.012 inch deep from the fatigue zone. This finding was evidence that a grinding crack had propagated along the CCNs within the case of the carburized component, then propagated by fatigue until final fast fracture.

Figure 25. Scanning Electron Micrograph of a Portion of a Secondary Fracture Surface. (This fracture occurred in the damping ring groove region, most likely from a grinding crack. The fracture surface contained an intergranular morphology within the carburized case, followed by a fatigue zone, and finally an overload region toward the center of the piece; magnification 20x.)

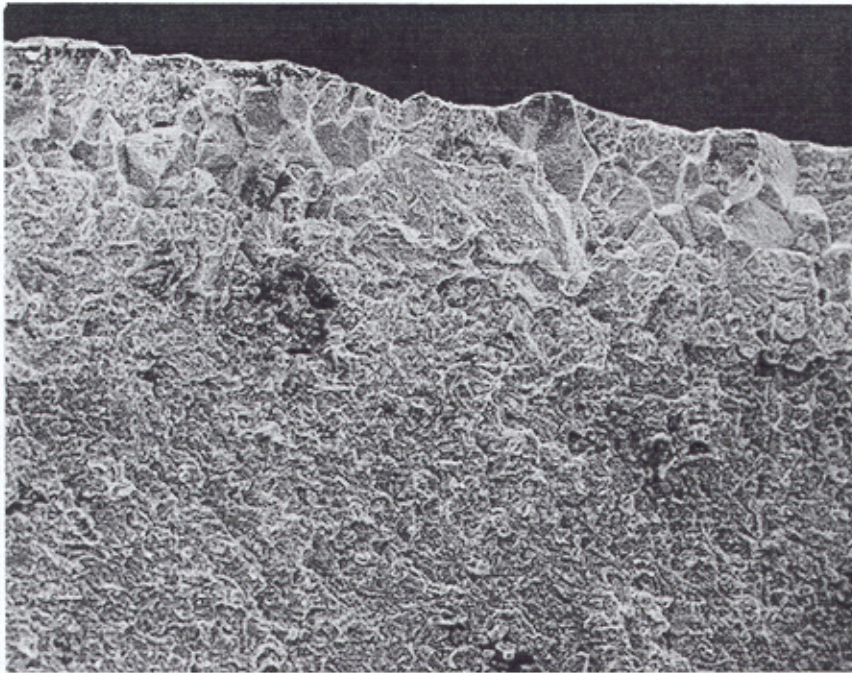
Figure 26. Scanning Electron Micrograph Showing the Intergranular Morphology Within the Carburized Case of the Secondary Fracture (magnification 200x).

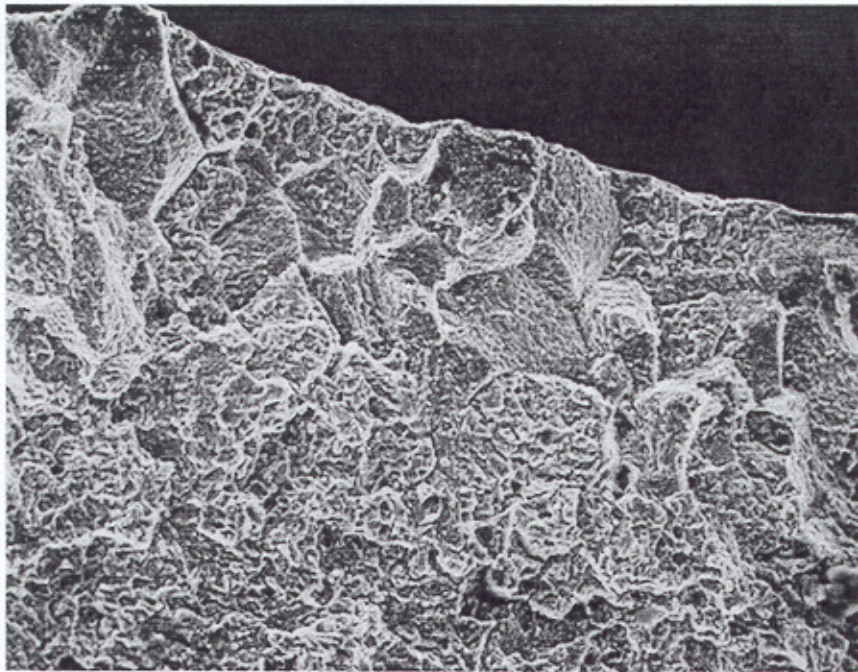
Figure 27. Scanning Electron Micrograph Showing the Intergranular Morphology of Figure 26 at Higher Magnification (magnification 400x).

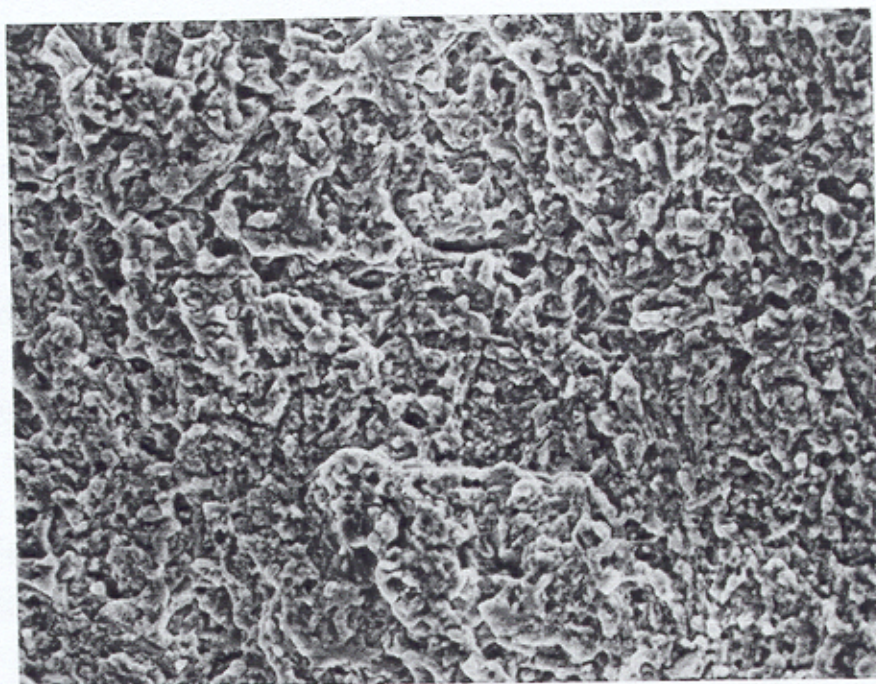
Figure 28. Scanning Electron Micrograph Showing a Morphology Consistent With the Fatigue Region Noted Within the Primary Fracture (see Figure 22). (This region was located between the intergranular and overload zones; magnification 1000x.)

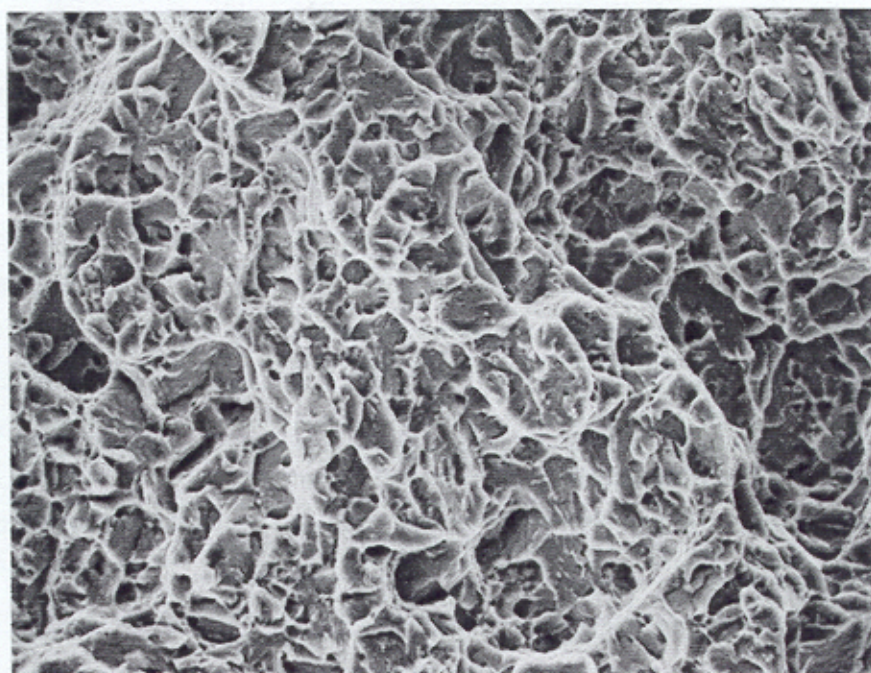
Figure 29. Scanning Electron Micrograph Showing the Overload Morphology Noted at the Center of the Failed Piece (magnification 1000x).
