submitted to Composites Science and Technology
March 1987

**AN IMAGE ANALYSIS TECHNIQUE FOR EVALUATING
INTERNAL DAMAGE IN GRAPHITE/POLYIMIDE
FABRIC COMPOSITES**

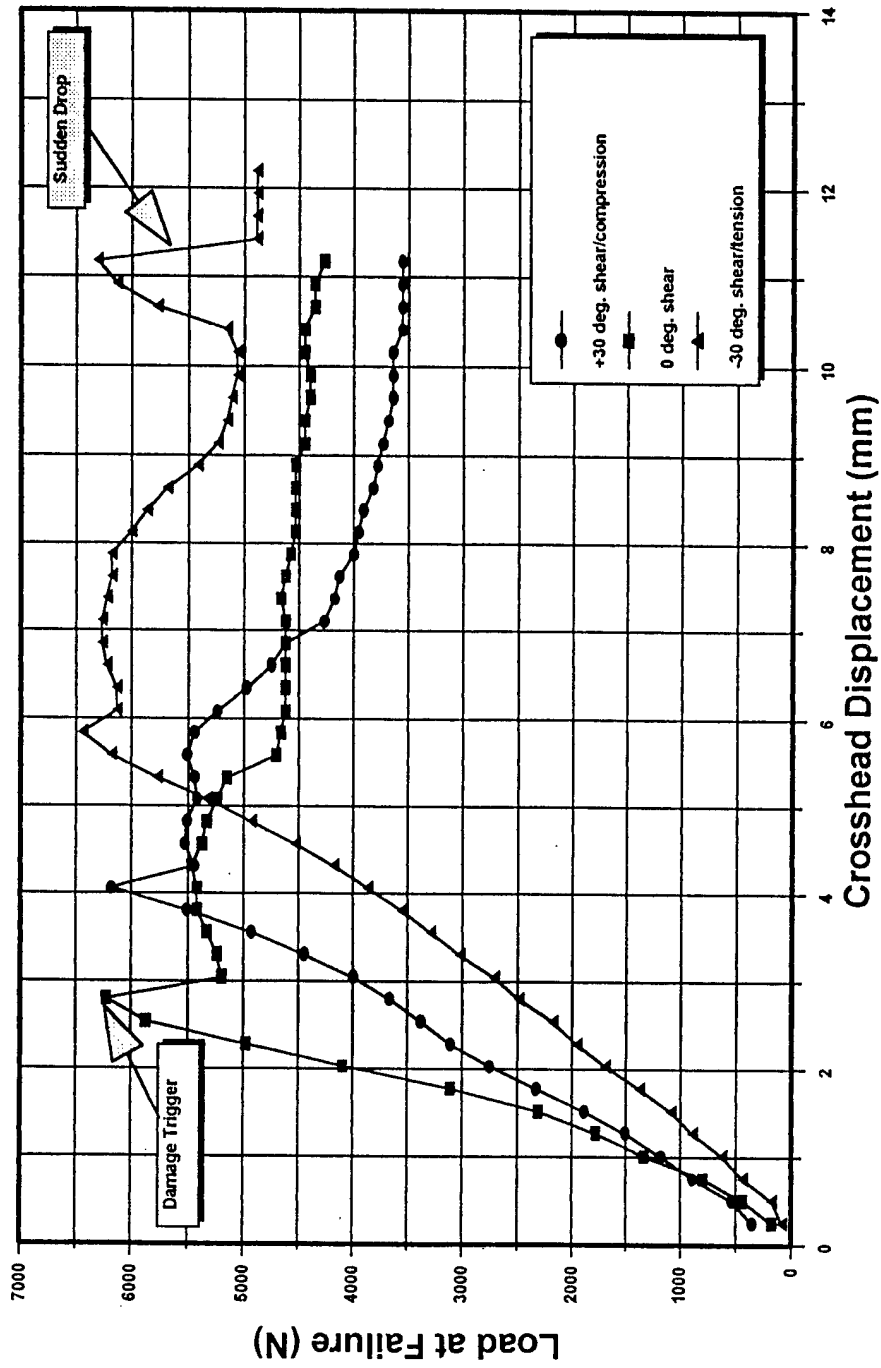
The load/displacement diagrams for the graphite/PMR-15 Iosipescu specimens tested in shear as well as shear/tension and shear/compression are shown in Figure 3. The curves presented in Figure 3 exhibit a maximum load followed by a sudden drop. This phenomenon was observed for all specimens tested in this study. The results also reveal a general trend towards stability of the process after the initial “damage trigger” as compared to graphite/epoxy laminates. Specimens tested under shear/tension loading conditions were the only exceptions to those observations. Here, the tests resulted in a significant increase in load for very high displacements followed by another “trigger”. In all cases, this process repeated itself two to three times.

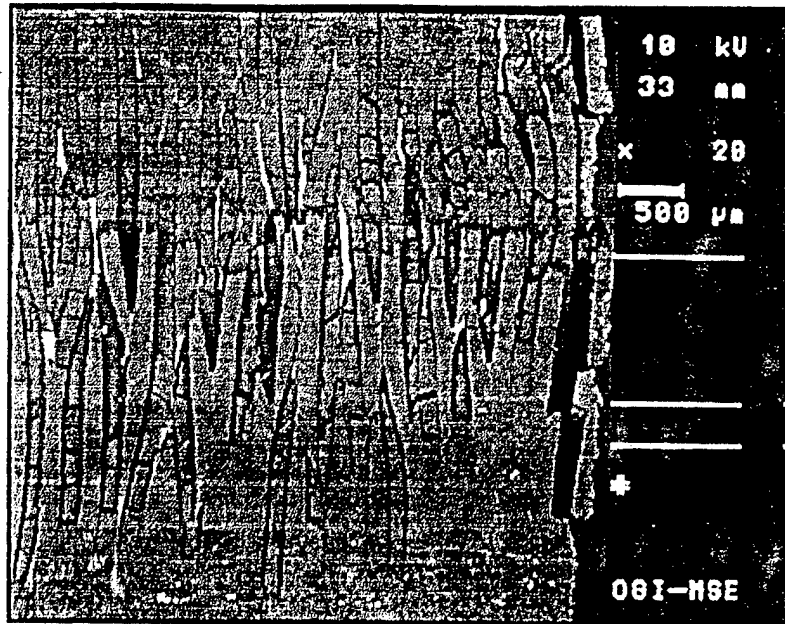
Figure 4

1. Large damage zones developed in the gage section of the specimens were observed. The zones consisted of multiple surface cracks (see Figure 4).

4. Scanning electron microscope (SEM) micrograph of cracking within the notch root as viewed looking from the top
5. Scanning electron microscope (SEM) micrograph showing the out-of-plane deformation and internal cracking

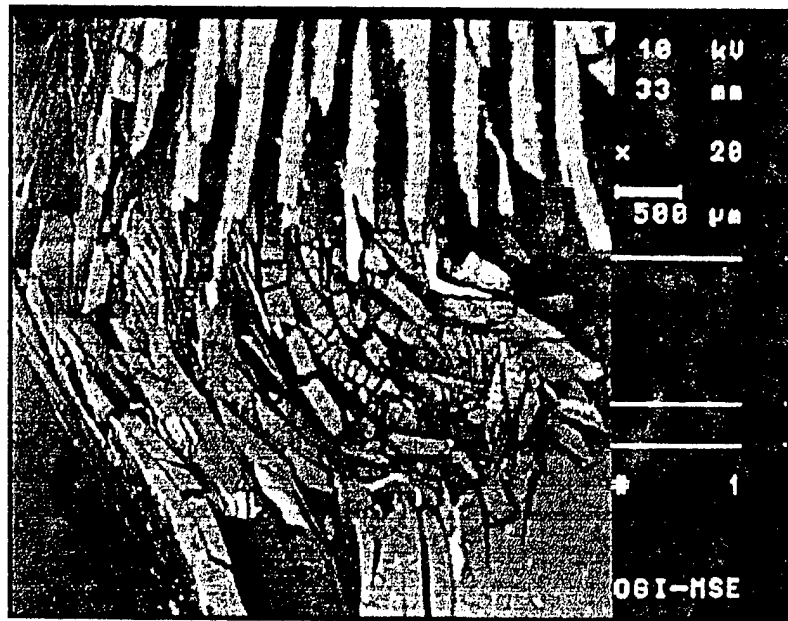
Figure 5

2. The damage zones were associated with significant and permanent out-of-plane deformations (bulging) on the surfaces of the specimens (see Figure 5). It seems that the specimen surface bulging developed just before the "damage trigger".
3. The damage zone morphology was almost identical for all loading angles. It appears, however, that damage zone size was slightly smaller in those samples tested in shear/compression in comparison to the zones developed under biaxial shear/tension loading conditions.

Simultaneously, the ends of the specimen move toward the center and kinking occurs. At some critical point during the loading process, interlaminar cracks develop and propagate, allowing the specimen to bulge outward from the centerline as shown in Figure 5. If the fracture toughness of the interfaces between the layers is low, some of the interlaminar cracks can propagate catastrophically along the specimen causing the load drops.

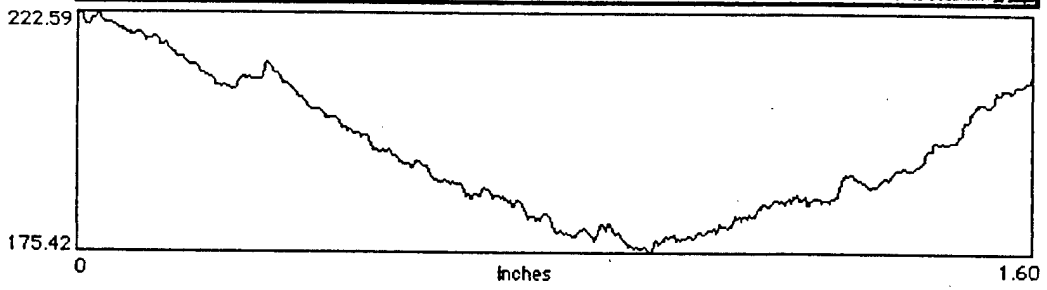
Figure 8

Figures 8 and 9 present two-dimensional maps for the shear tested graphite/polyimide Iosipescu specimen. The damage maps represent damage generated at the specimen center (Figure 8) and an area very close to the notch root (Figure 9), respectively. Each map denotes an approximate area on the specimen of 9 mm². Below each pixel-by-pixel averaged composite map a profile plot is presented showing the relative pixel contrast intensities by average gray values as a function of image width. The profile plot illustrates where the majority of cracks is distributed across each map and gives an indication of the size of cracks compared to the width of the map. From these maps, the location of damage in the examined areas can be estimated. Moreover, the crack propagation directions can also be determined.

It is quite possible that the diagonal perimeters shown on the map represent a combination of intralaminar failures at the fiber bundle-matrix interfaces and failure at weave (warp/fill) undulations or "crimps".

Very little cracking is evident in the longitudinal direction (direction parallel to the long axis of the specimen). Vertical cracks (damage zones) dictated by much larger areas seem to represent the interlaminar failure process between the layers. It is possible that one or several of the vertical cracks could be associated with the load-drops shown in Figure 3. It is assumed that the shearing process forces the bundles to rotate and fail at the undulations as progressive intralaminar damage develops.

It is obvious that the amount of damage generated in the specimen center is significantly higher in comparison with the area close to the notch root. Therefore, it can be concluded that the specimen developed large shear stresses at its center without any stress concentrations present at the roots of the notches. This effect will most likely be observed in the specimens tested under the biaxial shear/tension and shear/compression loading conditions.

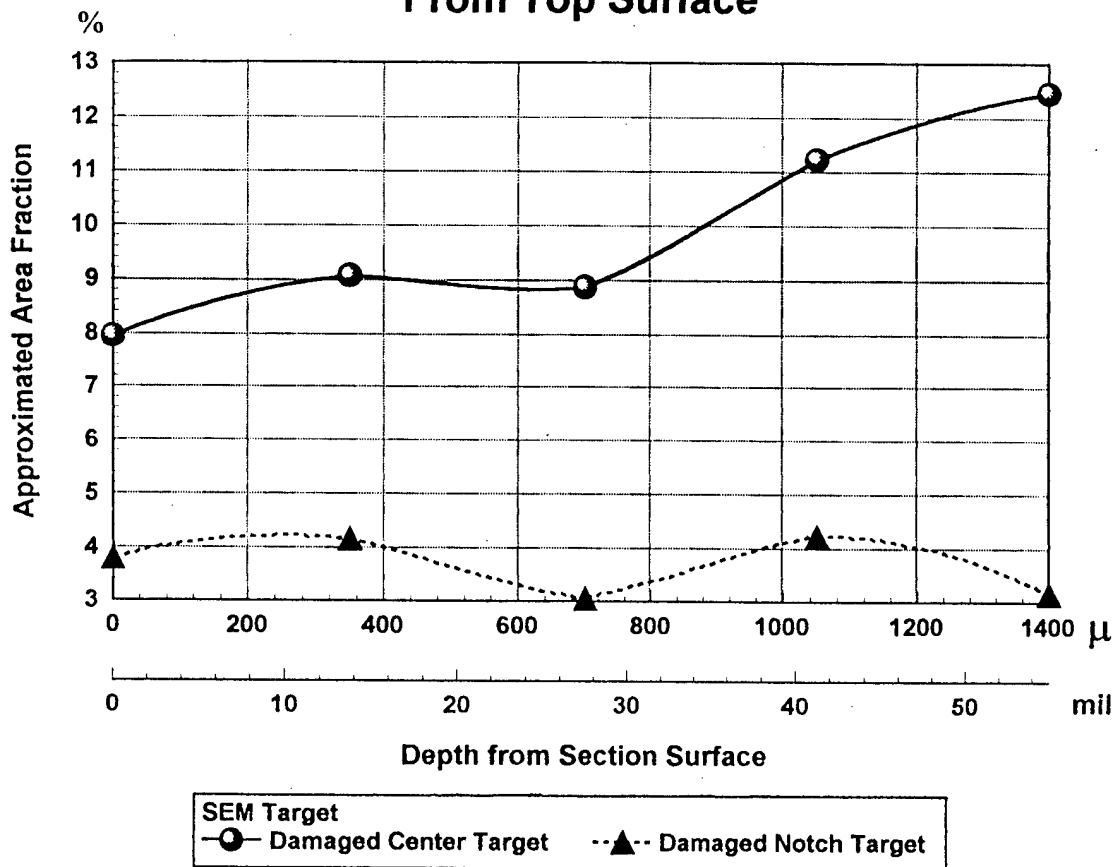
Damage area fractions represent the ratio of crack-inclusive areas to the total area. In this study, all images captured retained a 230,400 sq. pixel area or 480 x 480 resolution. Figure 12 illustrates the difference between the center and notch target measured damage as a function of depth from the surface. Clearly, damage accumulated near the Iosipescu specimen upper notch is less significant compared to the center. Also, the notch target area fraction oscillates between 3-4%, while the center target area fraction progresses from 8-12.5%. It appears that the shear initiated, catastrophic failure (the load drop in Figure 3) may originate near the specimen centerline and propagate outwards through the thickness and the specimen length. Figure 13 compares respective targets in the untested material, showing ranges from 0.3-0.68%. These results seem reasonable and tend to enforce the belief that polishing does not significantly alter the state of the material after testing.

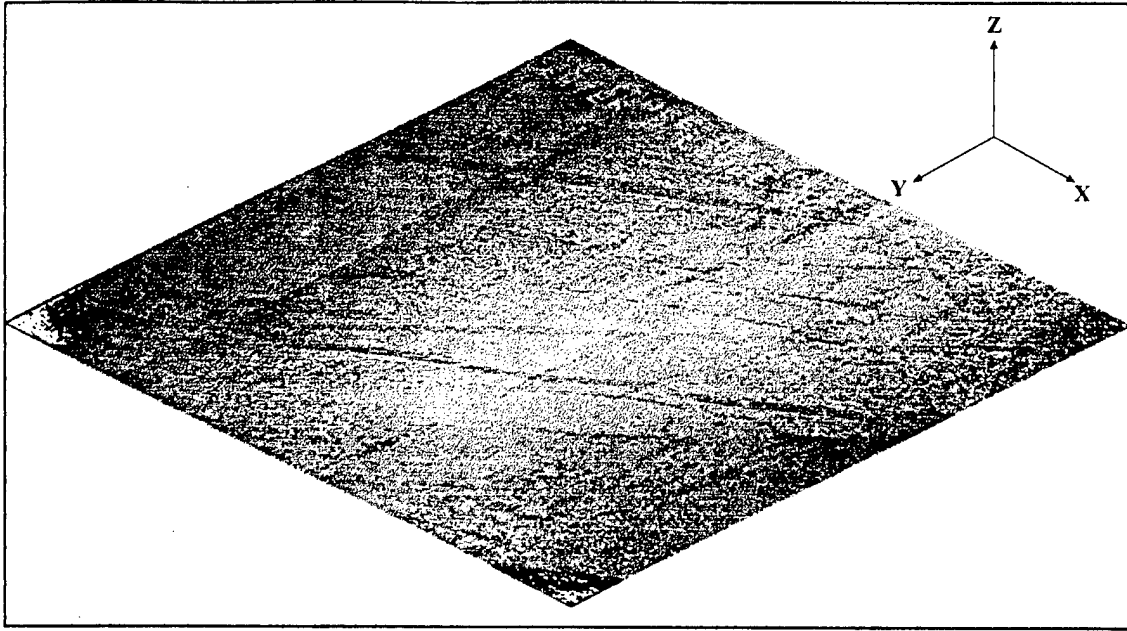
Figure 14a

Figures 14a and 14b show the projected three-dimensional reconstruction of the center and notch SEM targets from an assembly of index pairs 00-04. It can be seen from these figures that damage near the notch is not as pronounced and the majority of cracks follow diagonals similar to patterns where the warp/fill undulations are located. The projections give the illusion of transparency, but they actually represent a compilation of depth and intensity maps derived from the two-dimensional crack-laden stack averages. The darker corner areas are portions of the holes used to align each image from surface to sub-surface in sequence.
