**ENERGY SURVEY OF  
EISENHOWER ARMY MEDICAL CENTER  
FORT GORDON**

**AUGUSTA, GEORGIA**

**NARRATIVE REPORT**

**DECEMBER 23, 1996**

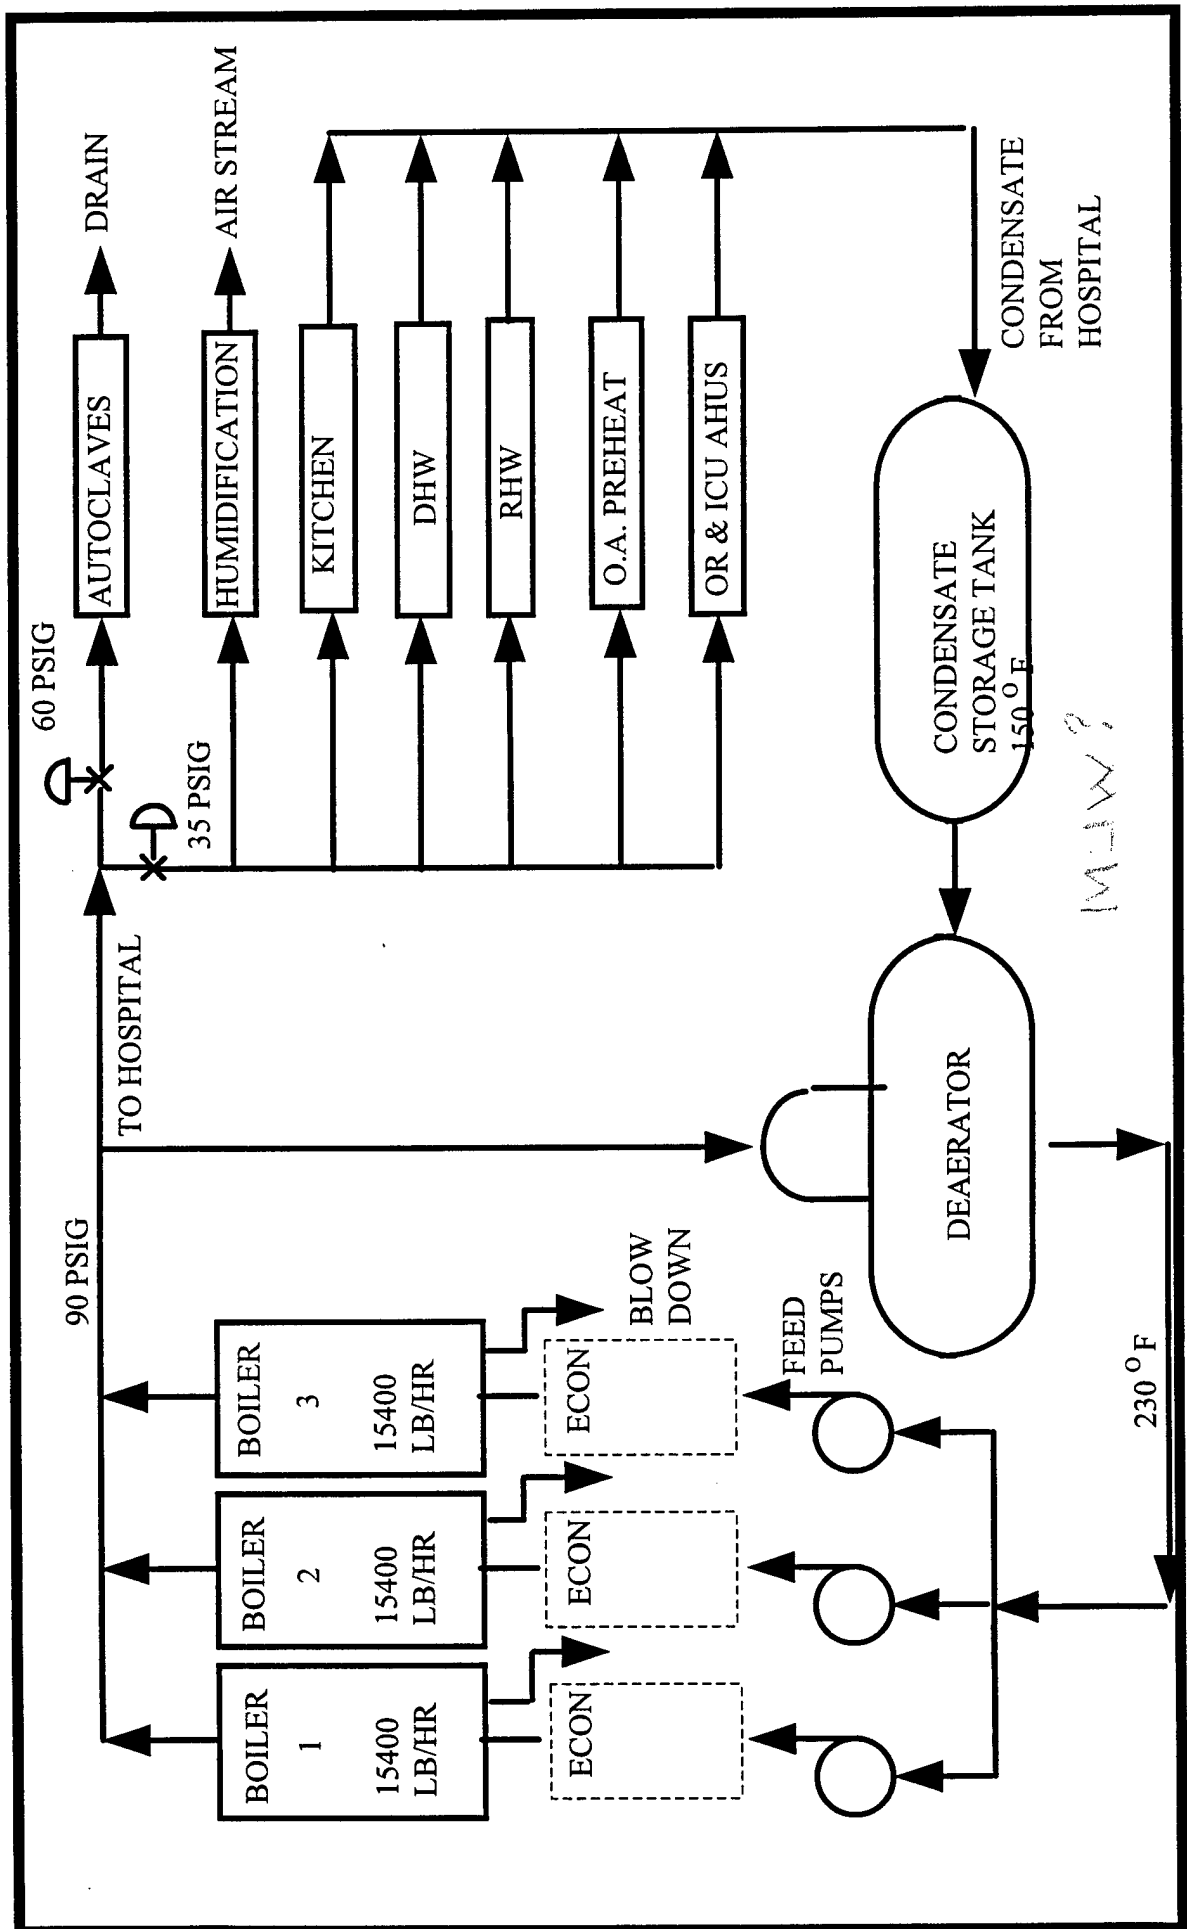
Figure 2.2-3

The boilers now operate at 75-90 psig supplying steam to the hospital (see Hospital Loads below for steam uses); and to the adjacent barracks for space heating and domestic hot water. Condensate from both locations is returned. Natural gas is used almost exclusively. Typically, only one boiler is needed to meet loads. The peak winter demand has never required more than two boilers. This was confirmed when we reviewed the boiler operating logs. Figure 2.2-4, which was generated from boiler log data, shows that only in the coldest weather would more than one boiler be required.

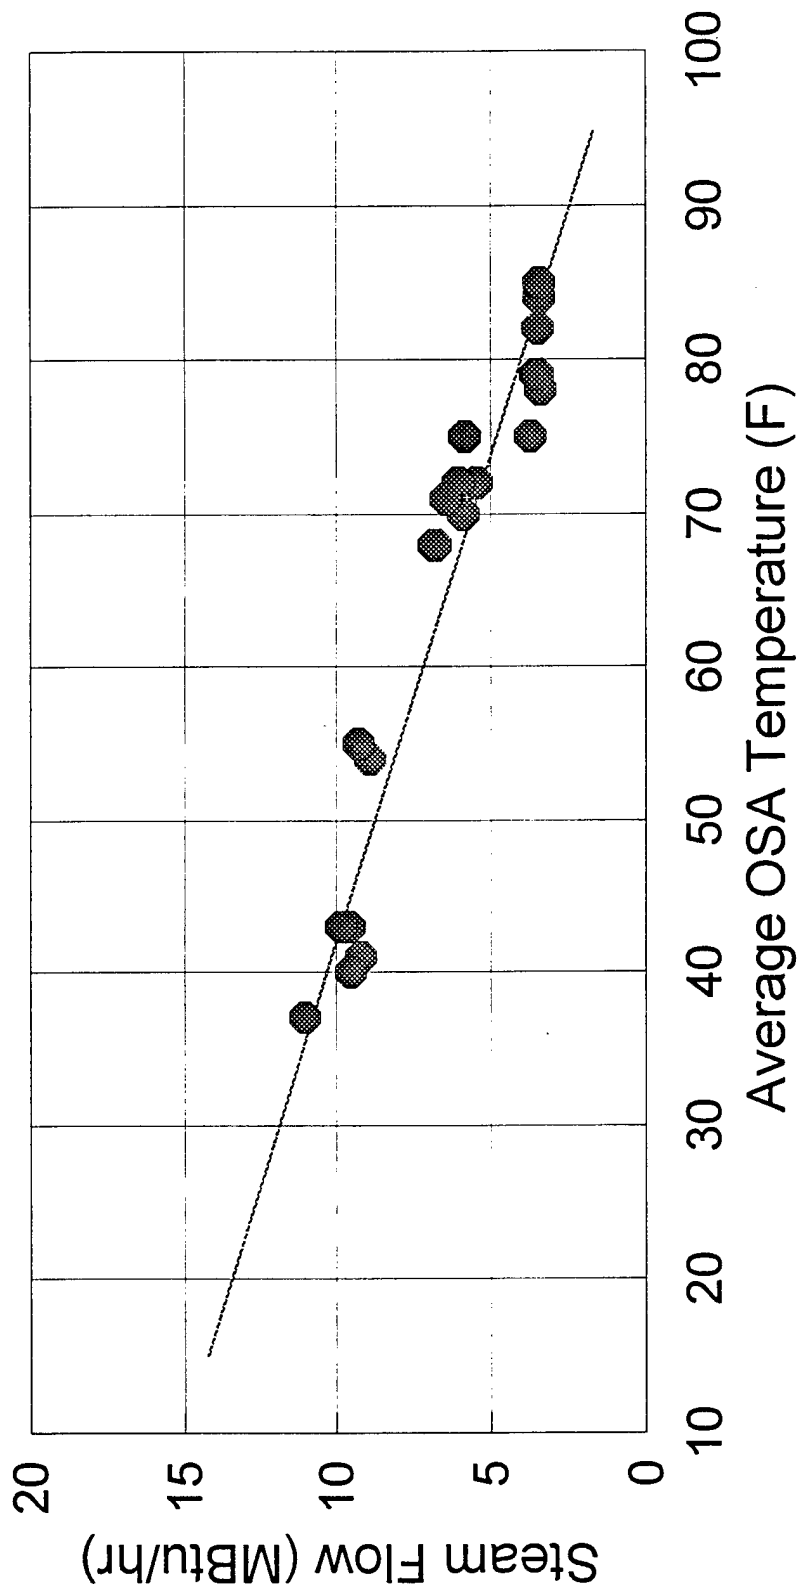
Figure 2.2-4

We did, however, note many problems with boiler operation. The boiler steam pressure is changing rapidly (spiking) resulting in sudden demand for, or reduction of, steam flow. The magnitude of the steam flow change can be as much as 40 percent of boiler capacity. The frequency of these episodes are as often as four to six times per hour and continue around the clock. (On a survey trip in June 1996, cycles with periods of 40 seconds were observed.) A review of past boiler recorder charts reveal that this phenomena has been occurring for many months. This continual spiking is causing drum level swings that can become nearly unmanageable. Often, the operator must put another boiler into service to dampen the swings to regain control of the drum level. The air flow and fuel flow are swinging with each spike.

**Feedwater.** The feedwater is nearly out of control. The drum level is swinging between 15 percent and 85 percent of the site glass range. The feed water valve is not modulating; it is either open or closed. This "on/off" feedwater operation slug feeds the steam drum with relatively cold water. Normal drum water level is two inches below the center line of the drum. A properly operating drum level control loop should control the drum level to within  $\pm$  one inch of the normal operating level.

All boilers and associated controls are to be replaced as part of the FY96 Renovation Project.

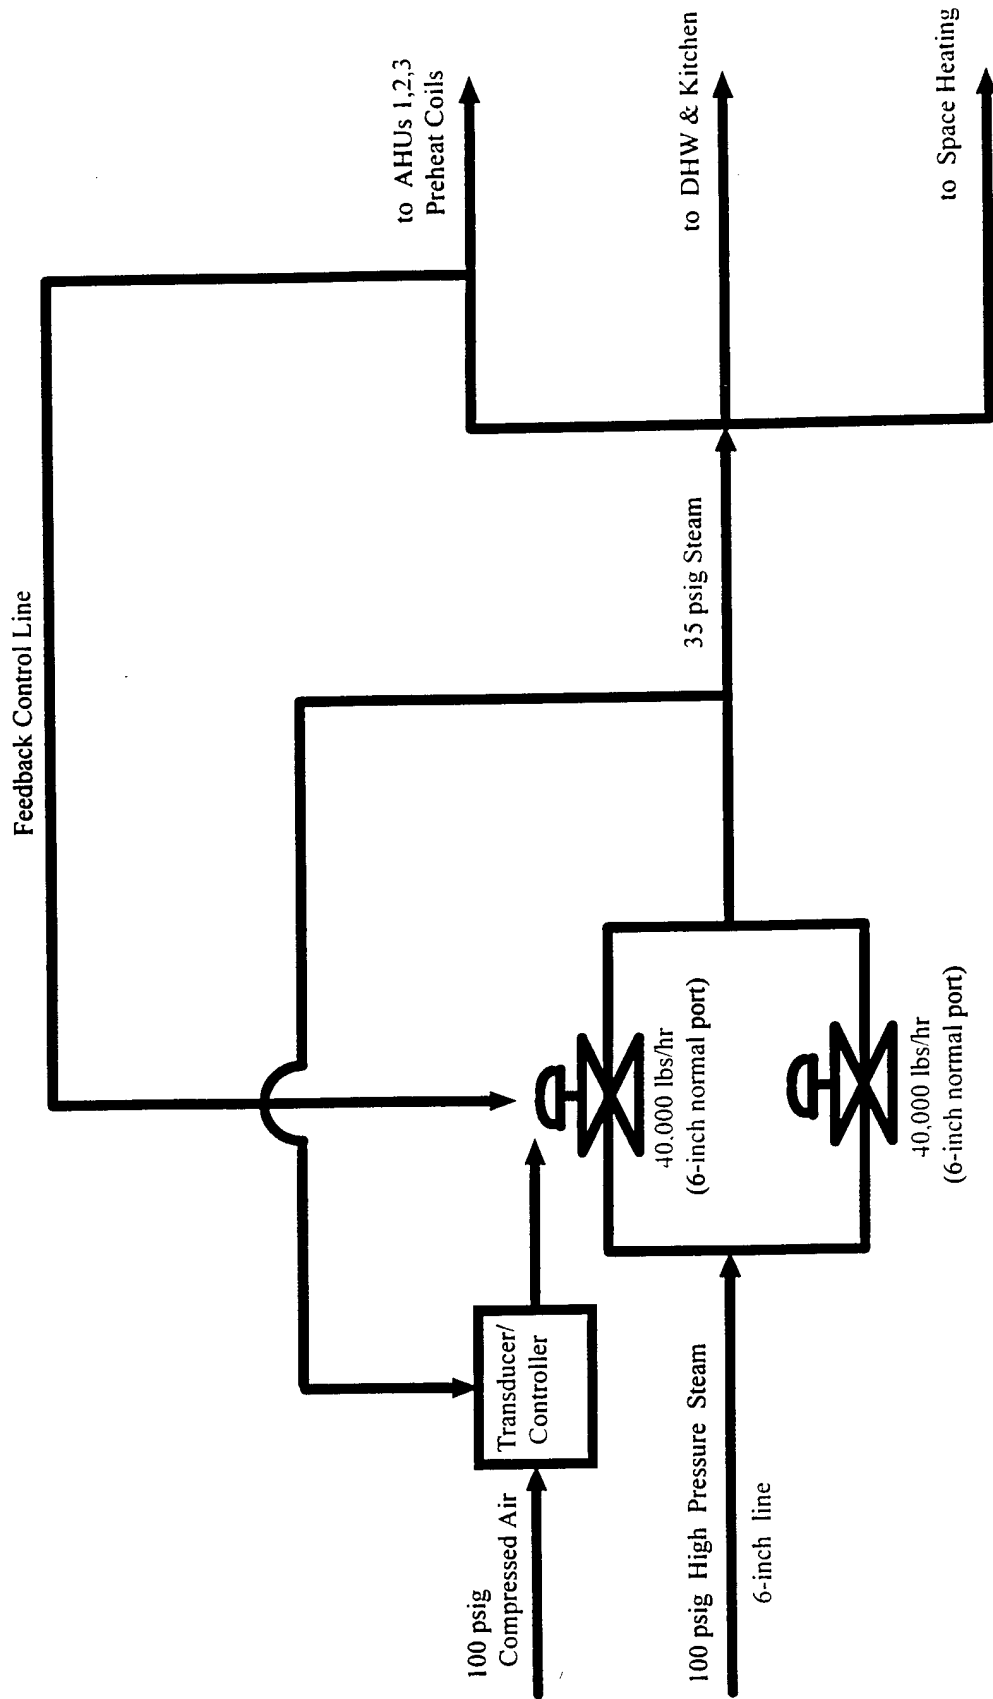
Figure 4.3-8 Hospital Low Pressure Steam Pressure Regulating Value Station - Current Configuration  
(both valves are controlled with the same signals - only one is shown here)

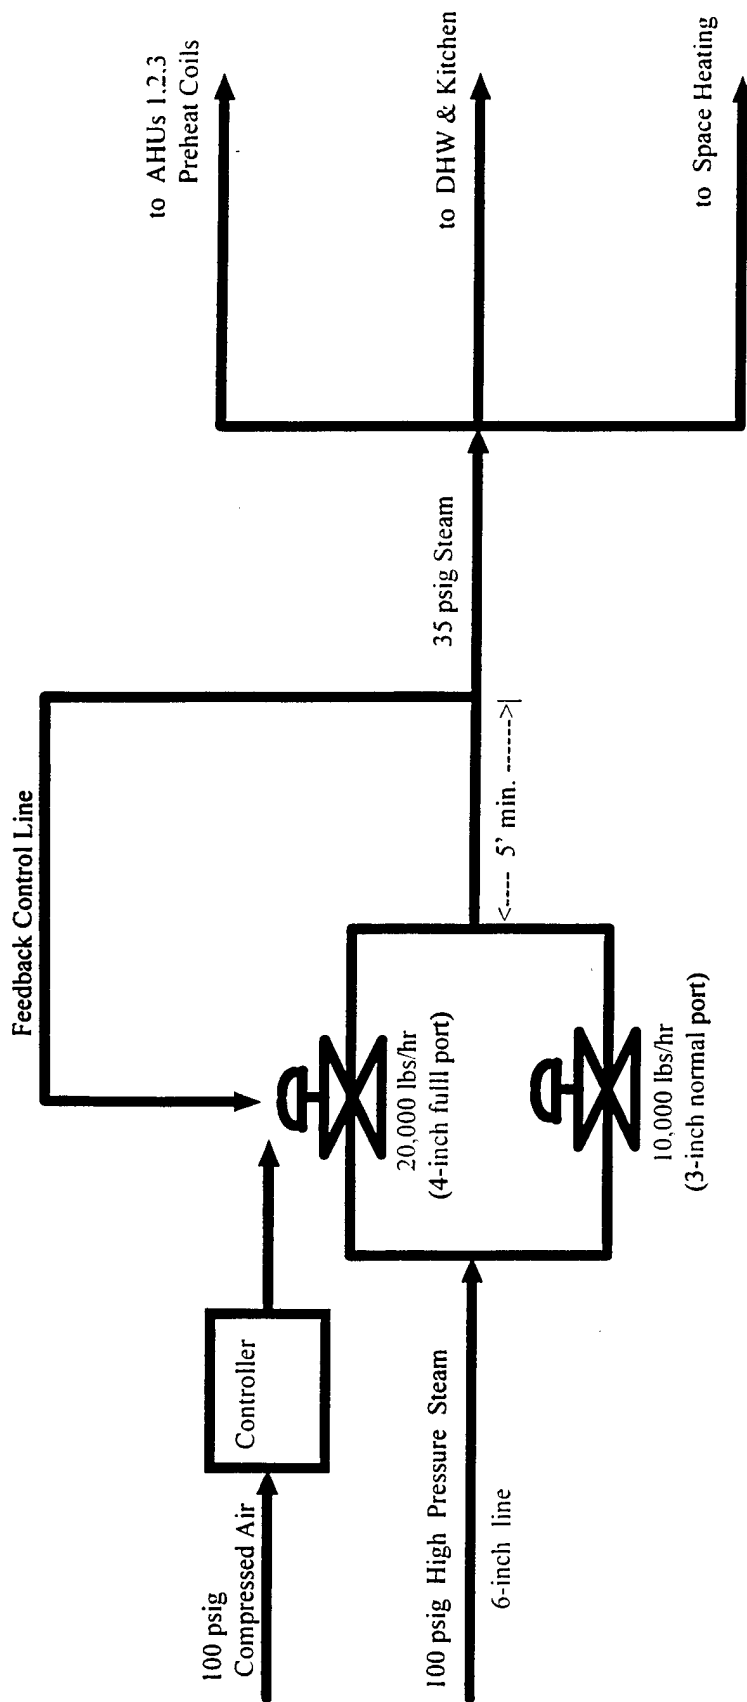
Figure 4.3-9 Hospital Low Pressure Steam Pressure Regulating Value Station - Proposed Configuration  
(the smaller valve leads in a lead/lag operation)

The proposed design is shown in Figure 4.3-9. The feedback signal should be relocated immediately downstream of the PRV station, but at least five feet from the last point of turbulence. The line should slope downward going away from the valve. The old setpoint signal tap may meet these requirements.

The pilot setpoint signal should be fed directly from a stable compressed air source through a controller that can provide a stable, constant air pressure.

The 10,000 lbs/hr valve controls would be set to open the valve before the larger valve. The small valve will be able to handle the loads until the outside temperature drops below about 40 degrees F (see Figure 2.2-4, p. 2-19). This occurs about 900 hours per year; therefore, the smaller valve will handle the load 90 percent of the year. The larger valve control setpoint should be slightly lower than the smaller valve. The larger valve will only open when the smaller valve cannot handle the load.
