TRI-SERVICE CONFERENCE ON CORROSION

21-23 JUNE 1994

Shipboard Exposure Testing of Aircraft Materials

Edwin S. Tankins*, J. Kozol & E. Lee

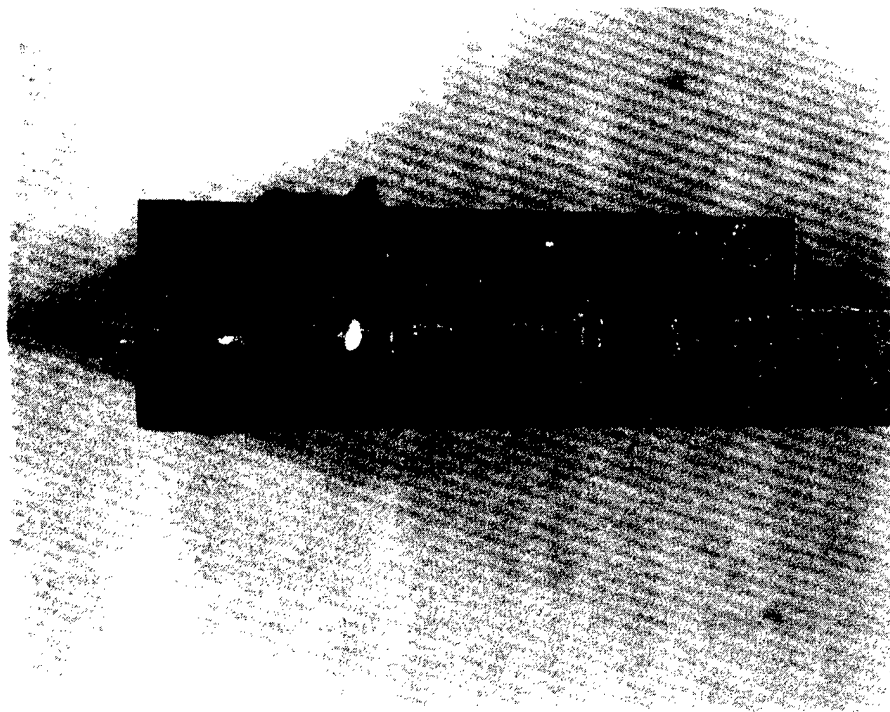
Fig. 5 - Side view of 7075 - T6 alloy showing extensive Oxidation.

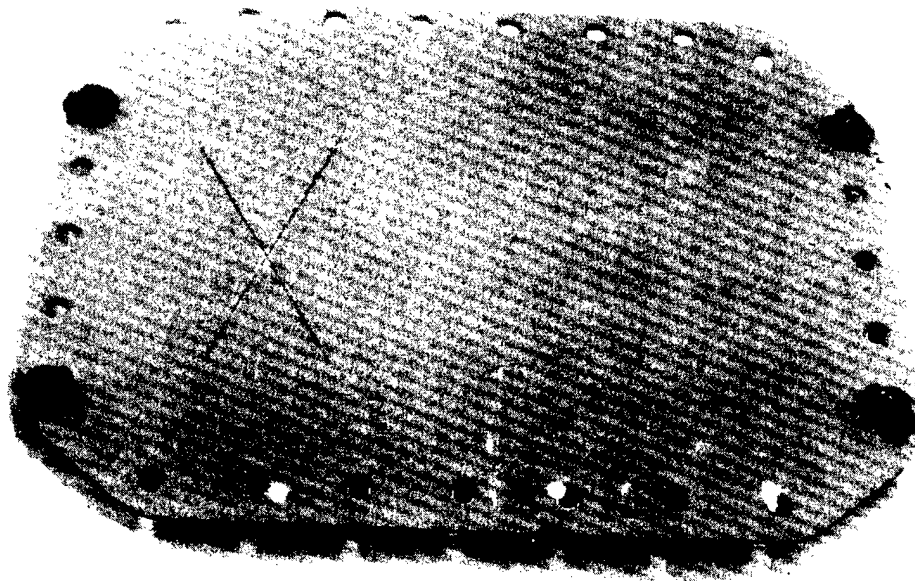
7075 T6
(a)

After 2 years at Key West, Florida, a small amount of incipient exfoliation appeared on the T/2 plane of the 7075-T6. Figure 6a compares access panels of 7075T6 and 209078 Al-Li alloy for the F/A-18. Figure 6b shows what looks like a slight blistering at the scribe mark. By comparison Fig 6b looks clean at the scribe marks. The behavior is basically comparable.

Fig. 6 - Access Panel from F/A - 18 with Scribe Marks.
