## Electroplating and Epoxy Repair Methods for Corroded 70/30 CuNi and Alloy 400 Seawater System Components.

Mr. Timothy J. Jackovic\*  
Mr. Edward B. Bieberich

Carderock Division  
Naval Surface Warfare Center  
Code 613  
3A Leggett Circle  
Annapolis, MD 21402-5067

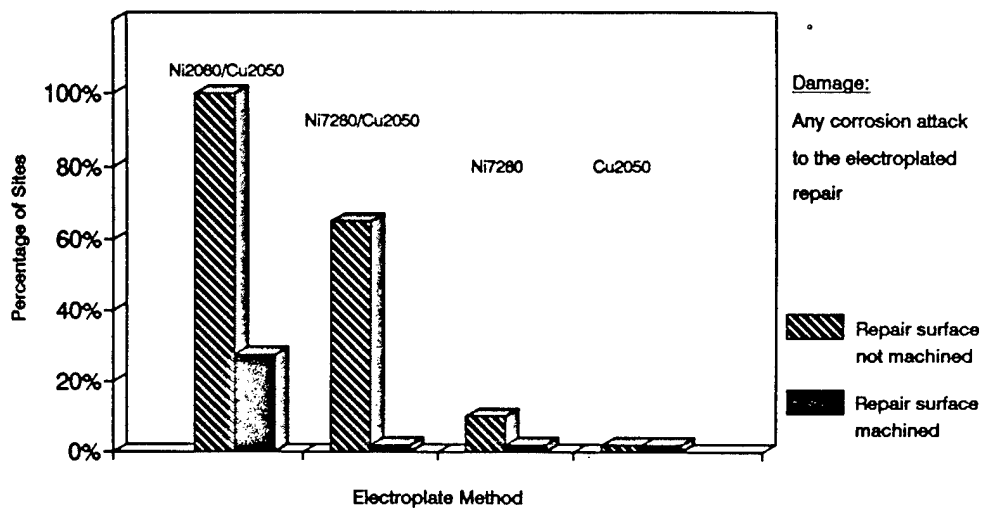
The electroplate repairs were considered to have failed when any corrosion damage occurred to the electroplate. Results of this evaluation are provided in Figure 3.

Figure 3: Results of electroplate repair corrosion tests.

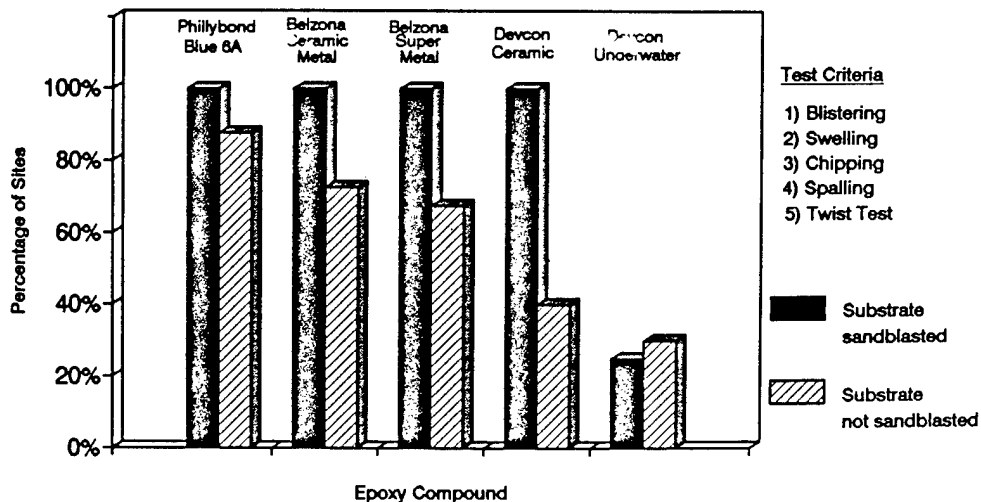
The epoxy coatings were rated as having passed or failed based on the following conditions for failure: blistering, chipping, spalling, swelling, or movement of the coating. The coatings were also considered failures if they could be twisted off by hand. The results of this inspection are provided in Figure 4.

Figure 4: Results of epoxy repair corrosion tests.

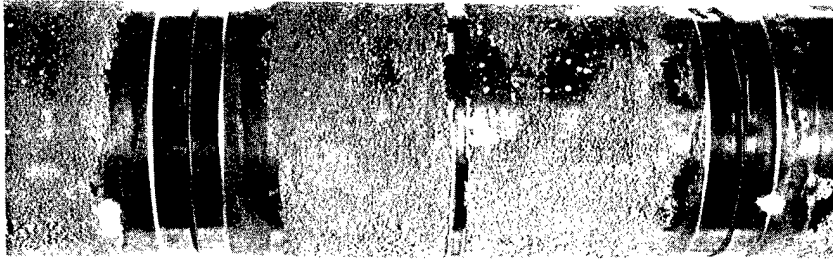
Cu2050 performed poorly as an O-ring sealing surface repair on both 70/30 CuNi and alloy 400. Cu2050 was found to be less noble than either substrate material and subsequently the O-ring seal area was damaged by galvanic corrosion, Figure 5. The corrosion was most severe adjacent to the O-ring which suggests that crevice corrosion was also a factor. Cu2050 was able to suppress some corrosion of the substrate, including reduced attack at the control sites. However, once the copper was sufficiently depleted, crevice corrosion of the substrate initiated. Electroplating with copper over a large surface area may suppress corrosion for a limited time, but the electroplate will galvanically corrode away leaving the original damaged area. It is recommended that Cu2050 not be used as a repair method on 70/30 CuNi or alloy 400.

Figure 5. Control site (middle) and corroded electroplated sites on alloy 400 specimen electroplated with Cu2050.

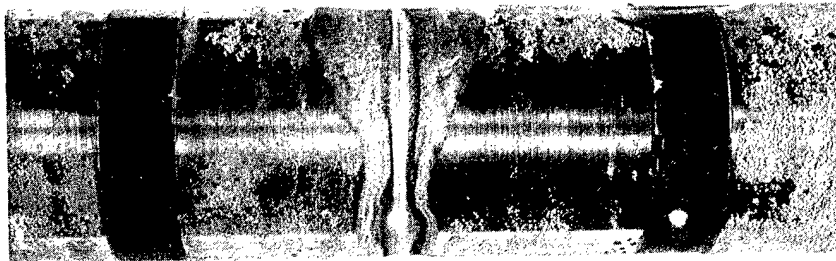
The PS specimens which had the grooves sandblasted prior to application of the epoxy showed superior resistance to failure. When sandblasted, 4 of the 5 epoxies had no failures on type I specimens. A representative specimen showing the good performance of epoxy is shown in Figure 7. Surface preparation is extremely important when applying mechanically bonded materials [2]. The roughened surface produced from sandblasting significantly increases the bond strength and therefore provides a longer lasting coating. Wherever feasible, it is recommended that sandblasting be done on all surfaces which are to be repaired by epoxy. Methods to sandblast limited access areas (eg., narrow width O-ring grooves) and to sandblast small areas on components aboard ship (without grit dust in the air) should be developed.

Figure 7. Control site (middle) and epoxy repaired sites on alloy 400 specimen repaired with Phillybond Blue 6A.

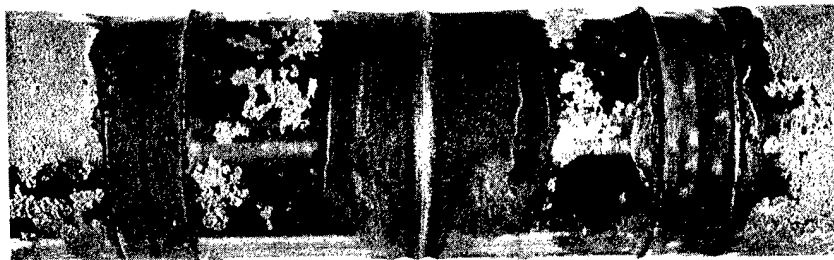
Most failures of epoxy coatings were seen on unsandblasted and type II specimens. These failures were caused by poor adhesion of the coatings allowing seawater to leak under the coatings. The Devcon Underwater had the worst performance of any of the epoxy repairs, Figure 8. Seawater leakage under this coating caused blistering and spalling of the coating. Of the 80 sites that were repaired with Devcon Underwater, 58 failed. Sandblasting of the grooved surface did not improve this coating's resistance to failure.

Figure 8. Control site (middle) and blistered epoxy repair sites on alloy 400 specimen repaired with Devcon Underwater.
