Access Study to all Pertinent Parts of
Dam Projects During High Reservoir
Conditions

Upper Connecticut Basin New Hampshire and Vermont

JULY 1992

US Army Corps
of Engineers
New England Division

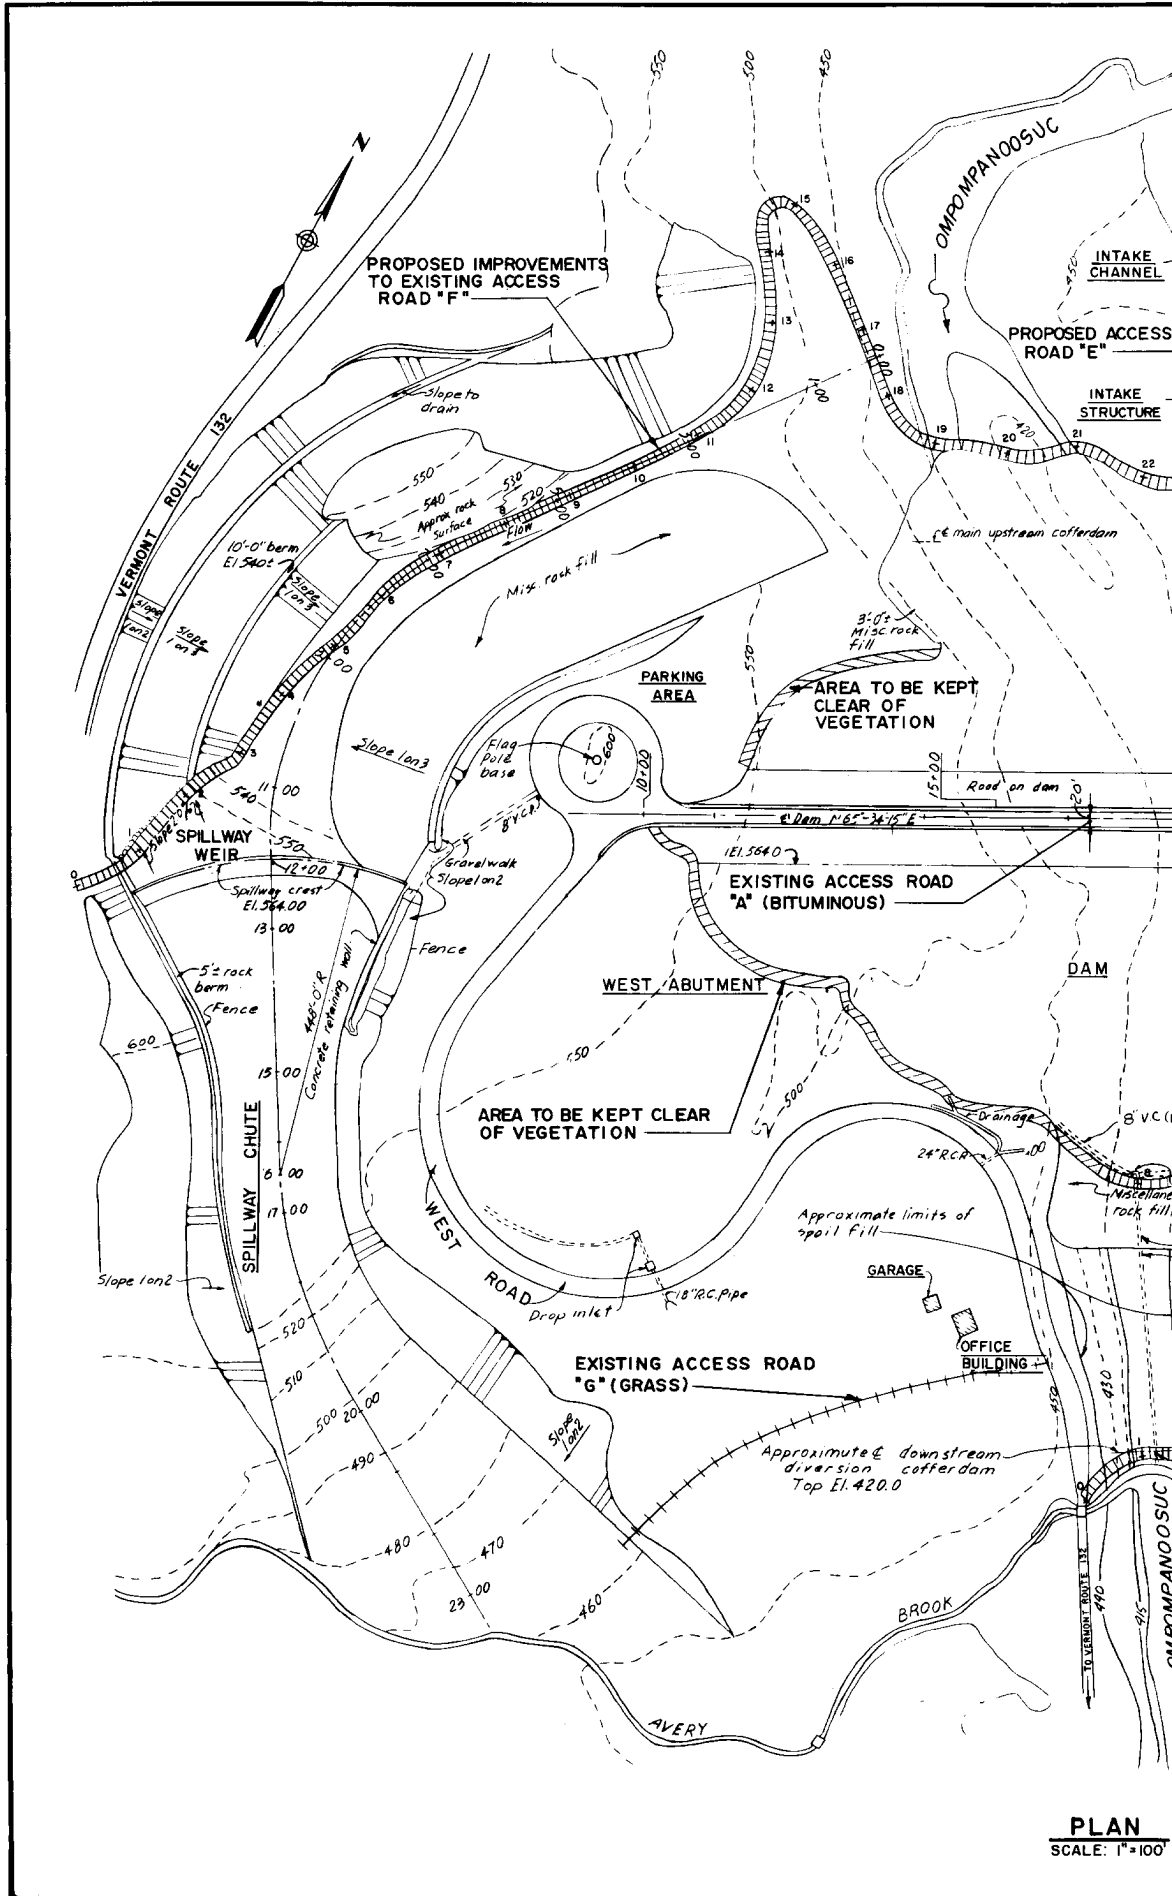
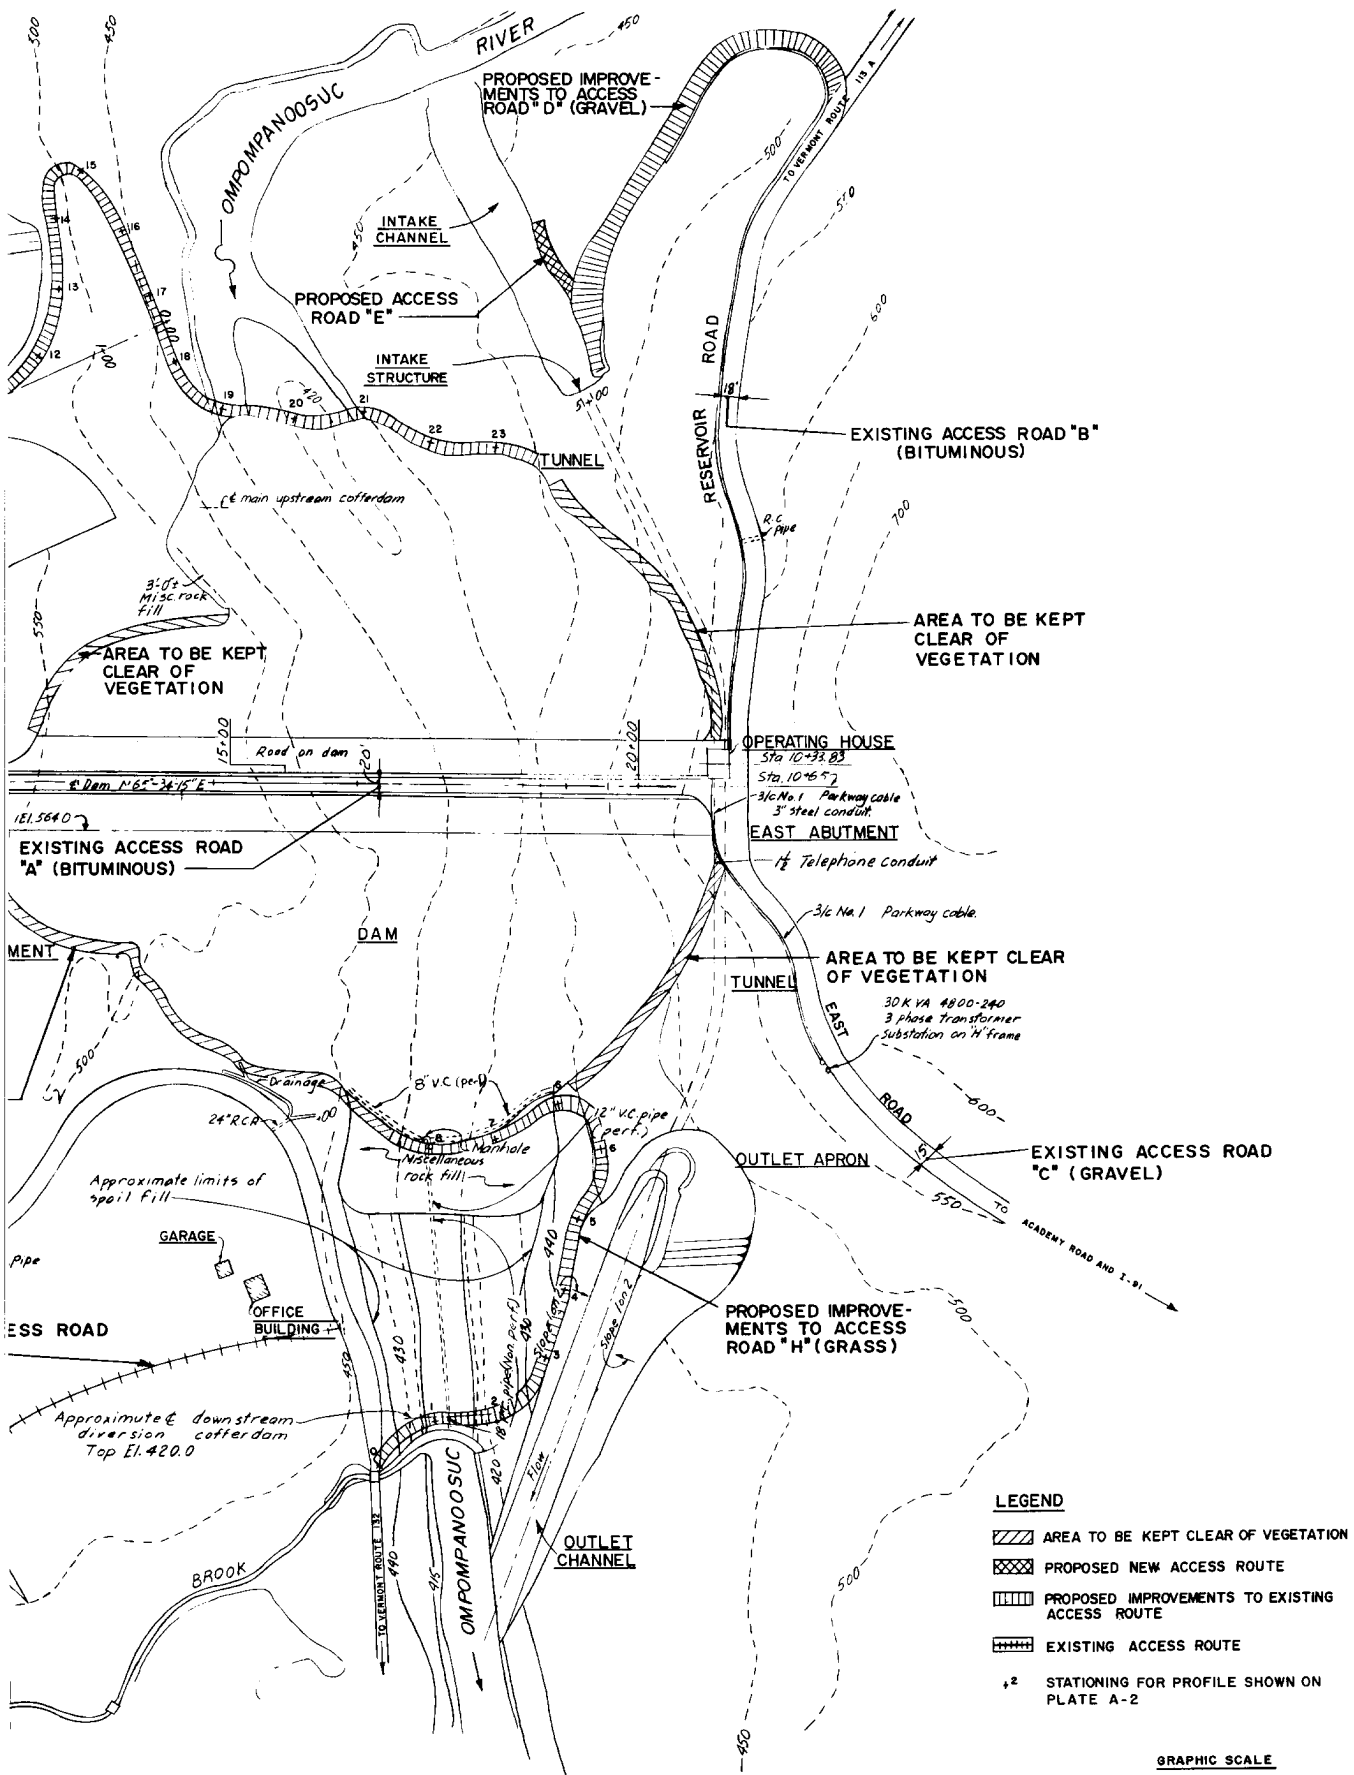
DEPARTMENT OF THE ARMY NEW ENGLAND DIVISION CORPS OF ENGINEERS WALTHAM, MASS.	
EMERGENCY ACCESS STUDY UPPER CONNECTICUT RIVER BASIN UNION VILLAGE DAM GENERAL PLAN	
DES. BY.	
DR. BY.	
CK. BY.	
GEOTECH. ENG. DIV. PLATE A-1	SCALE: <u>AS SHOWN</u> DATE: <u>AUG 1990</u>

3. Adequacy of Access. The grassy area in the immediate vicinity of the downstream toe does not meet design criteria. Heavy equipment would probably have difficulty operating in the downstream toe area during spillway discharge. Only equipment under eight tons in weight could reach the toe area once spillway discharge conditions occurred because of the load limitations on the Academy Road covered bridge.

6. Adequacy of Access. Access to the crest of Union Village Dam is adequate. Presently, access to the lower portion of the upstream toe of the dam is inadequate during normal pool conditions.

4. Recommended Improvements. Access Road "H" as shown on Plates A-1 and A-2 should be improved in the downstream toe area. Flattening of the gravel ramp at West Road and a steep slope on the east side of the old Ompompanoosuc River channel would be required to improve Access Road "H". The improvement would also provide better access to the outlet channel and structure. Upgrading the covered bridge on Academy Road to allow a higher load limit is beyond the scope of this study.

7. Recommended Improvements. Access Road "F" should be improved, as shown in Plates A-1 and A-2, so that the upstream toe and slope of Union Village Dam can be reached during normal pool conditions. Flattening two steep slopes and placement of a significant amount of rock fill will be required to improve Access Road "F".

10. Recommended Improvements. Access Road "D" should be cleared, grubbed, widened and surfaced with six additional inches of gravel to make it easier to use the road. Access "E" should be constructed as shown in Plates A-1 and A-2 to provide access to the north 100 feet of the inlet channel. Access Road "H" should be improved as discussed in paragraph 4 to provide better access to the outlet channel and structure.

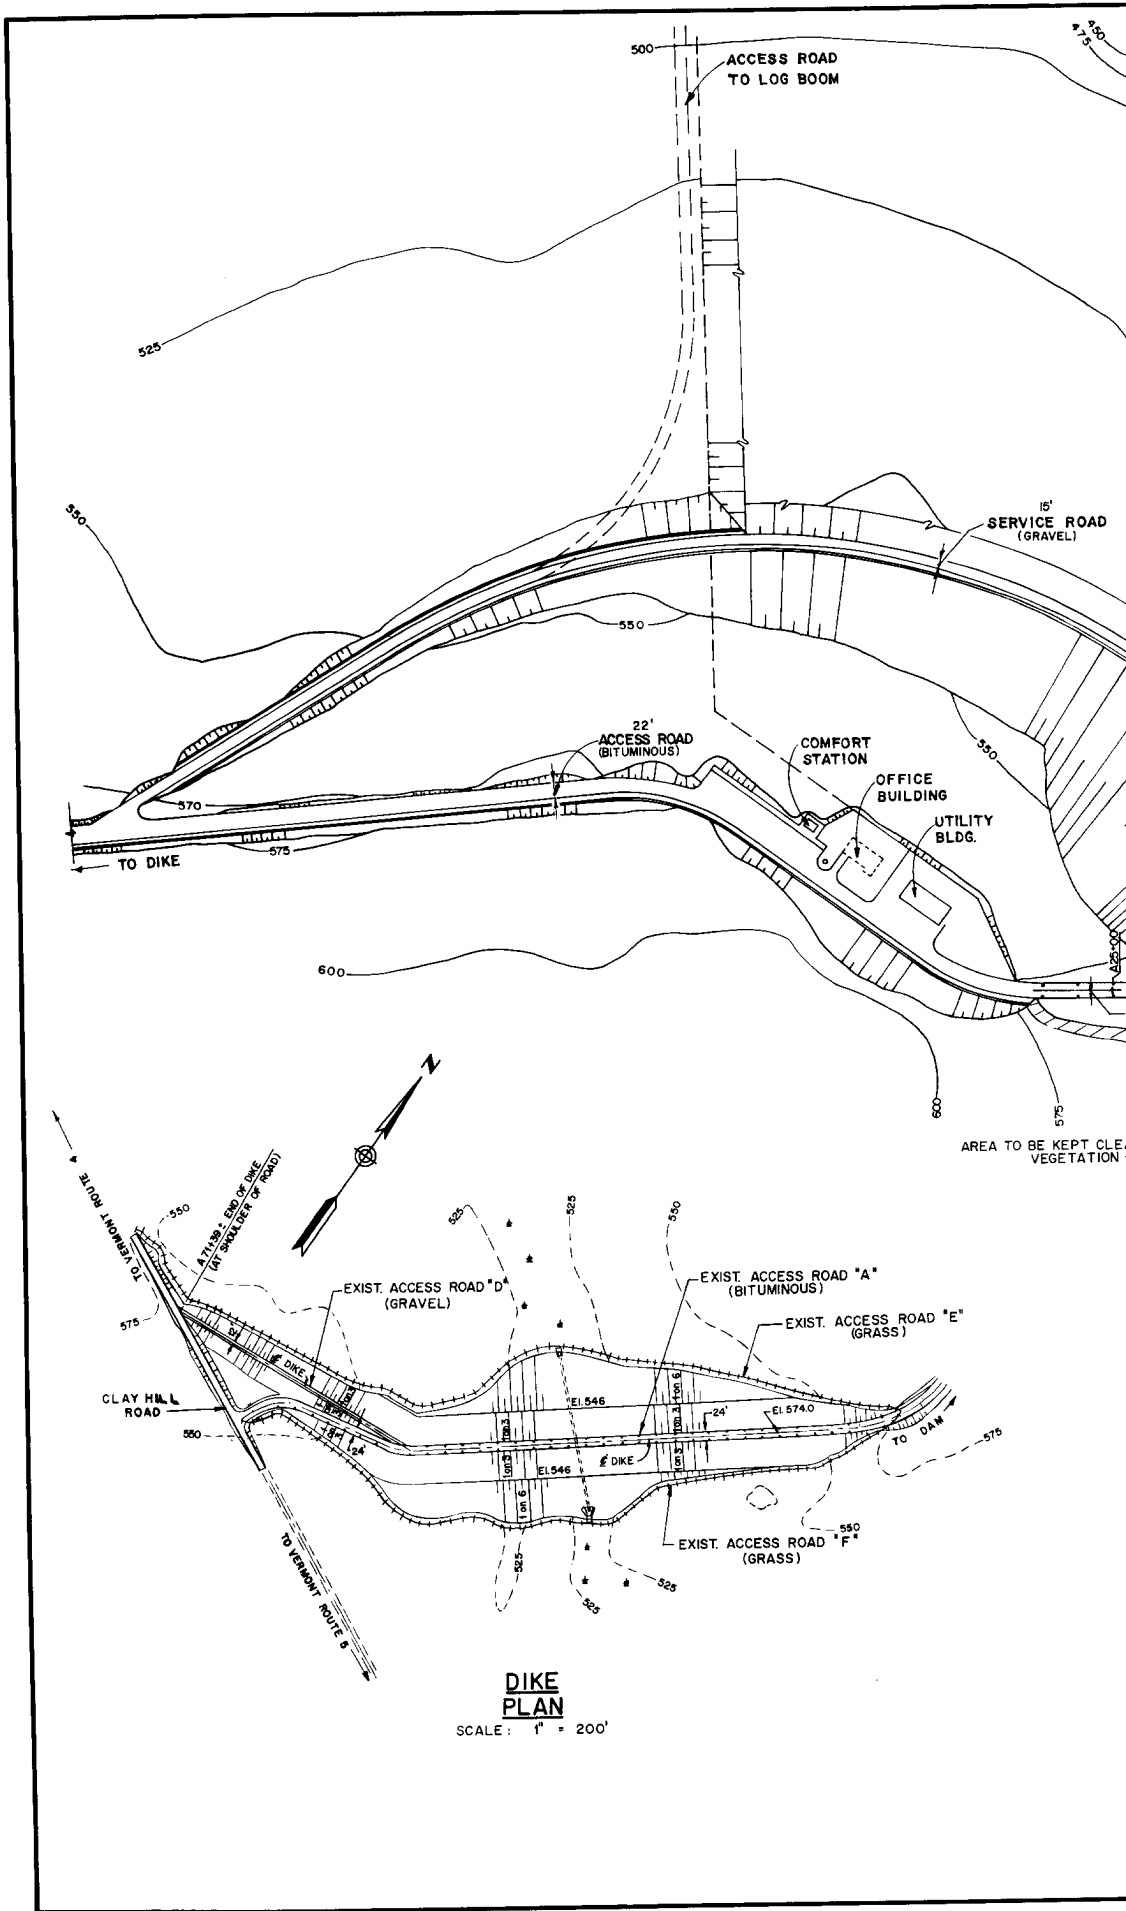
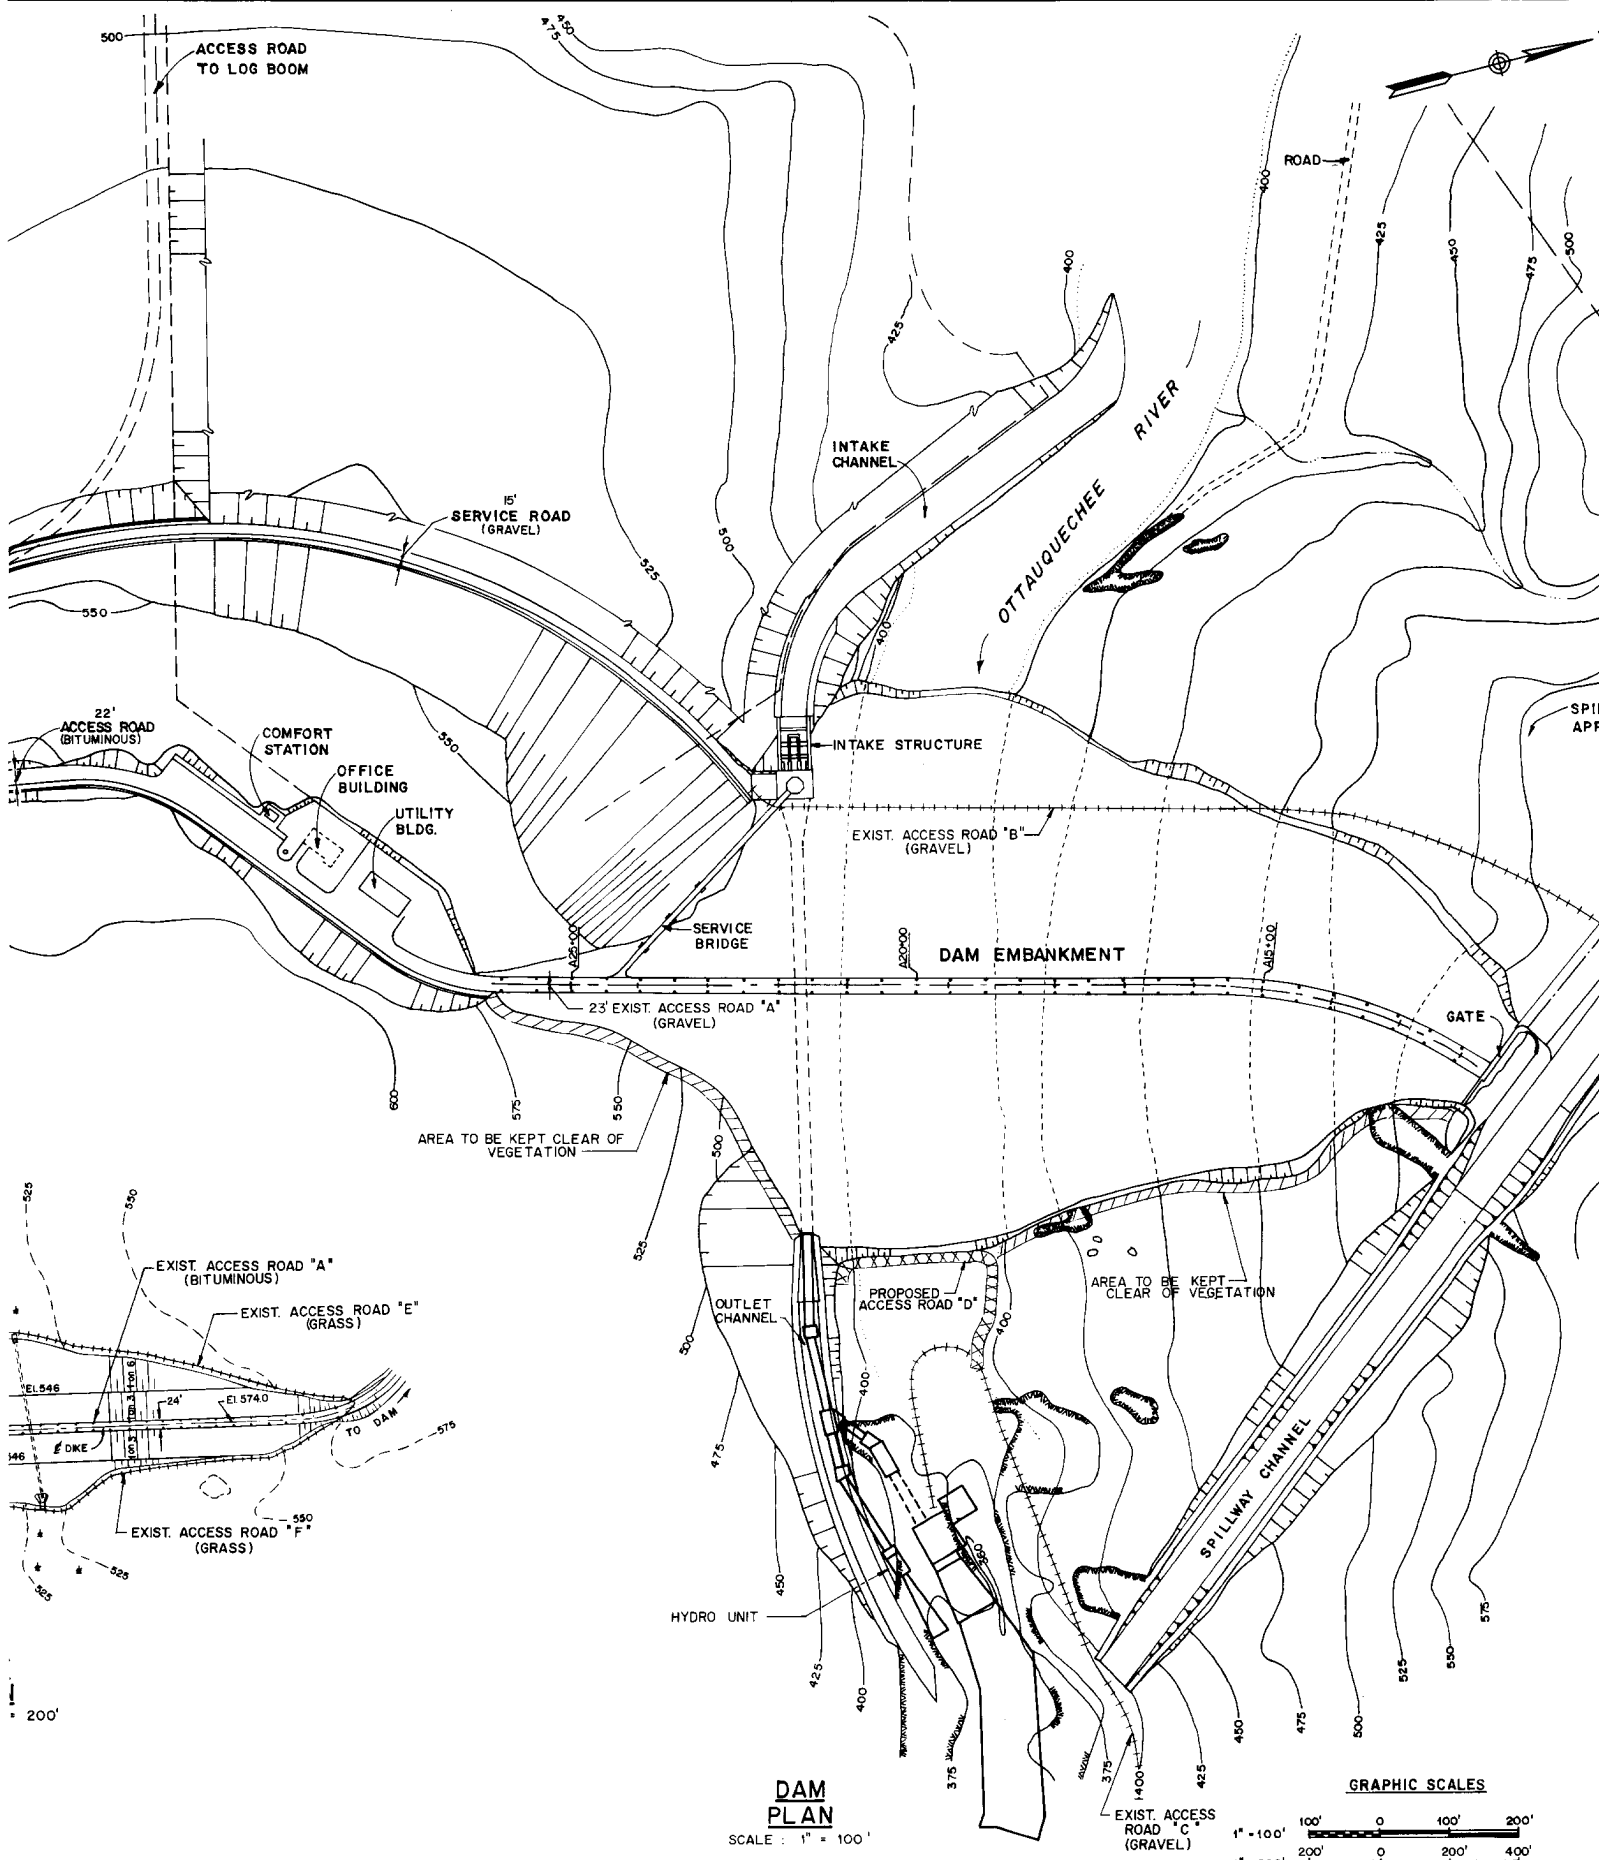
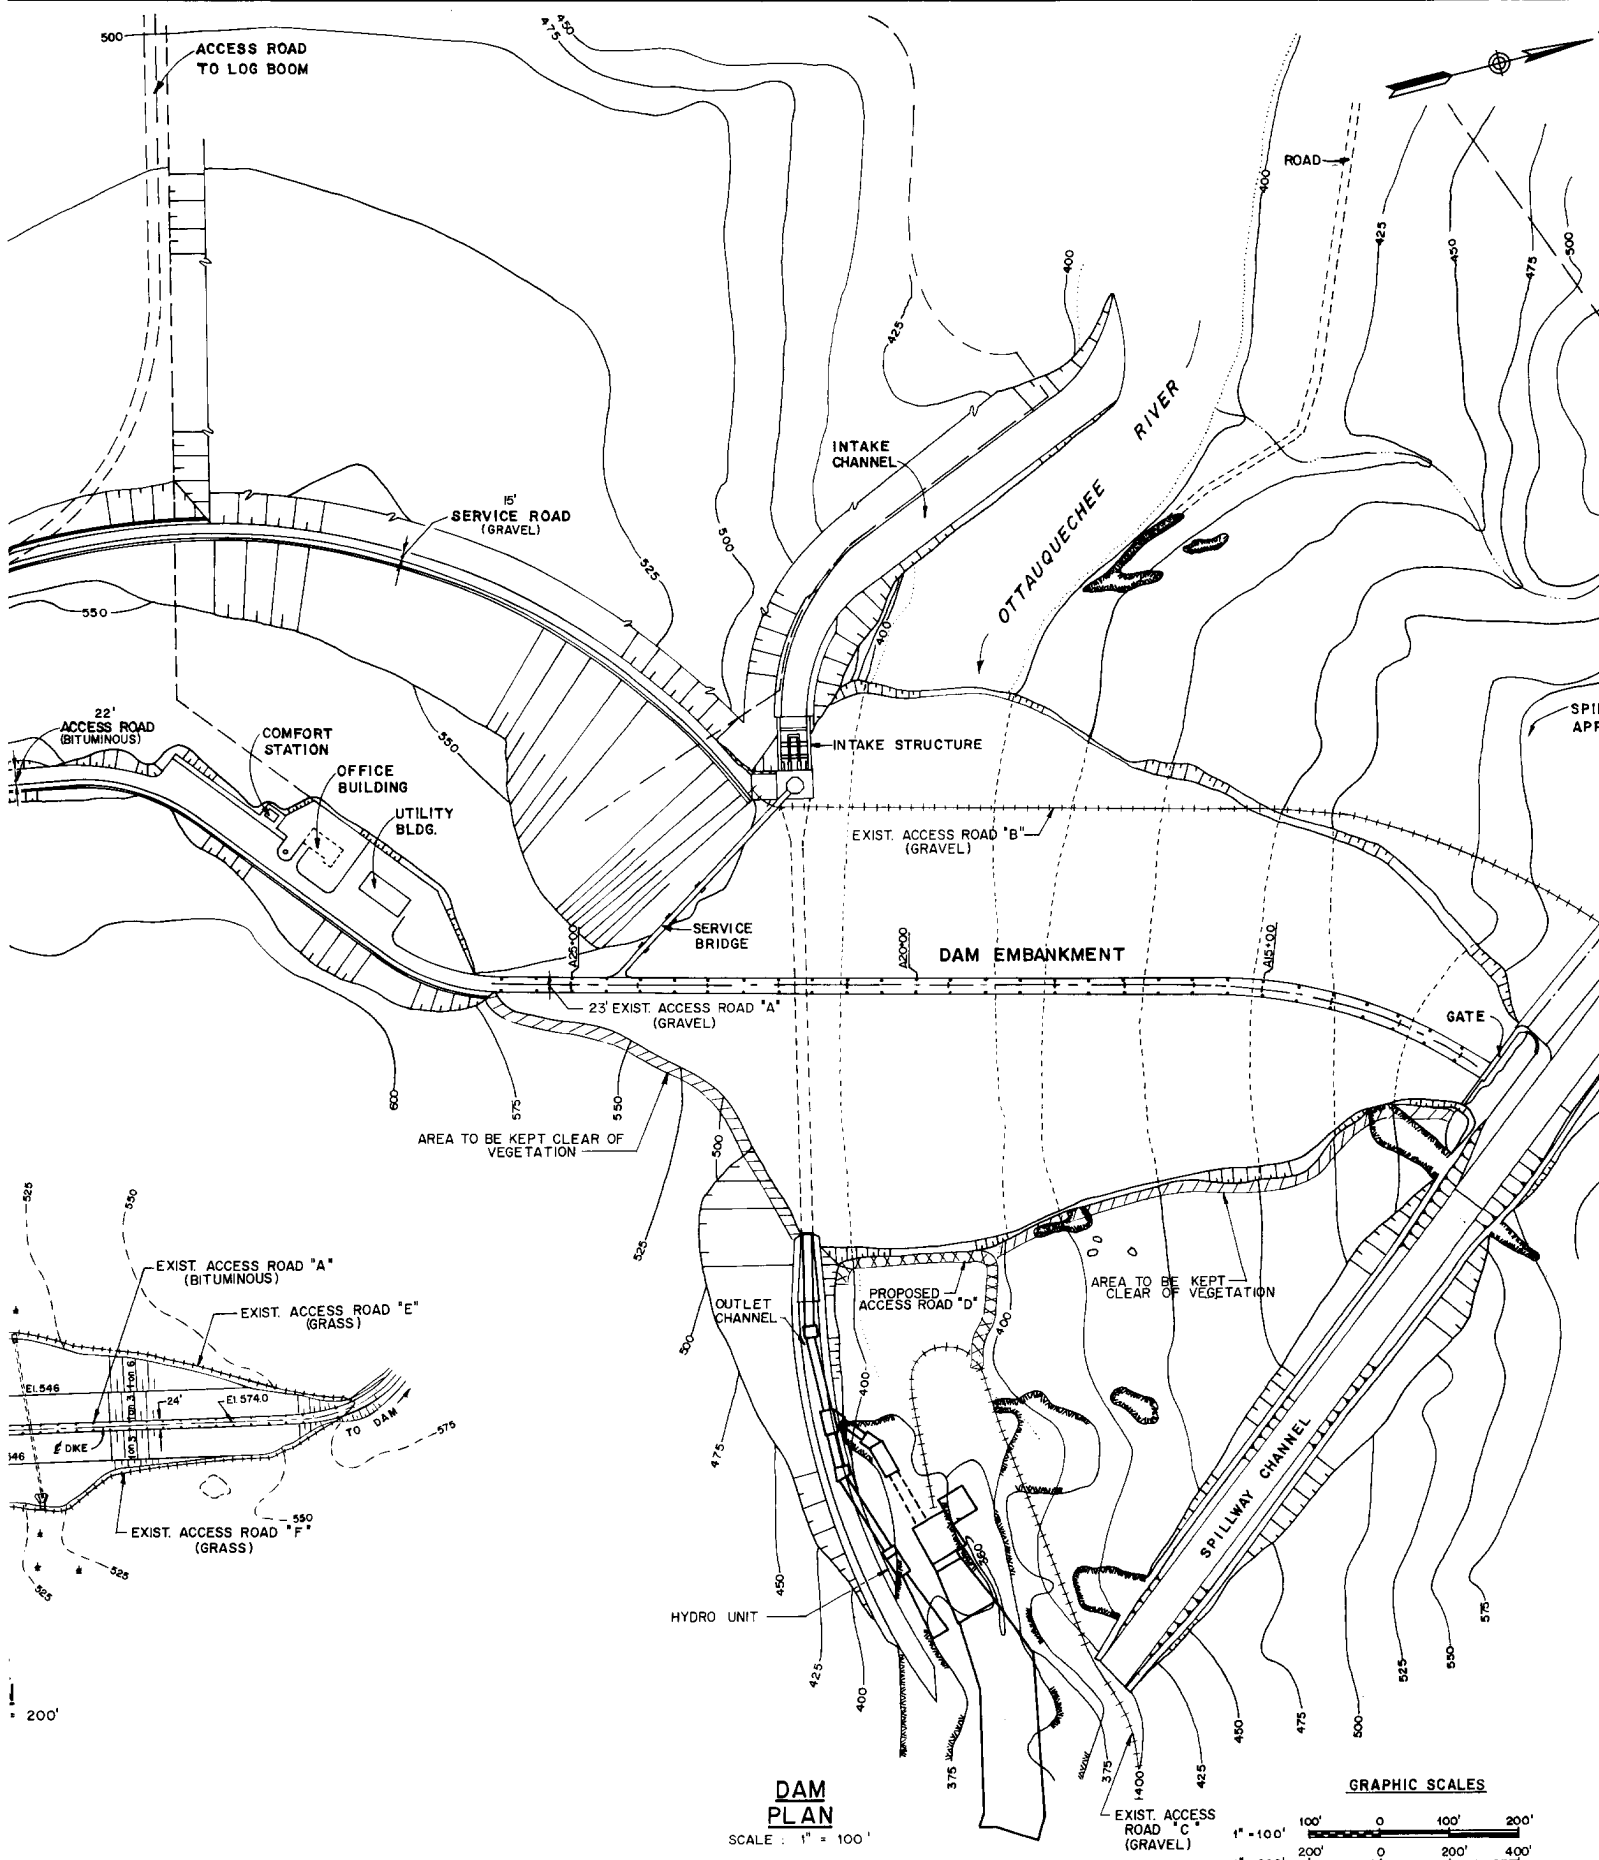
**DAM
PLAN**

3. Adequacy of Access. Access to the downstream toe of North Hartland Dam is inadequate. Heavy equipment may bog down in the grassy downstream toe area and cannot traverse the steep adjacent abutment slopes. Spillway discharges would prevent access to the area by blocking Access Road "C". Providing access to the downstream toe during spillway discharge is beyond the scope of this study.

4. Recommended Improvements. Access Road "D" should be constructed to allow heavy equipment to reach the downstream toe of North Hartland Dam without bogging down. Access Road "D" construction would require removal of existing vegetation and soft material along the proposed road alinement and then placement of 12 inches of gravel. Vegetation should be periodically removed from the dam abutment interfaces to allow for inspection of the interfaces and light weight equipment to traverse the interfaces.
