# Zebra Mussel Research Technical Notes

Technical Note ZMR-2-19

## Comparison of the Component-Level Performance of Anti-Zebra Mussel Coating Systems with Research Coupon Results

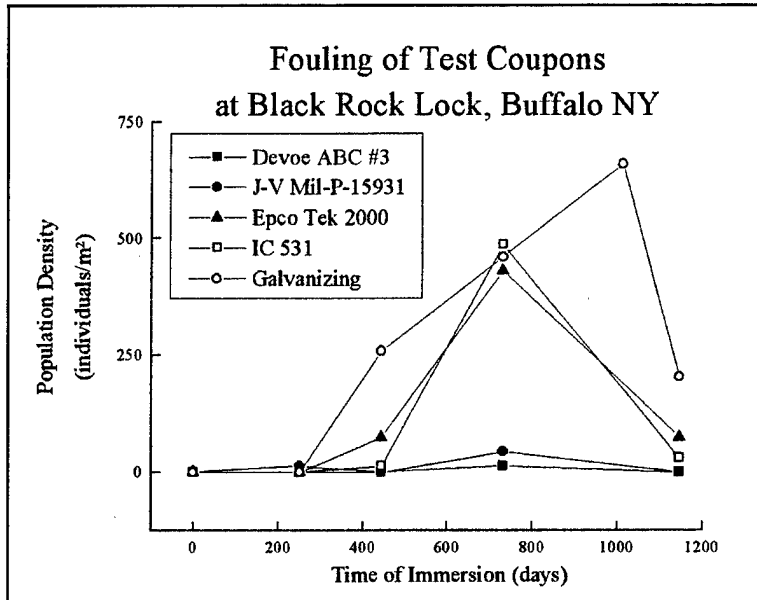
Figure 1 plots the population densities (zebra mussels per square meter) that have infested the test coupons at Black Rock Lock over time. The two copper oxide-containing coatings (Devoe ABC No. 3 and J-V Mil-P-15931) had essentially no zebra mussels during the 3-year test. Infestations on the other coatings seem to have peaked, and are now retreating.

**Figure 1. Population density of zebra mussels over time during immersion at Black Rock Lock for copper- and zinc-bearing coatings**

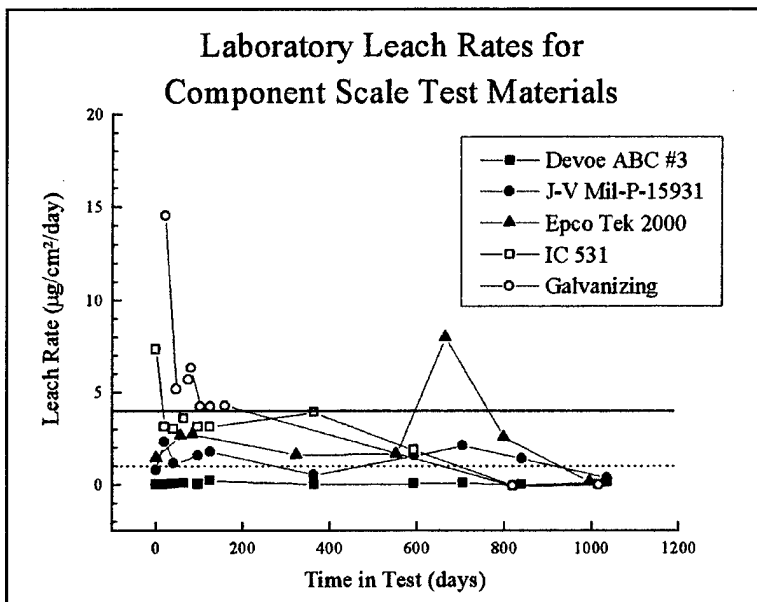
The leach rates of the primary antifouling metal ion, as a function of the time of immersion in flowing water, for the five laboratory-tested coatings are shown in Figure 2. The minimum values of the leach rate estimated for maintaining the antifouling properties in copper- and zinc-bearing coatings are also plotted.

**Figure 2. Leach rates of metal ion from copper- and zinc-bearing coatings, measured at intervals over a 3-year period. Horizontal lines indicate the estimated minimum values of leach rate for maintenance of antifouling properties in coatings (dashed line = copper; solid line = zinc-bearing coating)**

As laboratory zinc leach rates have fallen, the infestation density has risen at Black Rock Lock. The bars on the trash racks at Markland Lock and Dam have not been coated long enough for the leach rates to have diminished significantly. It is anticipated that the use of thermal-sprayed zinc or zinc alloy materials would work similarly to the inorganic zinc material. These materials might be more abrasion resistant, adhere better, and provide better corrosion inhibition for a longer period.
