Report No. CG-D-02-98

## IMPROVED INSPECTION OF WOODEN VESSEL FASTENERS

**Kurt A. Hansen**

Final Report  
August 1997

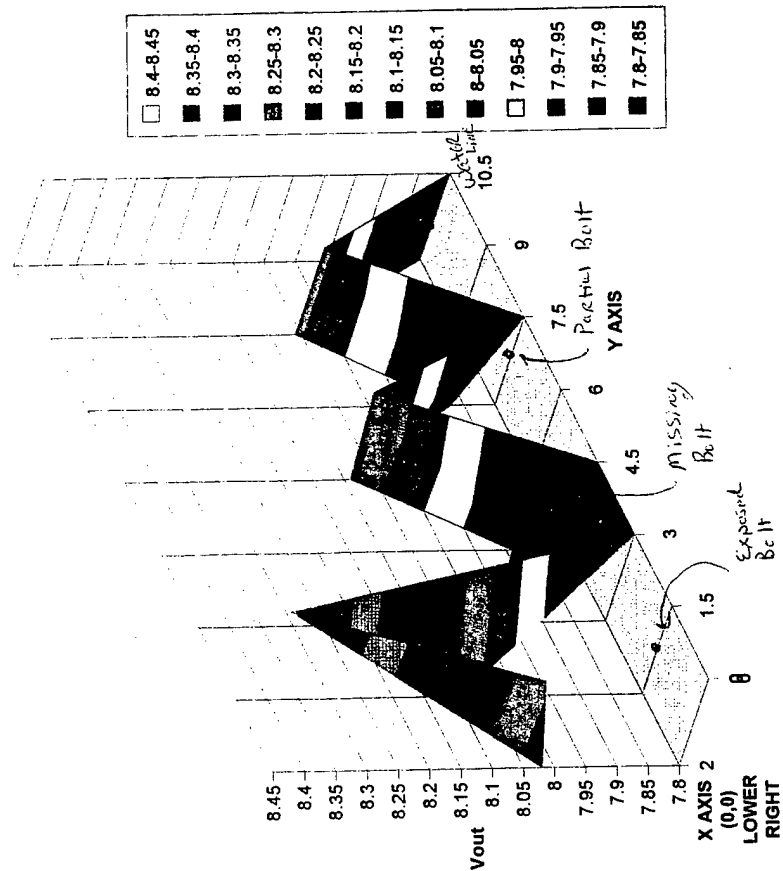
FIGURE 29. Capaciflector Results (Area 4)

In Area 4, under the waterline, the readings were taken at a frame (see Figure 29). There was wood missing from around two of the bolts. In addition, the bolt was exposed at one location at ( $y = 1.5$ ), missing from a second (at  $y = 4.5$ ), and only a partial bolt was located at a third location (at  $y = 7.5$ ). The readings are consistent here as a partial bolt and an empty bolt hole gave lower readings than the intact bolt.
