AAV IRAM TRANSMISSION REVIEW

**INTERIM REPORT
TFLRF No. 334**

**U.S. Army TARDEC Fuels and Lubricants Research Facility (SwRI)
Southwest Research Institute
San Antonio, TX**

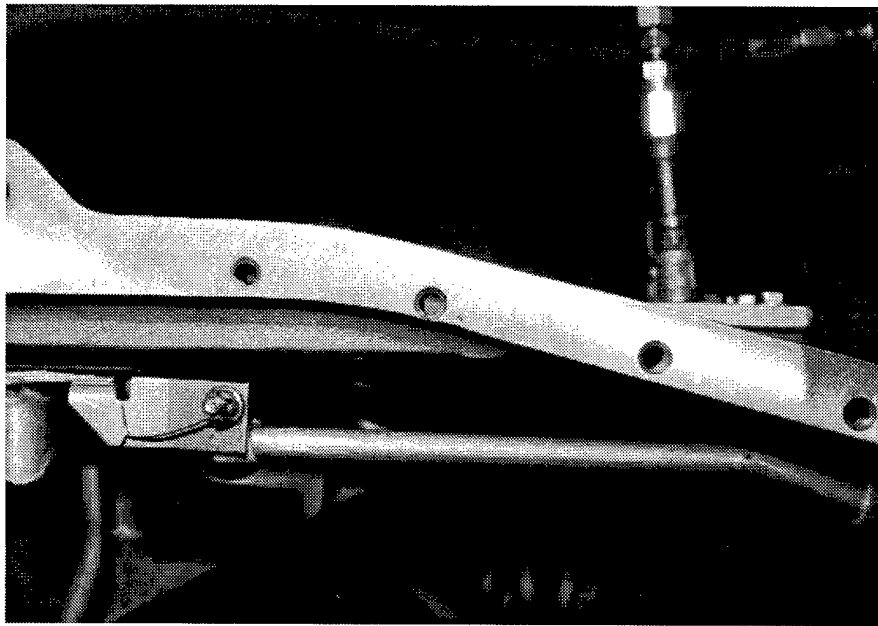
The gasket leakage stems from the insufficient gasket area (Figure 1), housing warpage (Figure 2), and poor quality gasket material. The access plate on the rear of the transmission, a common leakage area, has a cutout that leaves a very thin gasket surface, plus a very sparse bolt pattern in the same area. Attempts to torque the plate bolts to increase the pressure on the gasket tend to buckle the plate corner effectively reducing the pressure on the gasket. Additionally, a matched end plate and speed change housing may have had the bolt pattern shifted during original production such that insufficient gasket sealing surface remains. Gasket leakage also occurs due to warpage of the speed change housings. The warpage stems from the welding procedures used to repair the cracks in the housings (Figure 3).

Figure 1. Insufficient Gasket Area

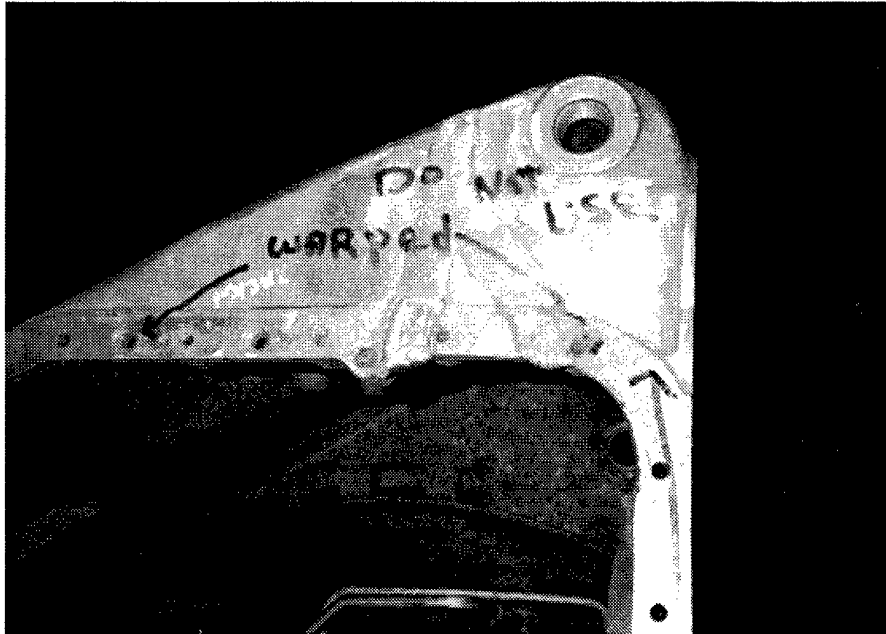
Figure 2. House Warpage

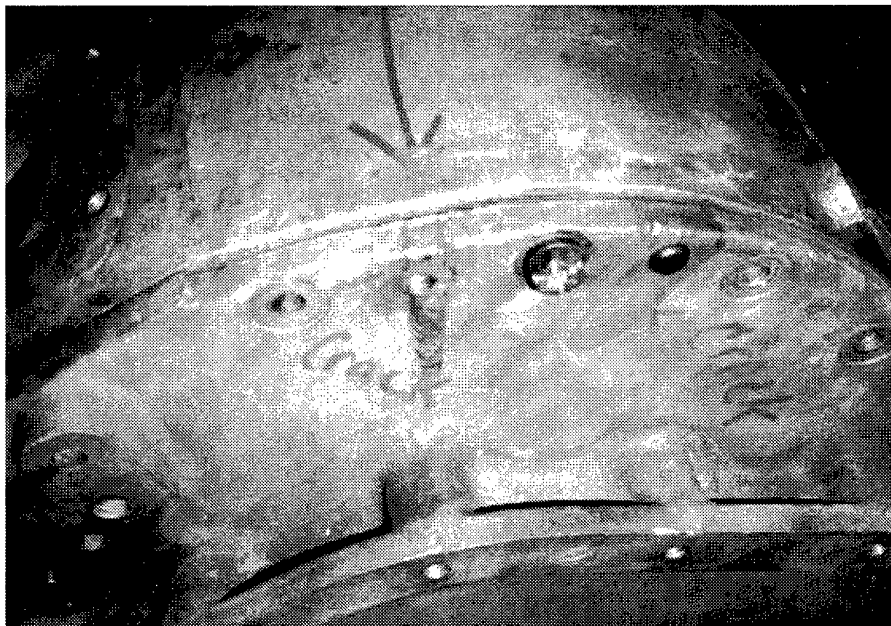
Figure 3. Crack at Dowel Pin Boss

Housing cracks appear due to disassembly and handling procedures and incorrect vehicle operation (Figure 3). Each time a transmission is rebuilt increases the likelihood of speed change housing damage. An example is that a crack typically shows up at a location consistent with the lower jackscrew used to separate the end plate from the speed change housing. It was noticed that there was localized yielding of the aluminum housing material at all jackscrew locations. Cracks were evident at the lower speed change housing dowel pin boss (Figure 3). The cracks in the dowel pin boss are typically repaired with Devcon epoxy putty. Another typical speed change housing crack occurs due to failure of the fan drive universal joint. The fan drive universal joint fails, and the flailing drive shaft impacts the speed change housing causing cracks. An ECP was developed to prevent this damage but was never implemented.

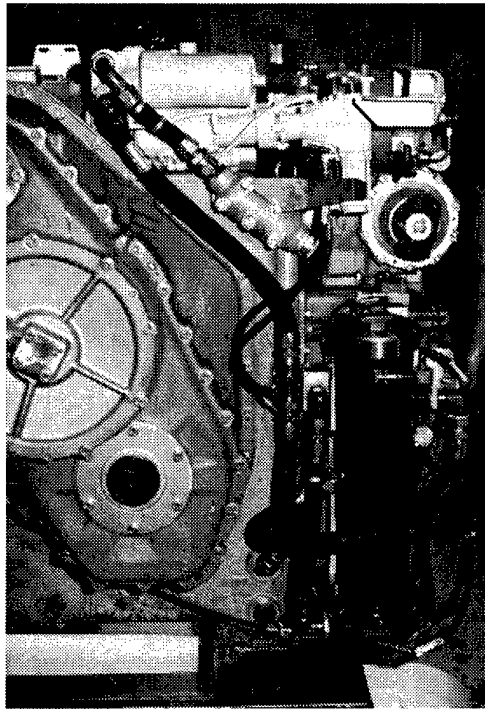
The IRAM transmission has incorporated a new Parker filtration system, which improved the efficiency and load capacity of the older filtration system (Figure 4). The drawing for this system is shown in Figure 5. This filtration system efficiency is rated as being 50% efficient at 2 μm ; 95 % efficient at 8 μm ; and 98.7% efficient at 10 μm . The apparent capacity for the Parker system is 200 grams. Based on past experience on other equipment with similar clearance (2), the critical particle size, which can cause significant damage, is approximately 6 μm . Although the

Figure 4. Improved Filtration System

Parker system has improved the filtration performance, for the ultimate practical protection, a 5 μm filtration system should be investigated.

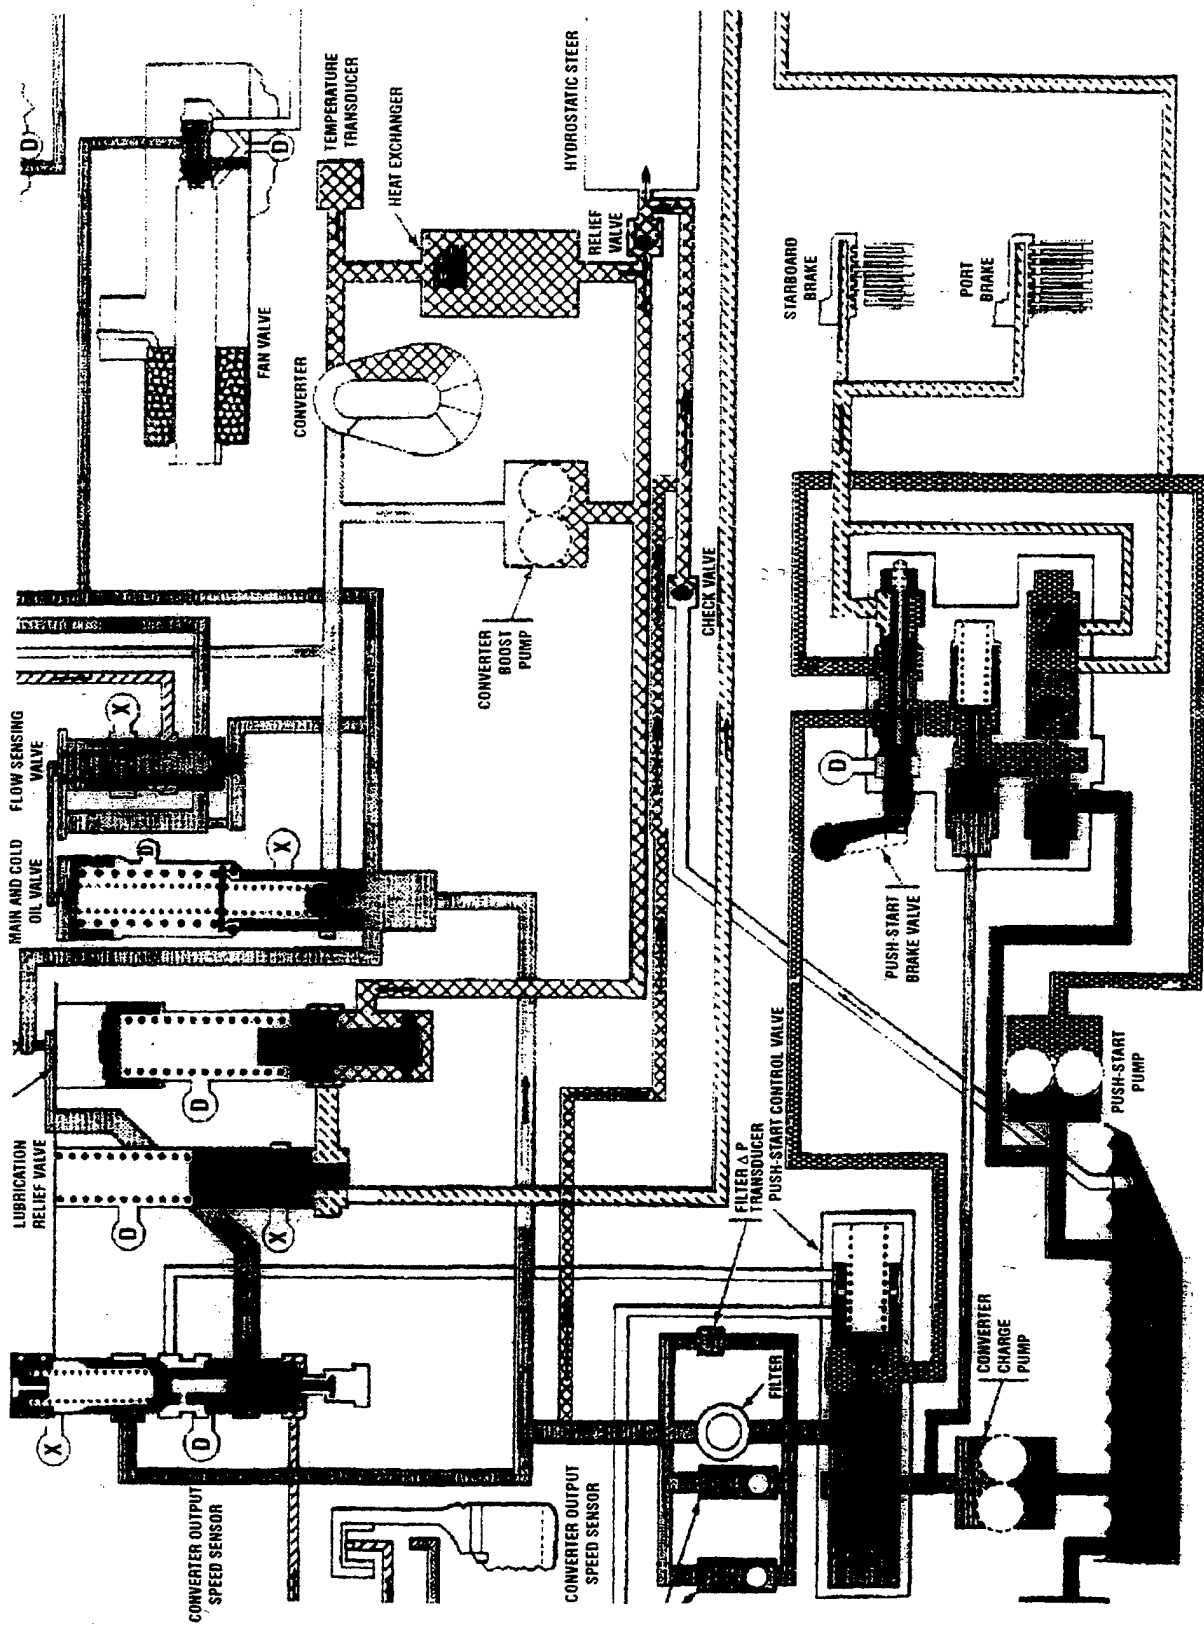
Figure 5. Barstow Recommended Oil Flow Modification

MC3 submitted a suggestion for improving the quality of the oil entering the HSU by modifying the filtration system. The re-plumbing of the oil system would tap into the oil line after the main oil filter (Figure 5). This method would improve the quality of the oil entering the torque converter pump, bypassing other debris-generating components. If approved, modification needs to be evaluated to determine if the oil flow pattern change and pressures effect the operational performance, i.e., AVTB.

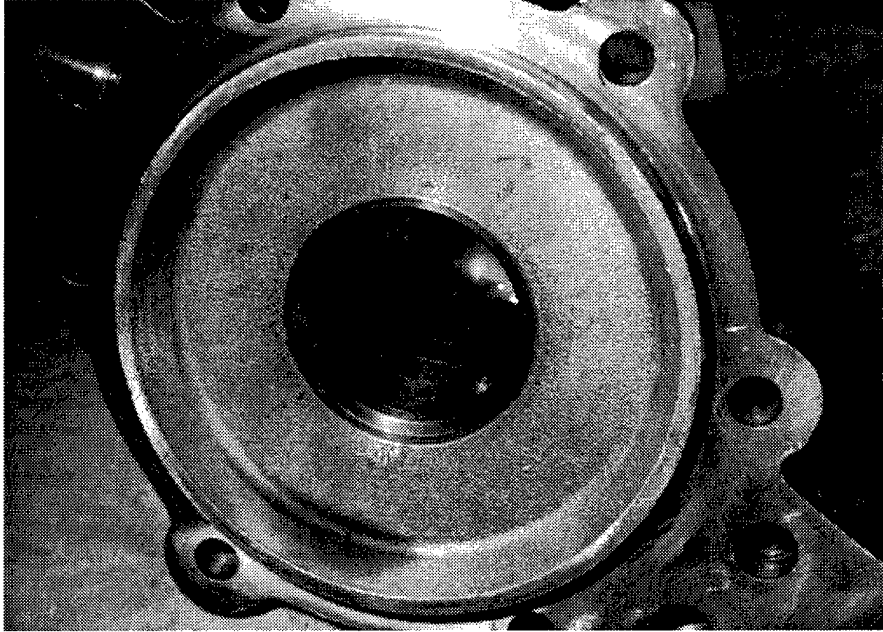
Figure 6. Inside Cover Using Aceomatic Seal Rings

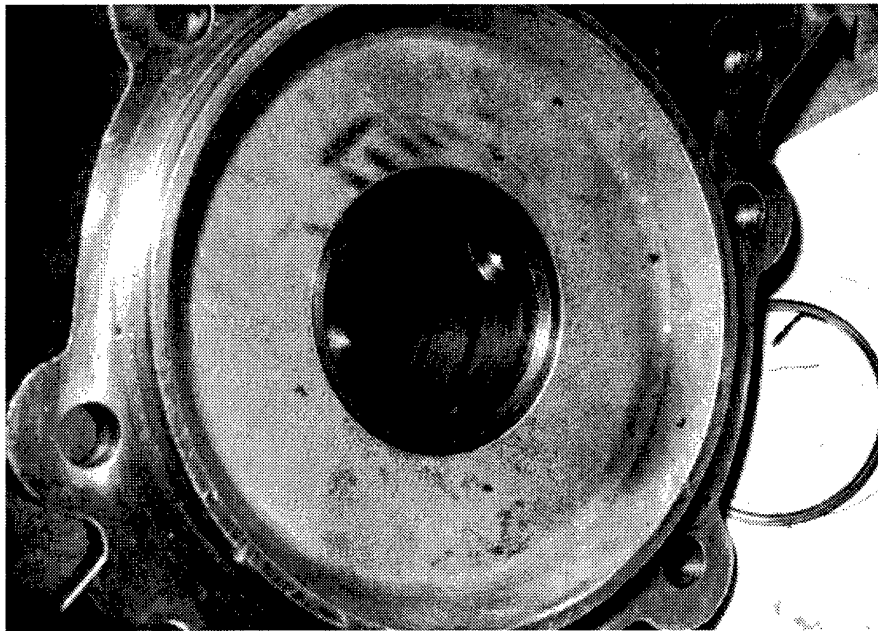
Figure 7. Inside Cover Using Twin Disc Seal Rings

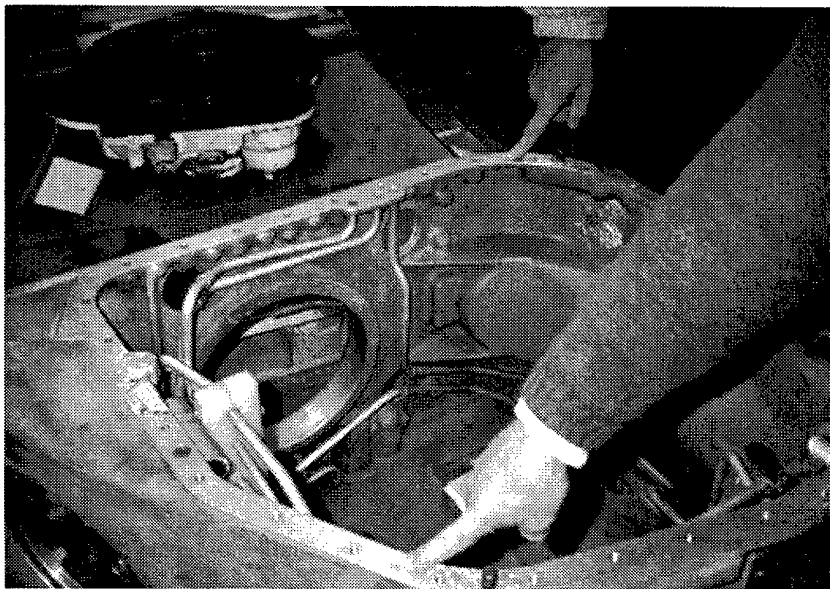
Speed change housing problems included housing cracks from jackscrews (Figure 8), fan drive universal joint failures, tubing swages, mismatched nylon tube locating blocks, bearing bore damage from spun bearings, and housing warpage from crack welding procedures.

Figure 8. Flange Deformation Due to Jackscrews

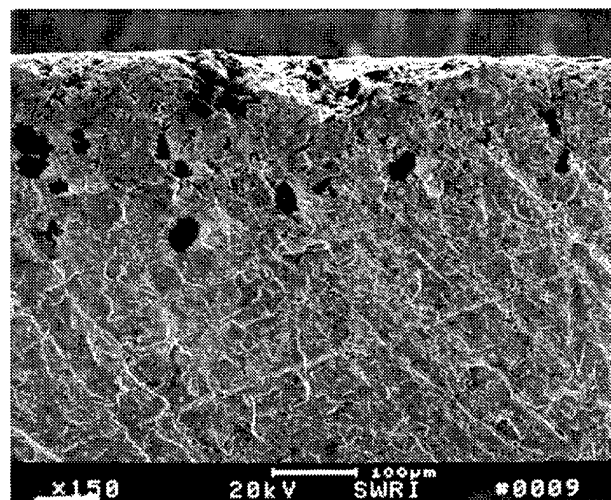
Following the hardness tests, the seal rings were examined under a low power stereomicroscope and in a Scanning Electron Microscope (SEM). The new Twin Disc seal ring exhibited chipping along the machined edges (Figure 10). A large radial crack was also present in the new ring (Figure 11). The broken Twin Disc seal rings (Figure 12), removed from the transmissions at MCAGCC exhibited more extensive chipping than the new seal ring.

Figure 10. New Twin Disc Seal Ring

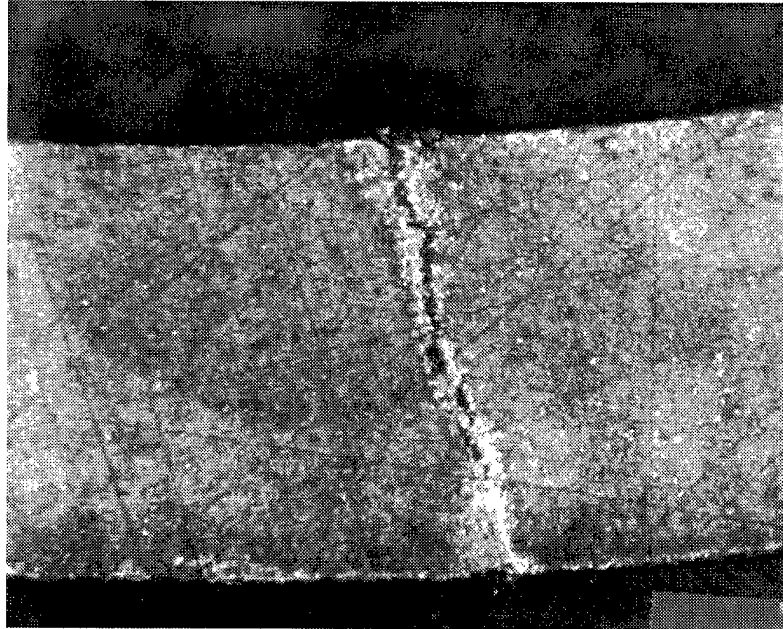
Figure 11. Cracked New Twin Disc Seal Ring

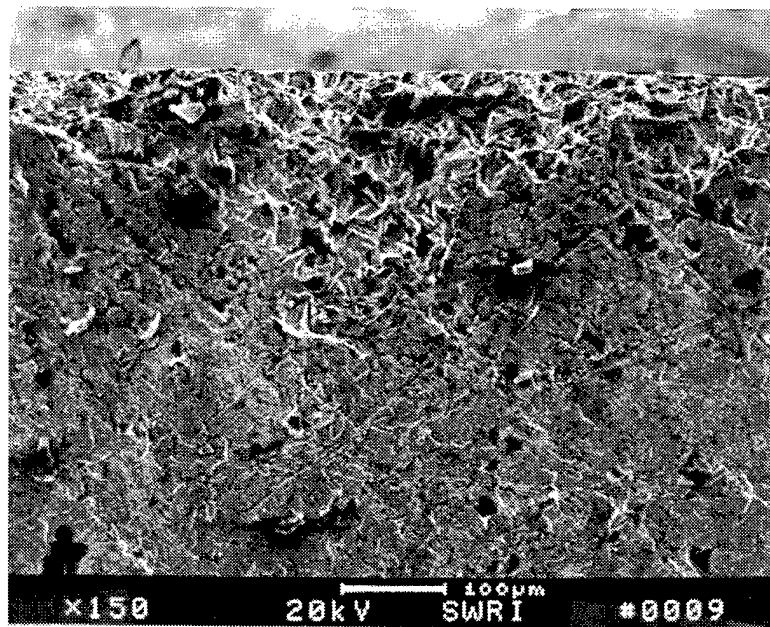
Figure 12. Used Twin Disc Seal Ring

In summary, although the Twin Disc seal rings performed reasonably well during the transmission test at MCAGCC, subsequent examination of the seal rings indicated that an undesirable wear mechanism (edge chipping) was operating during the test. This wear process produces sizeable wear particles that can cause 3-body abrasive wear of the mating surfaces. The wear that was observed on the cast iron sleeves was likely a result of such wear. Wear of this type can also lead to accelerated wear rates and catastrophic failures. Additionally, the condition of the new Twin Disc seal ring that was examined was unacceptable due to the presence of the large radial crack and a significant amount of edge chipping. Although a single sample may not be representative, the appearance of similar radial flaws on the two used Twin Disc seal rings suggests that these types of flaws may be widespread. In our opinion, the poor manufacturing quality and the presence of an undesirable wear mechanism make the Twin Disc seal rings unacceptable for the proposed application. These seal rings should not be considered as a secondary source.

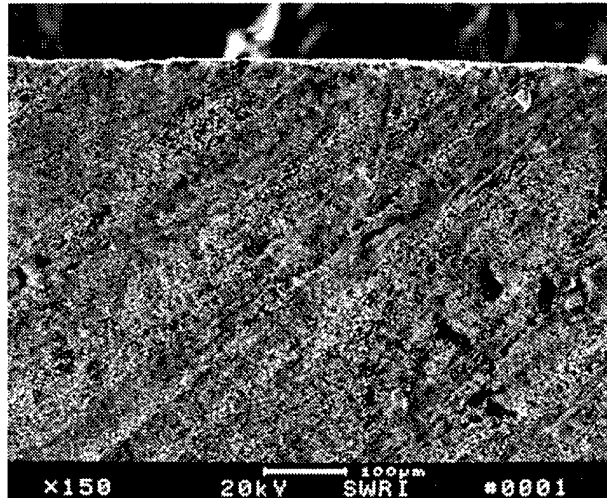
The appearance of the new Aceomatic seal ring was very different from that of the new Twin Disc seal ring. Very smooth edges, as shown in Figure 13, were evident around the entire ring, and no evidence of chipping or cracking was observed. The used Aceomatic seal rings that were delivered to SwRI from Barstow also exhibited smooth edges that were free of chipping and cracking, Figure 14.

Figure 13. New Aceomatic Seal Ring

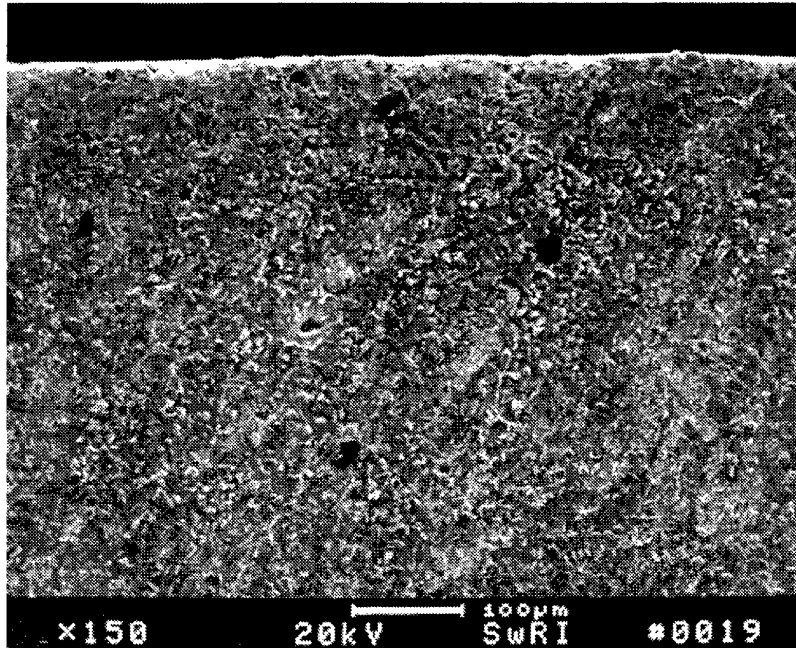
Figure 14. Used Aceomatic Seal Ring

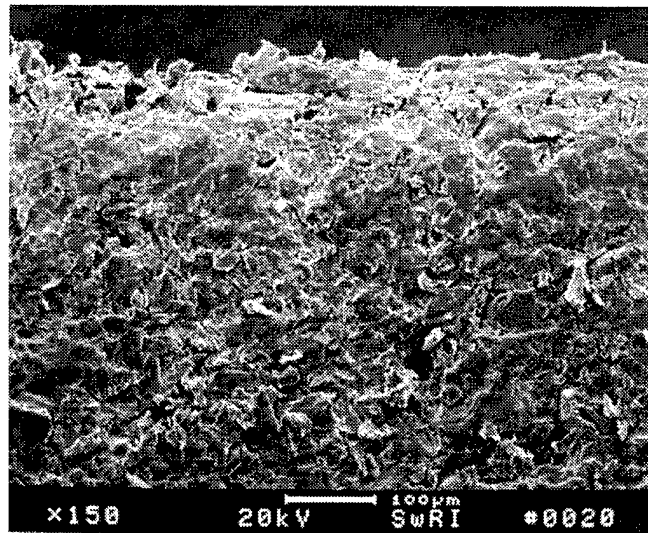
New and used, bronze impregnated, Teflon seal rings were also examined. As expected, their appearance was very different from either of the cast iron seal rings (Figures 15 and 16). However, due to the very different nature of the material of the rings, it is impossible to draw any conclusions about Teflon relative to cast iron seal rings from these micrographs.

Figure 15. New Teflon Seal Ring

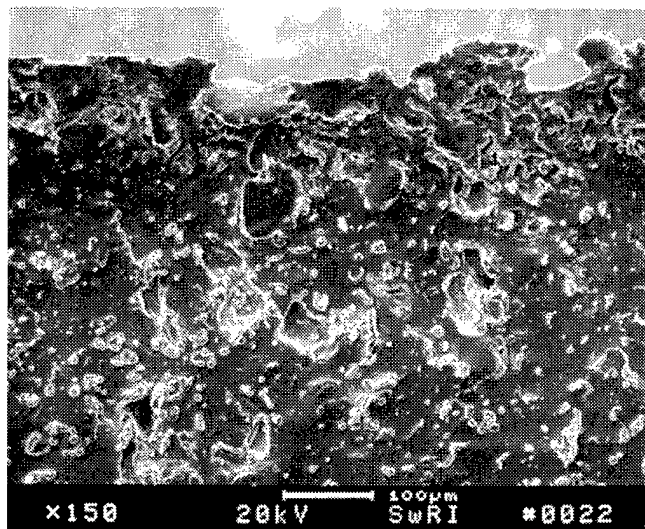
Figure 16. Used Teflon Seal Ring

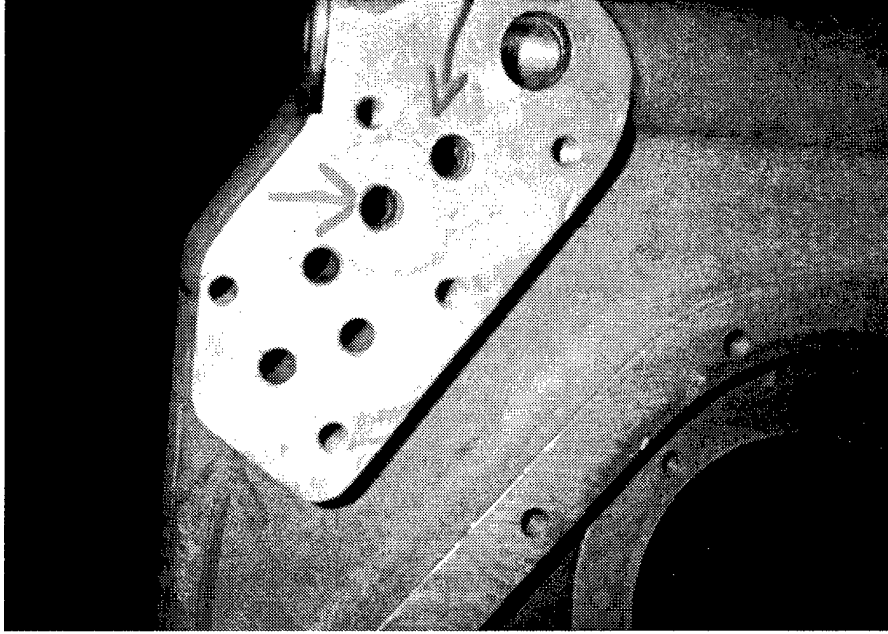
The problem is once the tubes are swaged into their respective holes (Figure 17); vibration of the material loosens the fit. In addition, if the tube swaging process is not performed correctly, the tubing wall thickness becomes very thin, cracking as a result of fatigue. Both of these problems result in the loss of oil pressure.

Figure 17. Tube Swage Problem Areas

The proposed method for the tube swaging is to set a limit on the hole diameters, then swage the tube until the ID of the tube is within a prescribed limit. The procedure will result in a 5% to 15% swage of the tube. The advantages of this method are that the number of measurements is reduced and no calculations are required. It will also be easy to determine in a post inspection if the tubes were properly swaged simply by measuring the ID of the installed tubes. The ability to check the degree of swage of an installed tube will be very helpful toward eliminating the improperly installed swage tubes. Although this procedure should aid in reducing the number of tubing swage problems, it is felt that this problem needs additional investigation to produce a better solution.
