USACERL Technical Report 98/34
January 1998

Seismic Mitigation for Equipment at Army Medical Centers

Methods Illustrated With Examples from Madigan Army Medical Center

Personnel from the U.S. Army Construction Engineering Research Laboratories (USACERL) conducted a walk-down inspection of Madigan Army Medical Center (MAMC) in December 1996. MAMC is located at Fort Lewis, WA, south of Tacoma. This center is quite new, having opened in March 1992, and care has clearly been taken on many of the systems to provide earthquake resistance. Most older medical centers would have many more problems to address, particularly in the areas of nonexistent or inadequate anchorage and a lack of flexible connections. Figure 1¹ shows the east side of the Nursing Tower at MAMC. To the West and connected to this tower is the ancillary building (not seen in the figure), which contains most of the critical equipment. To the north

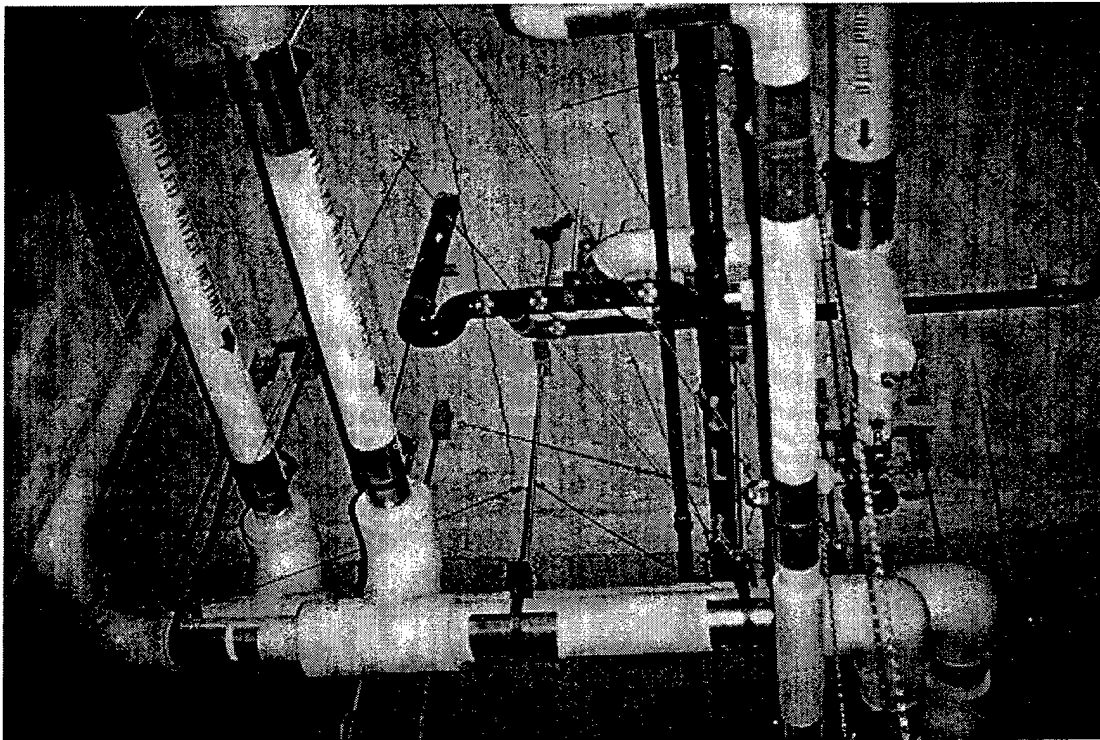
Figure 19 shows overhead suspended pipes in a mechanical room. These appear to be well suspended with tie rods and braced with cables. The cables carry tension only, so they must extend to the ceiling structure in all four directions (e.g., north, south, east, and west) in order to carry the seismically induced loads in both lateral directions. Overhead anchored equipment is supported through the ceiling by the interstitial floors. Figure 20 shows an overhead anchored telescopic arm supporting an x-ray head (collimator). The supporting rails appear to be well anchored to the overhead interstitial floor. Figure 21 is a view looking down at an interstitial floor showing a frame that distributes the load from overhead anchored equipment below to the interstitial floor. Based on the site visit it could not be determined what this frame is supporting, but it

Figure 19. Overhead suspended pipes in a mechanical room.

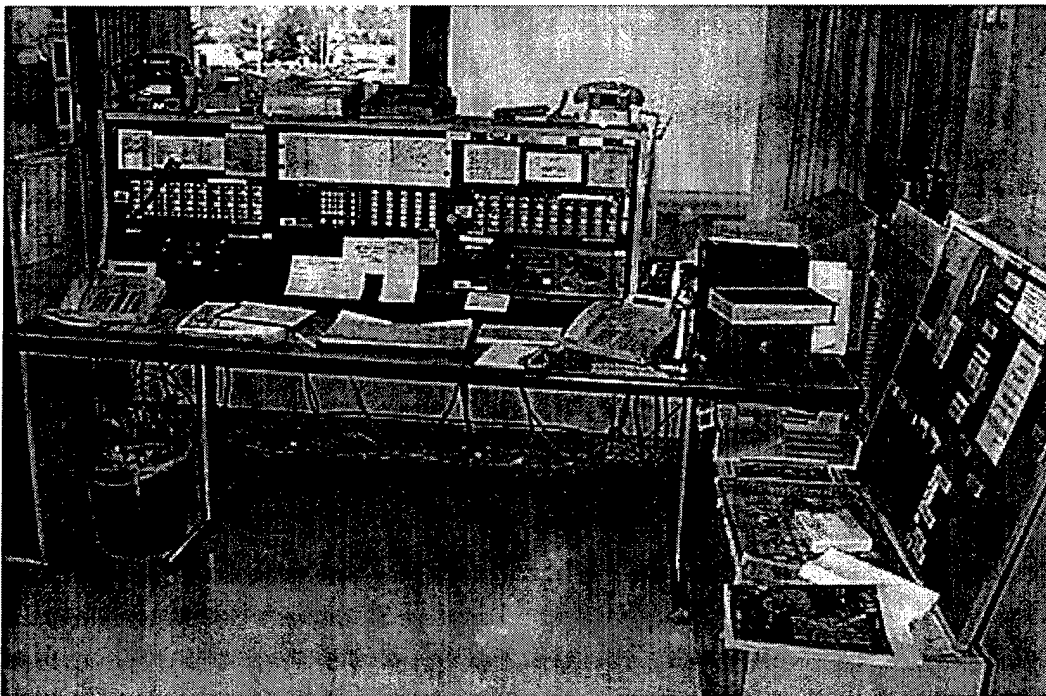
Figure 22 shows what may be the most urgent problem found at MAMC. Communications equipment at the emergency room communications center was resting loosely on a folding table, which in turn rests loosely on the floor. Figure 23 shows the edge of this equipment, which demonstrates how tall it is relative to its depth. According to the operators of this equipment, the supplier sent the wrong support cabinet. Apparently this unit was temporarily set loosely on the table, but the correct cabinet was never obtained or installed. In even a moderate earthquake the table would slide on the floor and the equipment would topple. The correct cabinet should be ordered as soon as possible. The communications equipment should be anchored to the cabinet and cabinet should be anchored to the floor. If this cannot be done immediately, the equipment should temporarily be anchored to a more stable counter. In this same room security monitors and fire detection units were well anchored, but the back of their cabinets were open. These cabinets should be closed to prevent the monitors from falling out backwards during an earthquake.

Figure 22. Equipment at emergency room communications center resting loosely on a table.

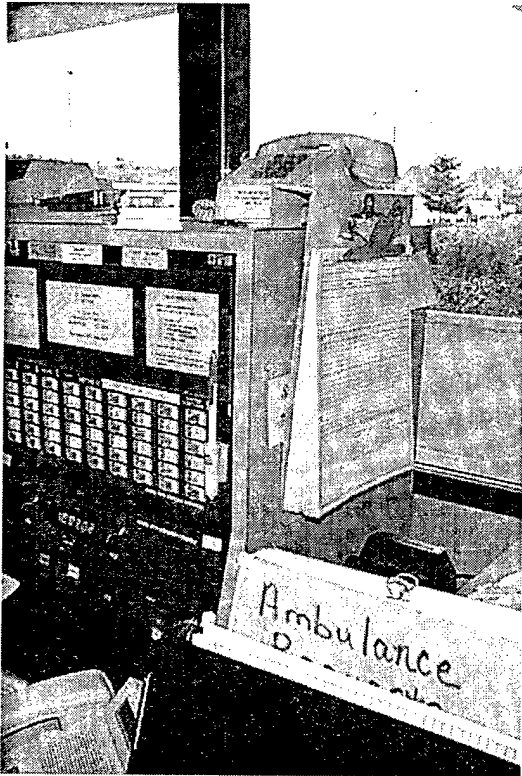
Figure 23. Side view of communications center equipment.

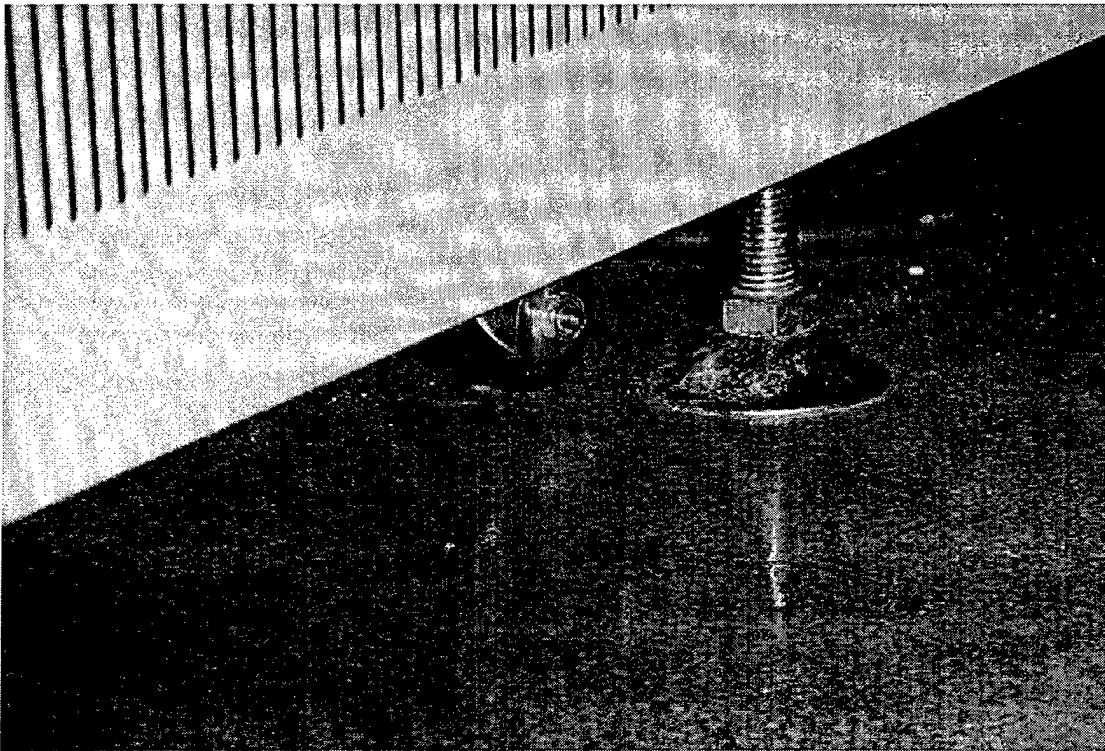
Figure 25. Close-up showing lack of anchorage for the Digiscan equipment.

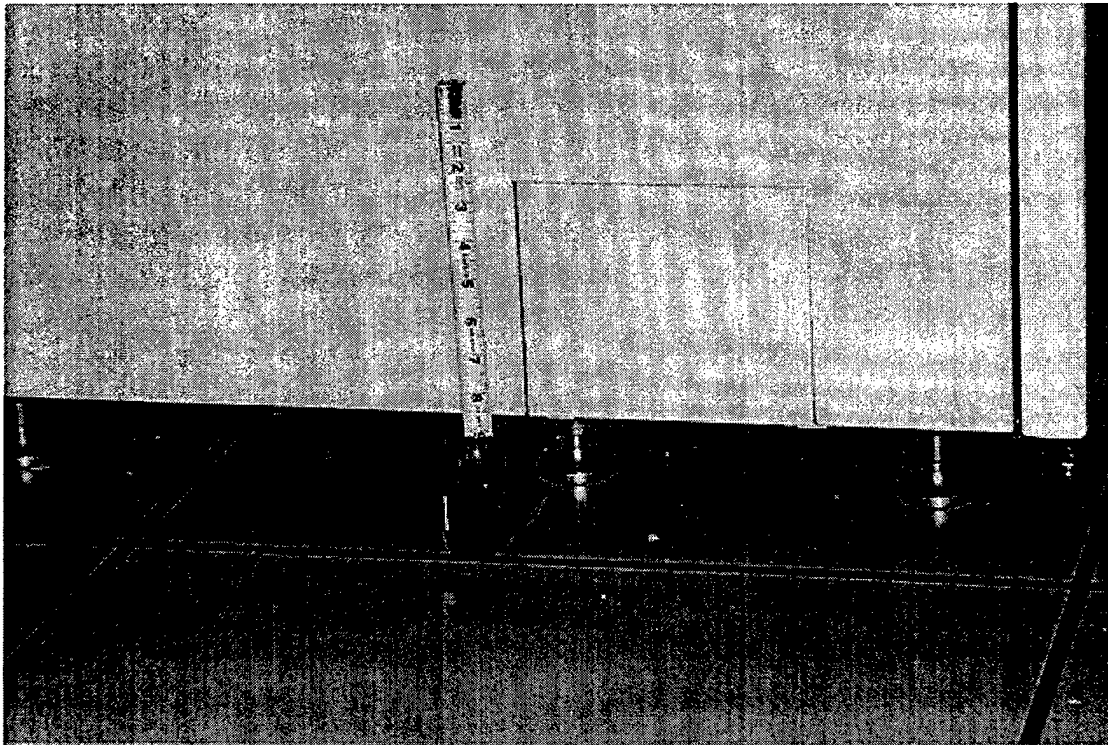
rests loosely on the computer floor (Figure 27) and is of critical importance to medical staff at MAMC. The supporting computer floor tiles are loosely supported on a stringer system frame. Computer floors supported on stringer system frames apparently perform well in earthquakes. Other computer floors are supported on a stringer-less system where a post supports and should be fastened to each corner of the floor tiles. These posts must be braced to resist lateral seismic motions. Often the fasteners are left out, and in earthquakes loose tiles near equipment could shift off their posts, and drop to the floor below. This in turn would allow equipment to shift and drop into the fallen tile area on one side, and then fall over. All critical equipment should either be bolted to the floor below the tile using a tie-rod or, for lighter equipment, bolted to individual floor tiles. Figure 28 shows a mainframe computer, supported on a computer floor that was tested on the USACERL Triaxial Earthquake and Shock Simulator (TESS). This was the standard field installation for seismic design where the tiles were fastened to the computer floor posts, the posts were braced, and the computer was fastened to the floor below using a tie-rod that penetrated the computer floor surface. This configuration performed well in seismic qualification tests.³

Figure 27. Close-up showing lack of anchorage for the optical disk system.

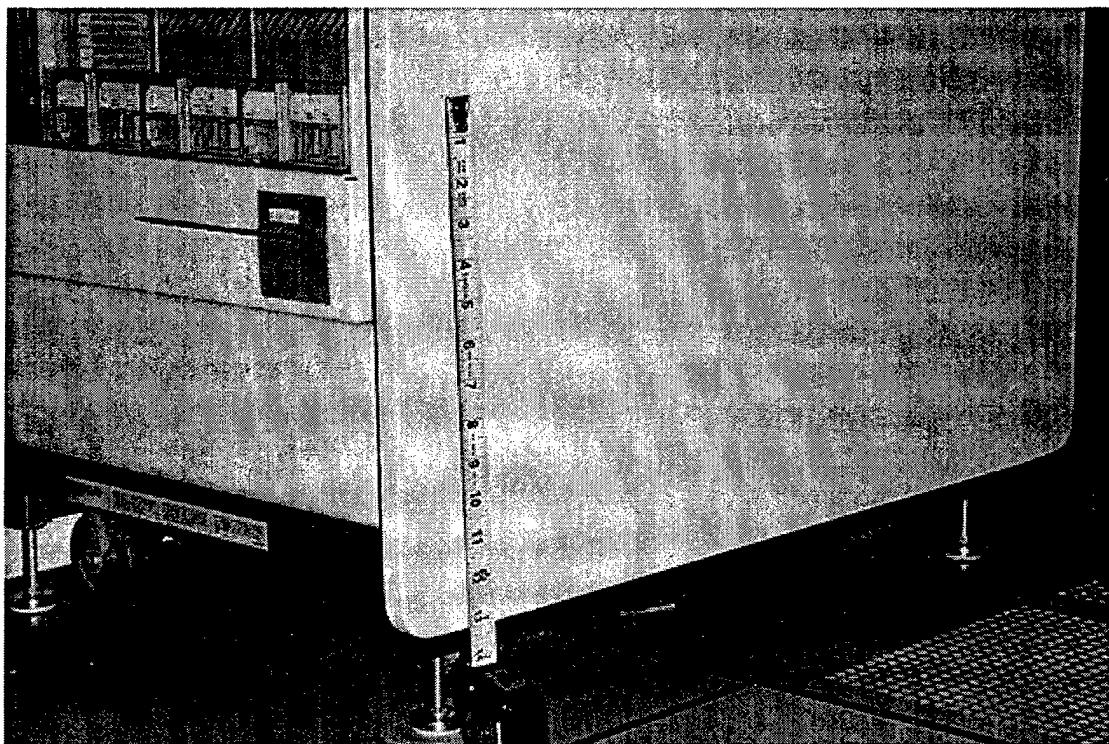
Figure 30. Close-up showing a lack of anchorage for the mini-computer.

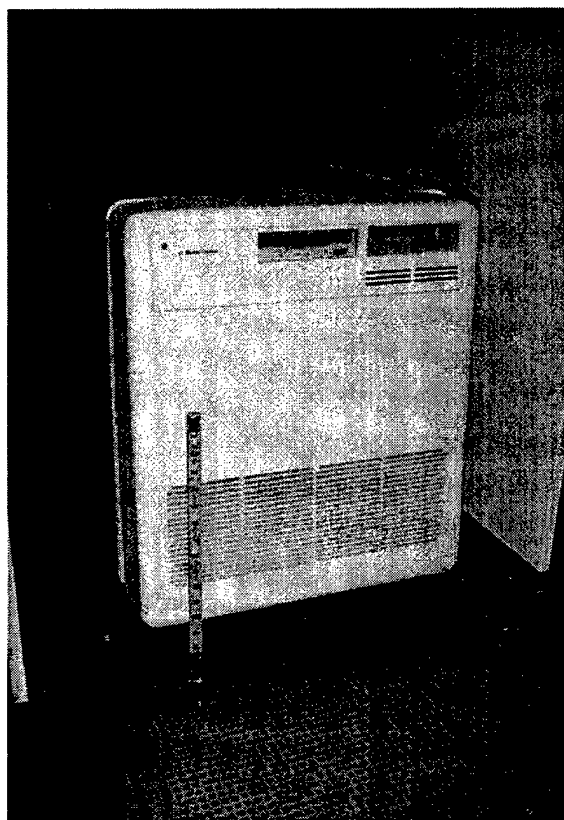
Figure 32. Computer that records MRI results, anchored to a single computer floor tile.

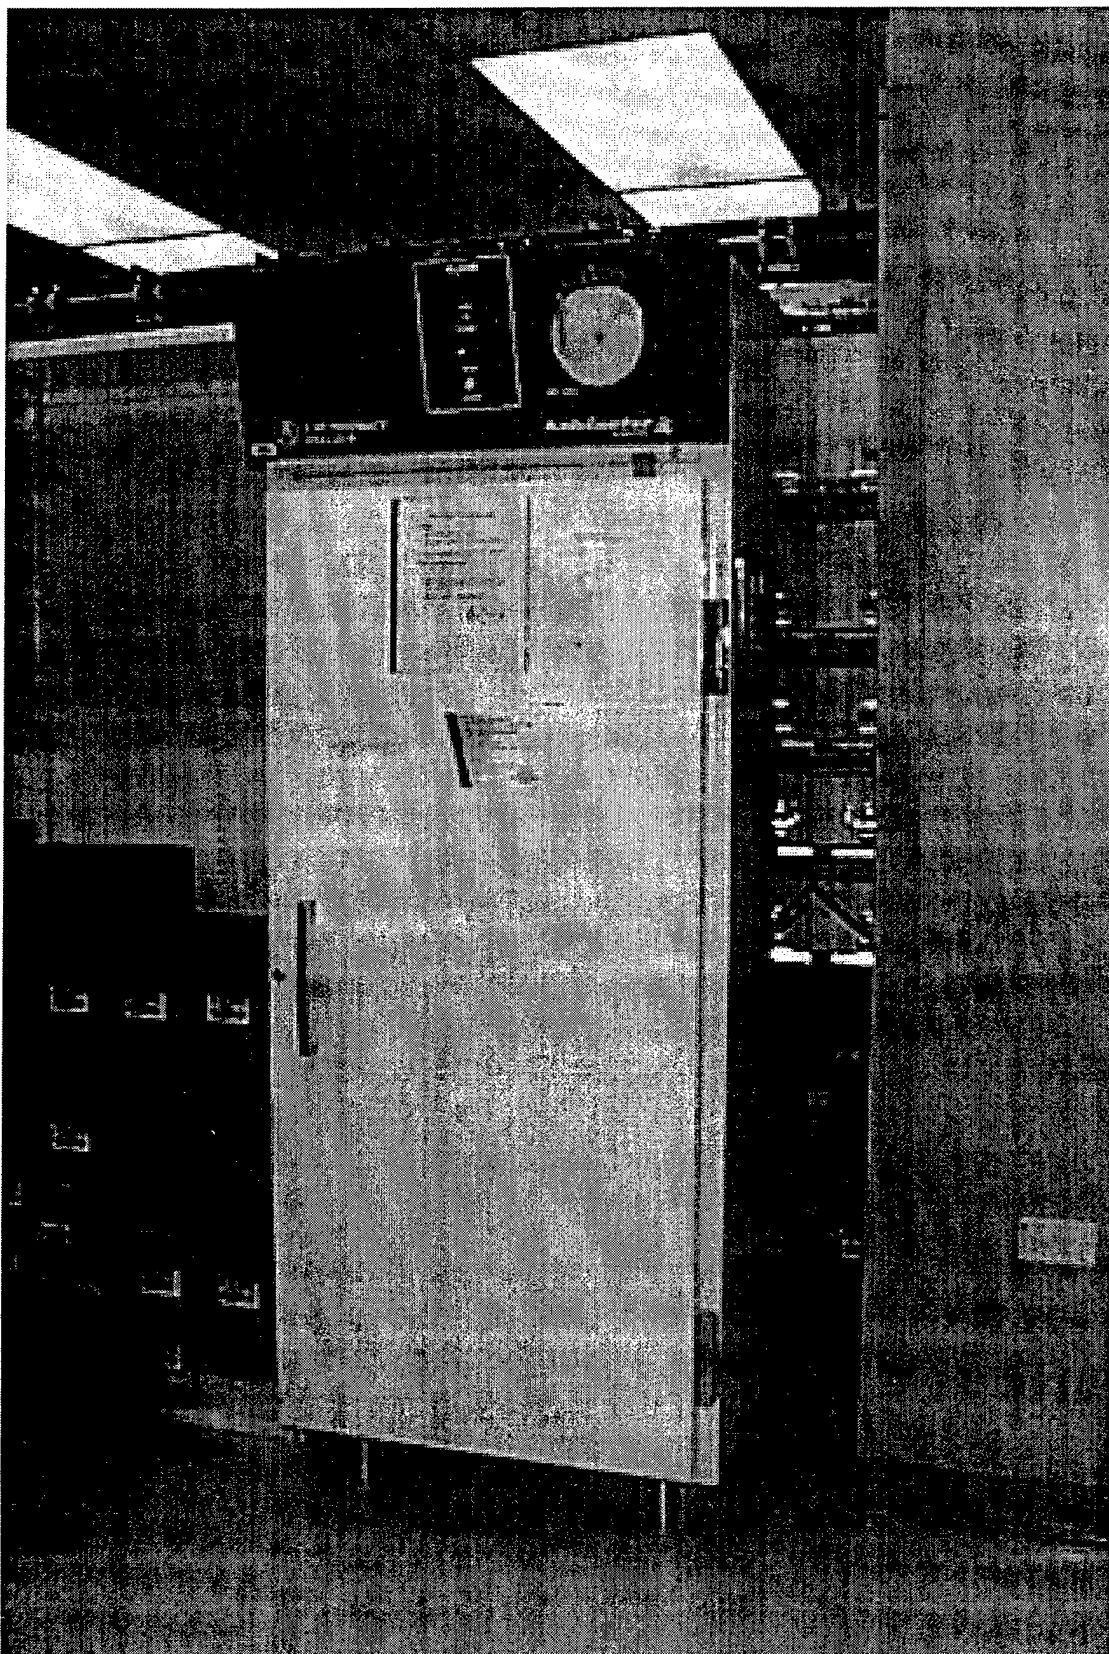
pharmacy freezer that is quite tall, has a small footprint, and is unanchored. (It should be noted that the kitchen also has many tall, narrow unanchored coolers and freezers similar to this.) These should either be braced (see Figures 4 and 14) or anchored to the floor. Figures 34 and 35 show tall, narrow shelves. These shelves can be simply braced by bolting them to a wall or to each other in a T or L configuration (in plan). The two shelves shown in Figure 34 could be braced by simply bolting them to each other near their tops and bottoms. (They will form a T configuration in plan if left in the positions shown in this figure.) Tall shelves such as those shown in Figures 34 and 35 could also be braced to the ceiling structural system. Shelves that are at least seven feet tall configured in parallel rows can be braced to each other perpendicular to the row and across the tops. Figure 36 shows small storage bins in the pharmacy. These bins have a small lip at the front. Storage bins like these should have a higher retainer edge to keep contents in the bins. The same retainer edge should be used for horizontal shelves throughout MAMC. It is recognized that such a retainer edge would make shelves slightly less accessible, but this is a relatively small cost to protect important medical assets. This approach is used in other types of facilities in active seismic regions, such as libraries in California which often have wires in front of books to hold them in place during an earthquake. Lightweight contents can also be held on shelves with cabinet doors with latches.

Figure 33. Tall unanchored pharmacy freezer with a narrow footprint.

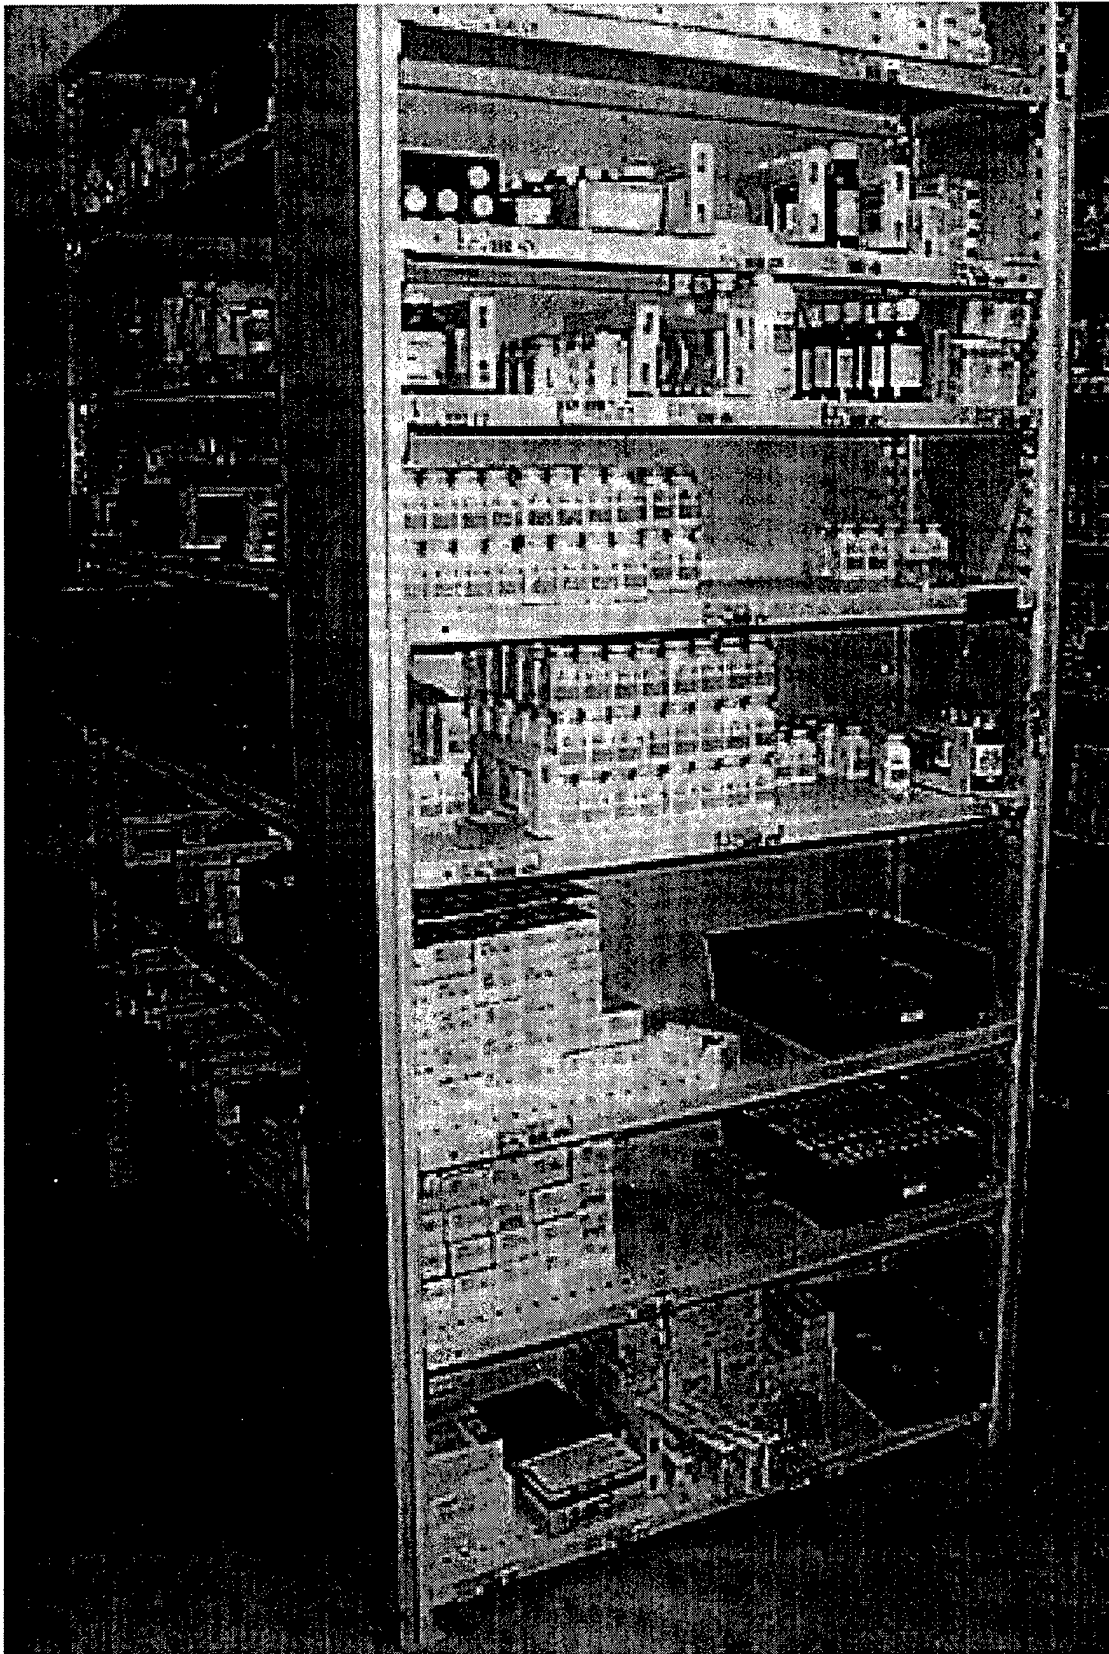
Figure 34. Unanchored tall narrow shelves that may be secured in their present configuration.

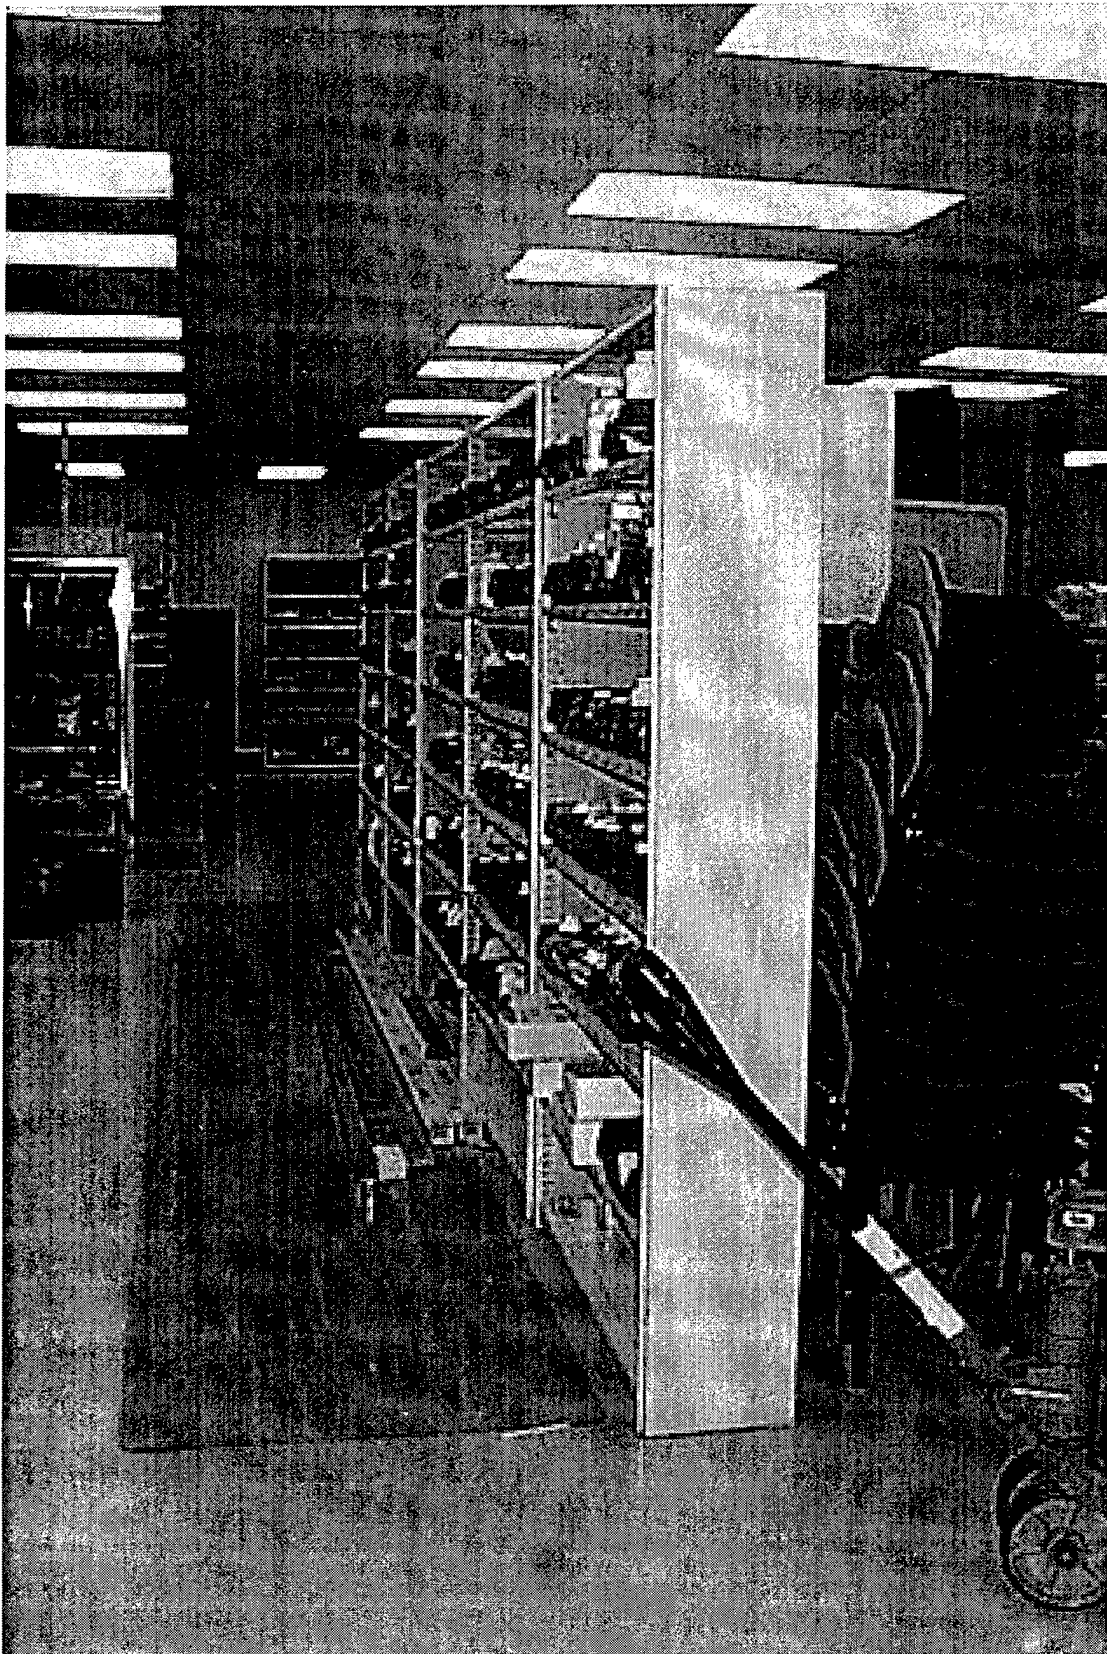
Figure 35. Unanchored tall narrow shelves.

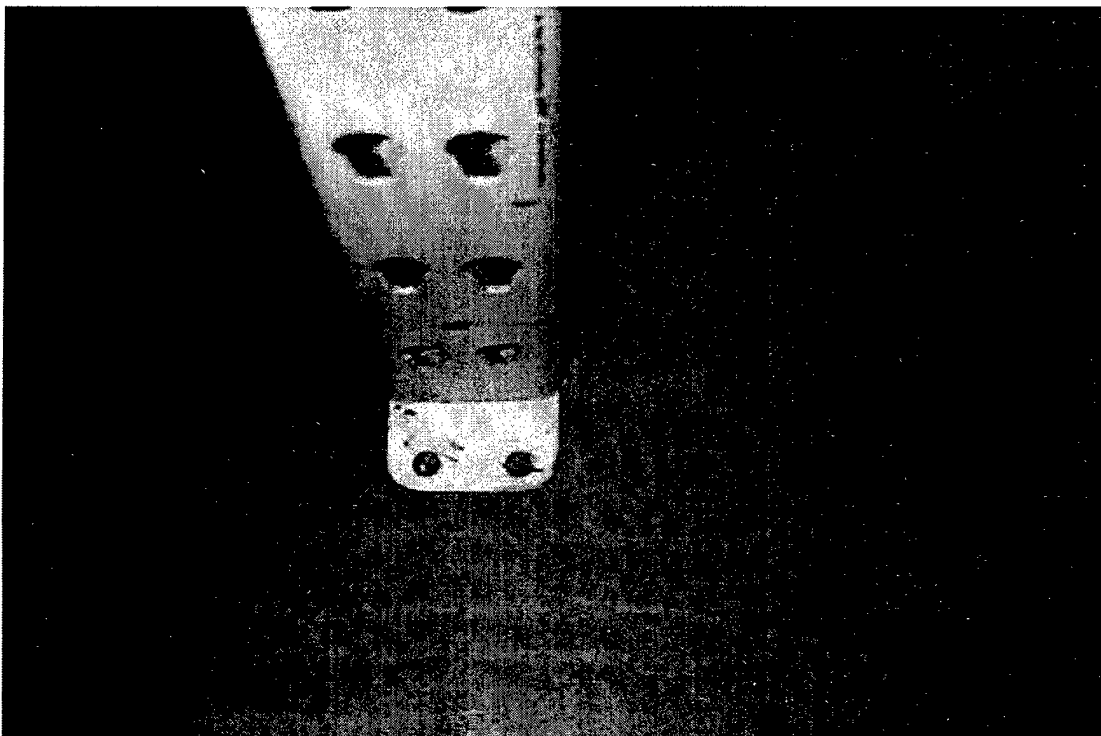
Figure 38. Close-up of logistics area storage racks showing lack of anchorage.

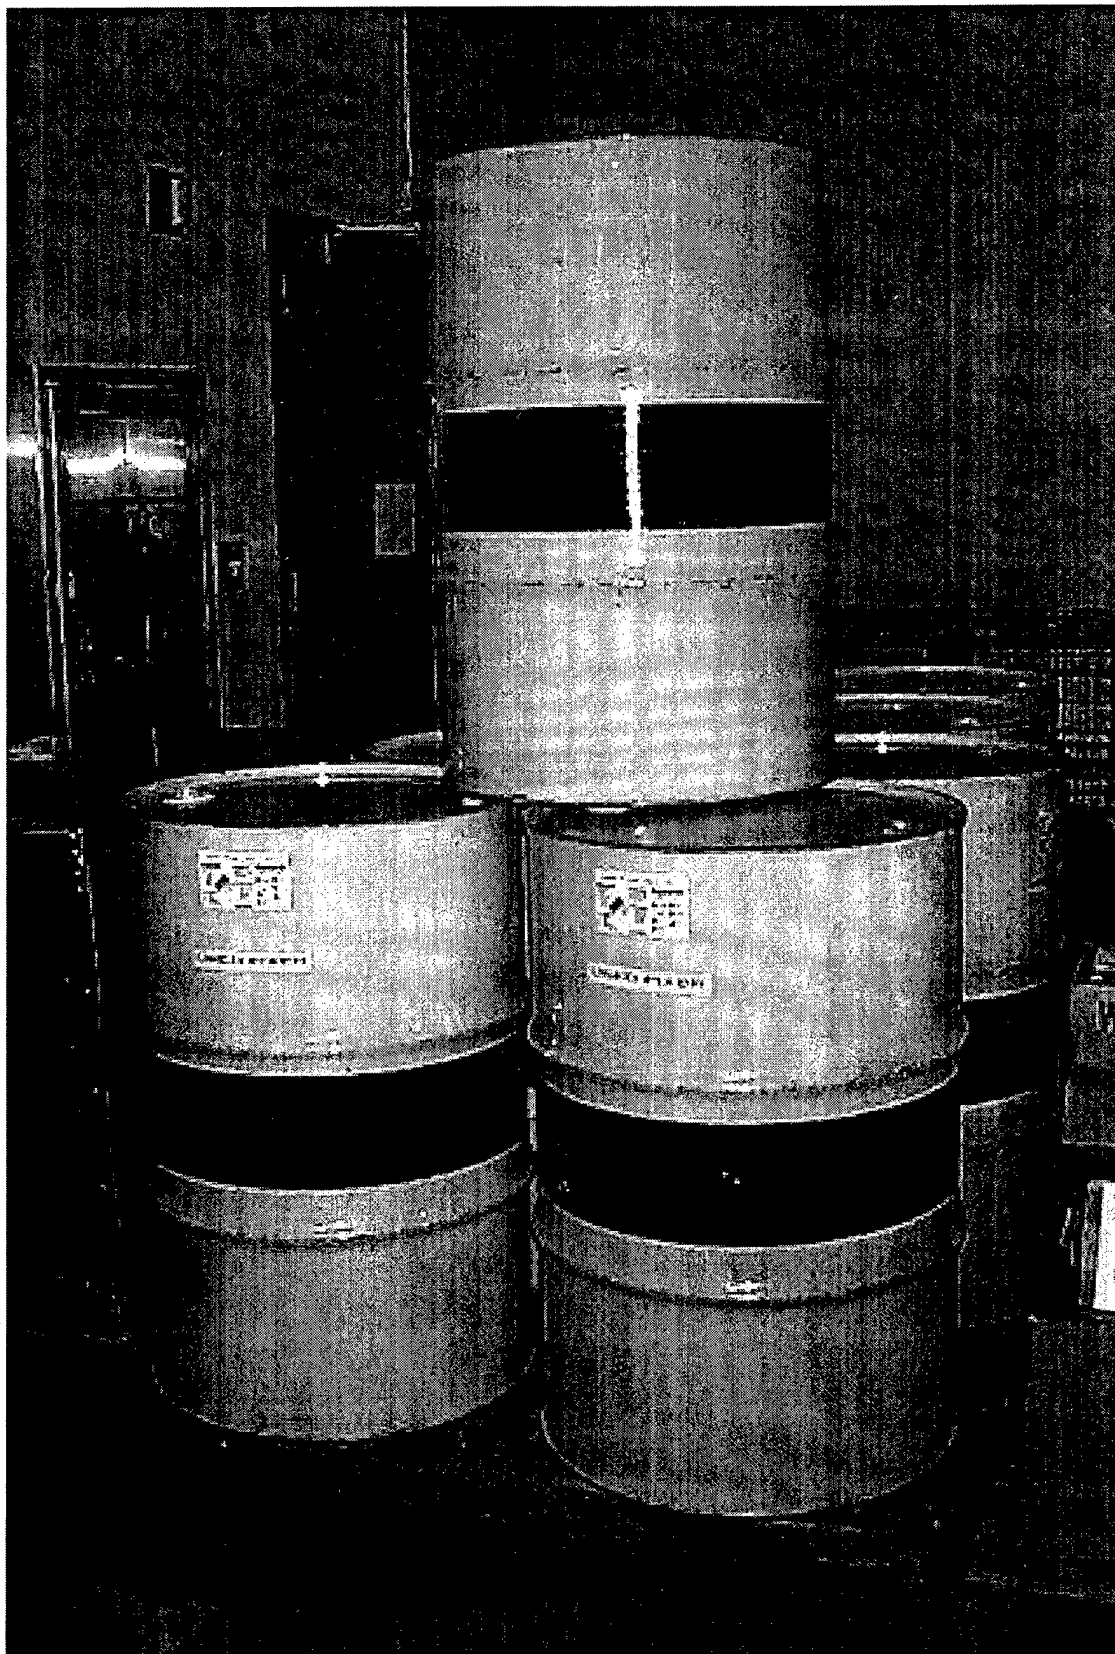
Figure 39. Loosely stacked barrels.

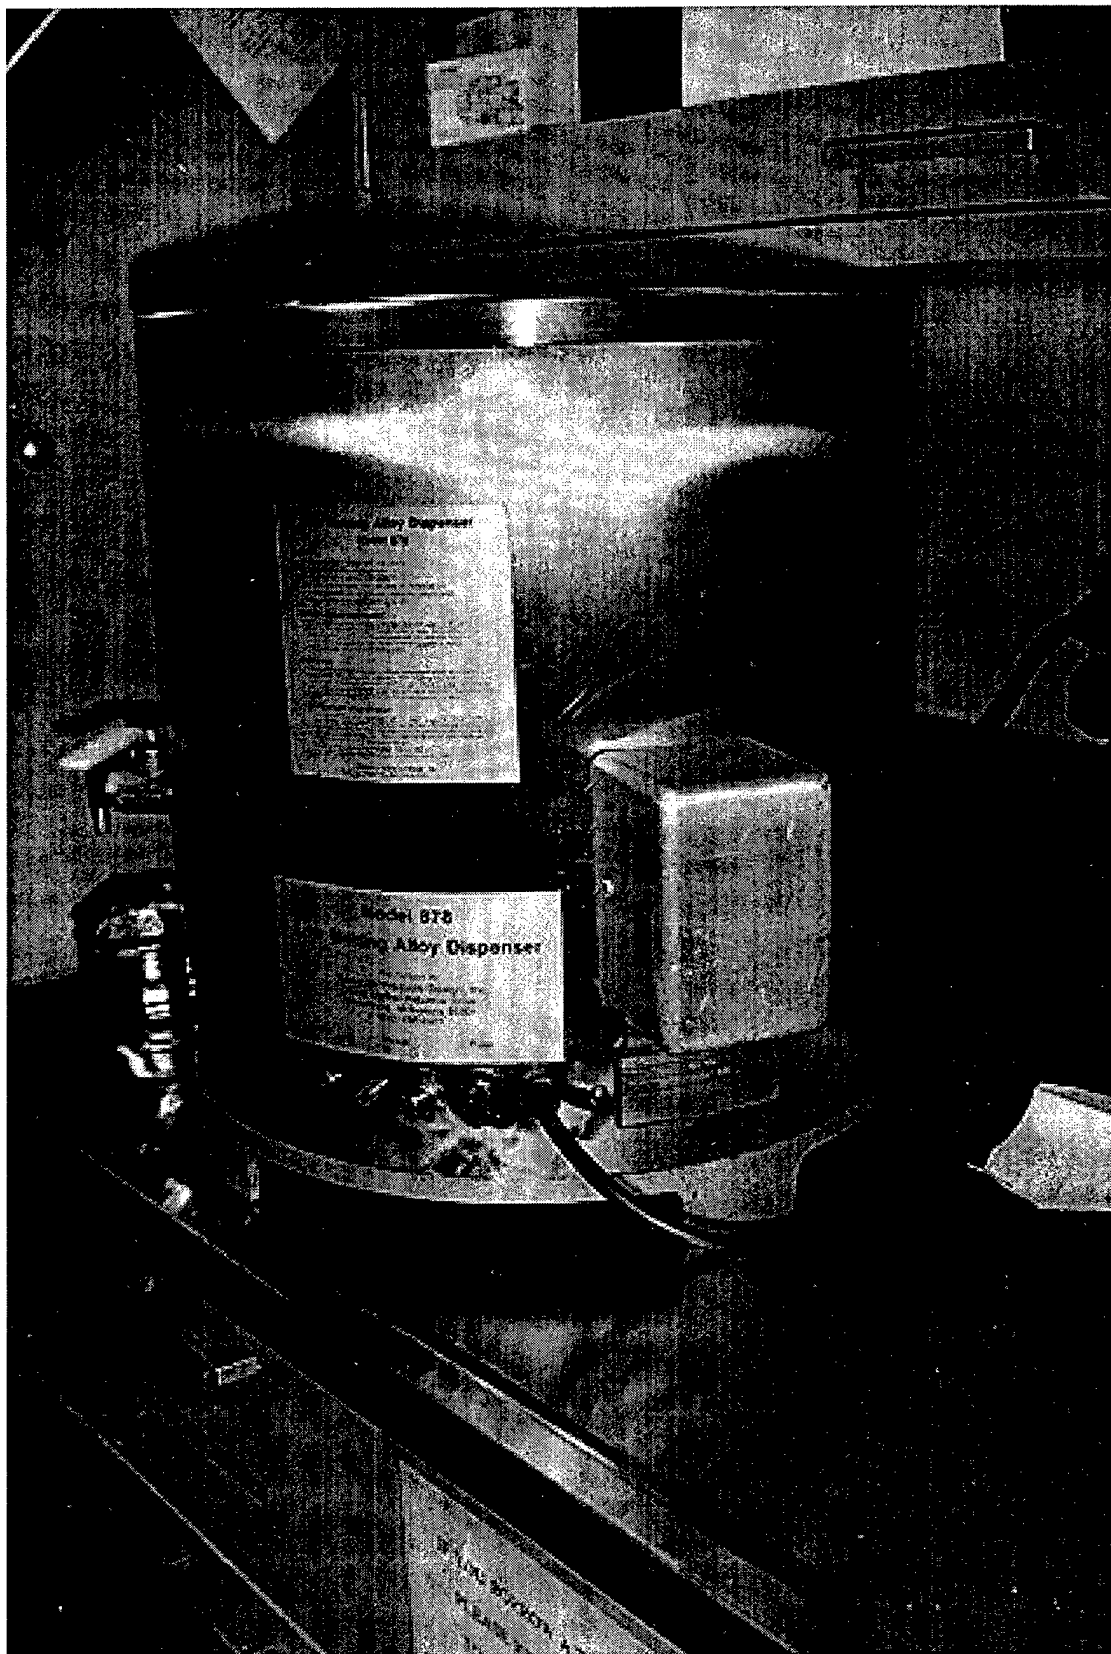
machine can easily be bolted to the floor. Figure 42 is a low-melting alloy dispenser, providing molten lead for casting radiation shielding blocks. This unit weighs over 100 lb (45 kg), and is resting loosely on the countertop. It should be anchored to the countertop or braced back to the wall. Figure 43 shows typical laboratory equipment — both the cabinet and its contents should be anchored. Also note the file cabinet on the right side of this figure — it is unanchored and may easily topple, blocking escape from the door next to it.

Figure 42. Low-melting alloy dispenser, shown resting loosely on countertop.

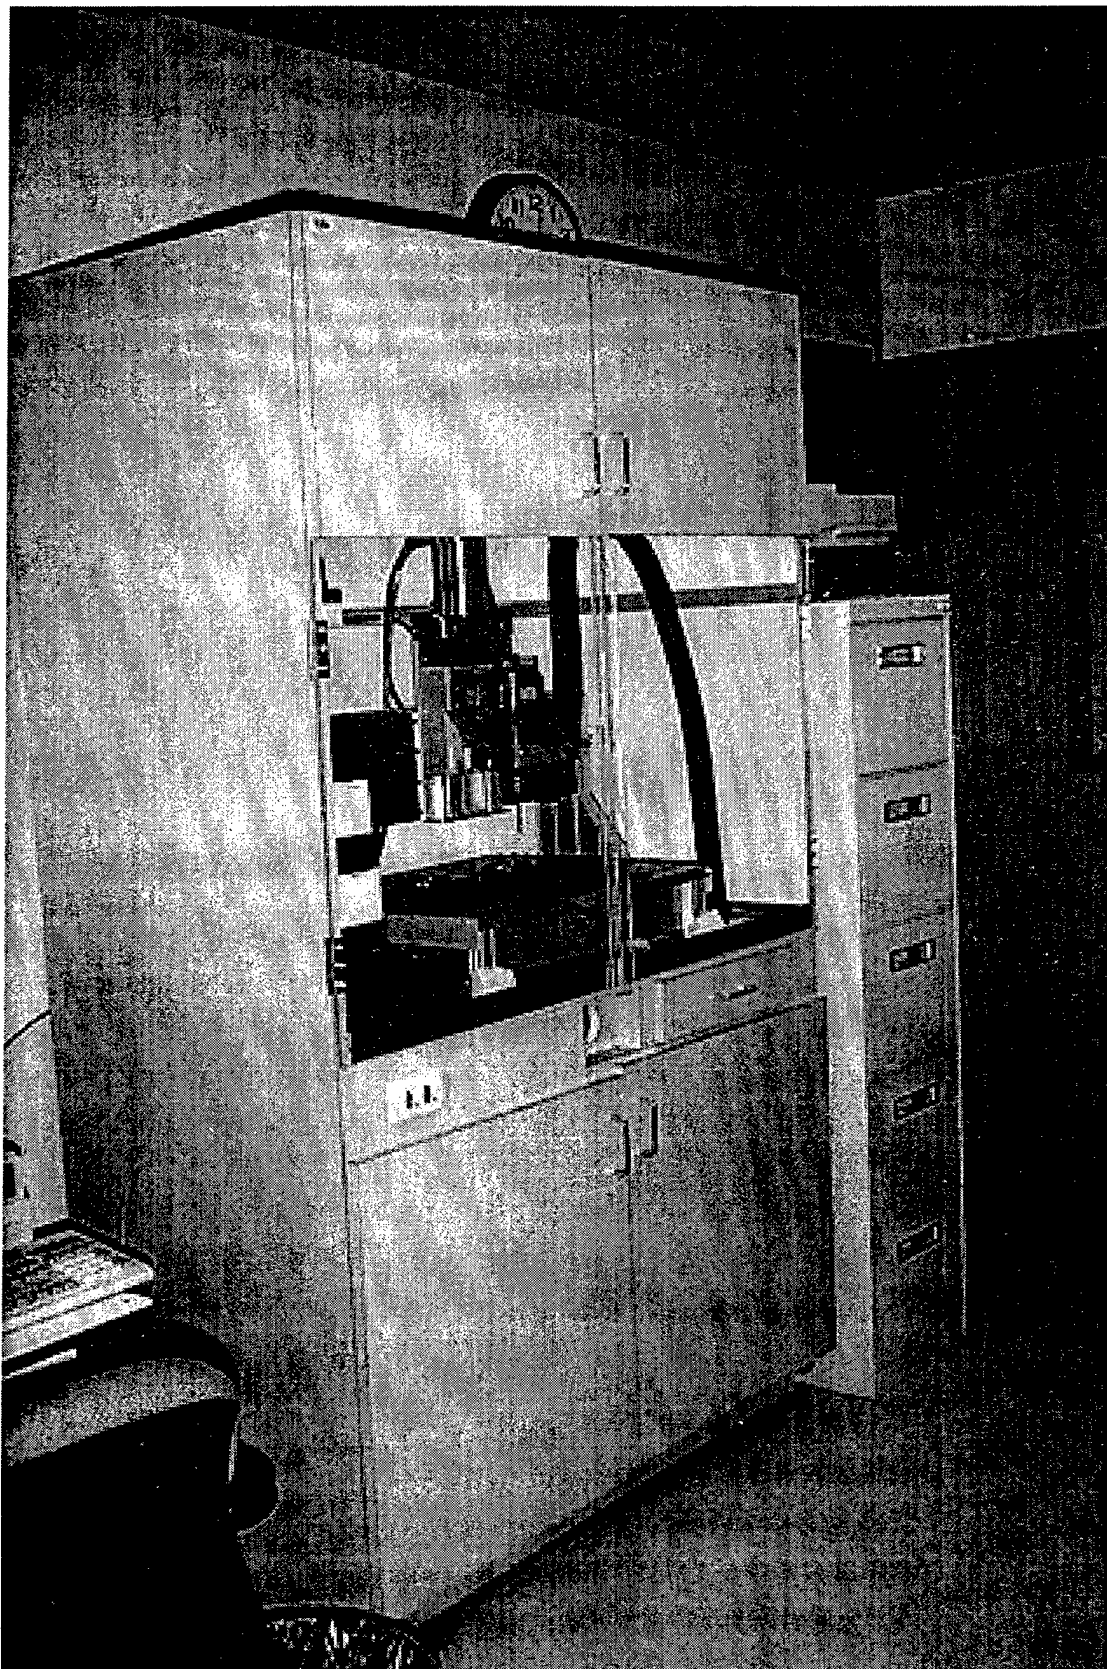
Figure 43. Unanchored typical laboratory equipment.

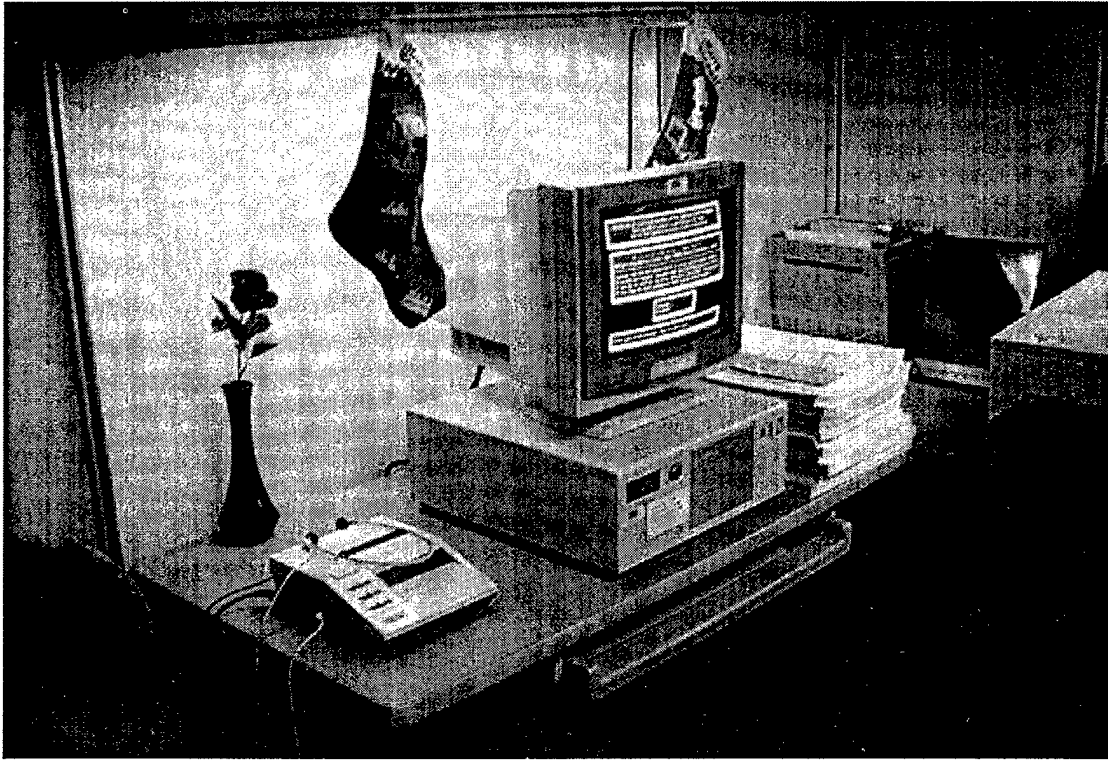
Figure 44. Unanchored desktop computer CPU and monitor.

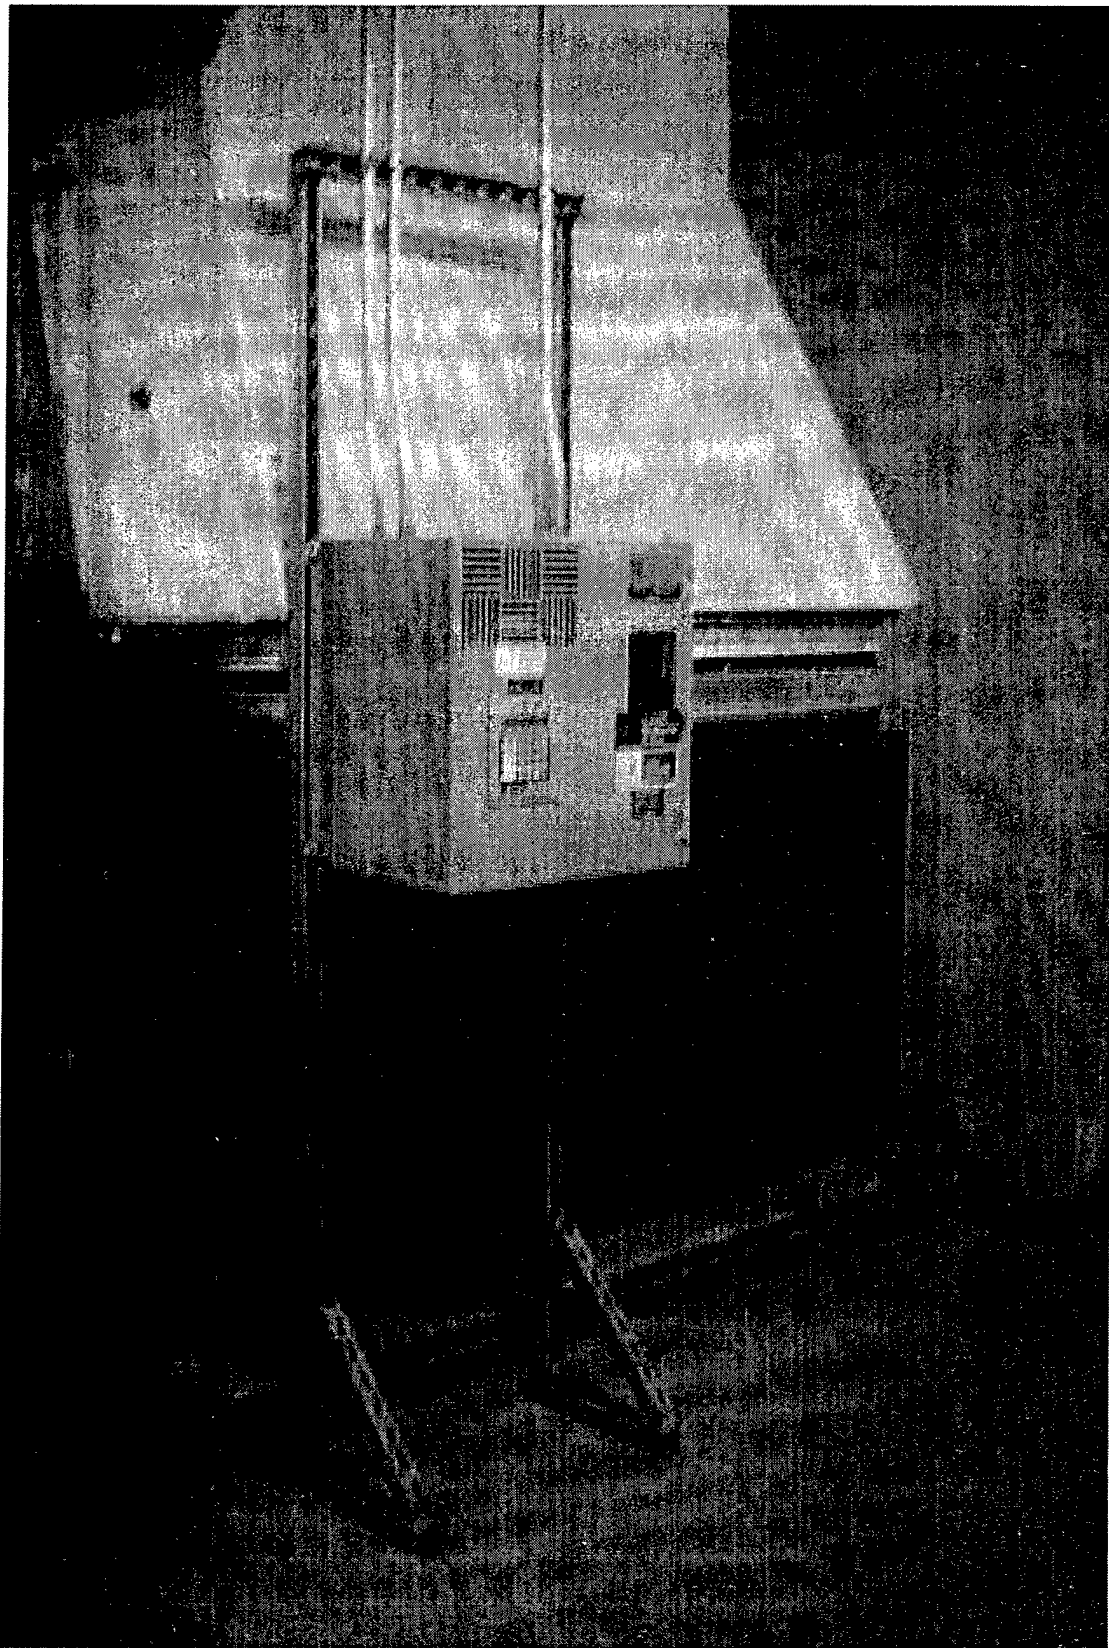
Friction clips, which are often used to support or brace cable trays and various other equipment, should be avoided. Figure 46 shows a Unistrut frame supporting an air-handling unit control panel in a mechanical room. The brace at the bottom of this frame uses friction clips to connect the diagonal members. These clips may work loose after several cycles of seismically induced motions. Such connections should be made with standard fasteners rather than these clips.

Figure 46. Unistrut frame with friction clips supporting air handling unit control panel.
