USACERL Technical Report 98/34
January 1998

Seismic Mitigation for Equipment at Army Medical Centers

Methods Illustrated With Examples from Madigan Army Medical Center

Personnel from the U.S. Army Construction Engineering Research Laboratories (USACERL) conducted a walk-down inspection of Madigan Army Medical Center (MAMC) in December 1996. MAMC is located at Fort Lewis, WA, south of Tacoma. This center is quite new, having opened in March 1992, and care has clearly been taken on many of the systems to provide earthquake resistance. Most older medical centers would have many more problems to address, particularly in the areas of nonexistent or inadequate anchorage and a lack of flexible connections. Figure 1¹ shows the east side of the Nursing Tower at MAMC. To the West and connected to this tower is the ancillary building (not seen in the figure), which contains most of the critical equipment. To the north

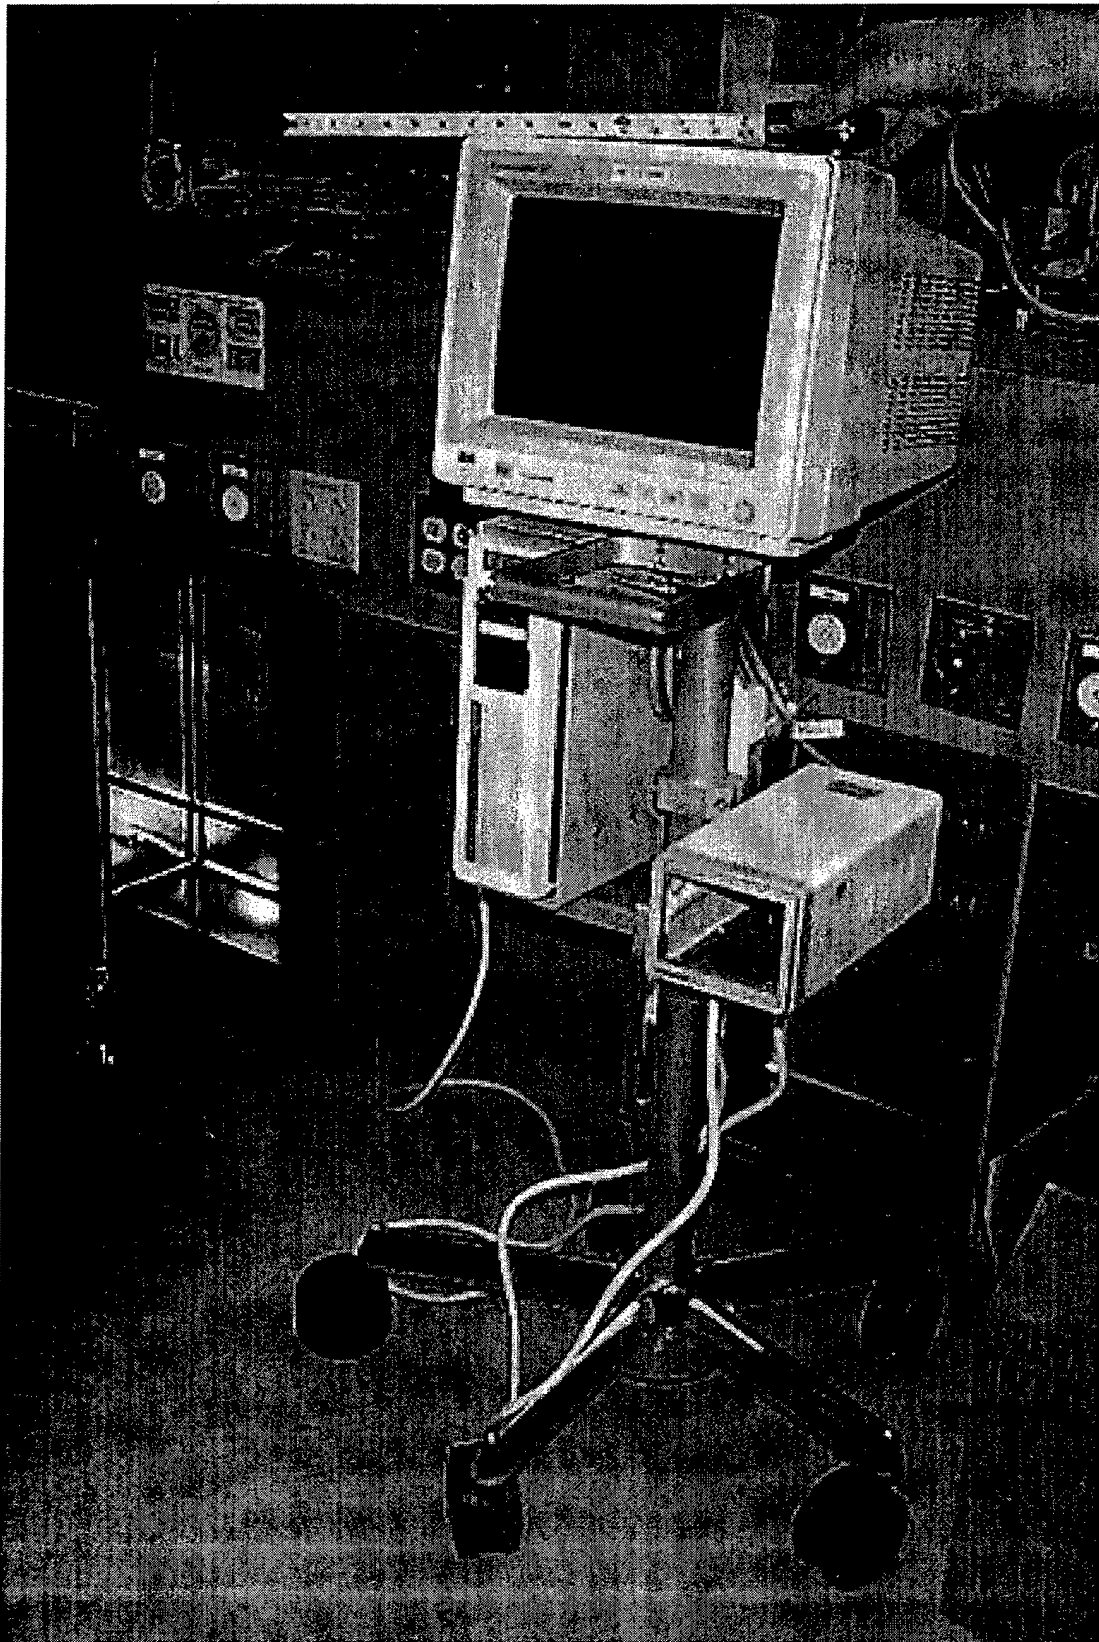
Figure 48. Monitor on wheels with a very narrow wheelbase.

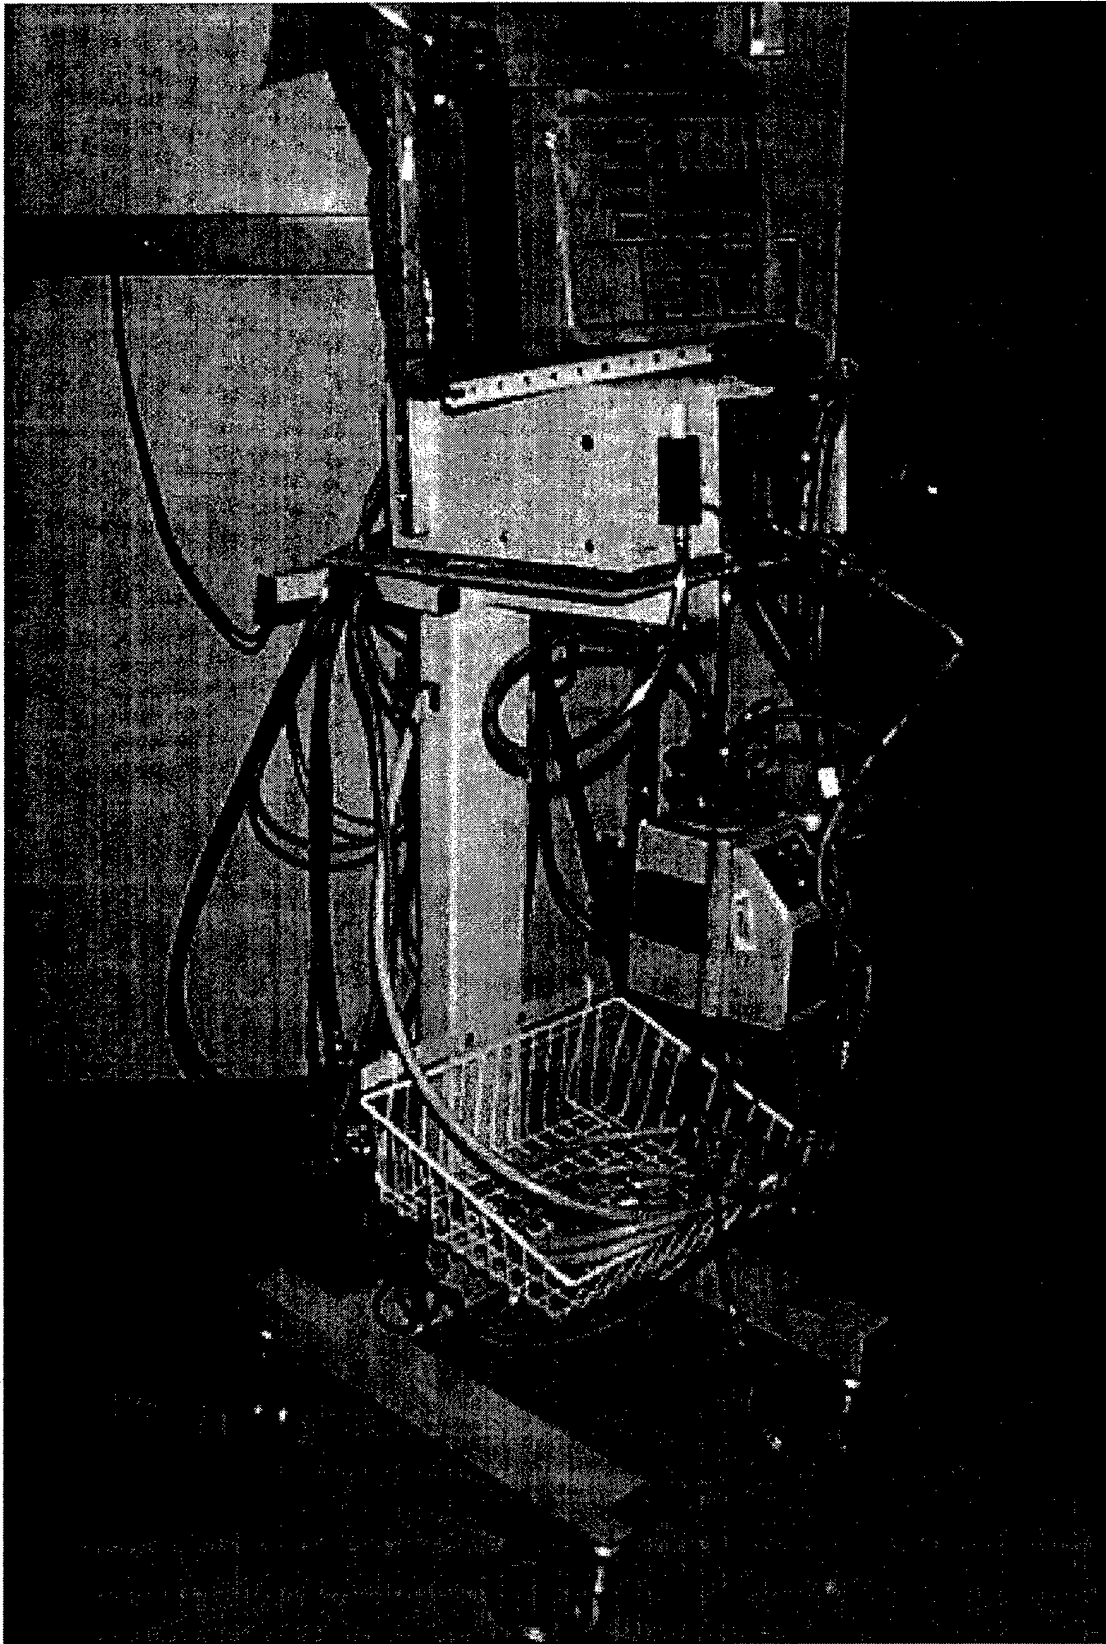
impact may damage either the equipment on wheels or whatever it hits, such as gas lines in intensive care units. It is recommended that the wheels on all such equipment be kept locked. Even with the wheels locked this equipment may fall over if the wheelbase is not wide enough relative to the height of the equipment center of gravity. If such equipment cannot be anchored, it can only be protected by increasing the wheelbase or lowering the center of gravity. Equipment on rollers was seen in the emergency room communications center, intensive care unit (ICU) rooms, ICU nursery, delivery rooms, operating rooms, and in the area near gamma ray cameras. Figure 47 shows a nursery bed on wheels in the ICU nursery. Figure 48 shows a monitor on wheels with a very narrow wheelbase. Figure 49 shows other equipment with a narrow wheelbase near the ICU nursery.

Figure 49. Other equipment on wheels with a narrow wheelbase.

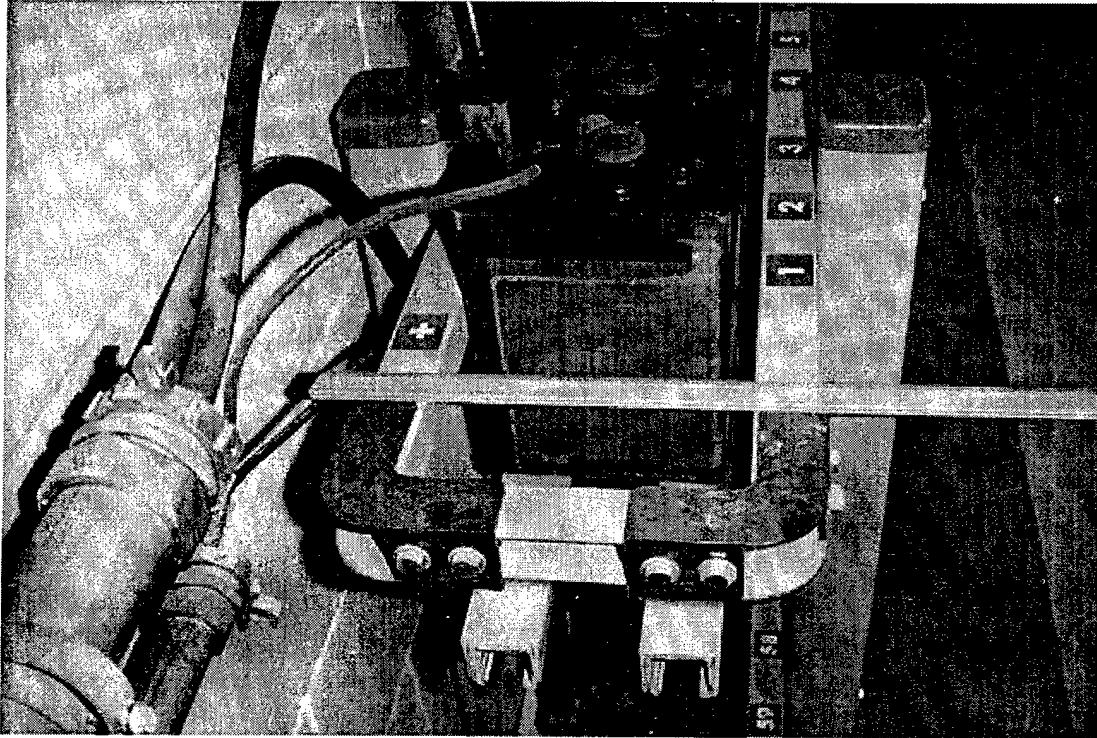
Figure 50. Close-up of station batteries showing lack of foam spacers.

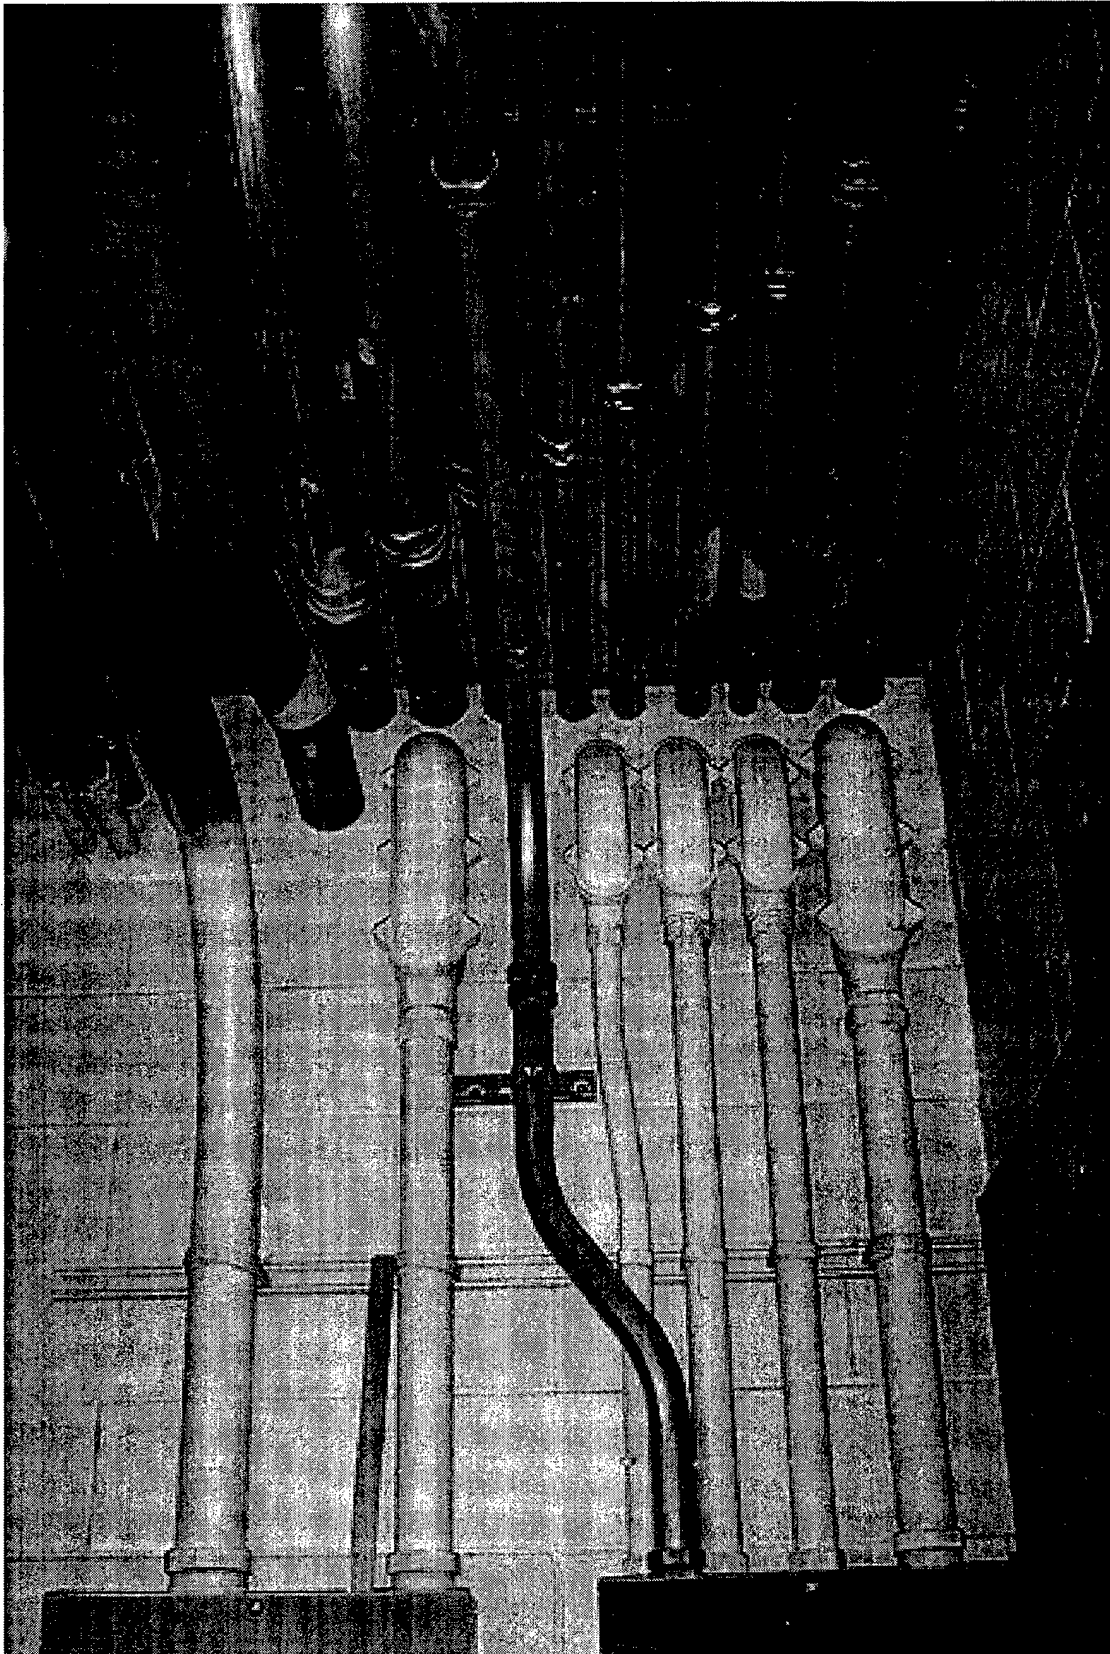
Figure 52. Heavy conduit penetrating CMU wall, loading wall out-of-plane.

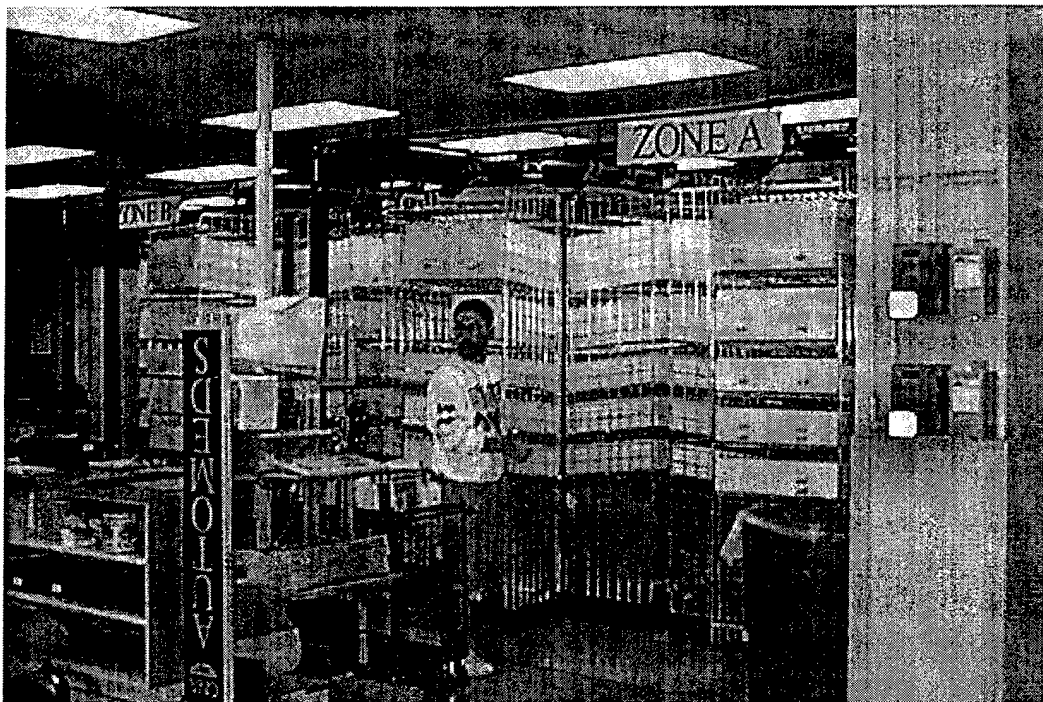
The outpatient pharmacy is supplied by the automated storage racks shown in Figure 53. These movable racks provide 10 days of supply storage. The racks are supported with a structural floor and frame designed to carry 1000 lb (453kg) per 2 x 2 ft (in plan) and 7 ft tall (0.6 x 0.6 x 2.1 m) unit. According to MAMC personnel responsible for this area, the actual weight per unit rarely exceeds 200 lb (90 kg). The logistics area has similar storage racks; their contents appear somewhat heavier, but still well within frame capacity. These frames are approximately 60 ft deep (front to back) and move clockwise along a horizontal track in such a way that racks on the right move toward the front while racks on the left move toward the rear. Therefore, one frame supports about 120 linear feet of 2 x 2 x 7 ft storage units. The pharmacy is equipped with five of these frames. The frames are well anchored to the floor and they appear to be well braced to carry seismically induced lateral loads. The storage units appear to be well supported, with all vertical loads carried along a track at the tops of the frames. The bottoms of these units are restrained by a roller from swinging in against a support bar on the frame, but they are free to swing out — particularly away from the track ends. The racks of one frame are separated from the racks of the parallel frame by only 6 in. Figure 54 shows the bottoms of the racks of two such frames, with the 6 in. separation seen in the center of the photo. In the center of this photo a box has been laid to span across between the two frames. In an earthquake, these frames will be free to swing out at their bottoms, striking the adjacent racks. Immediately after an earthquake begins the racks should be shut down so this impacting will not bind the racks to each other. However, rack contents such as the box shown in Figure 54 will probably fall out of the racks, or to an adjacent rack, or get wedged

between the racks, preventing the operation of the racks temporarily. This debris would need to be cleared away by manually removing rack units, climbing into the racks and removing the obstruction. It may require several hours to clear away the debris but should not cause a long-term problem. If someone attempts to operate the racks before removing this debris, the racks could be forced out of position and bind to each other. If this happened, the rack units or frames could twist, resulting in the need for time-consuming repairs. Therefore, after an earthquake, the racks should be inspected and debris removed to prevent longer-term problems. Figure 54 shows that the base of each rack section slopes in toward the center of the frame, which would help to retain most contents during an earthquake. The actual loss of rack contents should be minimal.

Figure 53. Front view of automated storage racks in the outpatient pharmacy.

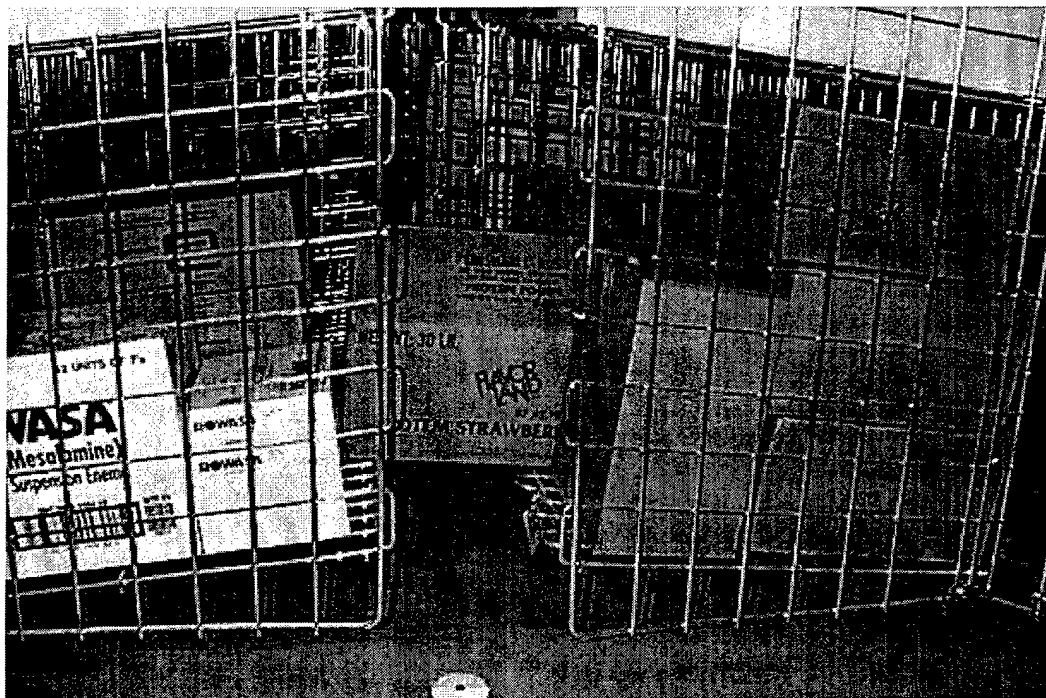
Figure 54. Close-up showing narrow gap between racks at bottom of automated storage racks.

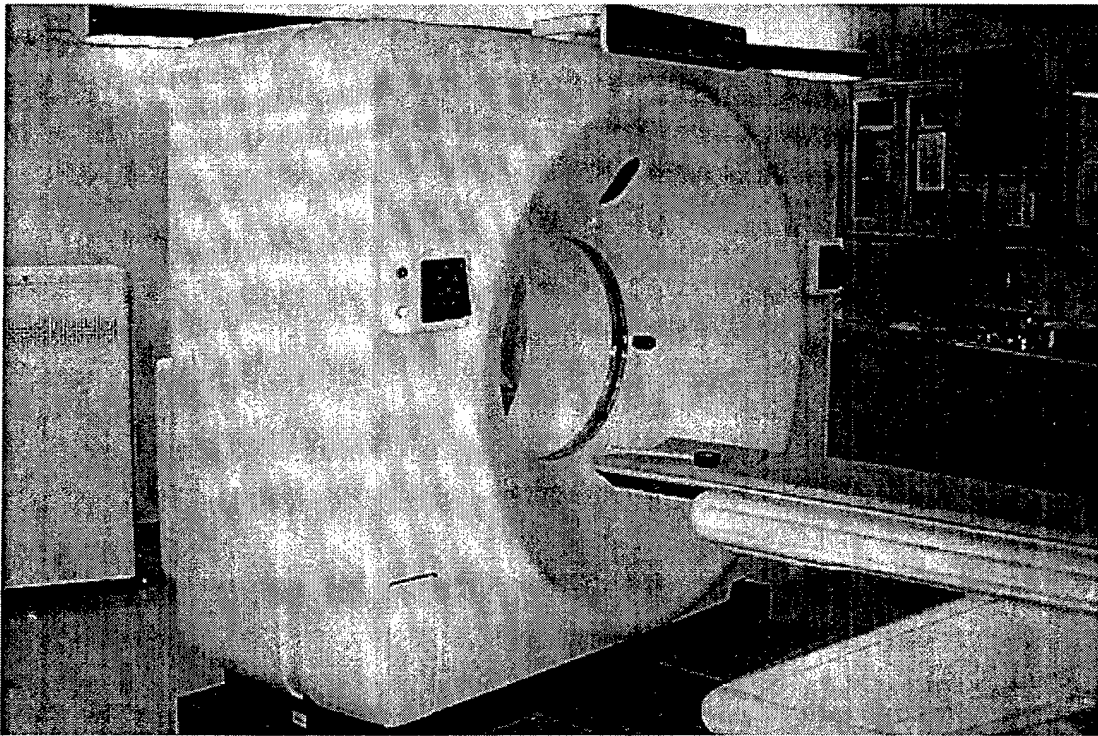
Figure 55 shows a General Electric (GE) computed tomography (CT) scanner. According to medical staff at MAMC, the x-ray tube and detector array rotate in the circular ring shown in Figure 55. These can easily move out of alignment during a seismic event — particularly while spinning. The CT scanner may be the most vulnerable medical equipment at MAMC and, as noted previously, is of particular concern to medical staff.

Figure 55. General Electric CT Scanner, potentially the most vulnerable equipment at MAMC.

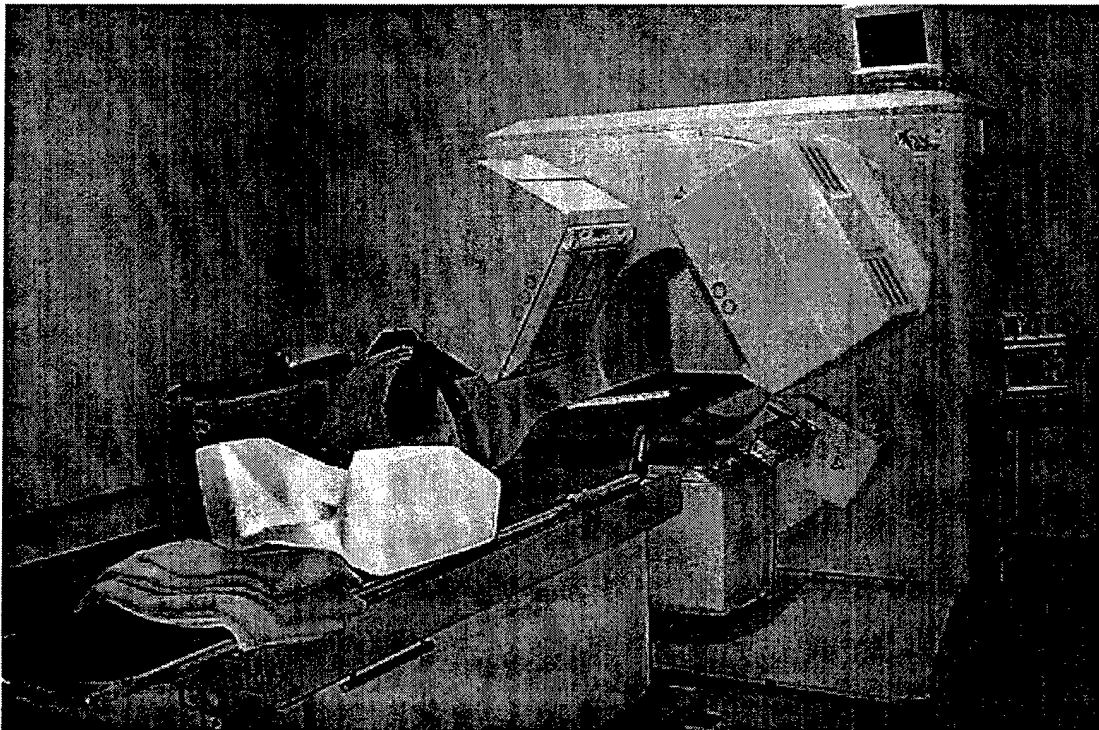
Gamma ray cameras of various types, all manufactured by Siemens, were seen at MAMC. These include the single-head Orbiter, a single-square-head Diacam, and a triple-head Prism 3000 gamma camera. The triple-head camera is shown in Figure 56. Each head in this camera contains 60 glass tubes in rows, costing \$3000 per tube. USACERL inspected the Sepulveda Veterans Administration (VA) Medical Center, which is located about 20 miles (32 km), Northwest of downtown Los Angeles, CA, shortly after the 1994 Northridge Earthquake. Figure 57 shows a single-head gamma camera that was damaged in the Northridge event. The camera was well anchored to the floor, but the mechanism at the base of the cantilever arm supporting the head was damaged.

Figure 56. Triple-head Prism 3000 Gamma Camera.

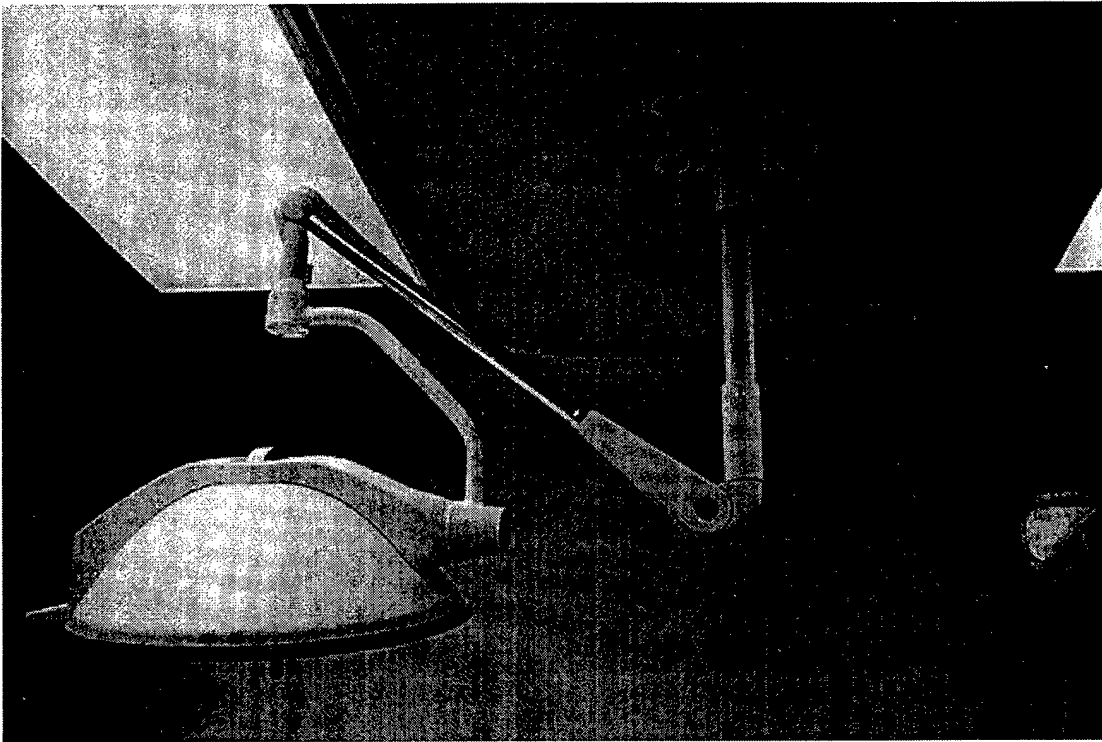
Overhead examination lights such as the one seen in Figure 59 are located throughout MAMC. These are well anchored to the roof above, but the supporting arm appears questionable, especially when fully extended. These may have been seismically qualified, but further investigation is needed to verify that.

Figure 59. Overhead examination light, typical of those located throughout MAMC.
