## FAILURE OF COMPONENTS ALTHOUGH THE CAUSES ARE SIMPLE & WELL DOCUMENTED

Massachusetts Materials Research, Inc.

1998

### Failed Pawls in Hand Operated Winches for Ladder Hoist

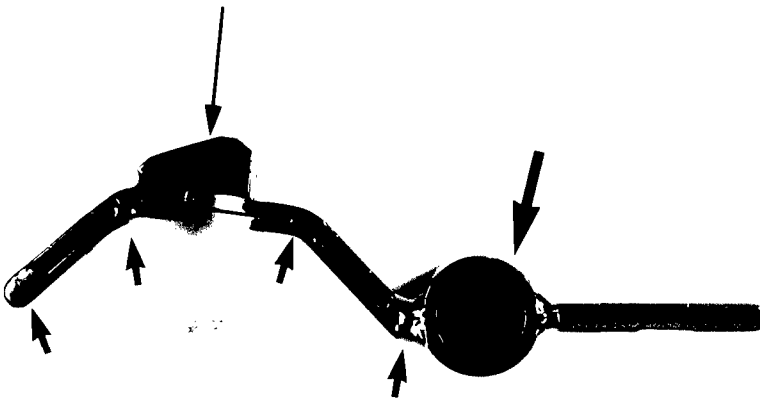
**Investigation:** A few fractured pawls were examined to determine the root cause of the failure. Figure 1 shows a new pawl finger as viewed from one side. The spring plate is "sandwiched" in the bracket and the two sides of the bracket are welded in four locations (small arrows). The longer arrow is pointing to the pawl weight and the thicker arrow is showing the fulcrum bushing.

Figure 1. Overall view of a new pawl. Small arrows are pointing to the welded spots; the long thin arrow is showing the weight and the thick arrow is showing the fulcrum bushing. Mag. 0.6X

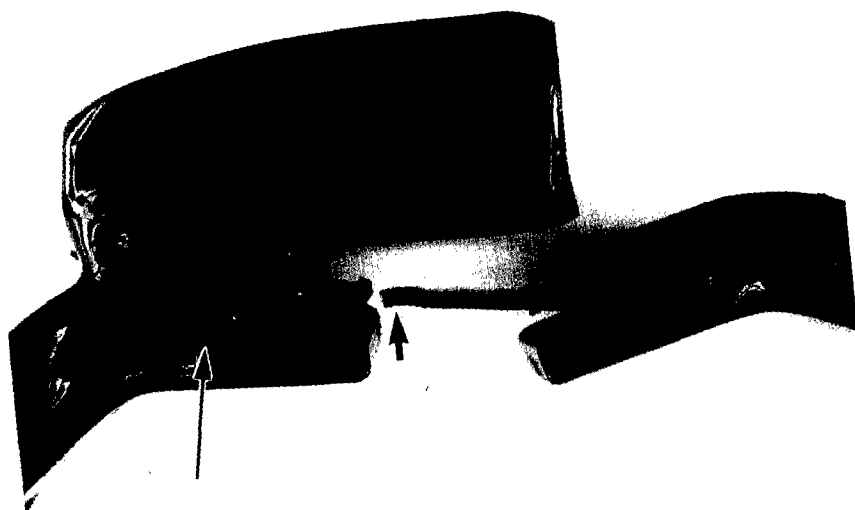
Binocular Microscope Examination: The spring strips always failed in an area that is unsupported by the bracket. Figure 2 presents an overall view of a failed pawl. Some plastic deformation was observed near the fractured surfaces of the spring strips.

Figure 2. A fractured pawl; the smaller arrow is pointing to the plastic deformation and the longer arrow is showing the cracked weld. Mag. 2.2X

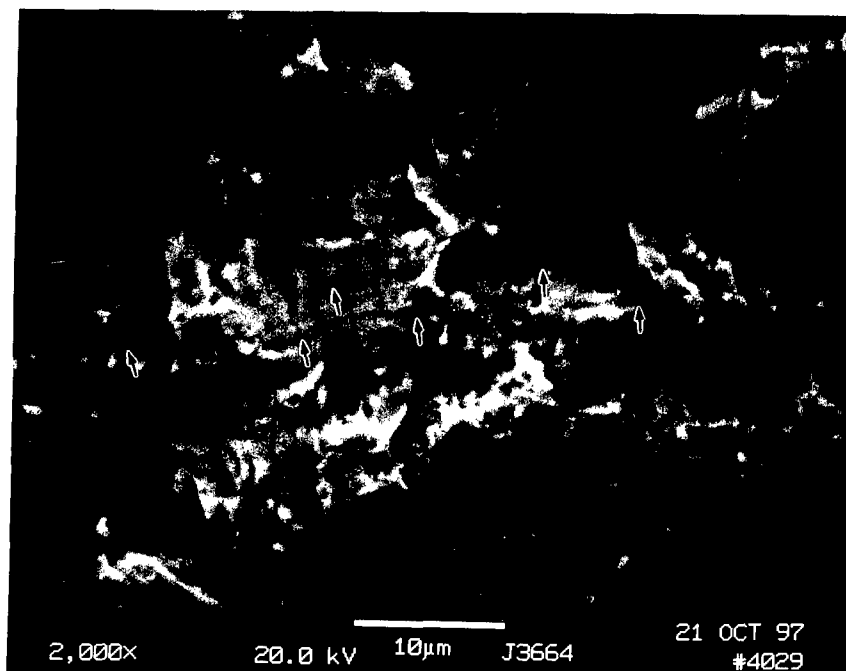
Scanning Electron Microscopy: The fracture surfaces from the samples were examined at higher magnifications for determination of the fracture mode. The origins were always from the same side and from the surface. No anomalies were observed at or near the origins. Fatigue striations were visible emanating from the origins. Figure 4 presents an area with striations. Each striation indicates the position of the crack front after each succeeding cycle of stress or loading and are indicative of fatigue fracture.

Figure 4. Higher magnification SEM photograph revealing fatigue striations (arrows) emanating from one of the origins. Mag. 2,000X

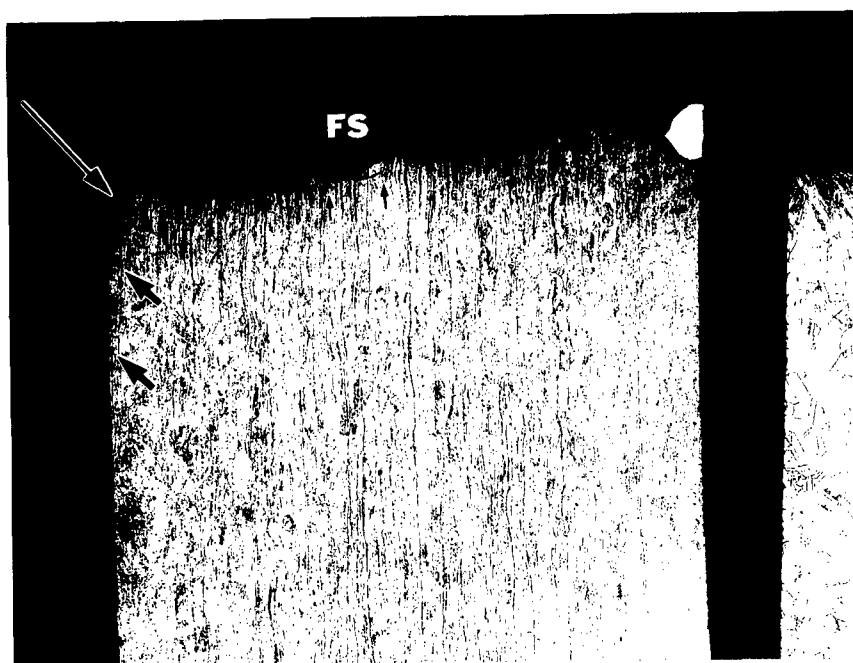
Optical Microscopy: Cross-sections were made through the origins of the two fractured samples. No microstructural anomalies were found in the samples. The microstructure consisted of heavily worked elongated austenite grains, typical of full hard 301 stainless steel (SS). Figure 5 shows an overall view of the mounted cross-section through one of the origins of sample #1. The longer arrow shows the origin. The fracture was predominantly transgranular and showed many secondary cracks (small arrows). The small thicker arrows on the left-hand side of Figure 5 show initiations of other fatigue cracks, parallel to the fracture surface (FS).

**Conclusions and Discussion:** The failed pawls fractured by fatigue in the center area of the spring strip. When the pawl fails to engage itself properly in-between the gear teeth, it experiences a significant amount of bending, causing permanent plastic deformation and locally damaging the spring metal. The material used for the spring strip, 301 stainless steel (full hard), is very notch sensitive. The magnitude of the applied cyclic vibrational forces on the spring strip when the pawl snaps off the top of the gear tooth

were large enough in the permanently bent areas to exceed the capability of the component and to initiate fatigue cracks. Continued use caused the fatigue cracks to grow to failure.

Figure 5. Mounted cross-section through one of the origins of sample #1. The longer arrow is pointing to the origin; small arrows are showing the secondary cracks on the FS. Thick small arrows on the left-hand side are showing other fatigue cracks initiating. Mag. 100X

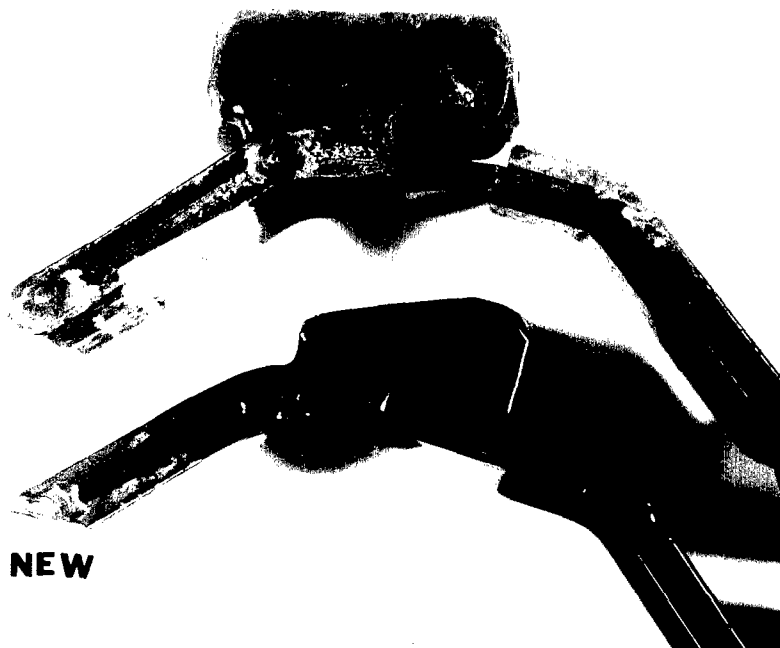
Figure 6. Suggested new pawl tip design for the existing pawls. The upper pawl is showing the tip design currently in use. Mag. 1.25X

**Recommendations:** We suggest a change in the shape of the tip of the pawl, which would be a retrofit to the existing pawls. Instead of the present rounded tip, the end should be ground so that the inner diameter side of the bracket makes an angle of about 40-45 degrees with the pawl weight side (outer diameter side) of the bracket (Figure 6). This reduces the contact area between the pawl tip and the gear tooth and the angled surface helps the pawl slide down to nest between the gear teeth. There is less chance of the pawl tip to get caught on the gear crest. The crests of the big gear teeth should be smoothed so that there are no burrs.

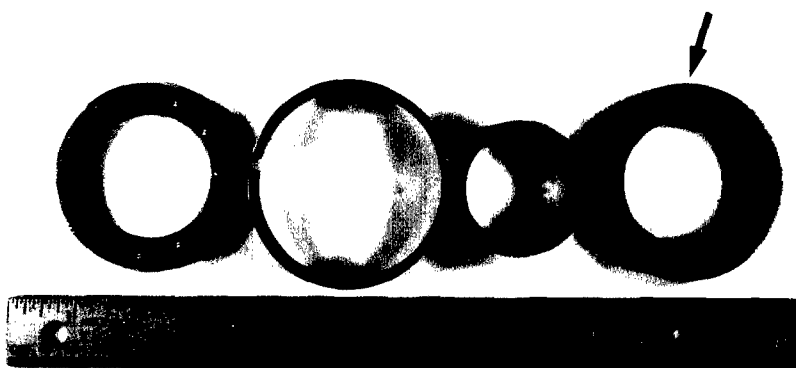
Binocular Microscopy: The Power Lock was disassembled, Figure 7, and examined with a binocular microscope. Cracks were observed on both sides of a drill hole in ring A, at the thinnest section. The arrow in Figure 7 is pointing to the crack. There were no cracks at any of the remaining drill holes.

Figure 7. Overall view of the disassembled "Power Lock". The arrow is pointing to the crack in Ring A.

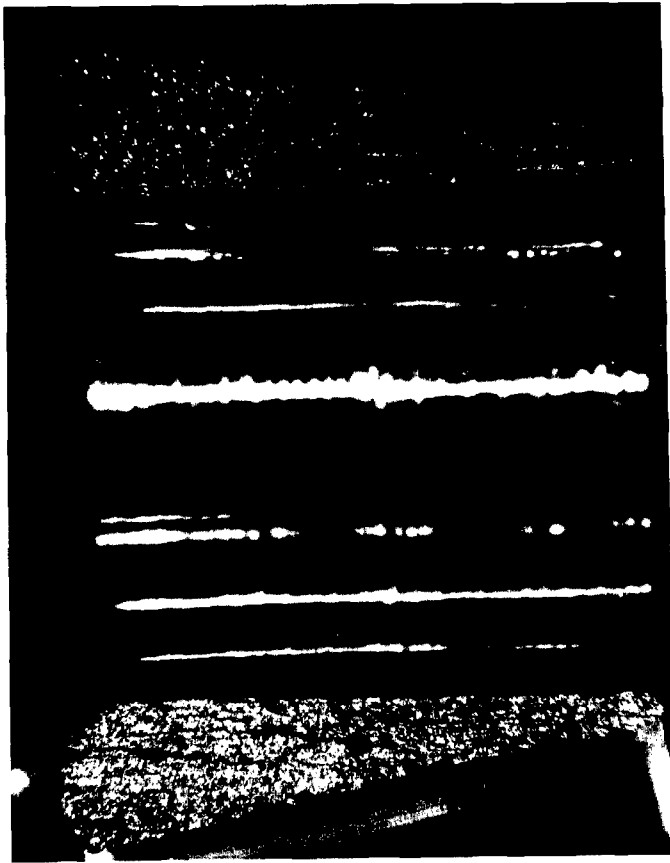
The crack was broken open and the fracture surface was examined, Figure 8. The portion of the fracture surface on the "inside radius" (bottom surface in Figure 8) had a "woody" type fracture appearance, indicative of the longitudinal direction of the original bar stock. The portion of the fracture surface on the "outer radius" (top surface in Figure 8) in the thin section appeared "woody" and dull, measuring approximately  $\frac{1}{4}$ ", and the thicker section (the remaining  $\frac{1}{8}$ ") was shiny and rough. The "woody" appearance is typical of transverse fractures through cold drawn steel products. The drawing operation elongates

the grains improving the yield strength of the bar in the longitudinal direction, while reducing the transverse properties.

Figure 8. Broken open crack.

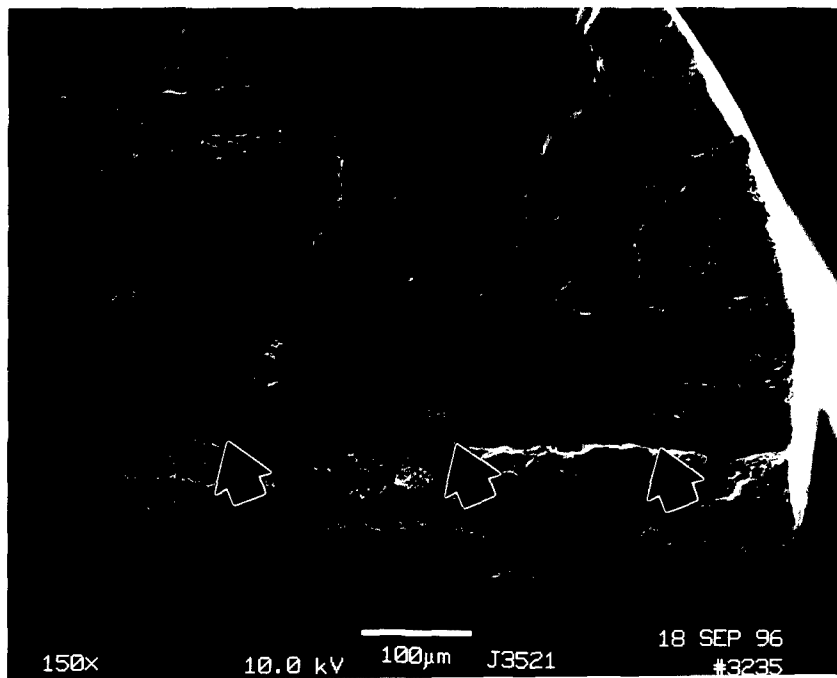
Scanning Electron Microscopy: High magnification examination of the outer radius fracture revealed that the thin end of the fracture had two “smooth” linear regions extending to the tip. Figure 9, at higher magnification, shows the tip of the fracture surface containing one of the smooth features. Energy dispersive x-ray spectroscopy was performed on the smooth linear portion and rough portion of the fracture surface. Analysis of the smooth surface revealed a major concentration of iron, minor concentrations of sulfur and manganese, and a trace of oxygen, indicative of a manganese sulfide inclusion. Analysis of the rough fracture surface revealed a major concentration of iron, and trace amounts of sulfur, manganese and oxygen indicative of the base steel material.

Figure 9. Higher magnification SEM fractograph reveals a long, smooth, flat area

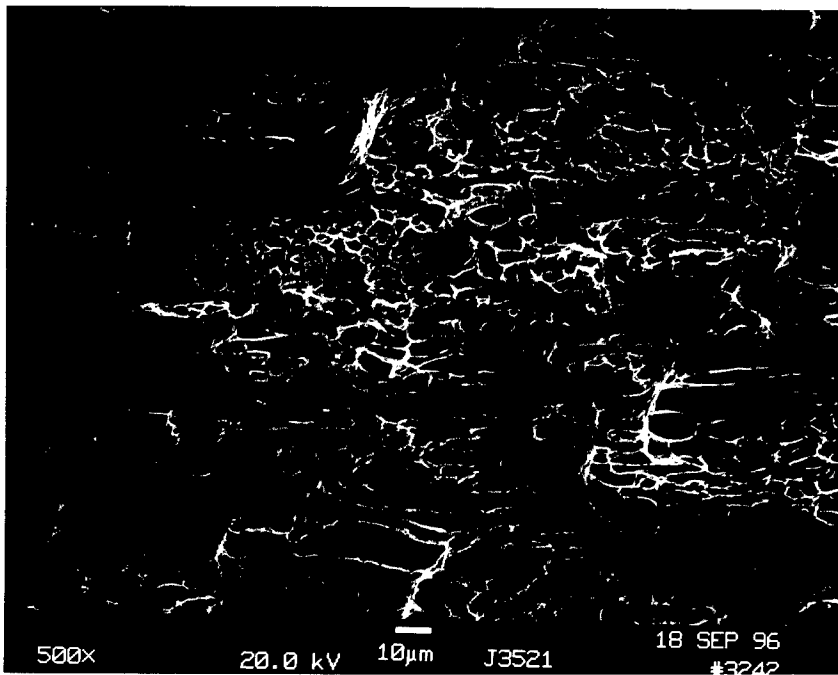
The rough “woody” features on the fracture surfaces are ductile, as shown by the dimple rupture in Figure 10. The thick end of the fracture, which appeared to be shiny and rough in our binocular examination, are “cleavage” facets, indicating a fast fracture, probably the last portion to separate.

Figure 10. Ductile dimple rupture type of fracture observed in the “woody” areas of the fracture surface.  
Mag. 500X

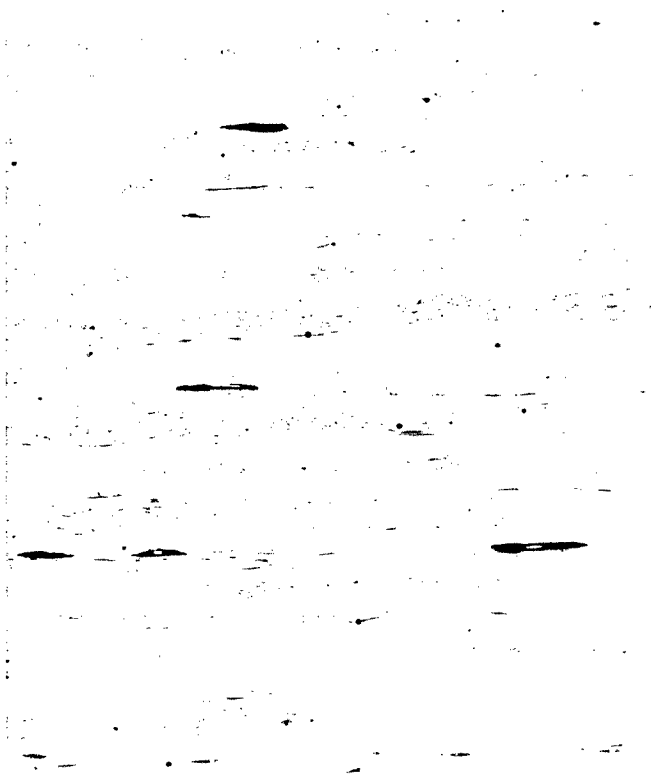
Optical Microscopy: The failed ring was cross sectioned away from the fracture for microstructural analysis. Figure 11 shows the inclusions in the longitudinal cross-section. The inclusion content is quite significant and is typical for a resulfurized steel.

**Conclusions and Discussion:** The failure was caused by use of an inappropriate material. The large inclusion, comprised of manganese sulfide (a normal inclusion found in 1144, a “resulfurized” grade of steel) was observed at the origin of cracking at the thinnest section of tapered Ring A. The circumferential stresses applied to the ring during tightening created a crack and ultimately a rapid fracture of the ring. This was a fracture that occurred during a single application of load. No evidence of fatigue or other forms of “progressive” fracture were observed.

Figure 11. Mounted longitudinal cross-section through ring A showing manganese sulfide inclusions. As-polished.  
Mag. 100X

**Recommendations:** Since the tapered rings were stressed circumferentially, (i.e. transverse to the drawing direction), selection of a material with: 1) a low inclusion content, such as a non-resulfurized grade; and 2) fabricated by hot-rolling rather than cold drawing should improve the product.
