**PROGRESS IN THE NONDESTRUCTIVE  
EVALUATION OF CF-18 COMPOSITE  
FLIGHT CONTROLS FOR WATER  
INGRESS AND RELATED DAMAGE**

June 1998

DCIEM Report No. 98 - TM - 44

B.A. Lepine, Capt  
K.I. McRae

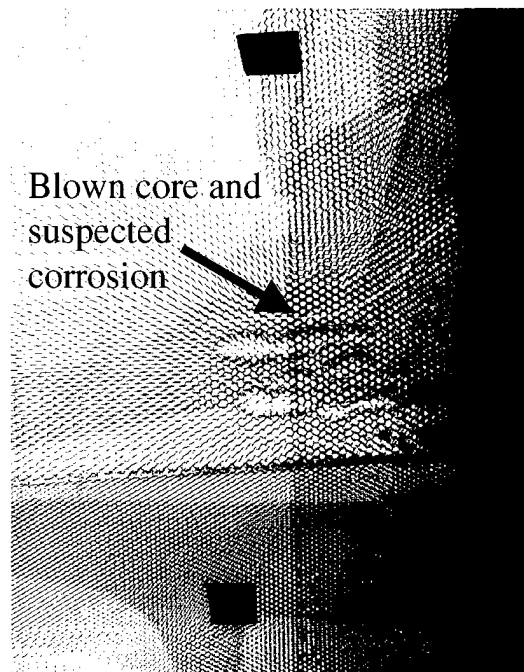
X-ray

**RH Trailing Edge Flap A16-0307  
(Aircraft CF188729)**

| A/C number | Flight control | Serial Number | Type of damage | N-ray | X-ray | UT C-scan | Comments |
|---|---|---|---|---|---|---|---|
| | | | blown core & suspect corrosion | | *xtef0307 | | *using new technique with LORAD tube |

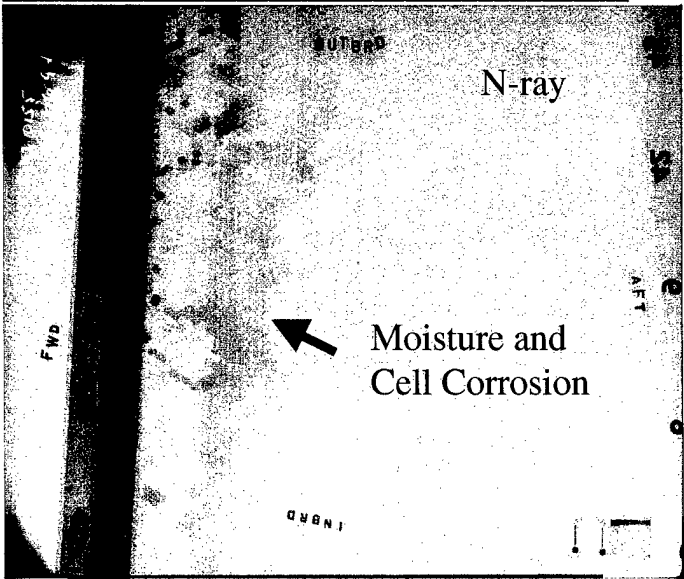
N-ray

LH Rudder - U22-0155  
(Aircraft CF188736)

Moisture and  
Cell Corrosion

| A/C number | Flight control | Serial Number | Type of damage | N-ray | X-ray | UT C-scan | Comments |
|---|---|---|---|---|---|---|---|
| 188736<br>(only rudders) | LH rudder | U22-0155 | moisture and cell corrosion | x1rud736 | | | |

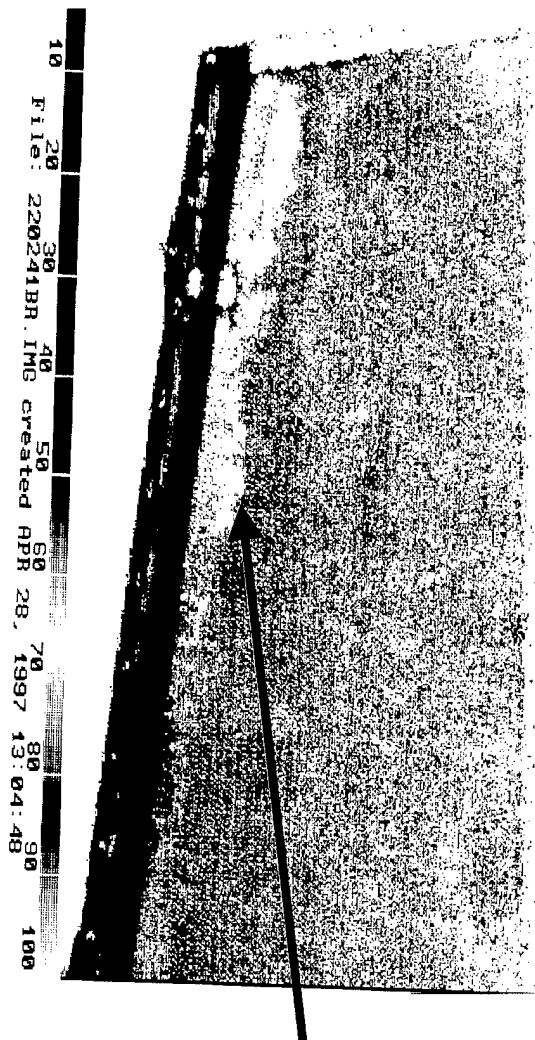
T.T. Ultrasound

**RH Rudder - U22-0241  
(Aircraft CF188708)**

| A/C number | Flight control | Serial Number | Type of damage | N-ray | X-ray | UT C-scan | Comments |
|---|---|---|---|---|---|---|---|
| | | | water ingress | | *xrud0241 | urud0241 | *using new technique with LORAD tube |

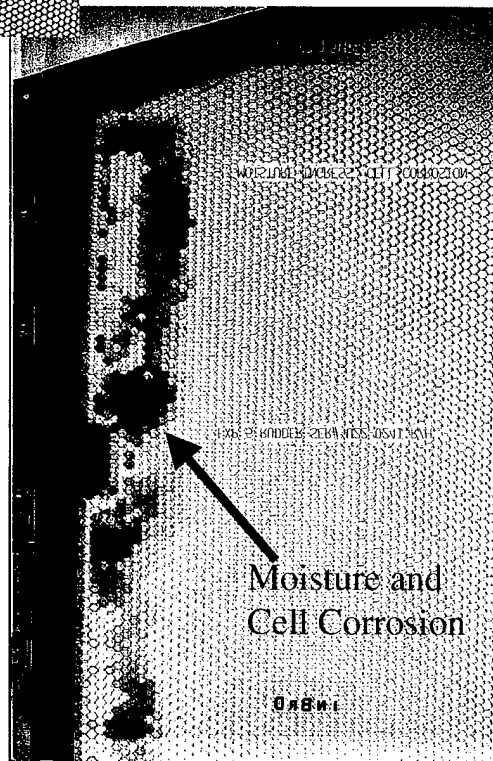
N-ray

| A/C number | Flight control | Serial Number | Type of damage | N-ray | X-ray | UT C-scan | Comments |
|---|---|---|---|---|---|---|---|
| | RH Rudder | U22-0241 | moisture and cell corrosion | x4r0241 | | | |
