MODIFICATIONS TO THE TUBE-LAUNCHED, OPTICALLY  
TRACKED, WIRE-COMMAND MISSILE LAUNCHER FOR  
THE BRADLEY FIGHTING VEHICLE SYSTEM

Report Number 98-165

June 25, 1998

Office of the Inspector General  
Department of Defense

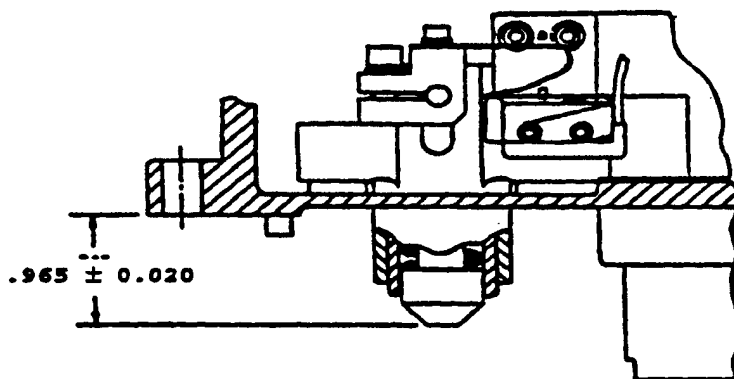
Figure 3. Umbilical Switch Specification

**Alignment of Umbilical Switches.** The DMWR requires the gauge set to align and test the ACU umbilical switches S1, S2, S3, and S4. Switches S1 and S2 are associated with the inboard launcher tube, while S3 and S4 are associated with the outboard launcher tube. The S2 and S4 switches, when activated, signal that a missile is present. The S1 and S3 switches, when activated, signal that a missile has been selected. According to the design specifications, those umbilical switches should be aligned to activate when the bottom of the holdback pin plunger is 0.965 inches, plus or minus 0.020 inches, from the bottom of the ACU housing as shown in Figure 3.

The S1 through S4 gauge assembly of the gauge set is used to measure the depth of the holdback pin plunger at the time the umbilical switches have been activated.

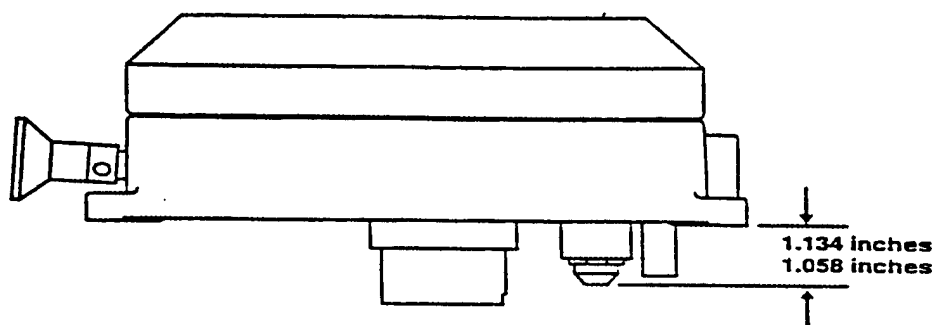
**Figure 4. Holdback Pin Plunger Depth Specification**

**Alignment of Motor Stop Switches.** The DMWR requires the gauge set to align and test motor stop switches S5 and S6. The S5 switch is the electrical limit switch for the extend function of the ACU motor. The S6 switch is the electrical limit switch for the retract function of the ACU motor. The S5 and S6 settings affect the distance that the holdback pin plunger and umbilical cable are extended when arming the system and retracted when disarming the system. The gauge set, specifically the S5 gauge assembly is required to ensure that the holdback pin plunger depth in relation to the ACU housing is between 1.058 inches and 1.134 inches, as shown in Figure 4, in order to satisfy design specifications.
