# Structural Analysis of DEW Line Station DYE-2, Greenland

1983-1988

Michael R. Walsh and Herbert T. Ueda

CRREL Report 98-3

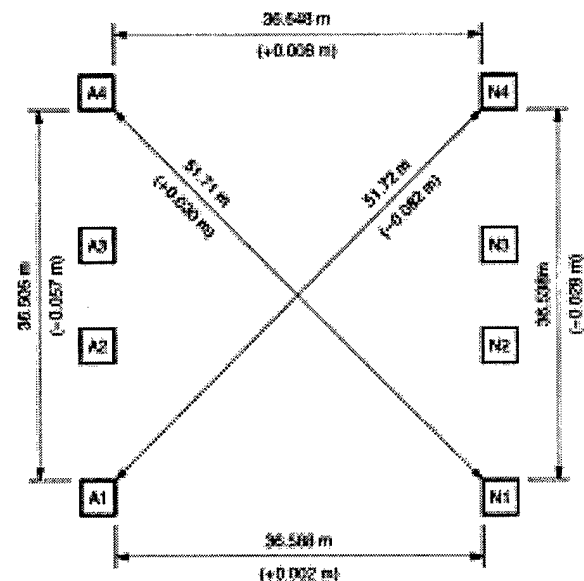
Figure 10. Horizontal movement of columns at snow surface.

Finally, as the footings settle and the ice cap drifts (App. A), the columns move differentially with respect to each other (Fig. 10). This differential movement, in addition to the column out-of-plumbness mentioned above, sets up horizontal distortions in the column-truss system that can result in high loads at restraining points at the collars and in the building. High bending moments at the column bases are a result of these large horizontal loads. The horizontal distortion of the truss system may also be the reason why pinching and spreading loads sometimes appeared during sway bolt measurements (described in

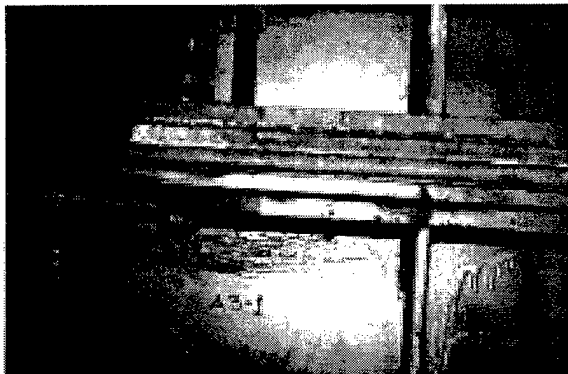
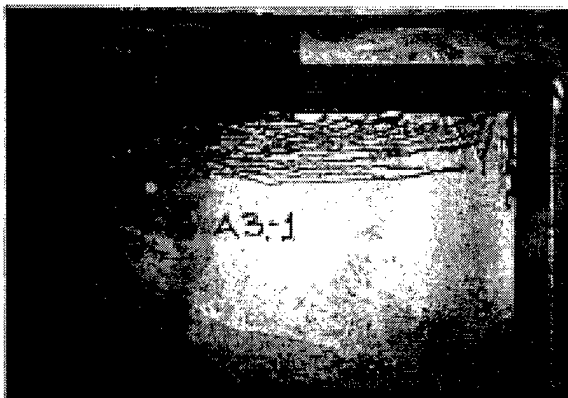
Figure 11. Leuder lines: column A base.

the next section). Leuder lines, distortions in the surface of a structural member indicative of localized yielding, were first observed in the supporting structure at the base of the columns below the footing support blocks in early 1988. These Leuder lines were thought to be evidence that high horizontal stresses, and therefore high moments, were being experienced by the columns. An example of Leuder lines is shown in Figure 11, which shows evidence of yielding below the support block of column A3.

- Footing tilts continued to increase as expected.
- There had been no significant increase in stress-induced Leuder lines in the bearing block supports on all column footings since June of 1988 (2 months). This was a qualitative assessment and indicated no further yielding in the supporting structure at the column bases over the summer. Later examination of photographic data showed

no increase in Leuder lines since the mini-life-extension operation in mid-1987, leading to the conclusion that the yielding had occurred during that work and not afterwards as previously thought.

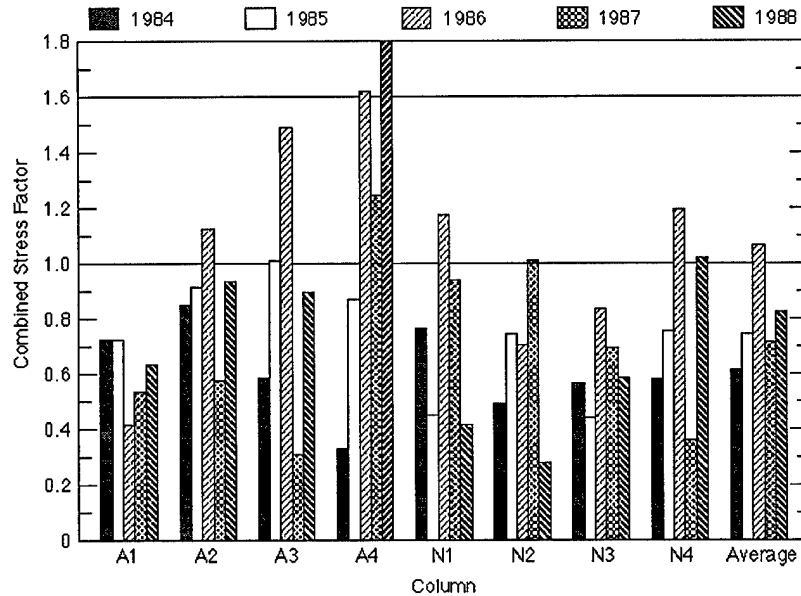
Figure 12. Summary of base level stress concentration factors: 1984-1988.

In 1984, after the building was moved and raised, stress levels were relatively uniform and

low, with an average base level combined stress factor (BLCSF) of about 0.61. BLCSFs are calculated loads on the column bases caused by stresses measured in the four collars of each column. There is no obvious pattern to the stress levels. None of the column BLCSFs exceed 1.00. In 1985, the stresses have become redistributed. The average BLCSF has increased to 0.71, with one column exceeding 1.00. Again, no pattern is obvious, although the A row is more heavily loaded than the N row.

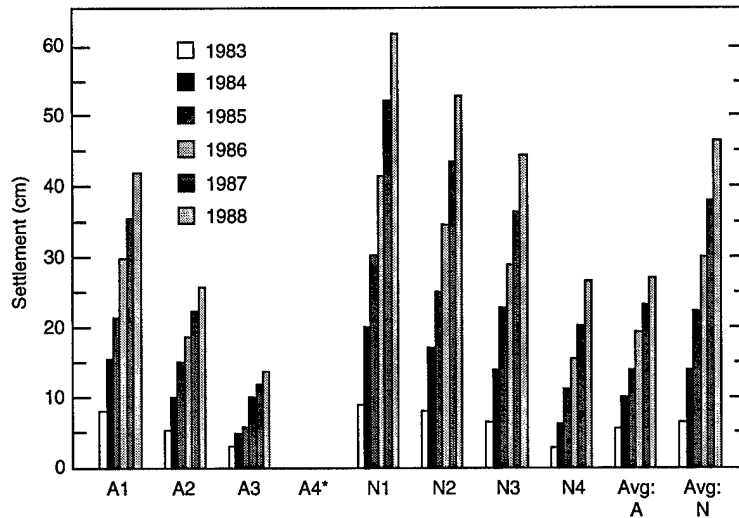
Figure 13. Footing settlements: 1982-1988.

at differing rates. Figure 13 shows the settlements of the A and N row of columns, as well as the averages of each respective row. Footing A4 was used as the datum point as this was the slowest settling footing and was used as the "baseline" footing previous to the move in 1982. Therefore no settlements are given for it.

From these figures, several observations can be made. The most obvious is that the N row is settling faster than the A row. The average rate of settlement of the N row with respect to A4 is 0.08 m/year. The settlement of columns A1 through A3 with respect to A4 is only 0.05 m/year. Footing settlement data can be found in Walsh (1992).

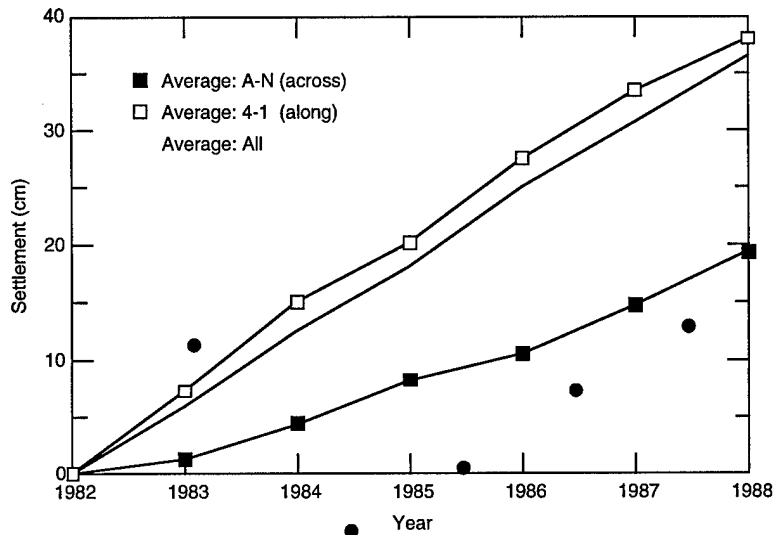
Figure 14. Footing settlement trends.

The across-row settlement as well as the along-row settlements for both rows show similar trends. Figure 14 shows these settlements for the years 1982 to 1988. Along-row settlements were normalized to A4 and N4 for their respective

A3, N3, and N4, we can see how this happens. As A3, N3 and N4 settle relative to A4, the building and truss also settle with respect to A4 at those locations. From Figure 14, the direction and magnitude of the footing tilts averages approximately  $300^\circ$  and 0.014 radians, respectively. The highest loads in the building and truss levels should then be at A4 with intermediate loads at A3 and N4 and the lowest loads at N3. The horizontal loads should be greatest where the settlement is least. Data taken during the 1988 field work confirm both conditions. This also applies to the forward truss.

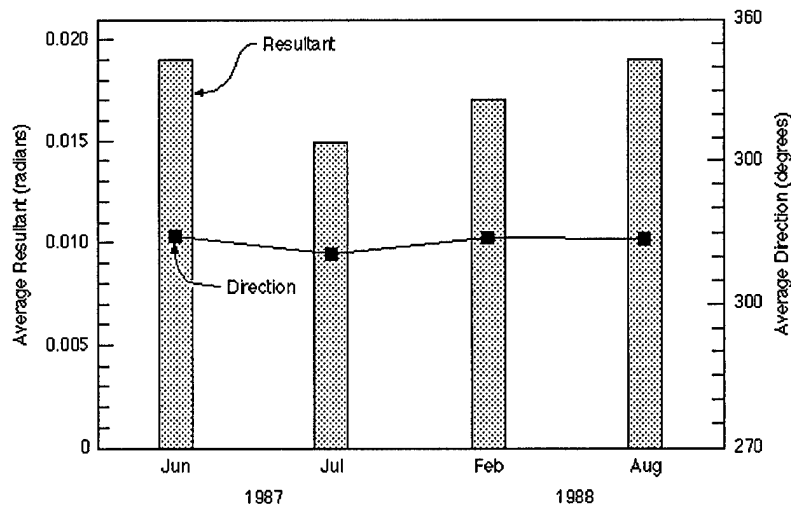
Figure 18. Column tilt trends.

A more serious phenomenon associated with differential settlement is column tilt. Column tilts are caused by the structural system leaning in one direction, as opposed to plumbness difficulties caused by individual footing tilts. However, footing tilts can exacerbate column tilts and vice versa, so the system as a whole can act as an open-loop feedback system. When the building was moved and raised in 1982-1983, the columns were not plumbed. This omission haunted DYE-2 until abandonment in 1988. Unlike DYE-3, where column tilts were not uniform, at DYE-2 the columns all tilted in one general direction,

causing the structure to become skewed. Although tilt measurements had only been taken on a regular basis since 1986, the data showed a disturbing trend: the columns were leaning at a rate that increased the out-of-plumbness by about 7 cm per year over a 29-m length. The column tilts affected the stresses experienced by the supporting structure in two ways. Axial loads no longer acted along the central axis of the columns, thereby generating moment loads at the base of the column where it attaches to the footing structure. Thus the angle between column and footing tilted. In addition, horizontal stresses are introduced at the truss connections (sway bolt locations) because of twisting forces on trusses. These were the static structural forces that were measured to determine the column stresses.

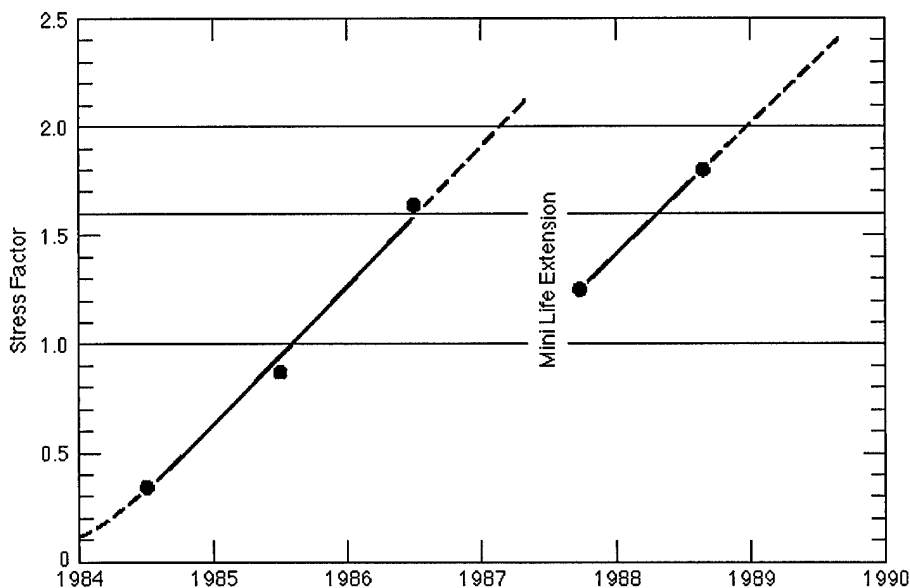
Figure 20. Extrapolation of base level combined stress factors for column A4.

not done. From the data, one can see a rise in the general state of stress in the structure, especially in column A4, which has a combined stress factor well in excess of 1.60. Extrapolation of this and previous years' data indicated a combined stress factor of more than 2.00 by year's end (Fig. 20).

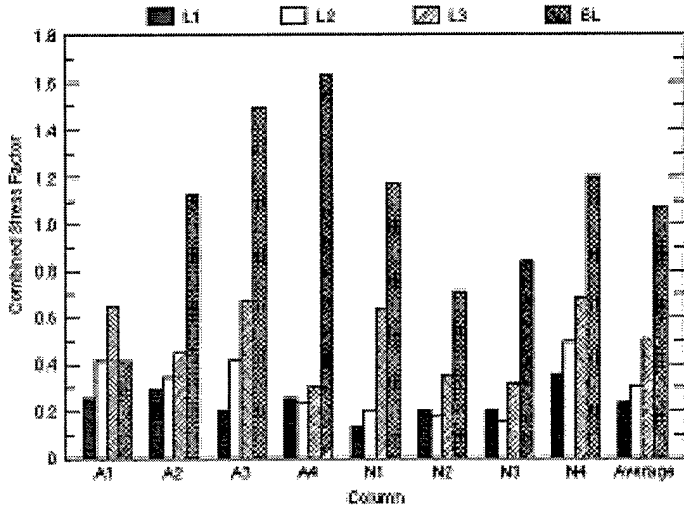
Figure B4. Swaybolt loads: 1986.

Figure B4 contains the third complete set of combined stress factors since the move in 1982. It is interesting to compare stress factors for 1984 through 1986 for trends. High stress concentration factors in general, and especially at column A4 (>1.60), led to a recommendation that work be contracted for the next summer to alleviate some of the high stresses. Column tilts were also a factor in this decision.

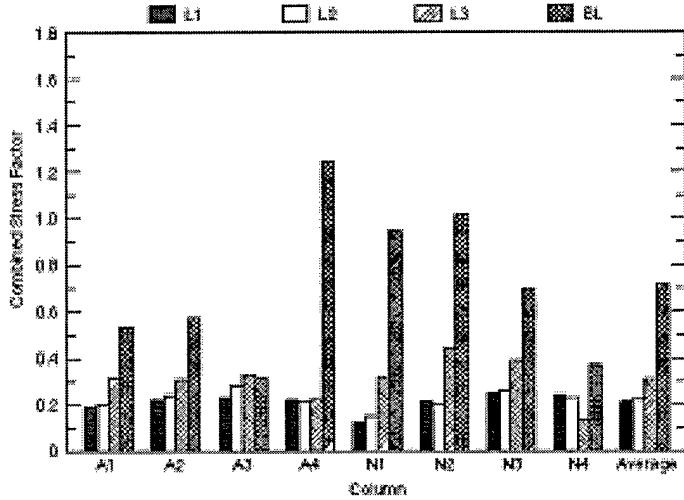
Figure B5. Swaybolt loads: 1987.

Figure B5 contains the fourth complete set of combined stress factors since the move in 1982 and the first since the mini-life-extension of 1987. Comparing stress factors for 1984 through 1987 points up several trends that are more obvious when examining Figure 12. Although the mini-life-extension served to lower most stress and redistribute stresses among the columns in general, trends dictated a repeat of the work performed in 1987 to assure the structural integrity of the building. Another mini-life-extension was therefore recommended for 1988.

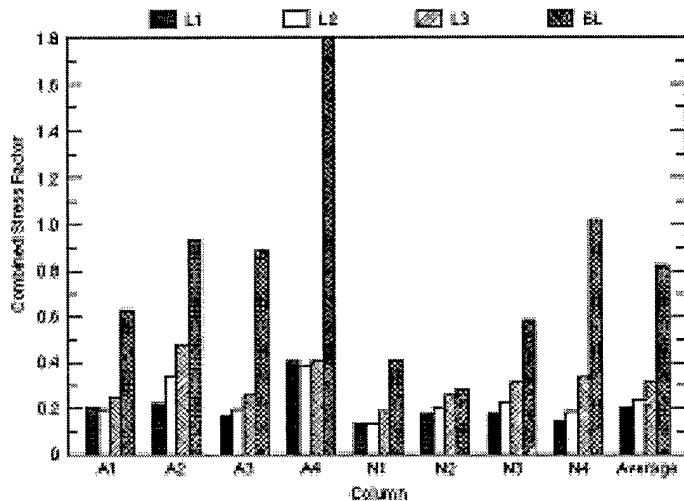
Figure B6. Swaybolt loads: 1988.

Figure B6 contains the final complete set of combined stress factors calculated for DYE-2 and the second since the mini-life-extension of 1987. Comparing stress factors for 1984 through 1988 points up several trends which are more obvious when examining Figure 12. Although the mini-life-extension was recommended for the summer of 1988, funding difficulties were encountered and the work was
