**SOHO Mission Interruption Joint NASA/ESA  
Investigation Board**

**Final Report**

**August 31, 1998**

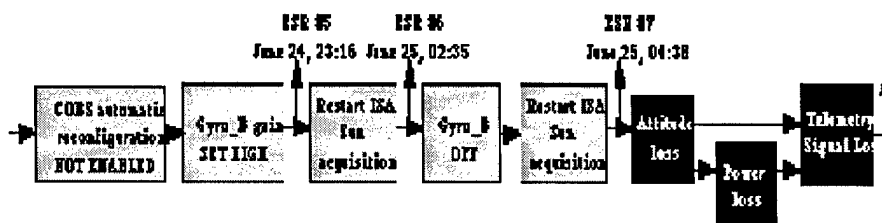
Diagram 1. Failure Event Tree - Top Level

The first two errors were contained in predefined command sequences executed from the Ground System, while the last error was a decision to send a command to the spacecraft in response to unexpected telemetry. The sequence of these errors and their relationship to the triggered-ESRs are graphically depicted in Diagram 1.

Following the momentum management maneuver, Gyro B, which is used for fault detection, was erroneously left in its high gain setting, resulting in an indicated roll rate of 20 times greater than actual. **The incorrect gain was due to an error in another predefined command sequence; this error resulted in an on-board fault detection output that triggered an ESR.** This ESR, the 5th since launch, occurred at 7:16 PM EDT (23:16 UT), June 24, 1998.

During ESR-5, the control Gyro A was not active because of the first error referenced above; however, there is no evidence or belief that any anomalous spacecraft behavior had occurred. As per design, the ESR event resulted in a reconfiguration of the gyros. Gyro A replaced Gyro C as the roll gyro used for the ESR thruster-based control mode, while Gyro B remained configured as the fault detection gyro. The error in Gyro B's gain was discovered and corrected, but the Gyro A despun status was not identified.

After transitioning to the ISA mode as part of the normal ESR recovery sequence, the attitude control system began integrating the gyro drift rate bias associated with the still despun Gyro A. After 15 minutes, this resulted in roll thruster firings intended to null the apparent (but non-existent) roll attitude error. In less than one minute, the roll rate was sufficiently high to trigger the Gyro B based fault detection once again, resulting in ESR-6 at 10:35 PM EDT (02:35 UT), June 24, 1998.

Although the spacecraft remained Sun-pointing within nominal limits and was therefore in a power-positive and thermally-safe attitude, the state of the spacecraft was precarious at this point in time. It had an anomalous roll rate and was depending on a deactivated gyro for roll control in both ESR and ISA modes. The personnel on the ground were not aware of either of these facts at that time. Gyro C was correctly configured to the ACU since the reconfiguration at ESR-5. Gyro B was active and on-line for fault detection, and it was correctly measuring the anomalous roll rate. A rapid decision was made that Gyro B was faulty because its output disagreed with the rate indicated by Gyro A. This decision led to the commanding off of Gyro B.

During ESR-6 recovery, Ground Operations commanded the spacecraft to ISA mode. In ISA, the attitude control system resumed firing roll thrusters in an attempt to null the attitude error associated with the electrical rate bias term of the despun Gyro A. Gyro B and the associated fault detection were now inactive. The increasing roll rate eventually resulted in pitch and yaw Sun-pointing errors that exceeded a prescribed limit of five degrees, resulting in ESR-7 at 12:38 AM EDT (04:38 UT), June 25, 1998. Due to the gyroscopic cross-coupling torques caused by pitch and yaw thruster firings, and the absence of true roll rate indications, the ESR controller was no longer stable, and the spacecraft attitude diverged. **The incorrect diagnosis of a Gyro B fault and the subsequent ground response to this diagnosis ultimately resulted in loss of attitude control, subsequent loss of telemetry, and loss of power and thermal control.** Loss of telemetry occurred at 12:43:56 AM EDT (04:43:56 UT), June 25, 1998. It can not be determined whether this loss was a consequence of insufficient power or a loss of communication link caused by spacecraft attitude.
