Effects of Concentrated Hydrochloric Acid Spills on Aircraft Aluminum Skin

July 1998

DOT/FAA/AR-TN97/108

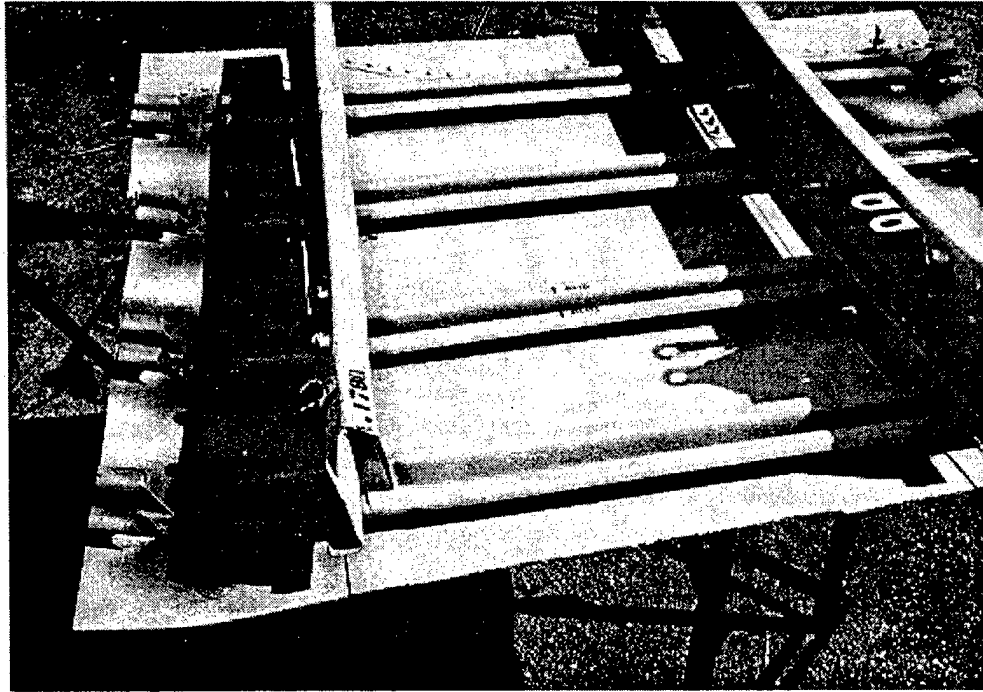
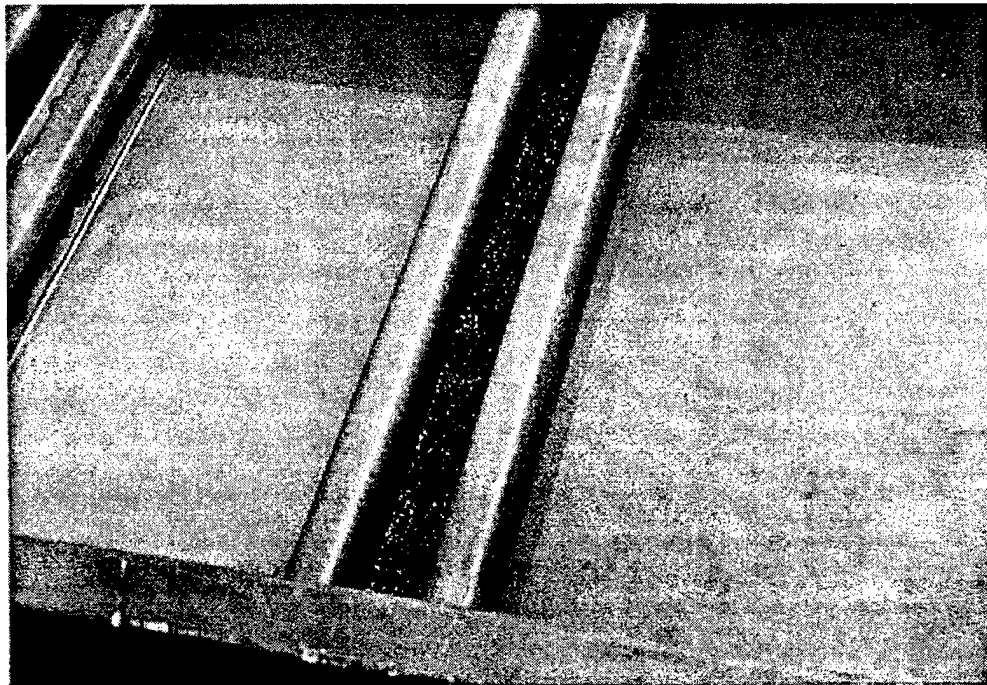
The first test was the largest, a 3- by 3-foot section with a 1-liter acid spill (figures 1 and 2). The edges of the skin were bent upwards to contain the acid. In the process of bending the skin and cutting notches in the ribs to allow the bending of the frame, scrapes and breaks in the surface coating of the aluminum skin were produced. There was no treatment of the marred surfaces in this test. The acid contacted not only the interior skin surface but also the bulkhead plates and fittings and the ribs and attaching grommets.

FIGURE 1. TEST ARTICLE FOR TEST 1: 3- BY 3-FOOT SIDEWALL OF A BOEING 747

FIGURE 2. TEST 1 IN PROGRESS WITH A 1-LITER SPILL OF CONCENTRATED HYDROCHLORIC ACID

Test No.	Test Article Description	Location of Failure	Time to Failure (min.)	Comments	Figure No.
1	3' x 3' section of fuselage	At scratched surfaces and at bends in skin	47, 65, and 80	Acid created hole in skin at scratched and bent surfaces.	1, 2
		At rivets	No failure	Rivets partially decomposed, but still intact.	
2	6" x 6" section of aluminum skin in a 7" x 7" Pyrex pan	At rivets	50	Three rivets eaten away below surface of skin.	3
		At ribs	70	Side of rib eaten 1/2 inch through the length of rib. Severe corrosion.	
			80	All submerged surfaces of unpainted rib completely gone.	
		At rivets	85	Only white exterior paint remained where rivets were.	
3	7" x 7" section of aluminum skin as base of pressurized box, 0-2.5 psi. Silicone caulk used as a seal.	At rivets	N/A	Severe corrosion. Rivets eaten through below surface of the skin.	4, 5, 6
		At ribs	90	Rib disconnected from aluminum skin. All submerged surfaces of unpainted rib completely gone. Base seal remained intact. Pressure not maintained during the test due to failure of lid seal.

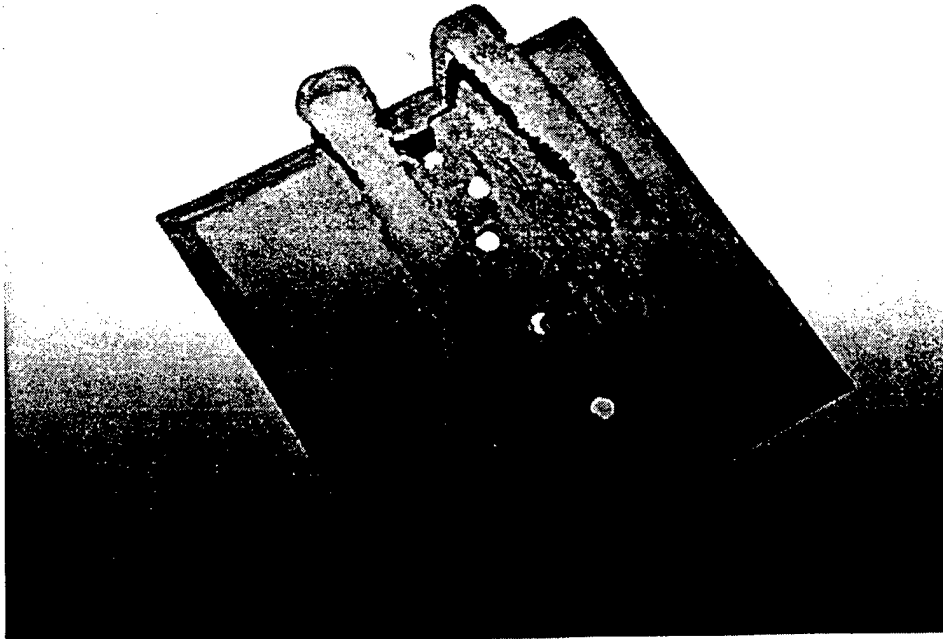
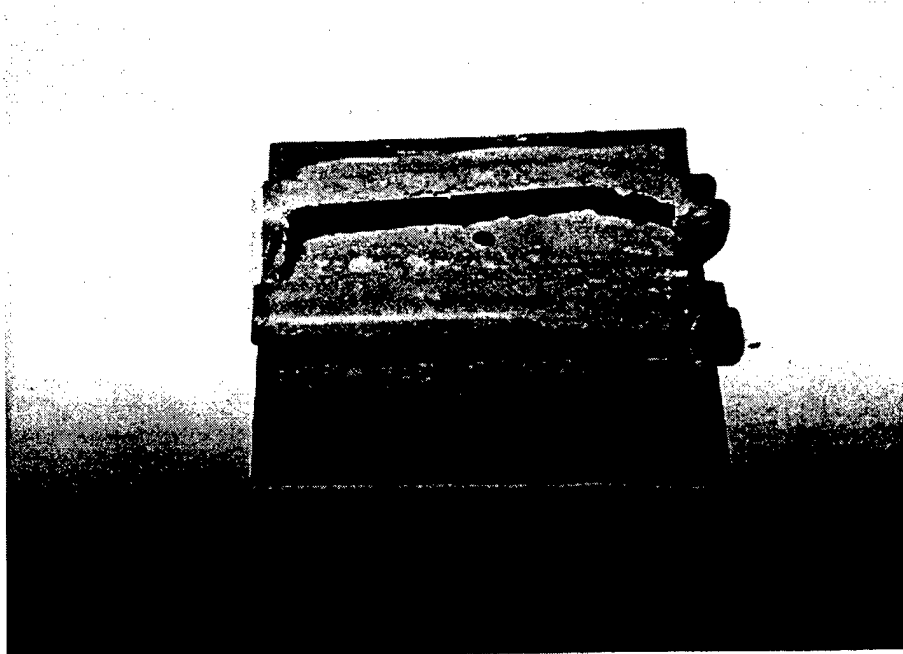
A 6- by 6-inch section of the skin, including the frame material, was placed in a Pyrex pan with the outside surface of the skin face down. All cut edges of the test sample were covered with epoxy paint. One liter of concentrated HCl was spilled into the Pyrex pan. The depth of acid was 1 1/4 inches. Periodically the section of skin was lifted out of the solution with metal tongs to visually evaluate the damage as a function of exposure time. The test specimen was rinsed with tap water at the conclusion of the test and photographed (figure 3).

**FIGURE 3. TEST ARTICLE FOR TEST 2 AFTER REMOVAL FROM PYREX PAN
CONTAINING 1 LITER OF CONCENTRATED HYDROCHLORIC ACID, TWO VIEWS**

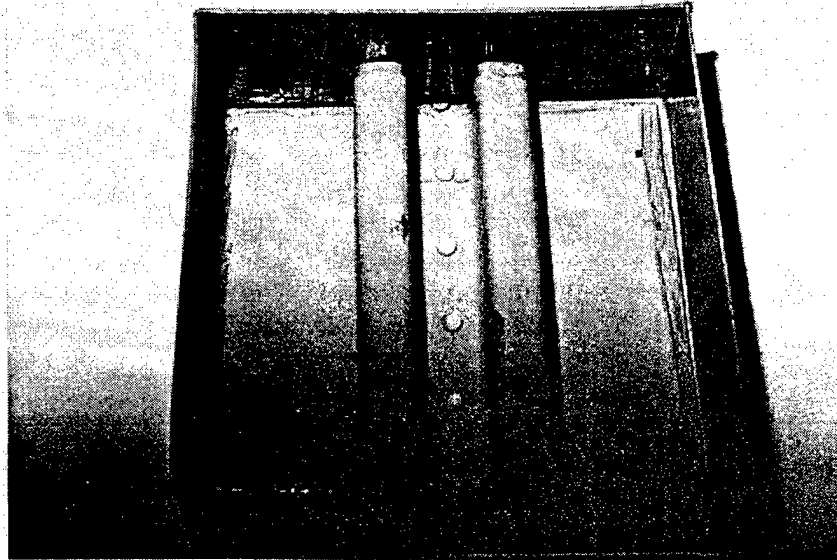
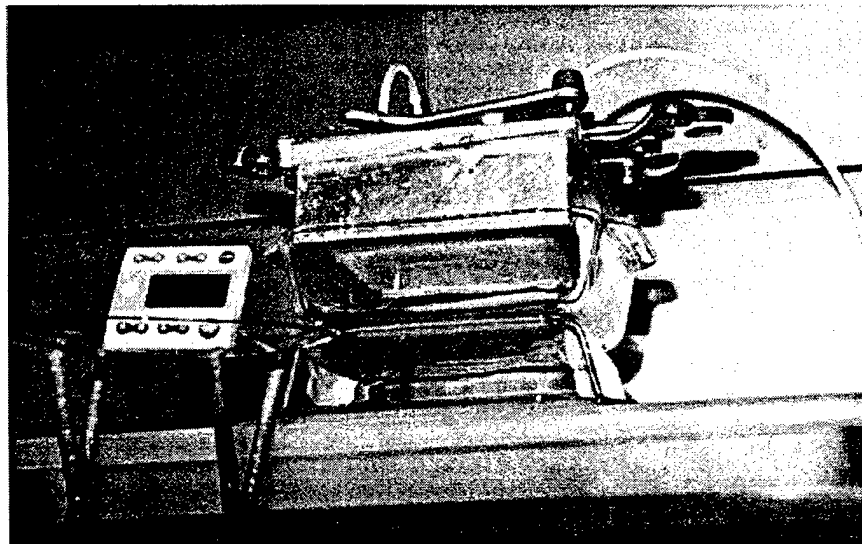
FIGURE 6. TEST ARTICLE FOR TEST 3 AFTER A 90-MINUTE CONTACT WITH SPILLED CONCENTRATED HYDROCHLORIC ACID. TOP OF TEST CONTAINER REMOVED.

A 2.5 psi box pressure simulates the ΔP_{skin} at 15,000 feet altitude. A small ΔP may result in the blowout of the white exterior epoxy paint on the bottom of the box when the rivets fail, giving a visual indication of failure. However, the silicone lid seal failed early into the test and pressure fell to ambient.
