Technical Report REMR-CS-60  
September 1998

*Repair, Evaluation, Maintenance, and Rehabilitation Research Program*

# **Performance Criteria for Concrete Repair Materials, Phase II Field Studies**

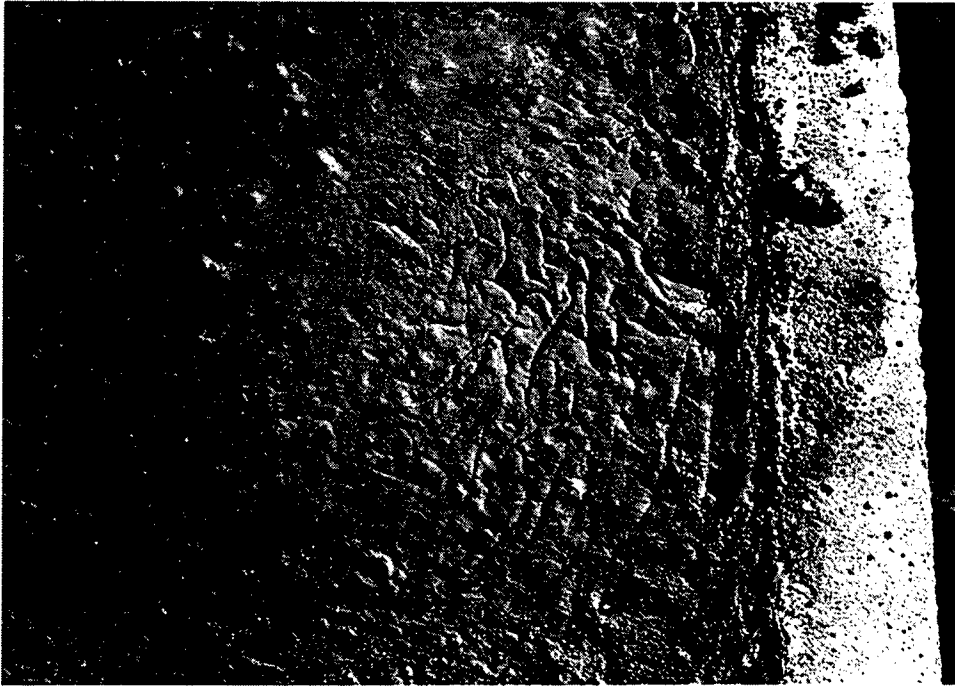
Figure 14. Very cohesive material (No. 10), sticky, difficult to finish (Florida)

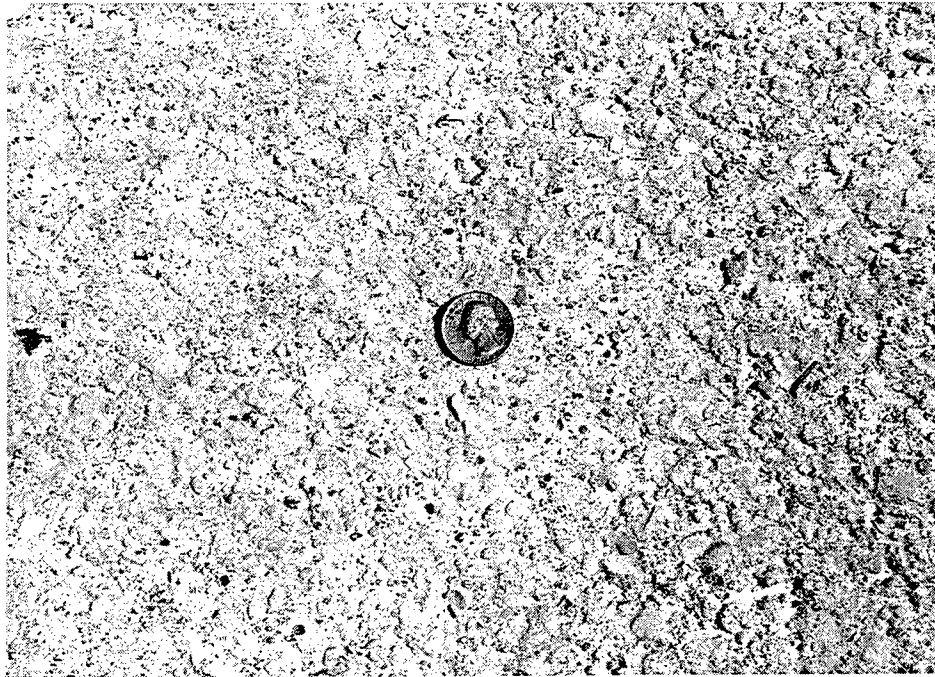
| <b>Table 6</b><br><b>Results of Repair Monitoring - Illinois</b> | | | | |
|---|---|---|---|---|
| 12 | 09/14/94 | Surface deterioration. Figure 37. | No cracks. | No cracks. |

Figure 37. Surface deterioration of Material No. 12C (Illinois)

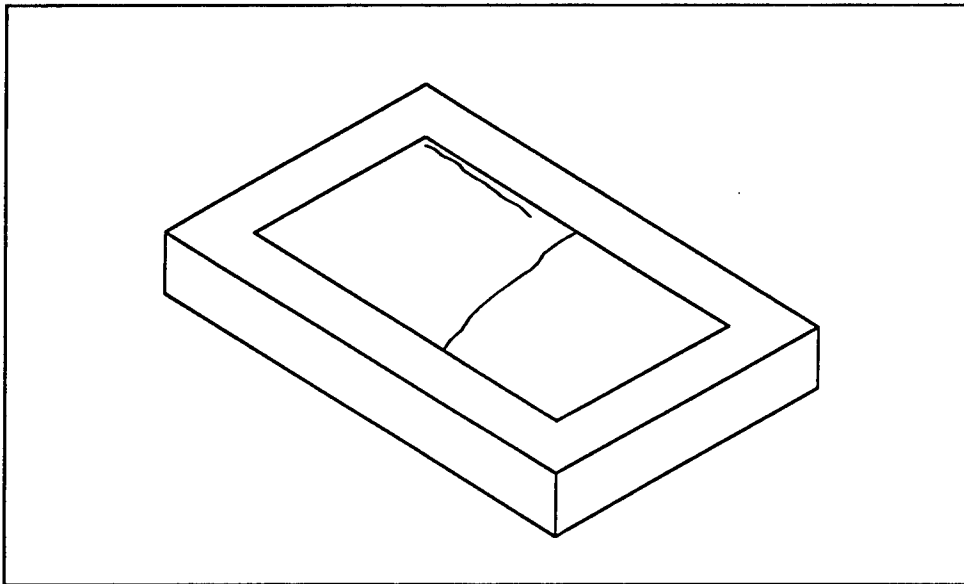
Figure 40. Cracking of Material No. 5B (Arizona)

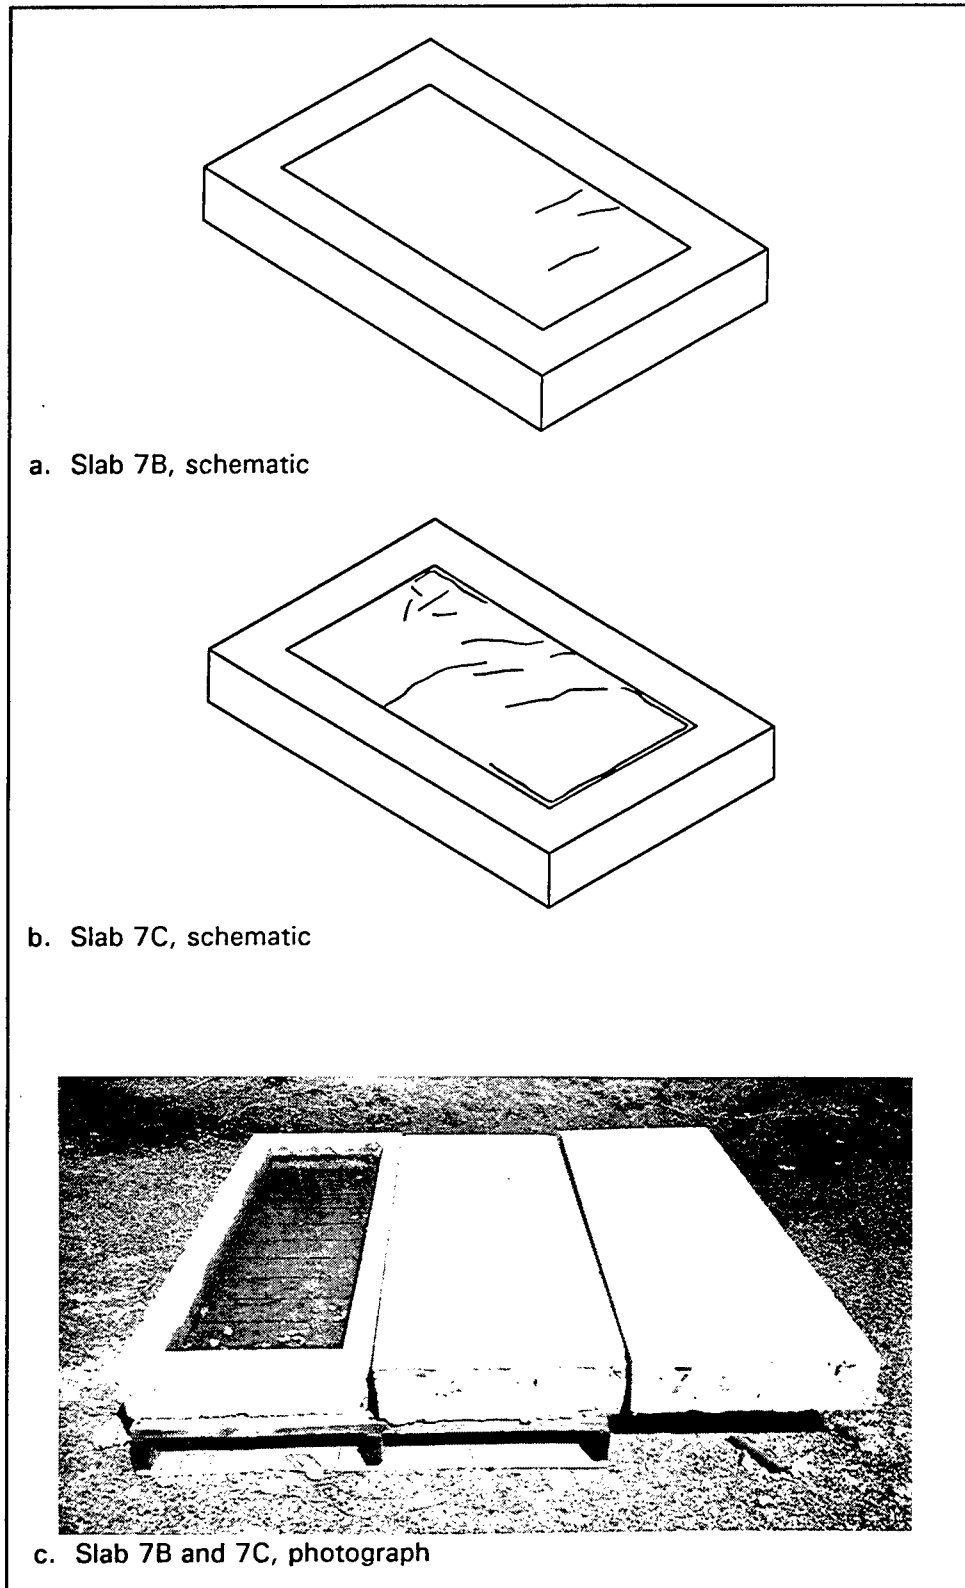
Figure 42. Cracking of Material No. 7 (Arizona)

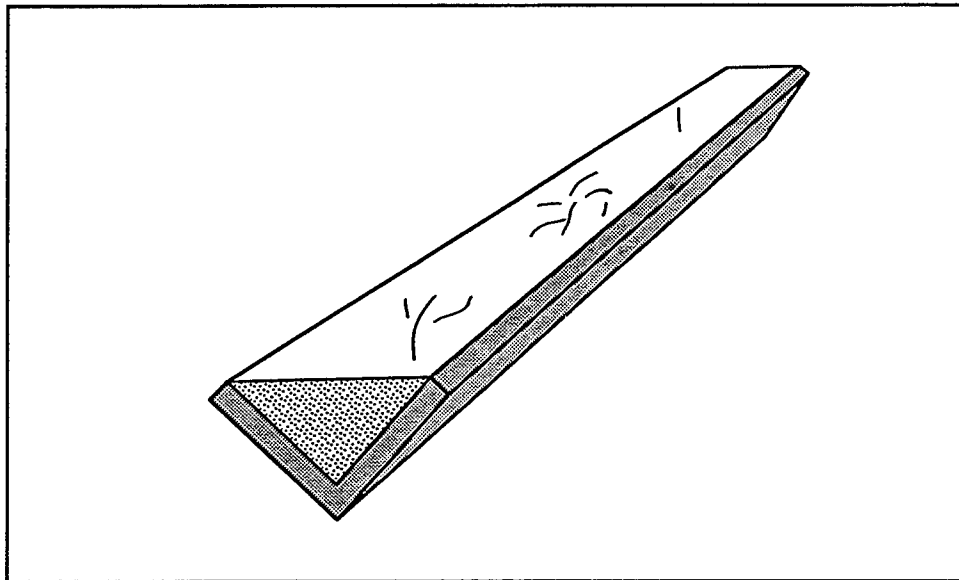
Figure 48. Cracking of Material No. 7 (Florida)

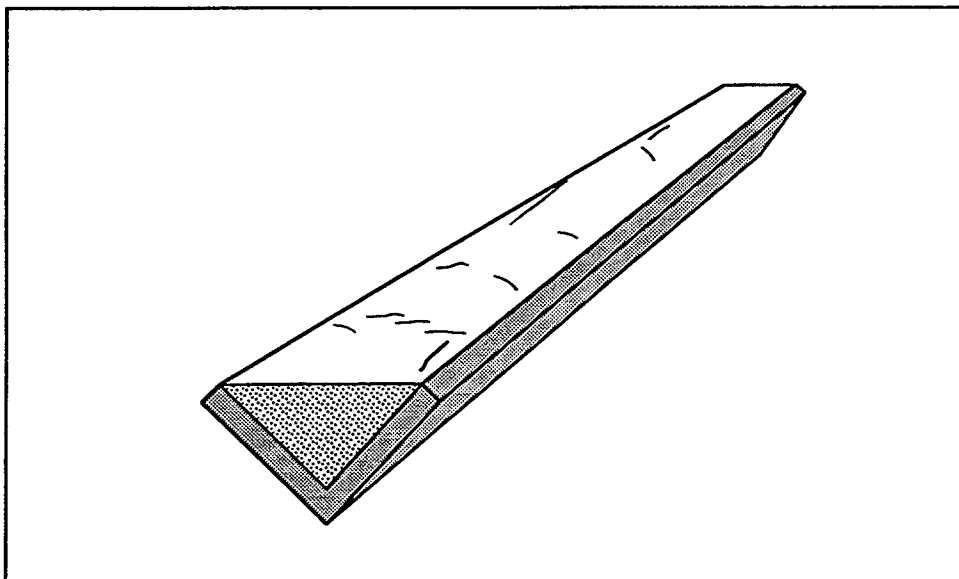
Figure 49. Cracking of Material No. 11 (Florida)

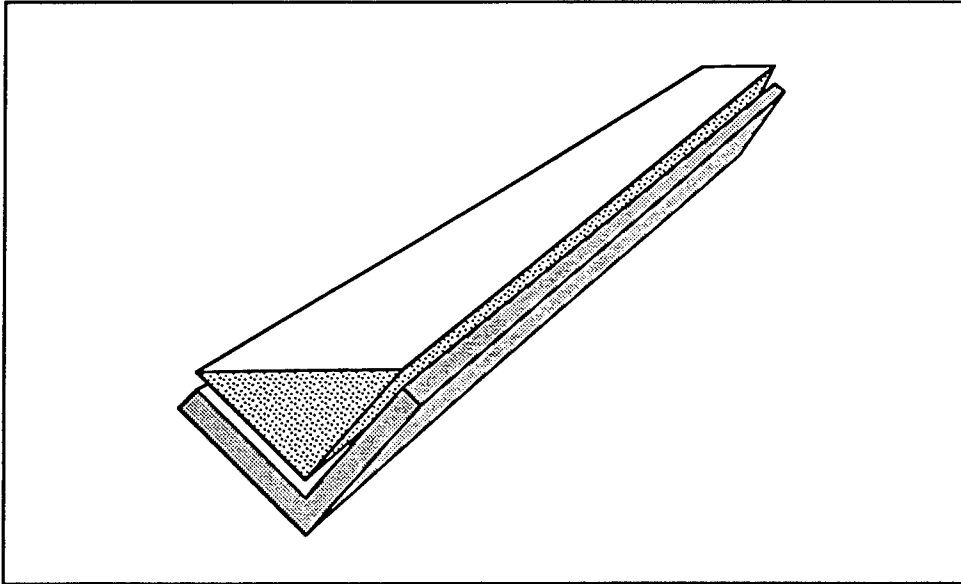
Figure 50. Debonding of Material No. 5 (Illinois)

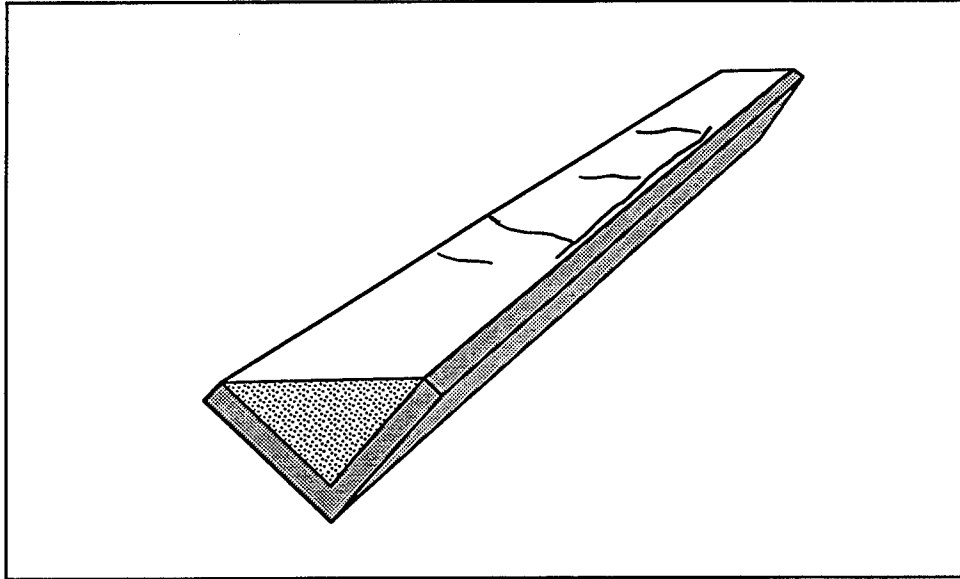
Figure 51. Cracking of Material No. 6 (Illinois)

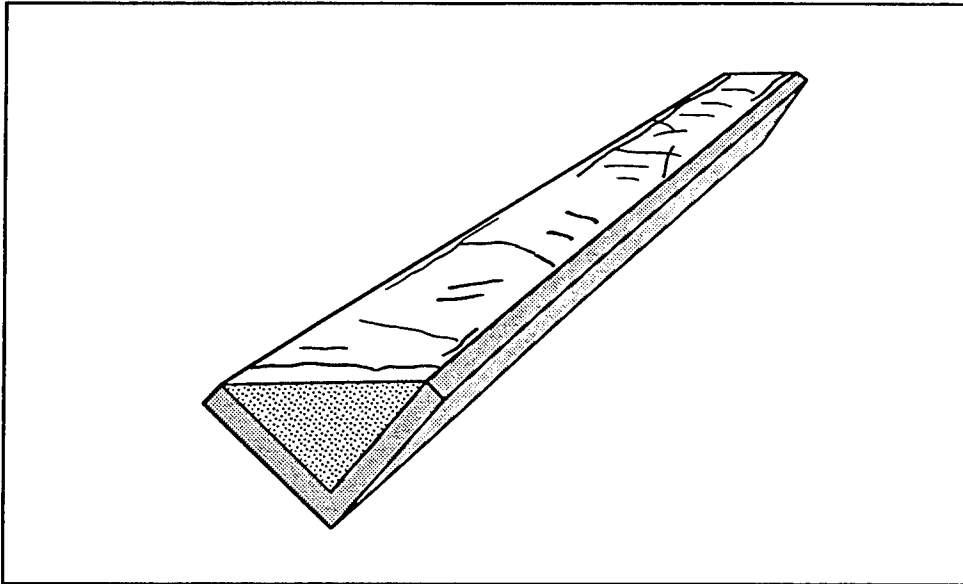
Figure 54. Cracking of Material No. 7 (Arizona)
