**US Army Corps
of Engineers®**
Cold Regions Research &
Engineering Laboratory

Moisture in the Roofs of Cold Storage Buildings

Wayne Tobiasson and Alan Greatorex

SPECIAL REPORT

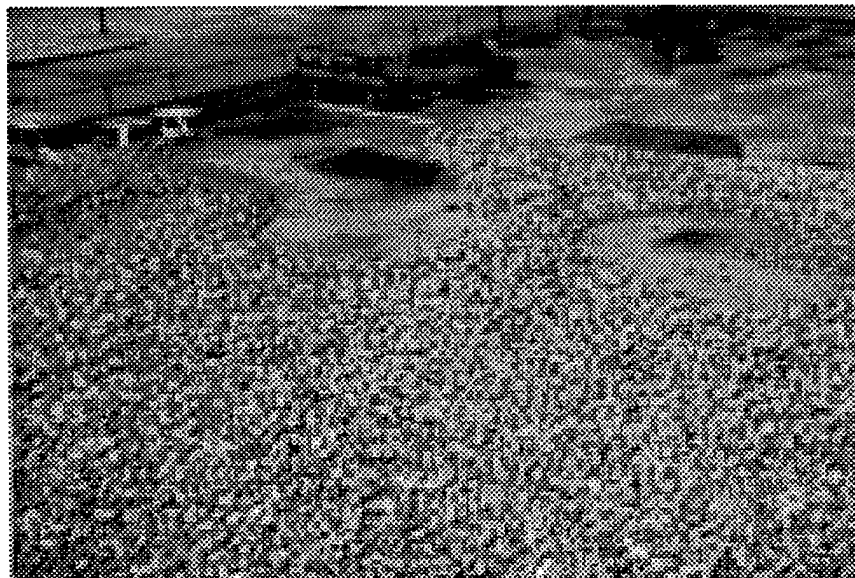
The daytime visual inspection revealed that ballast scour by wind existed in the northwest corner (Fig. 4); a portion of the north edge metal was depressed below the level of the membrane (Fig. 5); and a failed patch (Fig. 6) existed along the north edge 115 ft (35 m) from the northwest corner.

Figure 4. Ballast scour in the northeast corner of roof D1.

northeast and northwest corners, and perhaps all along the north edge, to prevent ballast scour there. Pavers are more stable in high winds.

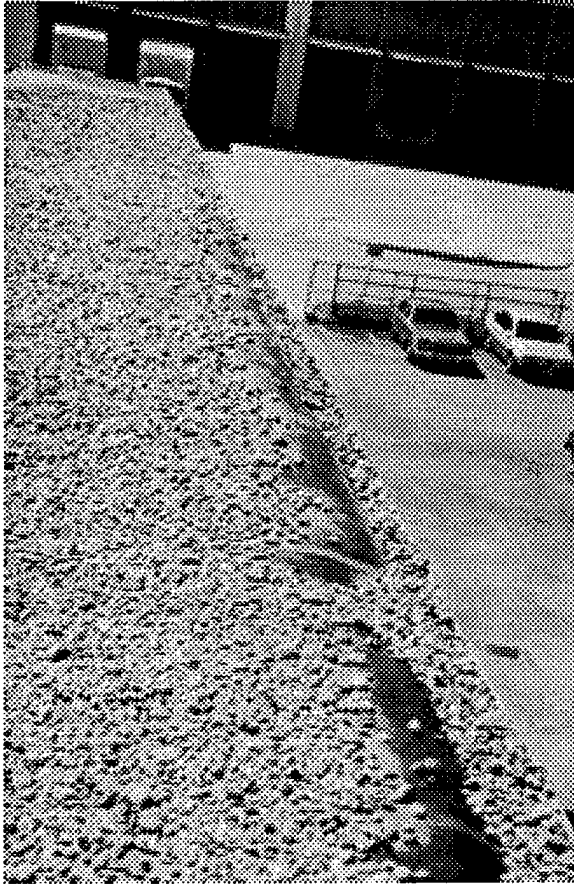
Figure 5. Depressed edge along a portion of the north side of roof D1, looking west.

Most of the waterproofing membrane on this roof is in good condition. It may be wise to revise the north edge of this roof to eliminate the problem shown in Figure 5. It may also be appropriate to replace the stone ballast with roof pavers in the

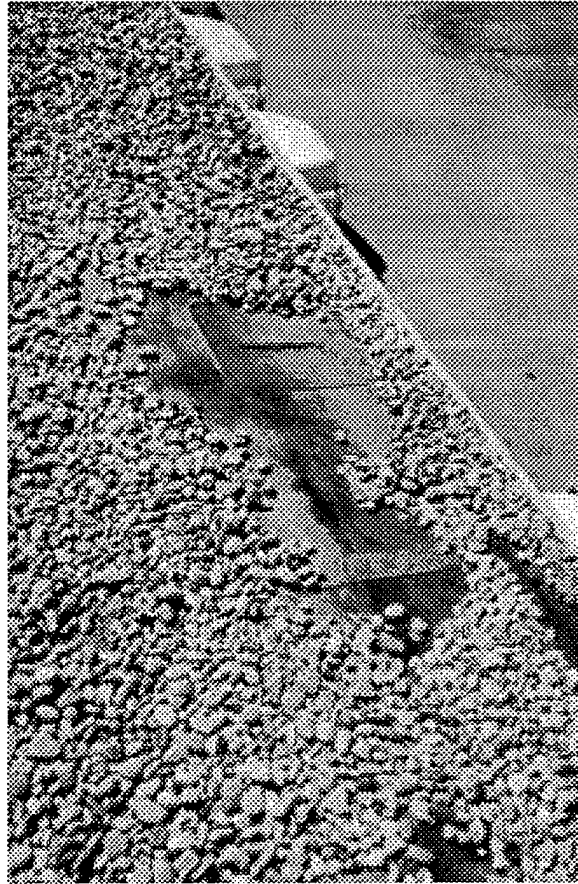
Figure 6. Failed patch along the north edge of roof D1, looking NW.

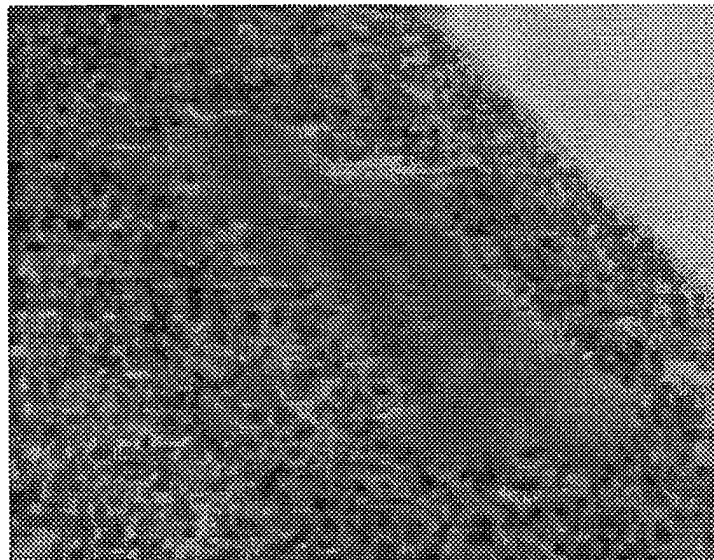
The nighttime on-the-roof infrared survey uncovered only a small area of brightness (Fig. 7) at the failed patch shown in Figure 6. Finger probing into the flaw revealed that wet insulation ex-

Figure 7. Thermal image (thermogram) of the failed patch shown in Figure 6, looking NW.

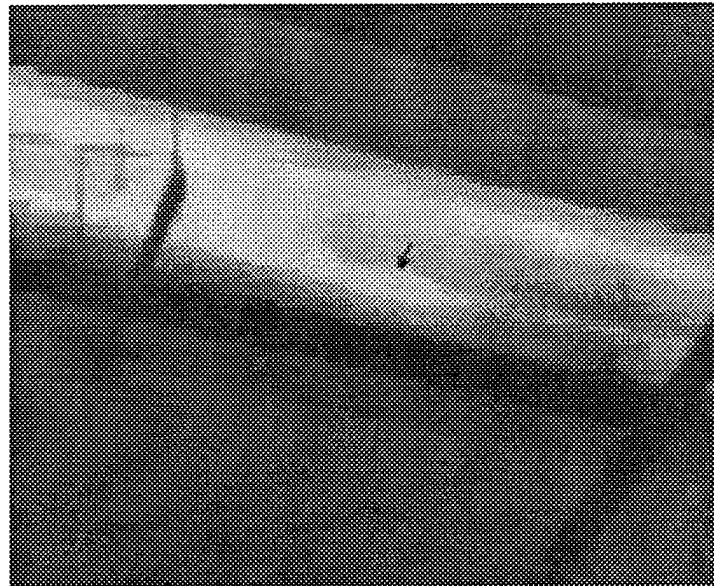
Figure 10. Photograph and thermogram from within the D1 freezer, showing ice and air infiltration where the roof and wall join.

a photograph and a thermogram of the area along the north side of the building where the roof and wall join. Ice is visible in the photograph and the bright thermal image indicates that warm outdoor air is leaking into the freezer along this seam. Figure 11 shows similar images taken of the northeast corner. Frost has accumulated there as warm outdoor air infiltrates into the freezer. Figures 10 and 11 indicate that air infiltration is occurring along the roof-wall intersection. The next time this freezer is warmed up, it may be appropriate to take steps to seal this joint. Spraying it with polyure-

thane foam may be worth considering. Warming this freezer could also be used to melt the ice in the fibrous glass insulation. The meltwater would probably leak out of the roof between the concrete double-tees, thereby drying out the wet fibrous glass insulation and recovering much of its lost insulating ability.

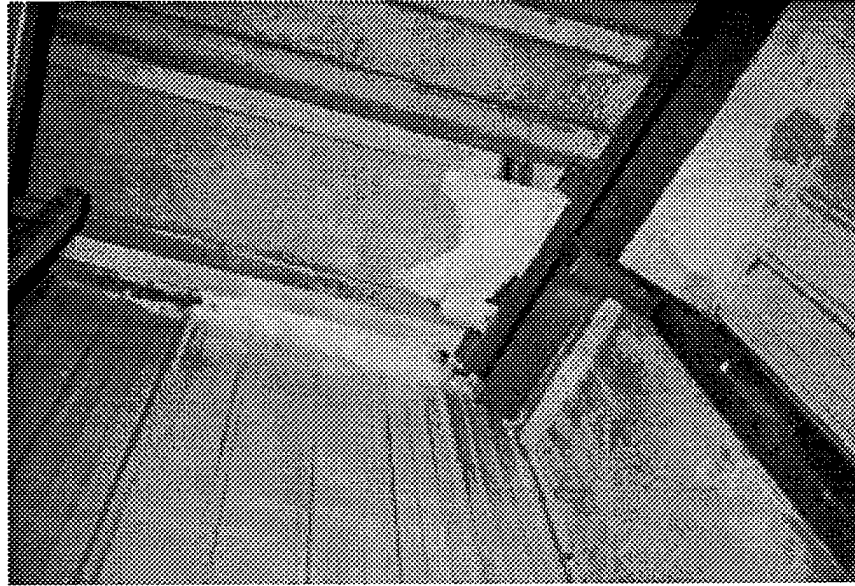
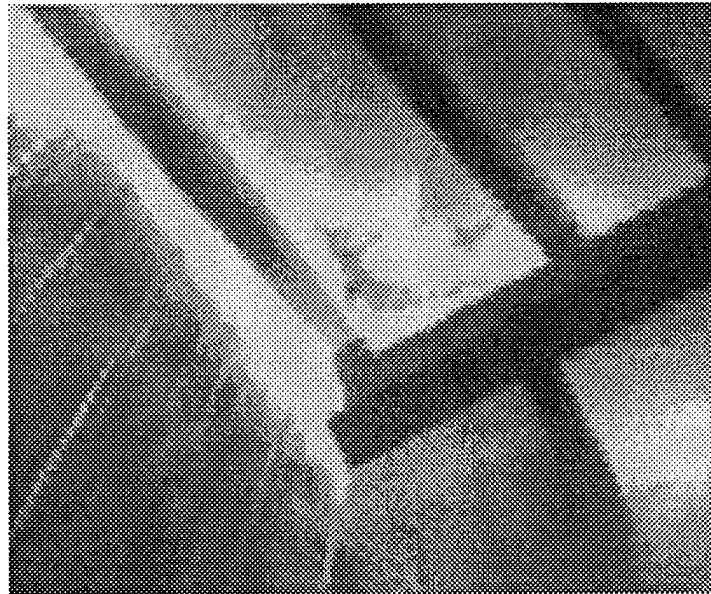
Figure 11. Photograph and thermogram from within the D1 freezer showing frost, ice, and air infiltration in the northeast corner of the D1 freezer where the two walls and roof join.

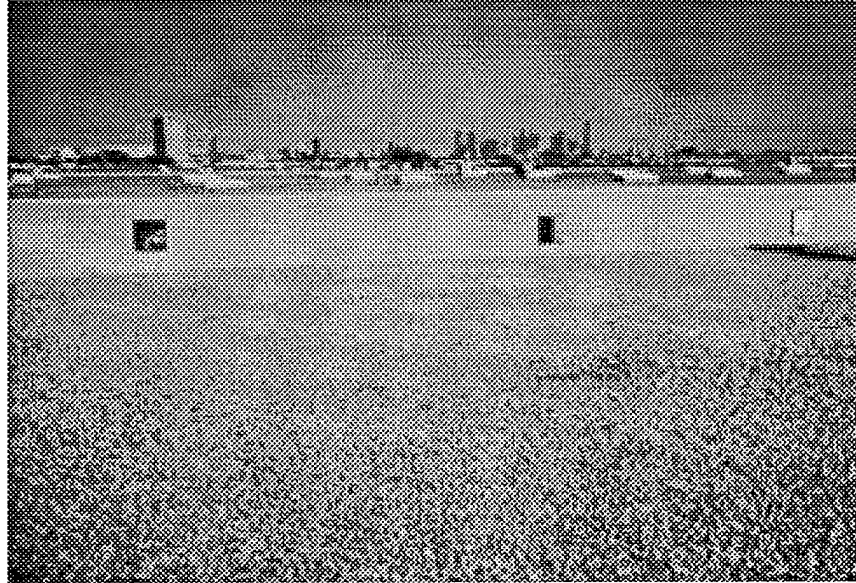
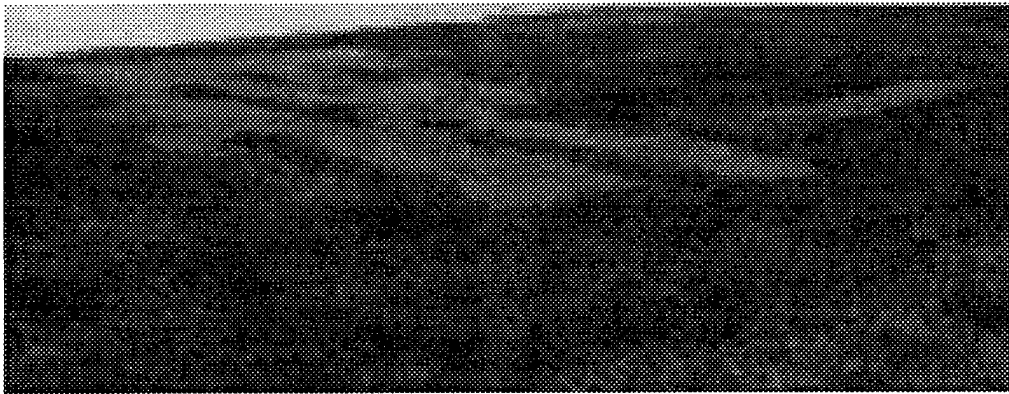
The daytime visual inspection revealed no roofing defects. During the nighttime on-the-roof infrared survey, large bright thermal anomalies were detected in the southeast corner. A few marks were made with orange spray paint there to define the general extent of these bright areas. Figure 12 shows a photograph and a thermogram of this corner of the roof. Figure 13 shows a photograph and a thermogram of a small rhombic anomaly also in this general area. That wet area is also visible at

Figure 12. Photograph and thermogram of the southeast corner of roof D2, looking SE. The bright area on the thermogram defines where wet EPS insulation exists below the EPDM membrane.

Leaving the wet insulation in this roof not only reduces its insulating ability but it also accelerates its rate of deterioration. It would be expensive to remove and replace all wet EPS insulation, but this option should be considered since this insulation cannot be dried out in place. The bituminous membrane below prevents downward drying.

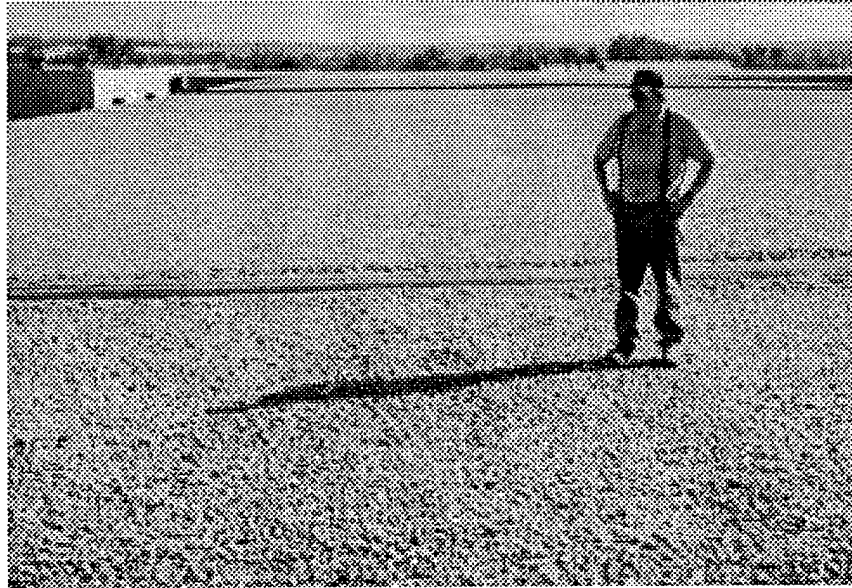
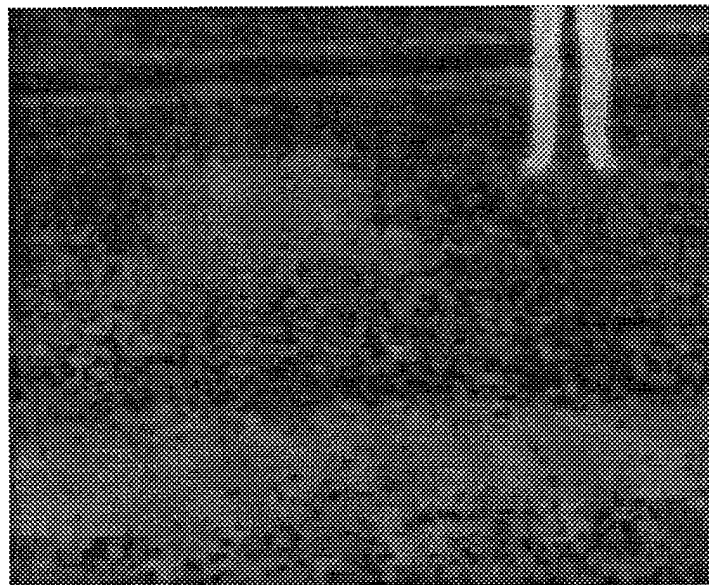
Figure 13. Photograph and thermogram taken near the area shown in Figure 12, looking south.

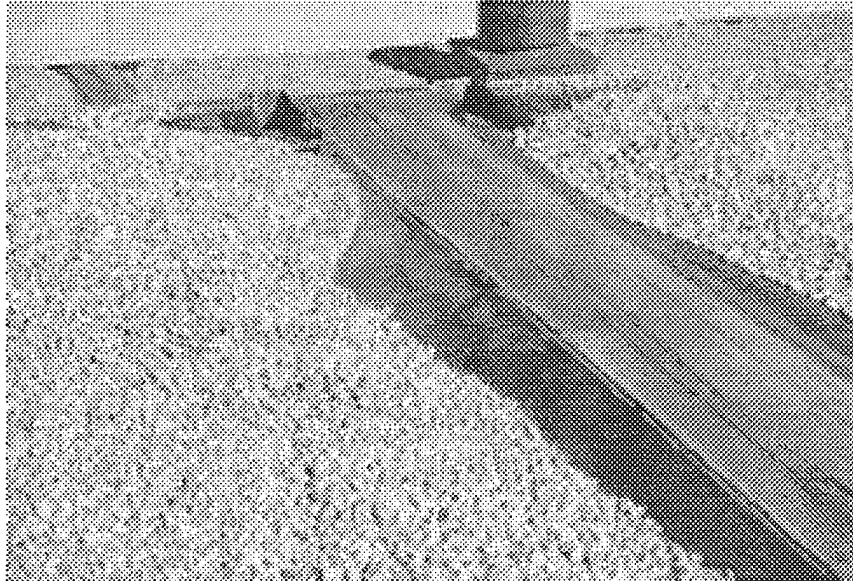
A photograph and thermogram of the east end of the expansion joint that forms the south end of roof D2 are shown in Figure 14. The insulation did not feel soft (i.e., wet) within the bright area of the thermogram. This and other evidence suggests that this warmth was caused by air infiltration from the edge of the roof. As stated for roof D1, if

Figure 14. Photograph and thermogram of the east end of the expansion joint at the southeast corner of roof D2. The intense brightness on the thermogram is probably due to air infiltration, not wet insulation.

and when this freezer is warmed up, such air infiltration paths should be blocked.

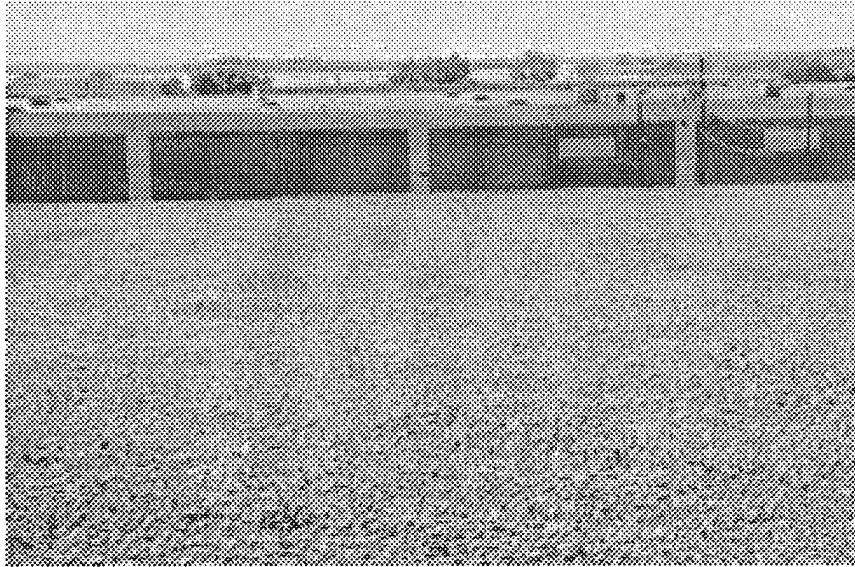
The western half of this roof contained numerous parallel bands of brightness when viewed with the infrared scanner. Figure 16 shows a photograph and thermogram of three such bands. They were all caused by differences in the ballast. All

bright areas correspond to bands of dark ballast as can be seen in the Figure 16 photograph. Core 10, the only sample taken on this roof, was taken in one of the bright areas to verify that all the brightness was caused by dark ballast. Its location is shown in Figure 2. Table 5 presents the information obtained at core 10. It verified that these bright bands were *not* moisture related.

Figure 16. Roof D3, looking west. The bright bands on the thermogram are due to dark ballast in those areas as shown in the photograph. Core 10, taken in one of the bright bands, verified that the brightness is not due to wet insulation.

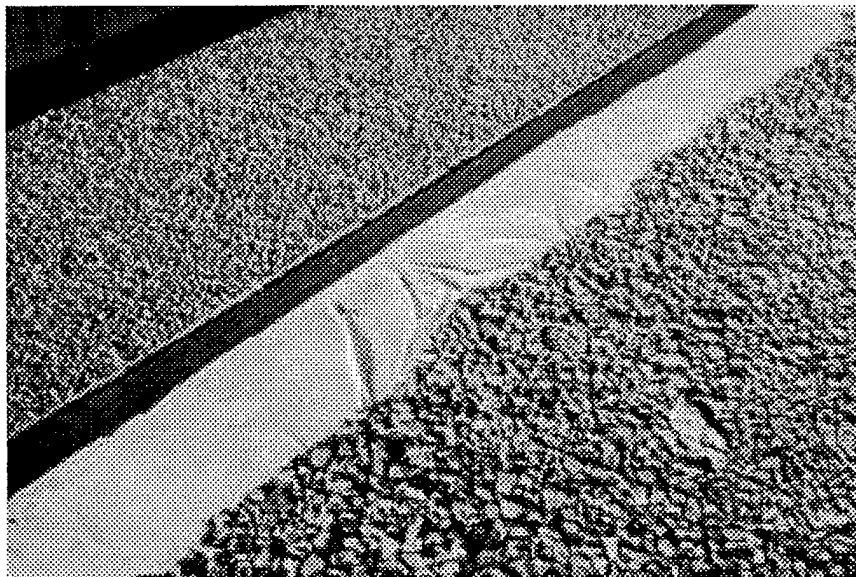
Figure 18. Raised edge of roof D5 showing wrinkled Hypalon.

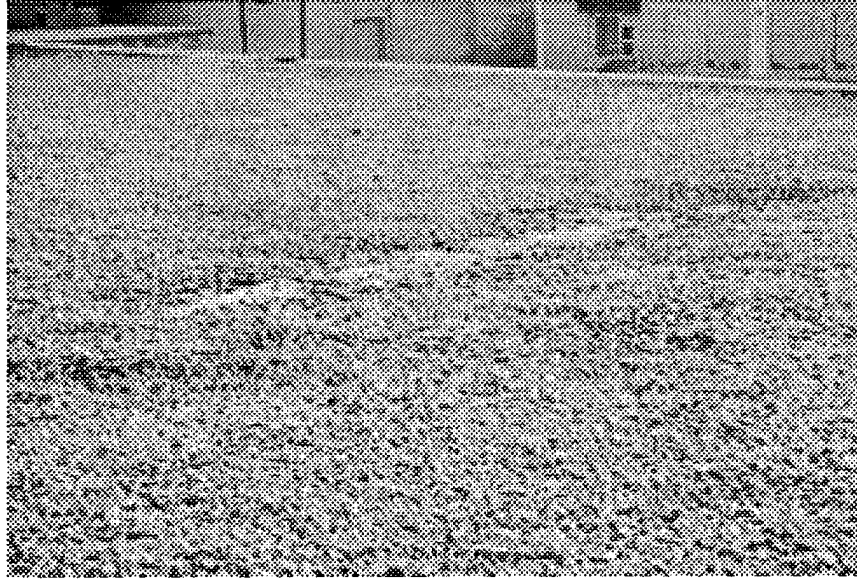
Figure 19. Bare area on roof D5, looking southwest.

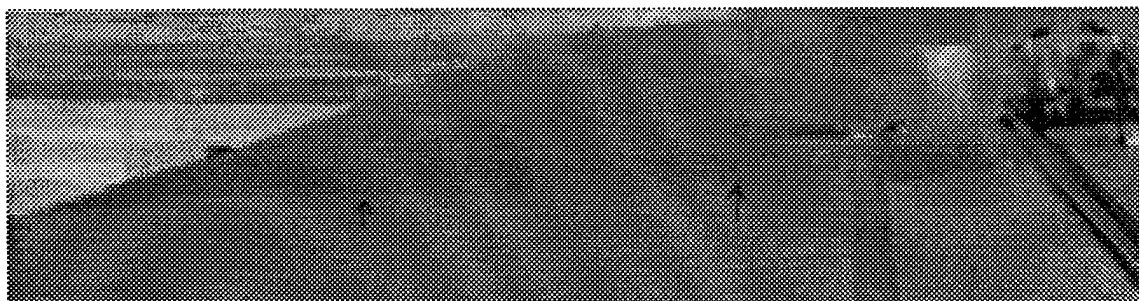
Figure 24. Thermogram showing the cold band caused by movement of cold water from refrigeration equipment across roof D7, looking north.

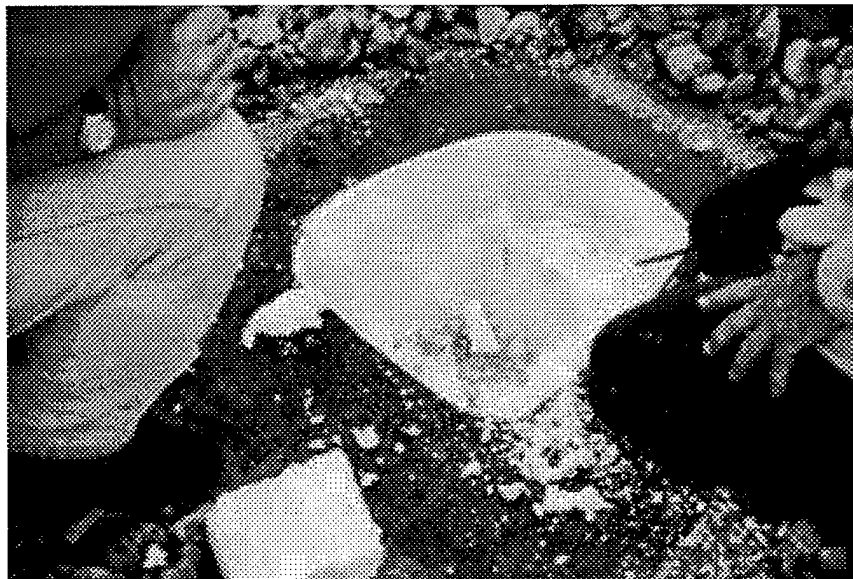
Figure 25. Taking cut F on roof D7. The lower layer of EPS was "full" of ice and frozen to the deck. A 12- x12-in. sample of it could not be obtained.

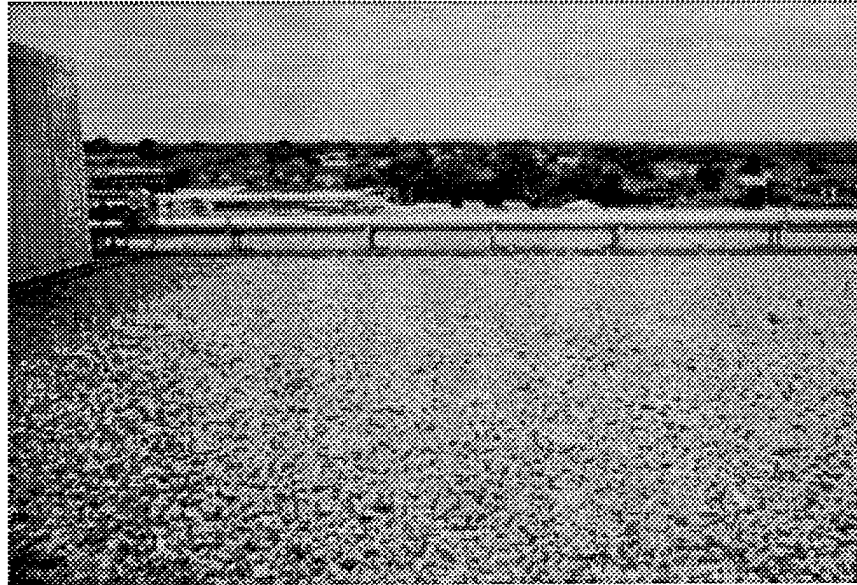
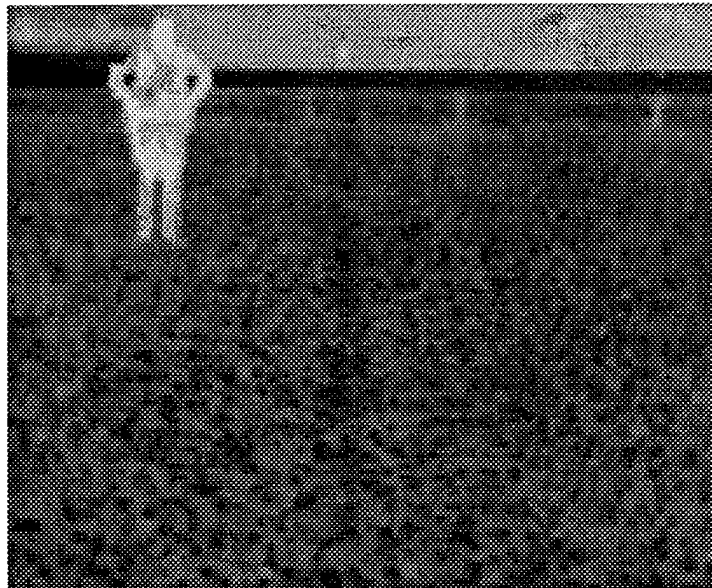
Figure 26. Photograph and thermogram of roof A1, looking west. The dark line in the thermogram is a hidden expansion joint.

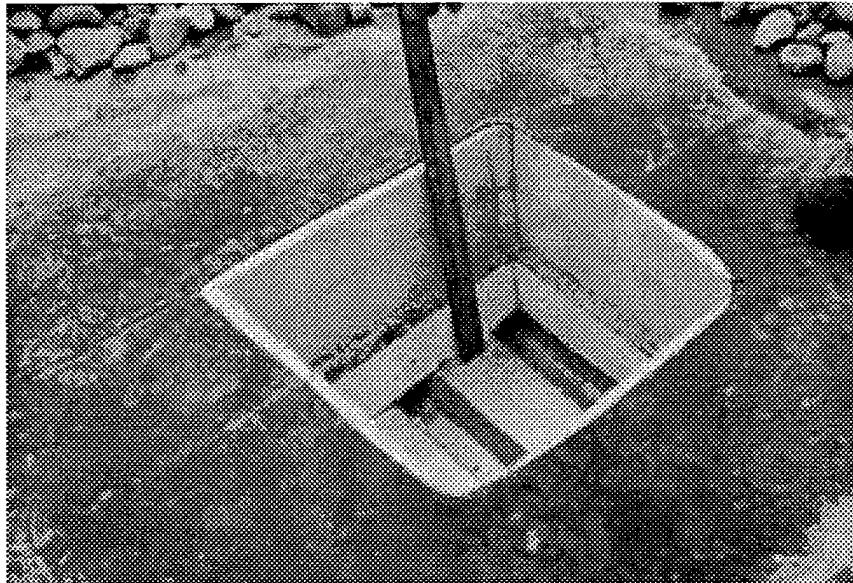
Figure 27. Hole made in roof A1 when taking cut G. No rust existed on the steel deck.

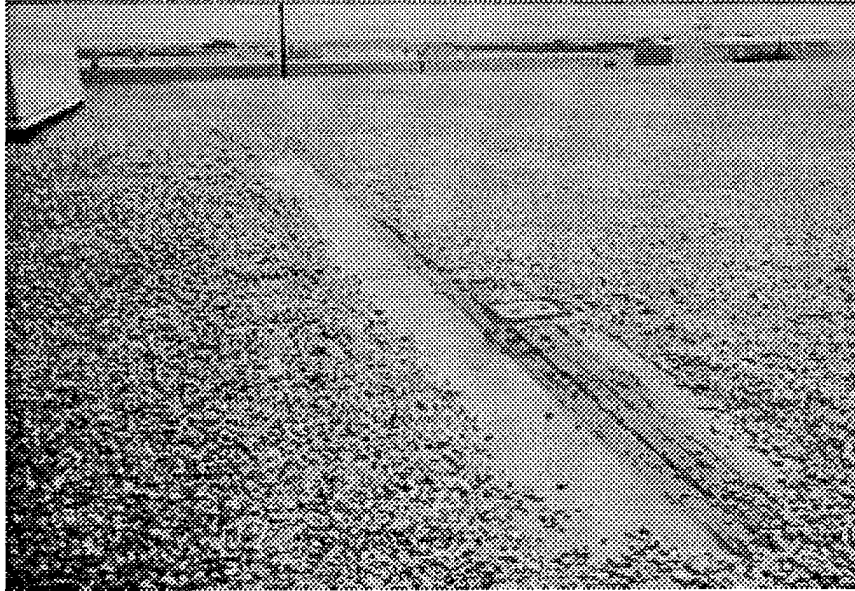
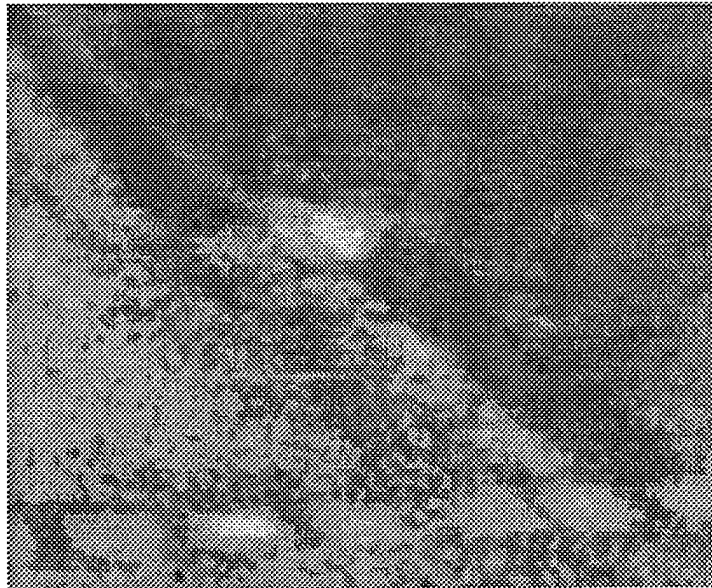
Figure 28. Photograph and thermogram of the expansion joint that separates roofs A2 and A3, looking a little south of east. The bright spot on the thermogram suggests that wet insulation exists below the patch.

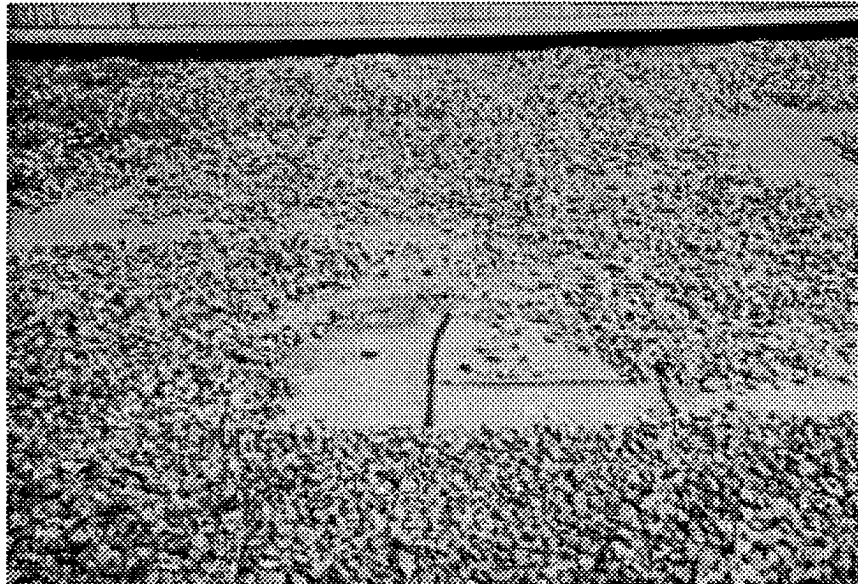
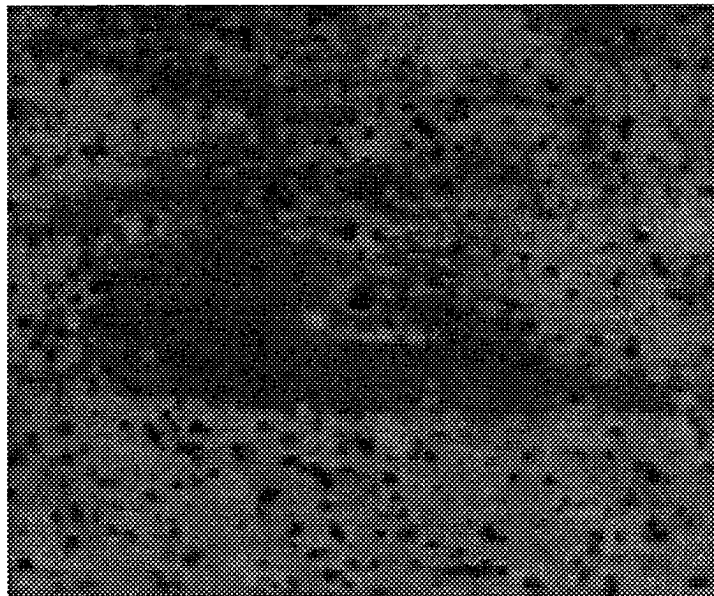
Figure 29. Photograph and thermogram of disturbed ballast on roof A2, looking north. The spray painted lines outline some insulation boards and the dot is where core 18 would soon be taken. Insulation was wet there.

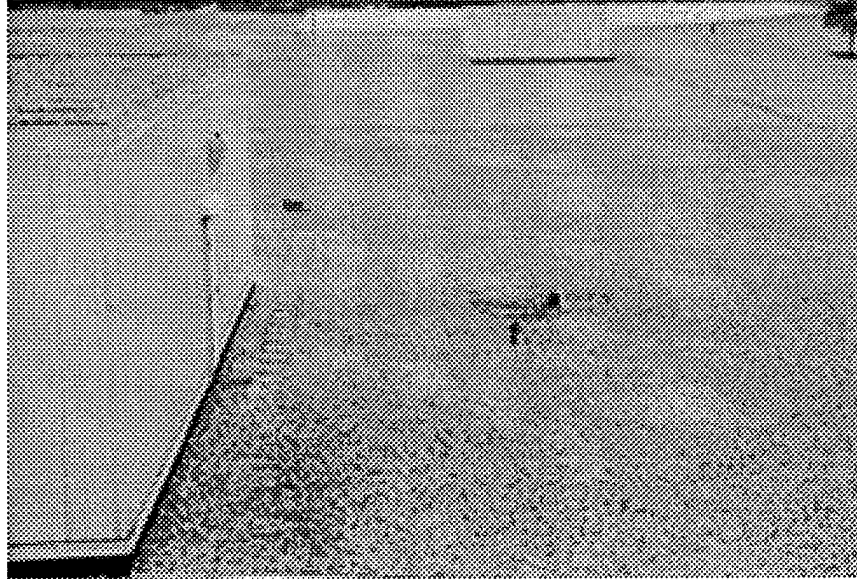
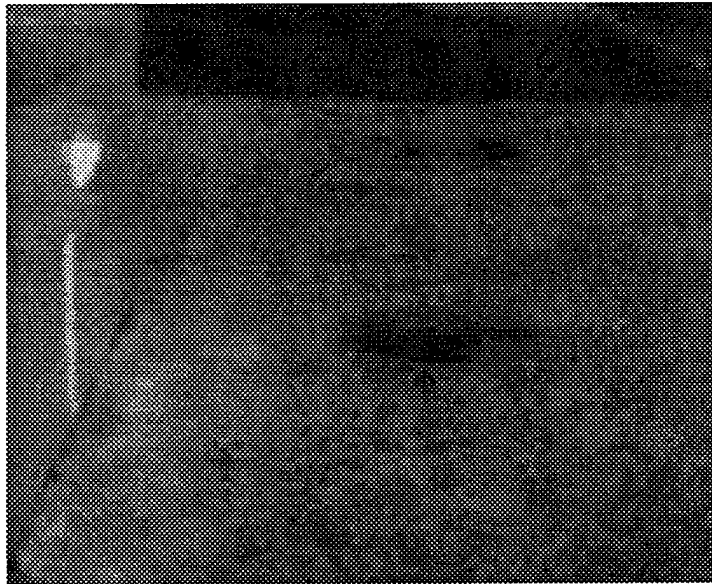
Figure 31. Photograph and thermogram of a strong thermal anomaly on roof A2, looking south. Core 17, taken here, found wet insulation.

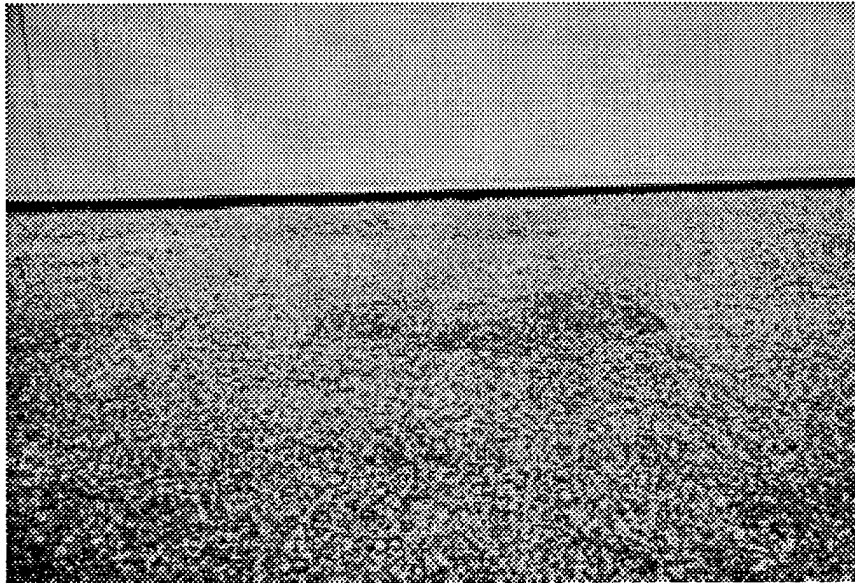
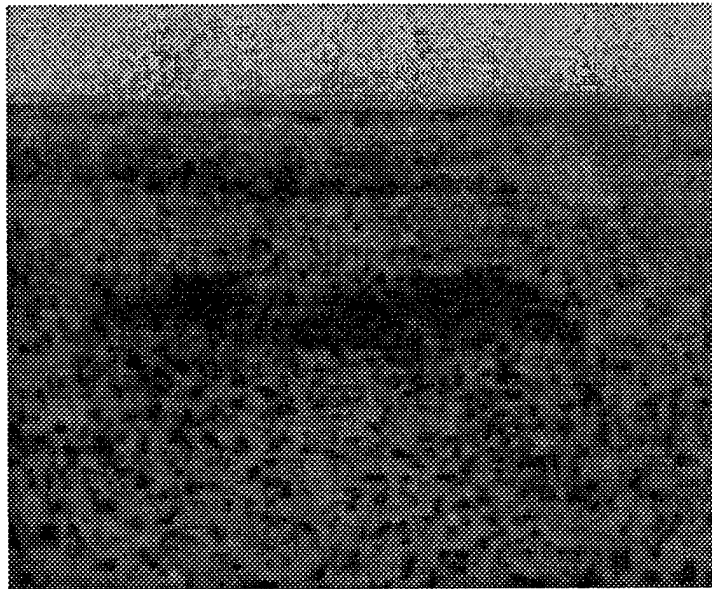
Figure 32. Photograph and thermogram of another strong thermal anomaly on roof A2, looking north. Core 19, taken here, found wet insulation.

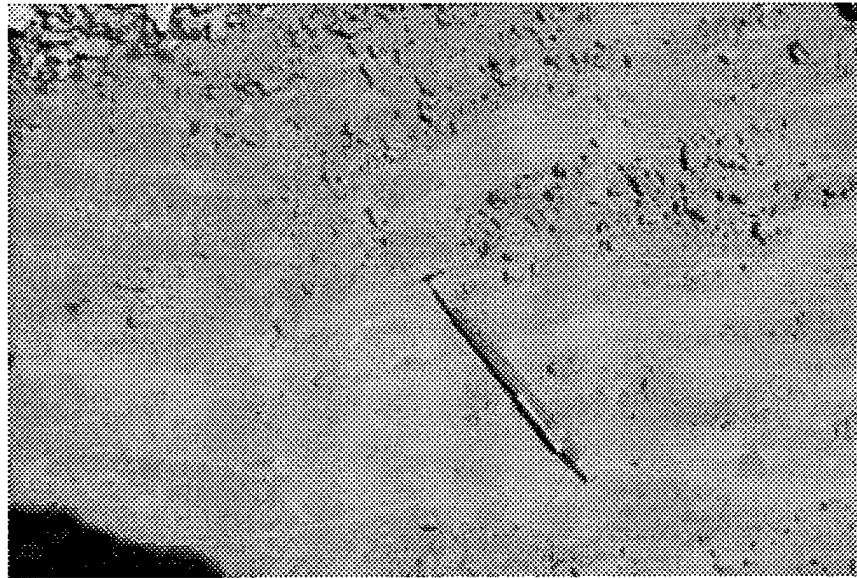
Figure 33. Ballast contained a lot of fine soil where core 19 was taken. Note the membrane slit at the upper end of the pencil.

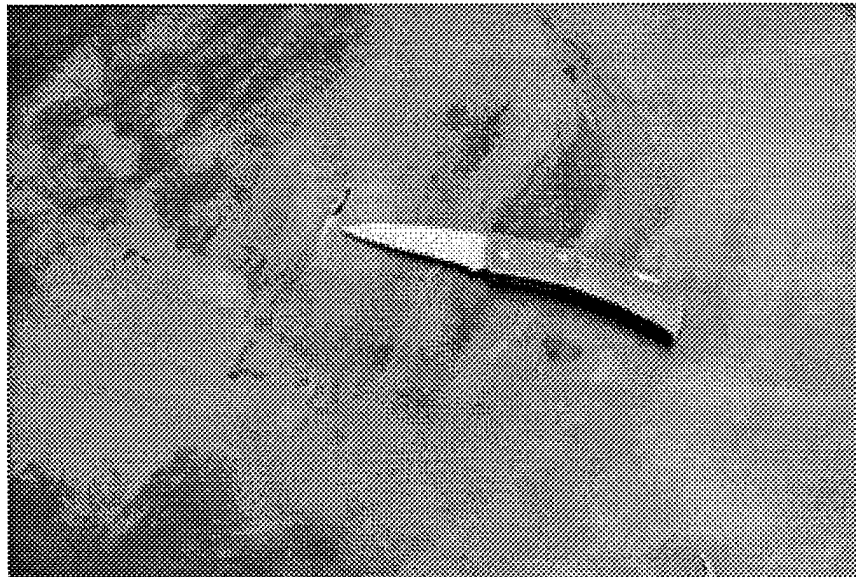
Figure 34. The membrane slit shown in Figure 33 after cleaning the membrane.

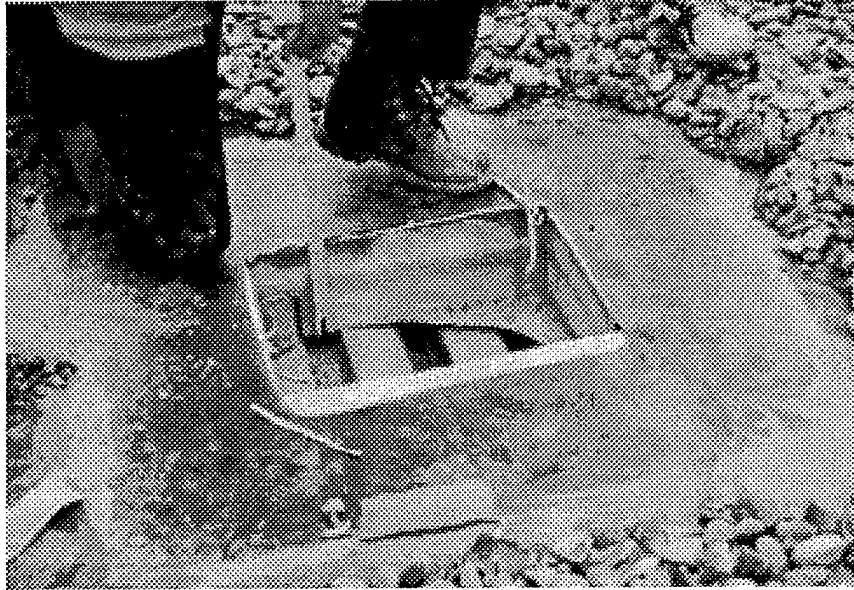
Figure 35. Cut H on roof A2. A small amount of rust was present in the flutes of the steel deck.

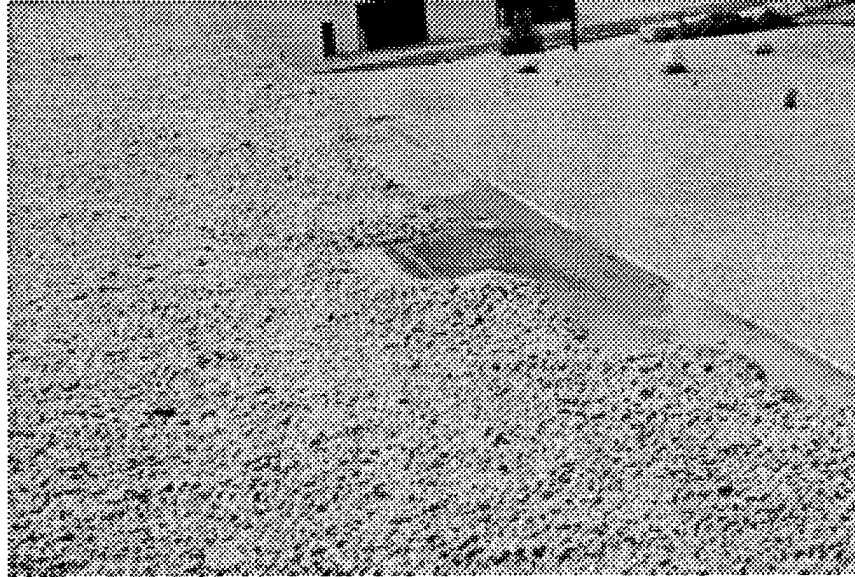
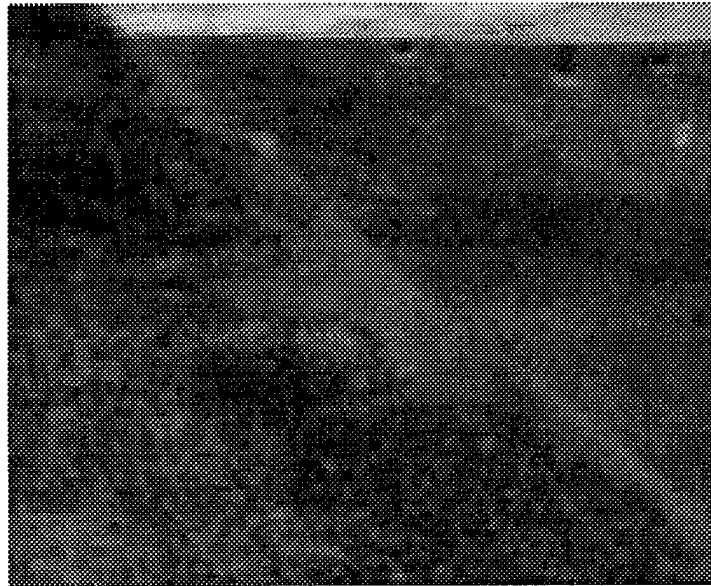
Figure 36. Photograph and thermogram of bare membrane and ponded water along the west side of roof A3, looking SW.

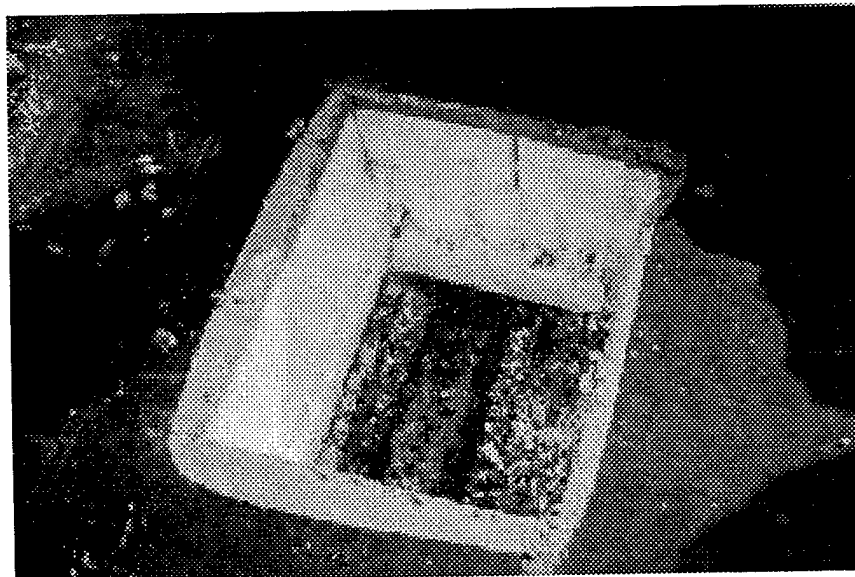
Figure 38. Hole made when taking core 14 and cut I. The bottom layer of perlite on the steel deck was wet and the steel was badly rusted.
