**AFRL-ML-WP-TR-1998-4191**

**CUT PROGRESSION DURING DYNAMOMETER  
TESTING OF FOREIGN OBJECT DAMAGED TYPE  
VII EXTRA HIGH PRESSURE AIRCRAFT TIRES  
SAE PAPER 912155**

**SEPTEMBER 1991**

**FINAL REPORT FOR 03/15/1984 – 06/15/1991**

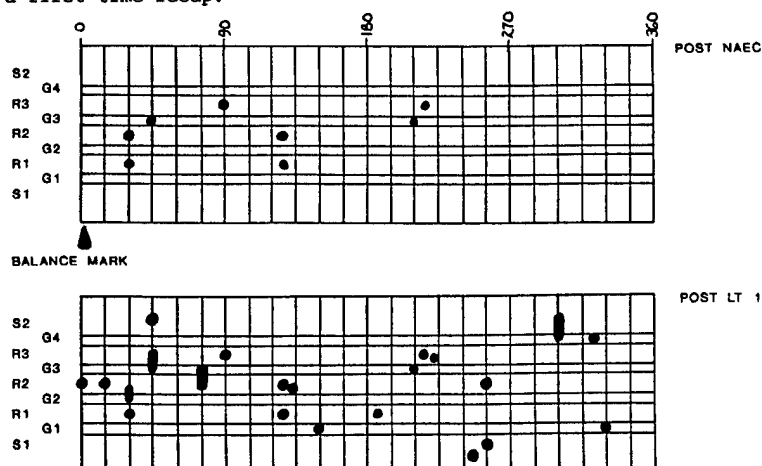
FIGURE 6: LEAST PRIMARY DAMAGE  
3242-0717/X-2A RECAPPED TIRE

**LEAST PRIMARY DAMAGE** - Tire X-2A (recap) sustained the fewest primary cuts of all dynamometer tires run on the track at NAEC, and is presented in Figure 6. There were four primary cuts (with one

past the Cut Limit) and four primary blemishes. As it ran on the dynamometer, the primary damage increased, and secondary cuts and blemishes appeared. After lab segment LT 1, there were six primary cuts (two past the Cut Limit) and one primary blemish; and 12 secondary cuts (with two past the Cut Limit) and three secondary blemishes.

Only 1.9% of the impacts at NAEC resulted in primary cuts and another 1.9% resulted in primary blemishes. After LT 1, the number of all cuts equalled 8.7% of the number of impacts. The 450% increase in the number of cuts, and 275% increase in total damage were the top percentage increase of damage for all tires tested. The tire stripped 100% of the tread during TTO 2.

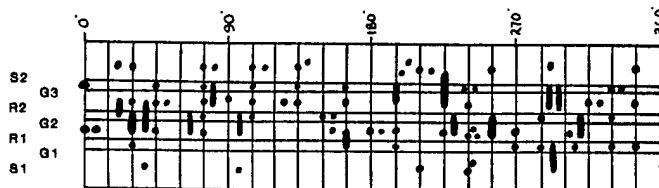
FIGURE 7: MOST PRIMARY DAMAGE  
8202-0886/J-20 NEW TIRE

**MOST PRIMARY DAMAGE - Tire J-20 (new)** sustained the most primary cuts, and is presented in Figure 7. There were 81 primary cuts (ten past the Cut Limit) and six primary blemishes. After lab segment TTO 1, there were 86 primary cuts (11 past the Cut Limit) and no blemishes; and 27 secondary cuts (two past the Cut Limit) and three secondary blemishes.

Twenty three percent of the impacts resulted in primary cuts and 2% resulted in primary blemishes. After TTO 1, the number of all cuts equalled 33% of the impacts. This tire stripped 200 degrees of the inboard (R2) center rib during TTO 3.

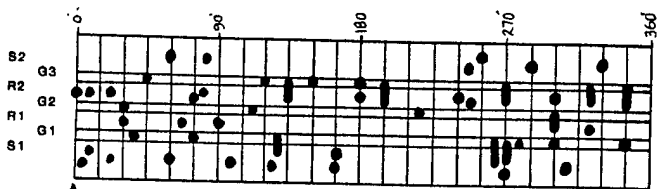
FIGURE 8: GREATEST SECONDARY DAMAGE  
4044-0951/H-8 NEW TIRE

**MOST SECONDARY DAMAGE - Tire H-8 (new)** sustained more than the mean (40) number of cuts at NAEC, and is presented in Figure 8. There were 49 primary cuts (four past the Cut Limit) and one primary blemish. Growth of secondary damage after lab segment TTO 1 was dramatic. After TTO 1, there were 50 primary cuts (five past the Cut Limit) and no primary blemishes; and 43 secondary cuts (two past the Cut Limit) and one secondary blemish. The 43 secondary cuts after TTO 1 were the most noticed during this program.

Fourteen percent of the impacts resulted in primary cuts, and less than 1% resulted in primary blemishes. After TTO 1, the number of all cuts equalled 27% of the impacts. The tire completed 3 TTO and 3 LT segments without failure, and was removed from the test queue for the dynamometer.

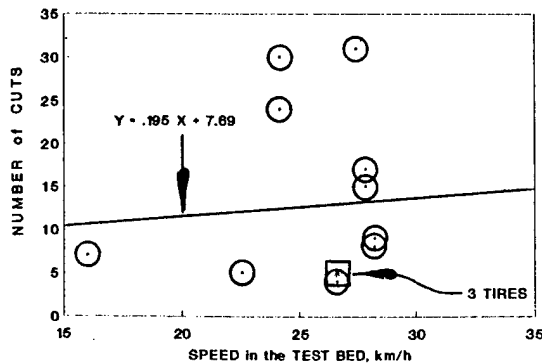
FIGURE 9: SPEED vs NUMBER OF CUTS  
Recapped Tires

The number of primary cuts produced is presented in Figure 9, as a function of speed in the test bed at NAEC. Individual tires had between four and 31 primary cuts, with 69% of the tires having 15 or fewer cuts. The positive slope indicates that more damage was done as the NAEC speed increased.

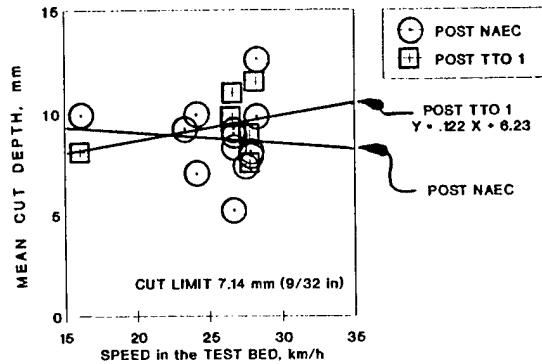
FIGURE 10: MEAN DEPTH OF PRIMARY CUTS  
Recapped Tires

The mean depth of the primary cuts on each tire is presented in Figure 10. 54% of the tires were at or above the 7.1 mm (9/32 inch) Cut Limit. The negative slope results from the choice of tires. A different group might have had a different slope.

The initial mean depth of all primary cuts on all tires was 6.7 mm (8.5/32 inch). After TTO 1, the value rose to 7.2 mm (9.1/32 inch). The number and depth of primary cuts were increasing. The internal damage done becomes apparent with continued dynamometer testing.

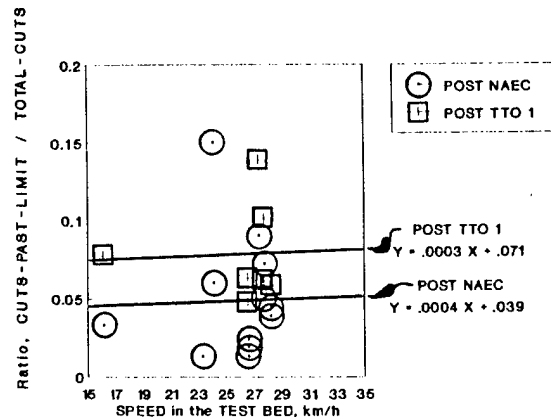
FIGURE 11: PAST LIMIT TIRE PERFORMANCE  
Recapped Tires

The ratio of cuts deeper than the Cut Limit, to the total number of cuts is presented in Figure 11. Both the POST NAEC and POST TTO 1 curves have a positive slope and positive intercept. As above, the number of cuts deeper than the Cut Limit is worse with higher track speed. The POST TTO 1 curve is above the POST NAEC curve: more internal damage is revealed with additional dynamometer testing.

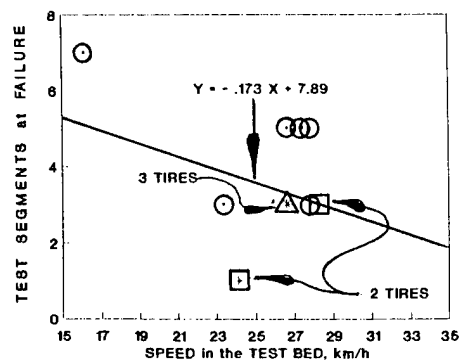
FIGURE 12: SPEED vs SEGMENTS at FAILURE  
Recapped Tires

tire failure is presented in Figure 12. On the dynamometer, 69% of the tires failed on or before TTO 2, Test Segment 3. The negative slope indicates more damage occurred at higher track speed, which resulted in a shorter life on the dynamometer. This curve complements the information in Figure 9.

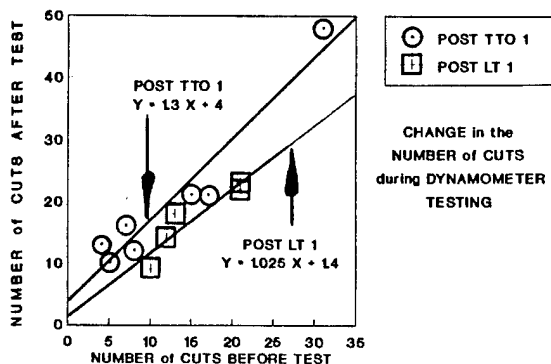
FIGURE 13: INCREASE in NUMBER of CUTS  
Recapped Tires

Data in Figure 13 highlights the increase in the number of cuts with testing. The X-axis indicates the number of cuts before a dynamometer test segment; the Y-axis indicates the number of cuts after a dynamometer test segment. Each data point is an individual dynamometer run for an individual tire. The slope of the Post TTO 1 curve is 1.3; the intercept is 4.0. These suggest that there were an average 34% more cuts visible after the first dynamometer event than on return from NAEC.

The slope of the LT 1 curve is 1.025 with an intercept of 1.4; a 3.9% increase in the number of cuts occurred after LT 1. The increase was less than after TTO 1, but still positive, i.e. the number of cuts continued to grow. Were this trend to continue and the tire to survive, one might expect to see a cut or blemish for each impact. The tires did not, however, last long enough to produce as many cuts and/or blemishes as impacts.

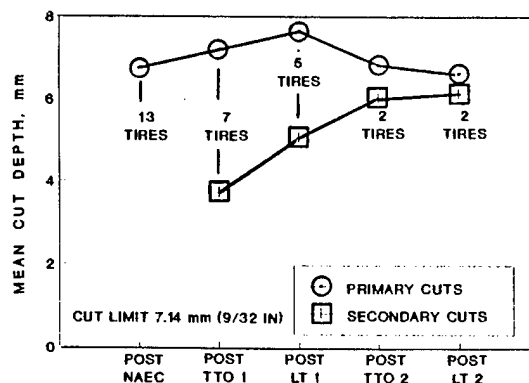
FIGURE 15: MEAN CUT DEPTH  
Recapped Tires

The mean depth of primary and secondary cuts of all recapped tires is presented in Figure 15 and Table 4. It is interesting to note that the primary and secondary cuts have significantly different mean depths. The primary cuts are deeper. The trend in both is to deepen until the crack approaches the reinforced carcass.

The calculation is from a decreasing data pool as the tests progressed. The Post NAEC point is from 165 primary cuts on 13 tires where the Post LT 2 point is from 23 primary cuts on 2 tires.

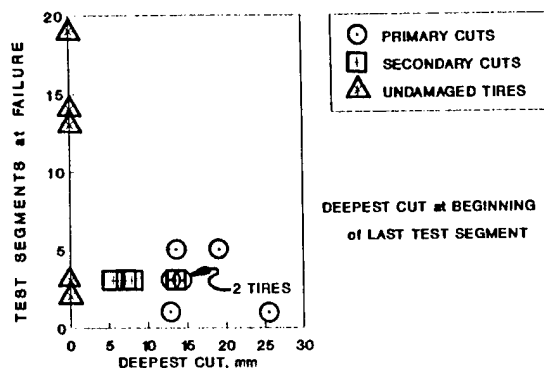
FIGURE 17: DEEPEST CUT at FAILURE Recapped Tires

The deepest primary and secondary cuts at the beginning of the last dynamometer test segment are presented in Figure 17. The primary cuts average 15.9 mm (20/32 inch) deep, more than twice the 7.1 mm (9/32 inch) Cut Limit. The secondary cuts average 7.9 mm (10/32 inch) deep which is just over the Cut Limit. As was noted above, 69% of the tires failed on or before TTO 2, Test Segment 3.

recapped tires. They were run on TTO schedules only. As noted in Figure 17, undamaged tires failed on segments 2, 3, 13, 14, and 19.

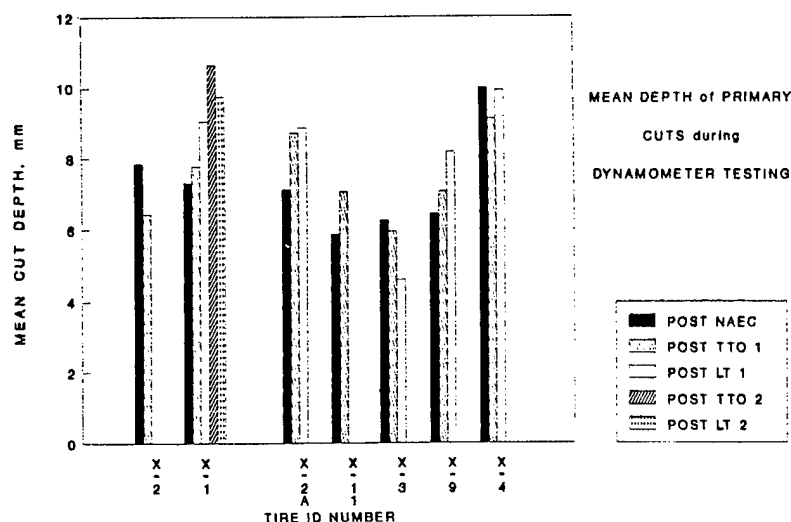
FIGURE 16: DEPTH CHANGES during TEST Recapped Tires

**INDIVIDUAL CONDITION WITH TESTING** - Changes in the mean cut depth of primary cuts of seven tires are presented in Figure 16. Damage is unpredictable. An increase or decrease in mean depth on one segment might be followed by the opposite after the next segment. The changes include the cut becoming shallower, deeper, or closing; new cuts appearing; or cuts going unchanged.

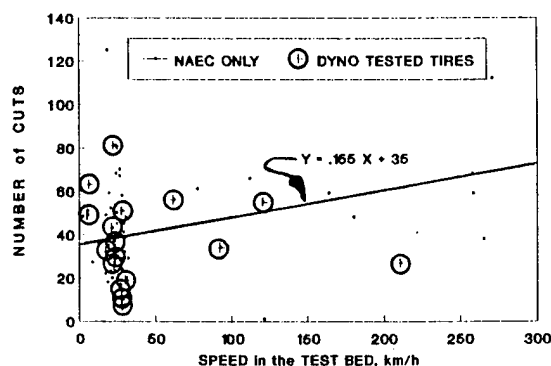
FIGURE 18: SPEED vs NUMBER of CUTS  
New Tires

The number of primary cuts produced is presented in Figure 18. Dynamometer tires had between seven and 81 primary cuts, with 59% having 40 or fewer cuts. The trend noted with recaps is repeated: more cuts at higher track speeds.

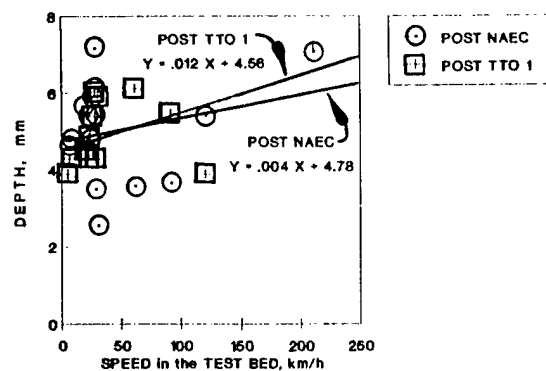
FIGURE 19: MEAN DEPTH of PRIMARY CUTS  
New Tires

The mean depth of the cuts on each tire is presented in Figure 19. 35% of the tires were at or above the 5.6 mm (7/32 inch) Cut Limit. This compares to 54% of the recaps that were at or above a deeper Cut Limit. The initial mean depth of all cuts on all dynamometer tires was 4.9 mm (6.17/32 inch). This compares to 6.7 mm (8.5/32 inch) for the recaps. A Shore Type A durometer comparison of the new and recap tire materials may explain this difference. The recaps registered 10% lower value (softer compound). As was noted above, the service life of recaps was not as good as the new tires. Recaps F-16 main tires were removed from flight status.

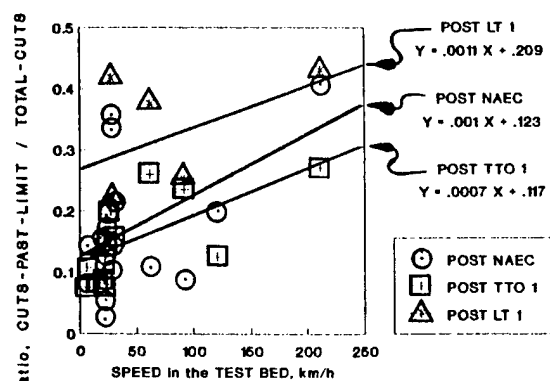
FIGURE 20: PAST LIMIT TIRE PERFORMANCE  
New Tires

The ratio of cuts deeper than the Cut Limit, to the total number of cuts is presented in Figure 20. All three curves have a positive slope. The amount of damage is higher for the new tires than with the recapped tires, but the performance trend is reversed: POST TTO 1 data is below POST NAEC data. In a number of tires, the number of cuts dropped between NAEC measurements and POST TTO 1 measurements.

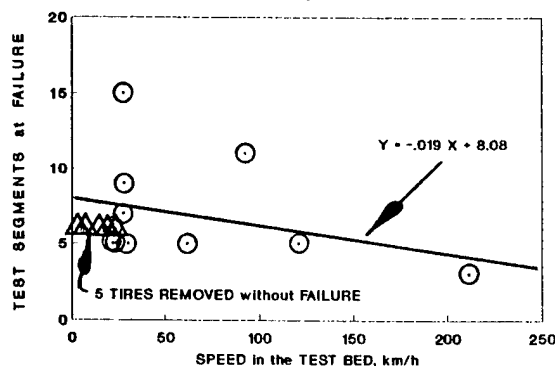
FIGURE 21: SPEED vs SEGMENTS at FAILURE  
New Tires

The number of test segments run at tire failure is presented in Figure 21. On the dynamometer, 64% of the tires failed on or before LT 3, Test Segment 6. The negative slope of the curve compliments the information in Figure 12: more damage occurred at higher track speed, resulted in shorter life on the dynamometer. This is similar to the trend seen on the recaps.

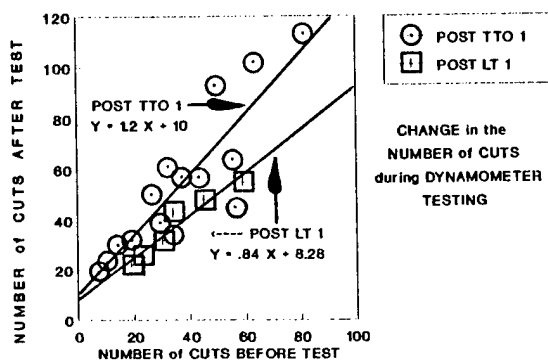
FIGURE 22: INCREASE in NUMBER of CUTS  
New Tires

OVERALL CONDITION WITH TESTING - Like the recaps, the new tires deteriorated with each run on the dynamometer. The number of cuts before and after each test segment in Figure 22 is similar to recapped tire data in Figure 13, except that the slope and intercept are different. New tire POST TTO 1 data indicates a 30% increase in the number of cuts over POST NAEC levels; it was 34% for the recapped tires. New tire POST LT 1 data indicates an 8% decrease in the number of cuts over POST TTO 1 levels; it was a 3.9% increase for the recapped tires. A difference in tread material, noted with the Shore durometer test, may explain this change. On landing, the high heat created by spin up seems to temporarily glue some cuts back together.

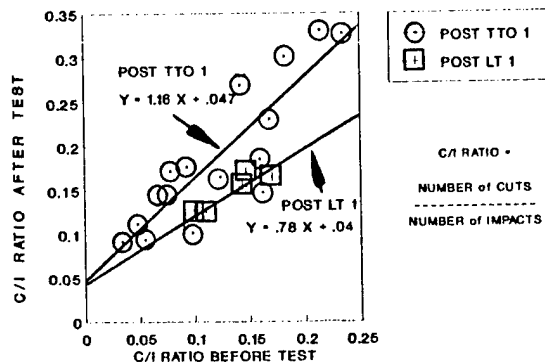
FIGURE 23: PERCENTAGE INCREASE in CUTS  
New Tires

In Figure 23, the data from Figure 22 is presented as the ratio of cuts-per-impact before and after each dynamometer test. The slope and intercept of new tire POST TTO 1 curve is greater than it was for recapped tires curve. The new tire POST LT 1 curve has an 18% decrease over POST NAEC data; the recapped tire POST LT 1 curve had a 5.5% increase.

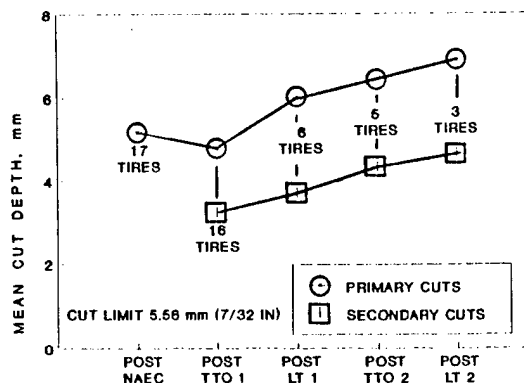
FIGURE 24: MEAN CUT DEPTH  
New Tires

The mean cut depth of primary and secondary cuts of all tires is presented in Figure 24 and Table 5. The new tire trend is more severe than it was for the recapped tires: the mean cut depth increased above the Cut Limit with dynamometer tests. The data pool shrank as the test continued because of tire failures or removals after three TTO and LT segments had been completed.

The greater damage may also reflect the conditions of test at NAEC: twice as many new tires ran over 38 mm (1.5 inch) rocks than did recapped tires; and some of the new tires ran at "high" speed (above 48 km/hr - 30 mph), while no recap ran over 29 km/hr (18 mph).

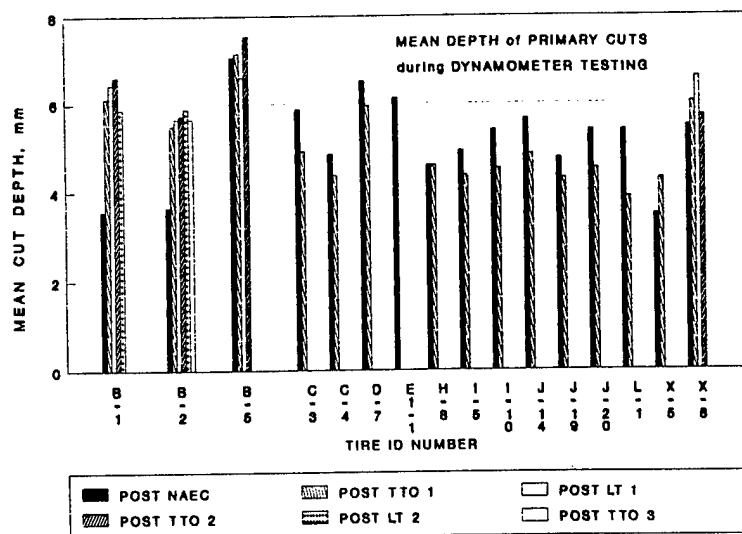
FIGURE 25: DEPTH CHANGES during TEST  
New Tires

INDIVIDUAL CONDITION WITH TESTING - Changes in the mean cut depth of primary cuts of seventeen new tires are presented in Figure 25. No rational pattern can be drawn from this data. The same was true of the recapped tires.

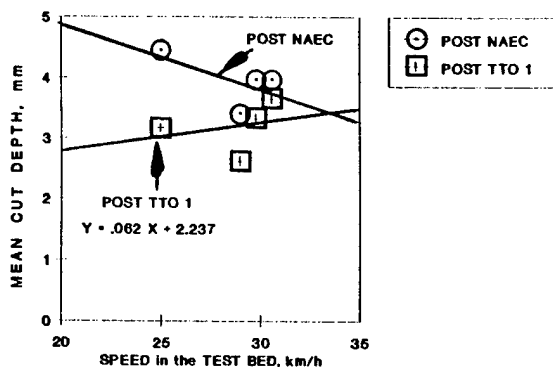
FIGURE 27: MEAN DEPTH OF PRIMARY CUTS  
Radial Tires

The mean depth of cuts on each tire is presented in Figure 27. Unlike the production bias tires that were tested, these prototype radial tires did not have a Cut Limit label cast on the sidewall. The POST TTO 1 data shows the familiar positive slope and intercept with speed. If H-4 is removed from the data, the initial mean depth of all cuts in the other tires is 4.0 mm (5.036/32 inch).

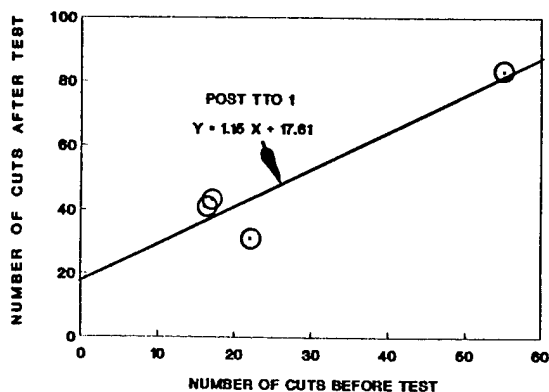
FIGURE 28: INCREASE IN NUMBER OF CUTS  
Radial Tires

OVERALL CONDITION WITH TESTING - Data in Figure 28 suggests a 33% increase in number of cuts after TTO 1. This performance is similar to the new and recapped tires. POST LT 1 data is not available, as the radial tires were only remapped after TTO 1.

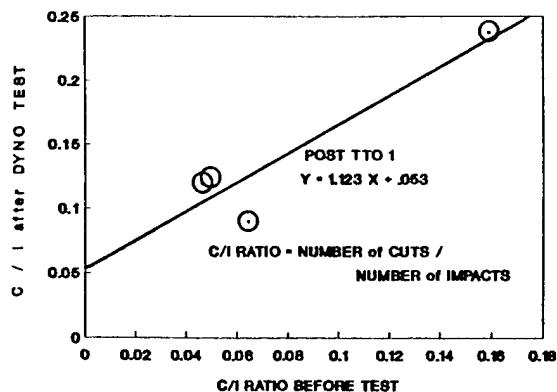
FIGURE 29: PERCENTAGE INCREASE IN CUTS  
Radial Tires

In Figure 29, the data from Figure 28 is presented in a ratio of cuts per impact form. An increase of 18% is suggested. This is higher than the recaps, but lower than the new tires.

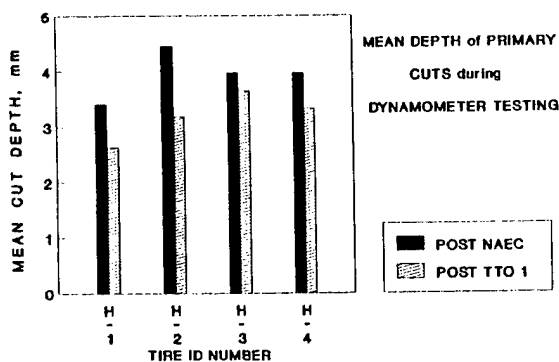
FIGURE 31: DEPTH CHANGES during TEST  
Radial Tires

INDIVIDUAL CONDITION WITH TESTING - Changes in the mean depth of primary cuts of the four tires are presented in Figure 31, as each tire was tested on the dynamometer. All four experienced a reduction of depth with testing. No further maps were made after TTO 1, so no other data is available.

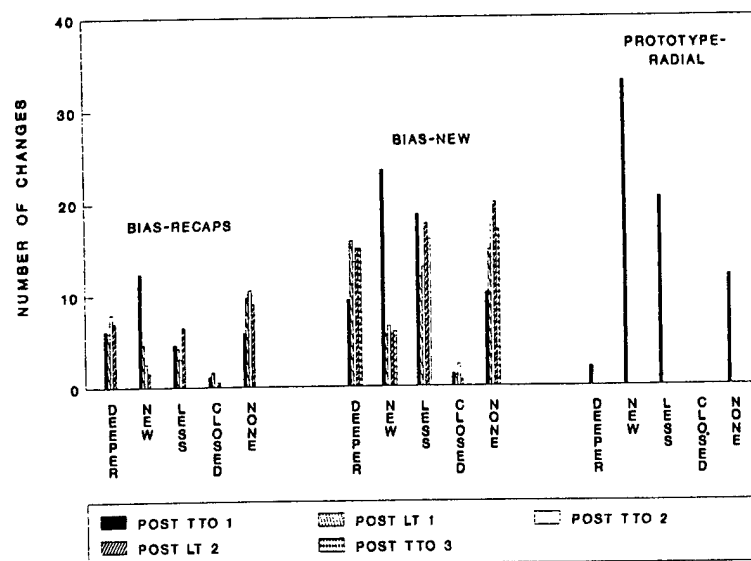
FIGURE 32: CUT ACTIVITY  
during TESTING

CUT DEPTH ACTIVITY - NEW cuts are indications of secondary damage. The number of new cuts is very high after the first taxi-takeoff segment. The activity then trails off greatly. The number of cuts that closed is very small throughout the tests. As was noted with the bias ply tires, the depth of the cuts increases with more test segments on the dynamometer.
