FINAL REPORT
ADVANCED STRUCTURAL REPAIR

*Design and Installation of Bonded Repairs
to cracked fuselage skins on C-5A T/N 69-021*

Contract F61708-94-C-0017

20 December 1995

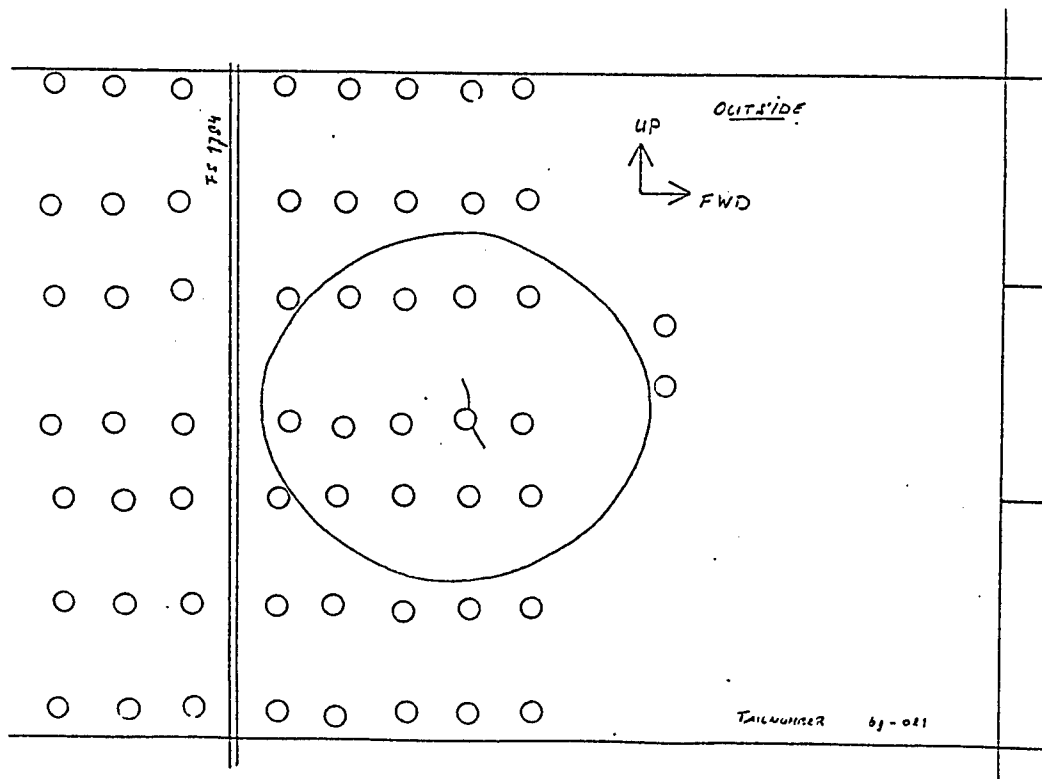
Figure 3. Trace of rivet pattern and patch location for repair to FS 1700.

Figure 3 shows a trace of the existing rivet pattern and the patch location on the aircraft at FS 1700. At the critical areas (patch tips) the rivets are all covered by the patch. By covering the rivet a high stress concentration due to the patch tip and the rivet is prevented, improving the durability of the repair system. Figure 4 shows the location of the two bonded repairs.

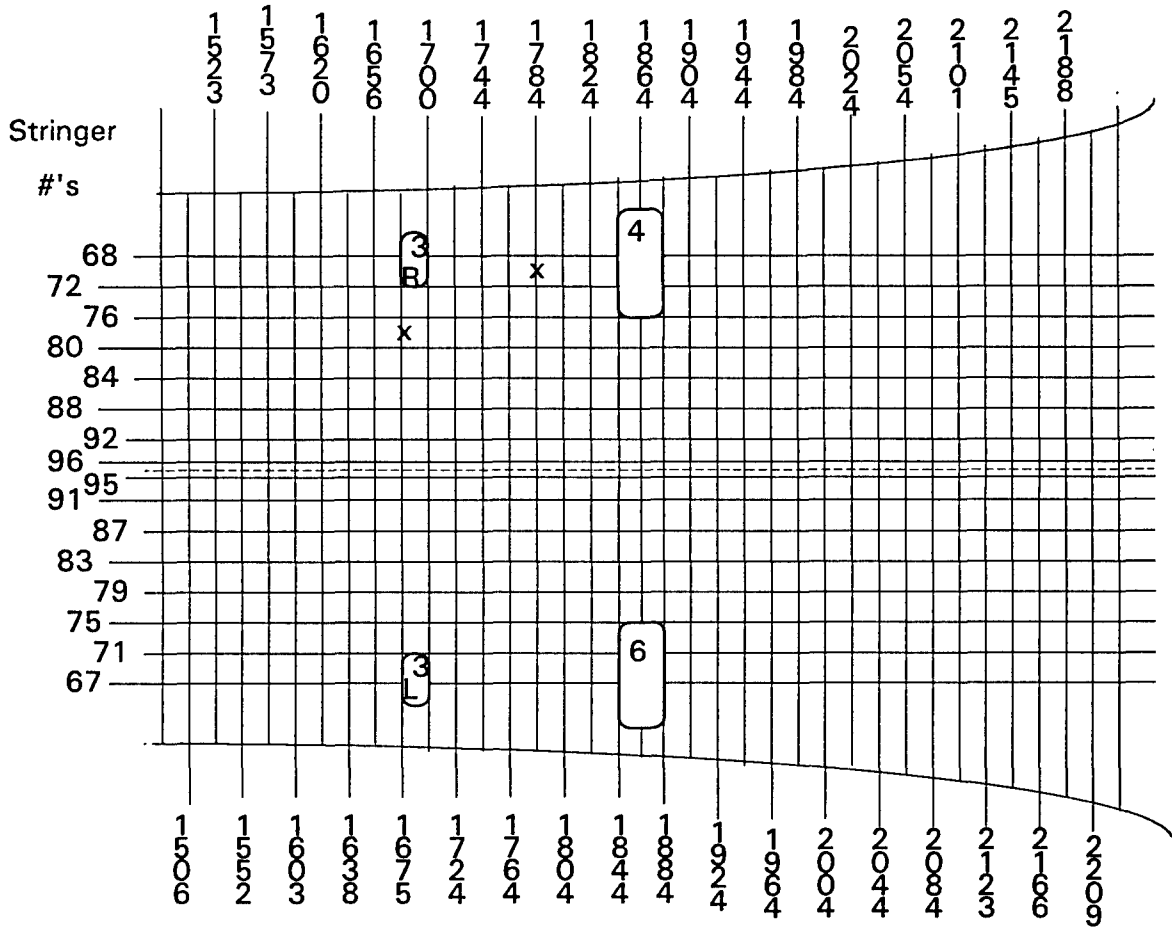
Figure 4. Location of fuselage cracks on T/N 69-021.

The two cracks repaired in T/N 69-021 are located at fuselage station 1675 near stringer 78 and at fuselage station 1784 near stringer 70. To design a suitable patch, the configuration has to meet the guidelines for typical loads, limit load and ultimate load. At typical loads the repair must show durable behavior, and greatly slow crack growth. At limit load, no yielding of any component is allowed. At ultimate design load (equal to 1.5 times the design limit load), the structure shall not fail, which means that all stresses should be less than the ultimate strength of the respective components.

Location of crack patches (x)

1. Fuselage Station 1675
Stringer #78
2. Fuselage Station 1784
Stringer #70
