# NATIONAL TRANSPORTATION SAFETY BOARD

## AIRCRAFT ACCIDENT REPORT

IN-FLIGHT FIRE/EMERGENCY LANDING  
FEDERAL EXPRESS FLIGHT 1406  
DOUGLAS DC-10-10, N68055  
NEWBURGH, NEW YORK  
SEPTEMBER 5, 1996

**Adopted: July 22, 1998  
Notation 6800B**

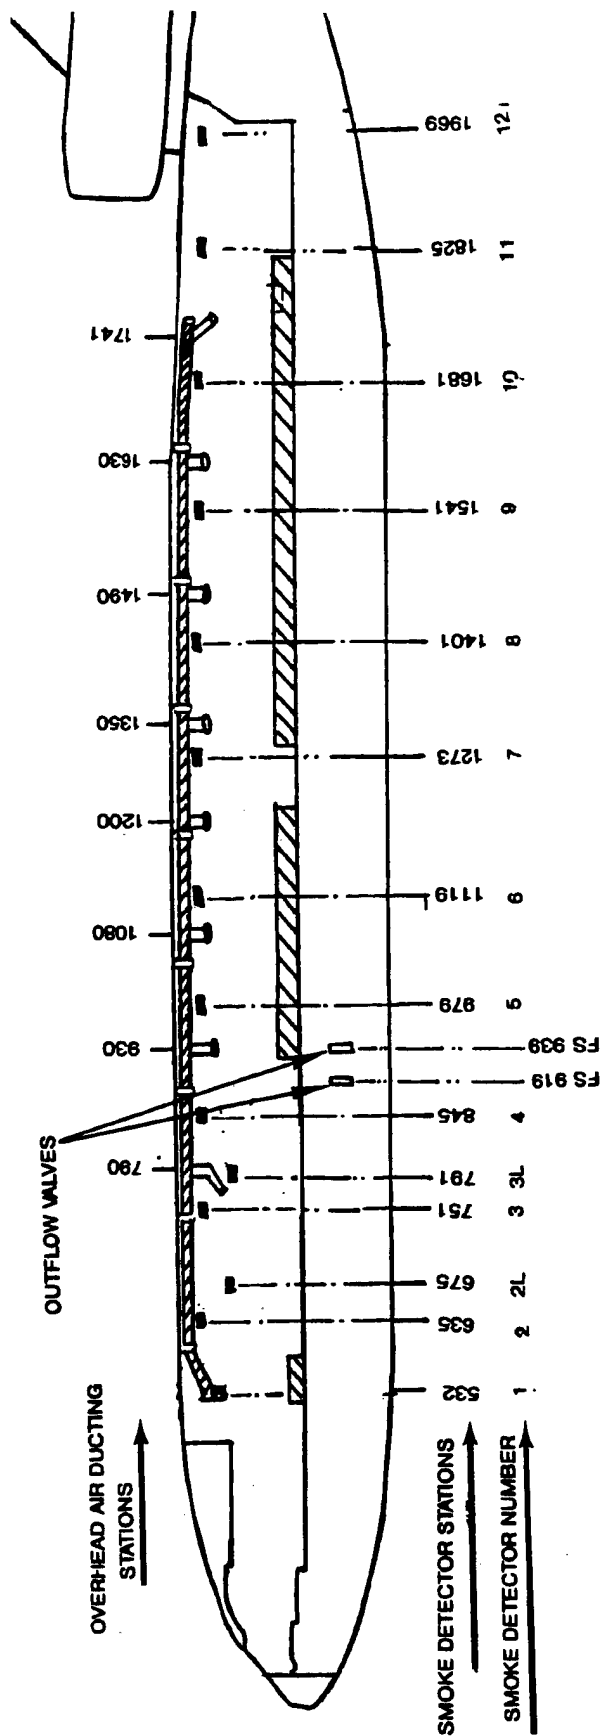
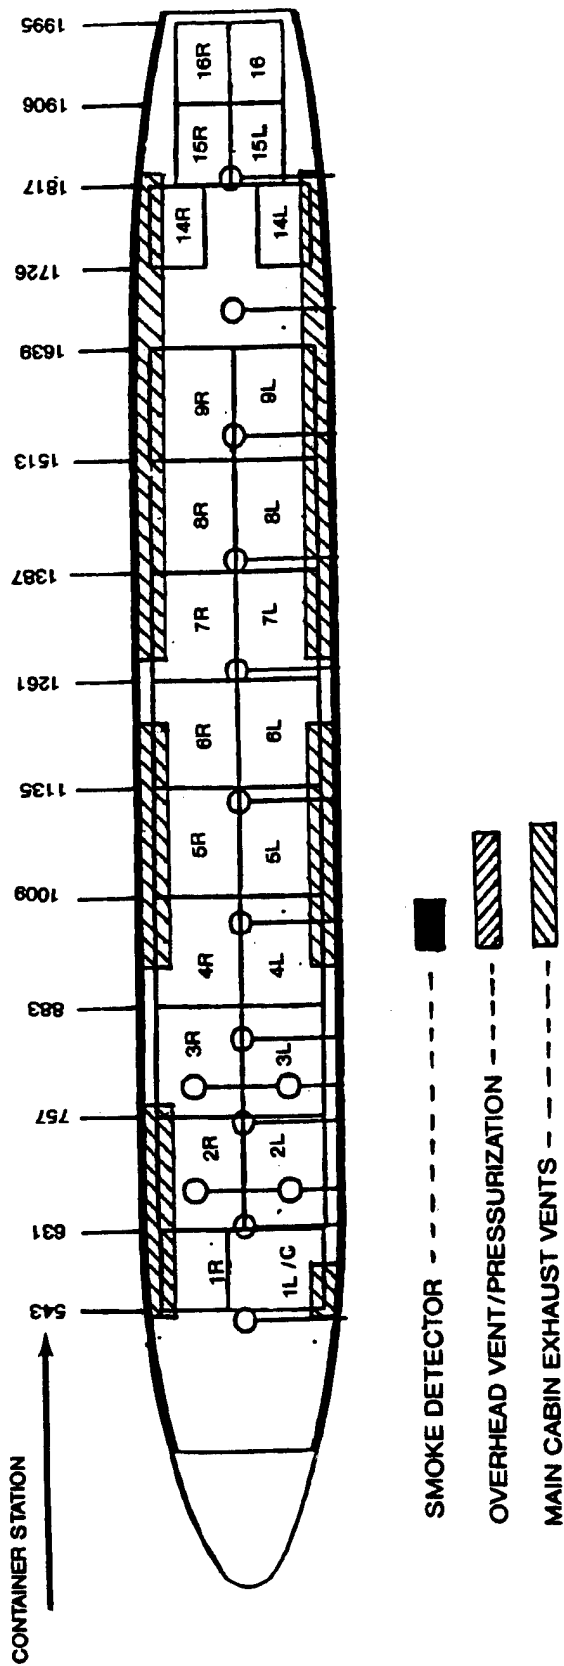
Figure 5.—DC-10-10, N68055, cargo container, smoke detector, and main cabin overhead ducting locations.

Smoke detection systems were installed in the main cargo cabin and lower cargo areas. The smoke detection system consisted of 16 main deck smoke detectors suspended from the cabin ceiling, each of which was connected to an indicator light in the cockpit, and 4 lower forward cargo compartment detectors. Postaccident examination of the smoke detection systems in the upper cabin cargo area revealed that they had been destroyed by fire. The lower cargo compartment detectors were in place and were not damaged. The system could not be functionally tested because of the damage to the upper cabin system and the associated wiring bundles.

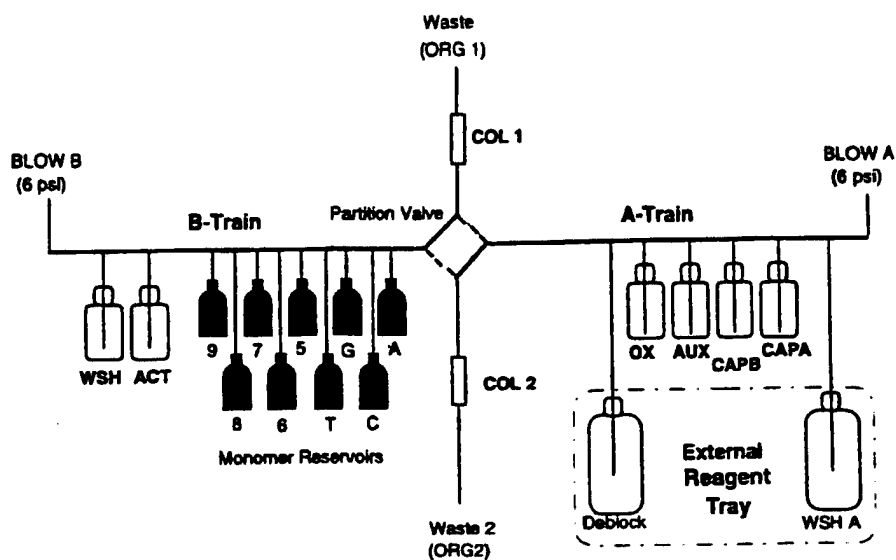
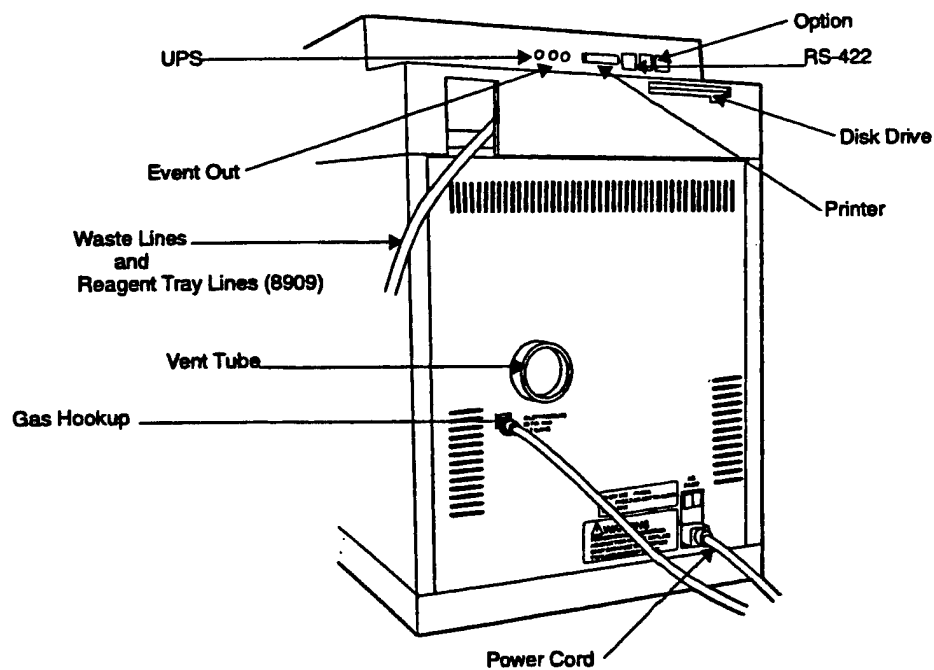
Figure A.—Expedite Model 8909 DNA synthesizer instrument diagram.

A paper diagram of the bottle locations and system schematic taped inside the front door of the synthesizer exhibited slight soot damage. The paint on the inside of the door below the window frame was undamaged but exhibited some sooting. The inside of the door exhibited heavier heat damage above the lower window frame than was observed below the window frame. The stainless steel bottle bracket was heavily sooted behind bottles 4, 5, and 6. The plastic dip tubes were cut off during the on-site accident phase. The upper third of the right side of the stainless steel bottle bracket exhibited some sooting and discoloration. The left side was sooted from the base to the top of the synthesizer. The polyethylene drip tray was melted along the right rear side and was heavily sooted along the left and forward walls. An 8½- by 9½- inch rectangular soot-free area was observed approximately 1 inch from the left side of the drip tray. Pieces of broken glass and a large amount of debris were found in the bottom of the drip tray. The floor of the synthesizer was heavily sooted and also contained pieces of debris. There was some blue discoloration along the right side of the stainless steel bracket where it intersected the mounting for bottles 1, 2, and 3.

Removal of the synthesizer controller top revealed that the controller top's interior exhibited extensive fire damage, and all of the electrical wire insulation was destroyed. The wire conductors were intact and brittle. The inside of the top was heavily sooted. Most of the paint was charred and missing under the controller PC board and around the floppy drive at the rear of the controller top. The resin binder for the controller PC board was destroyed by fire. The
