Service History of the F-111 Wing  
Pivot Fitting Upper Surface  
Boron/Epoxy Doublers

Peter Chalkley and Rowan Geddes

DSTO-TN-0168

**Airframes and Engines Division  
Aeronautical and Maritime Research Laboratory**

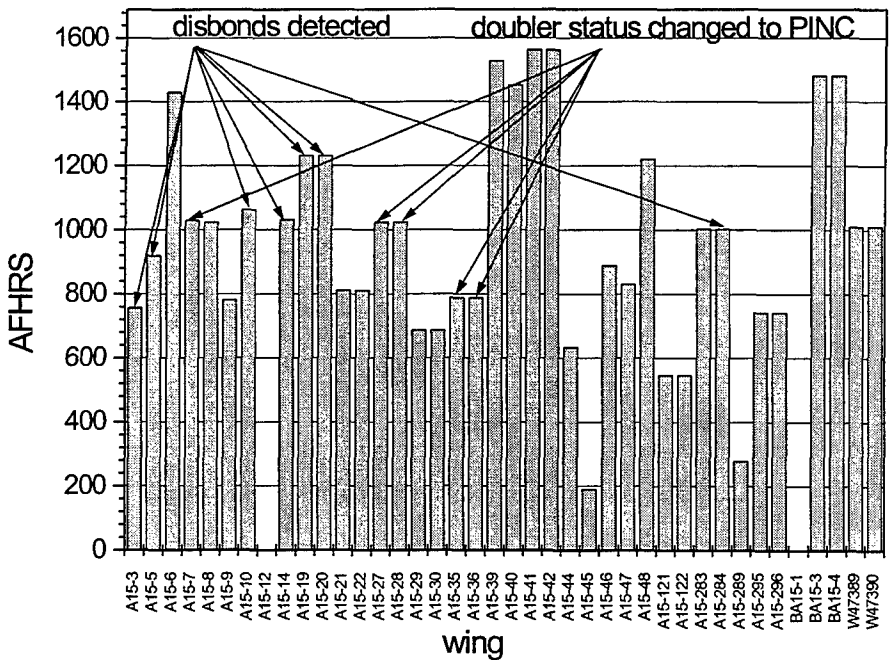
Most of the RAAF wings with doublers have seen between 4100 and 6100 hours of service. Since the application of the doublers, the wings have seen between 193 and 1565 hrs of service with the majority falling between 500 and 1500 hrs of service (Fig 1.)

Figure 1. Hours of service of boron doublers since fitment.

Note that some doublers have many more AFHRS than those found to be disbonded. However, because of the infrequent inspection of the doublers it cannot be assumed that these doublers have no disbonds. The two doublers with zero AFHRS of service probably failed during CPLT.

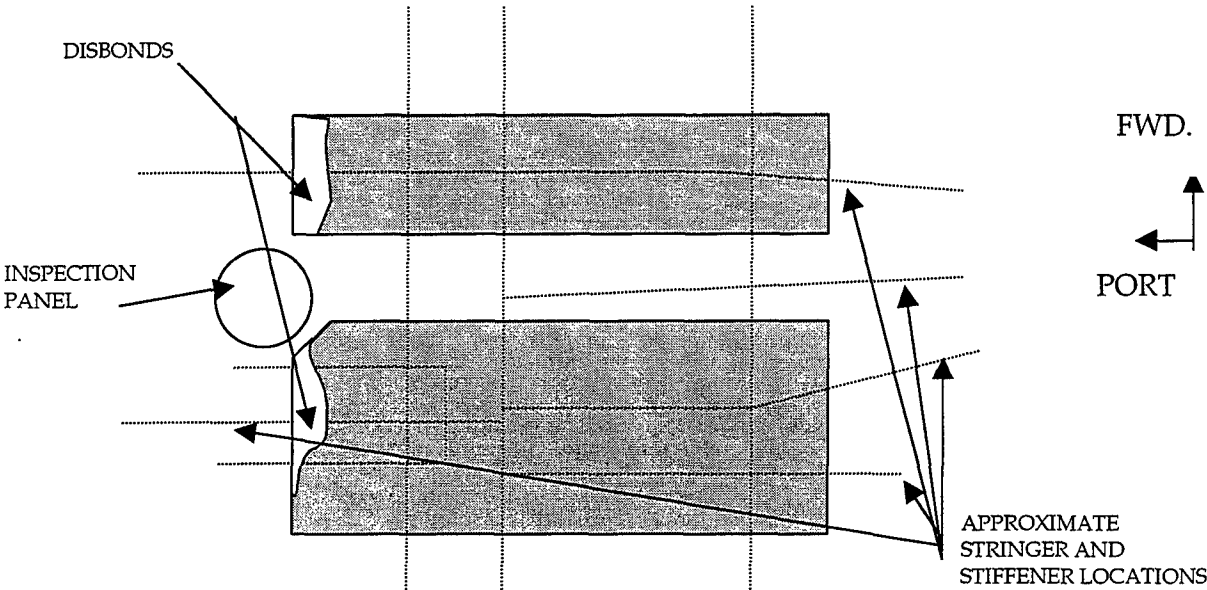
Figure 2 shows the outboard results of a tap test carried out by ex-RAAF NDI technician Wade Farley on wing A15-5 after 1432 AFHRS of doubler service.

Figure 2. Location of outboard edge disbonds in A15-5 as indicated by tap testing - July 98 (1432 AFHRS doubler service).

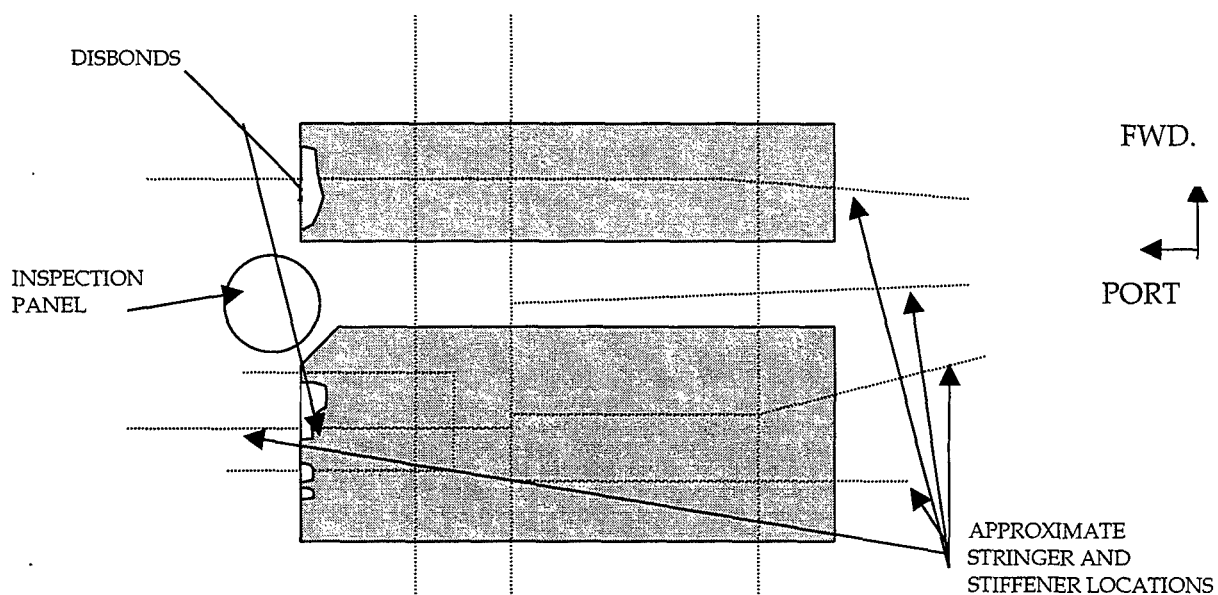
Figure 3 shows a schematic of outboard disbonds from an earlier ultrasonic inspection by RAAF NDISL (ref 501/A08C/11-01/A15-5/G Pt1 (11)).

Figure 3. Schematic of outboard-edge disbonds in A15-5 doublers from RAAF ultrasonic inspection (923 AFHRS doubler service).

Figure 3 shows that the FWD doubler disbonds started at the centre and travelled inboard and also outwards towards the forward and aft edges. Similar behaviour was seen in the AFT doubler. The initiation sites may coincide with stiffener positions. Further disbond records are being sort from the RAAF to clarify this possibility.

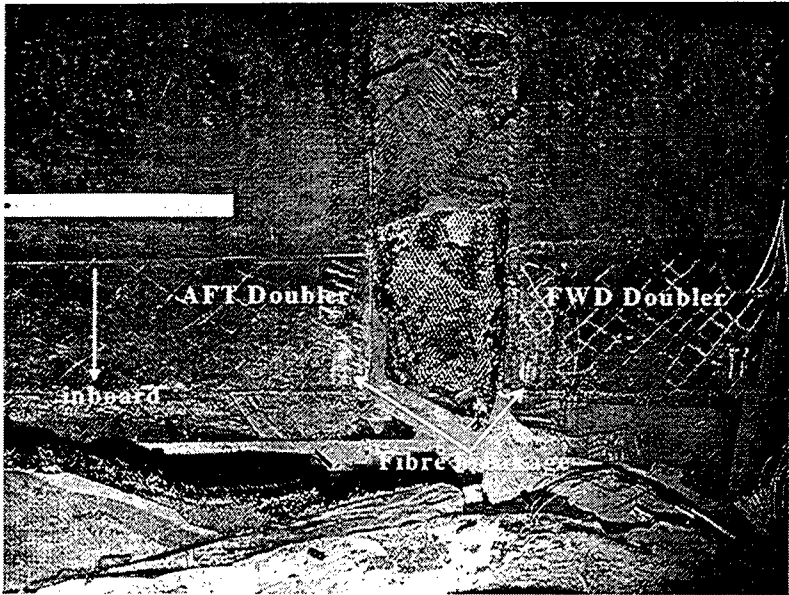
Fibre fracture has been found (Figures 4,5,6) at the central corners of the inboard edges of both the AFT and FWD doublers in wing A15-5. There is some evidence of similar failure in A15-35.

Figure 4. Overview of the inboard edges of the A15-5 doublers.

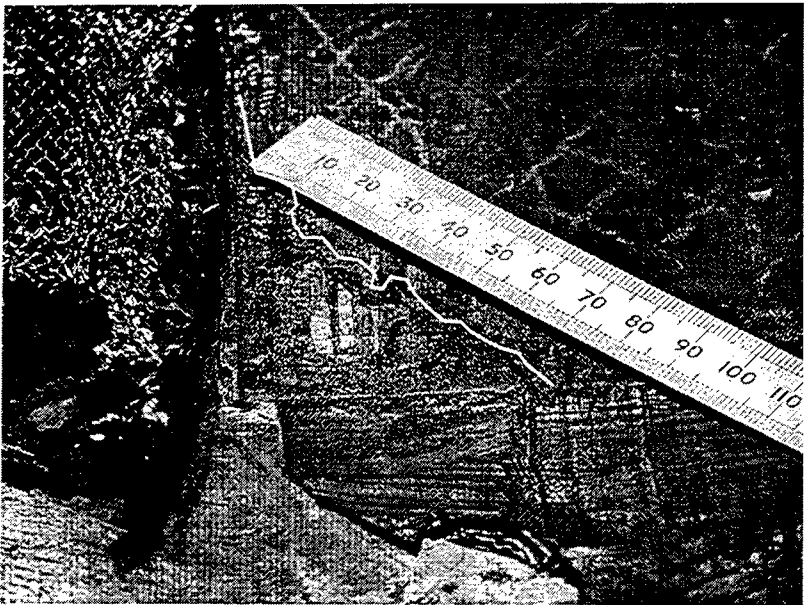
Figure 5 shows the central corner of the inboard edge in greater detail. The path of the fibre breakage is show by an offset white line.

Figure 5. Central corner of the inboard edge of FWD doubler – A15-5.

This fibre breakage probably occurred during CPLT – similar evidence is seen in photographs of A15-35 doublers (AIR1/4080/A8/1101-5 Pt 5 (25)) taken soon after CPLT.

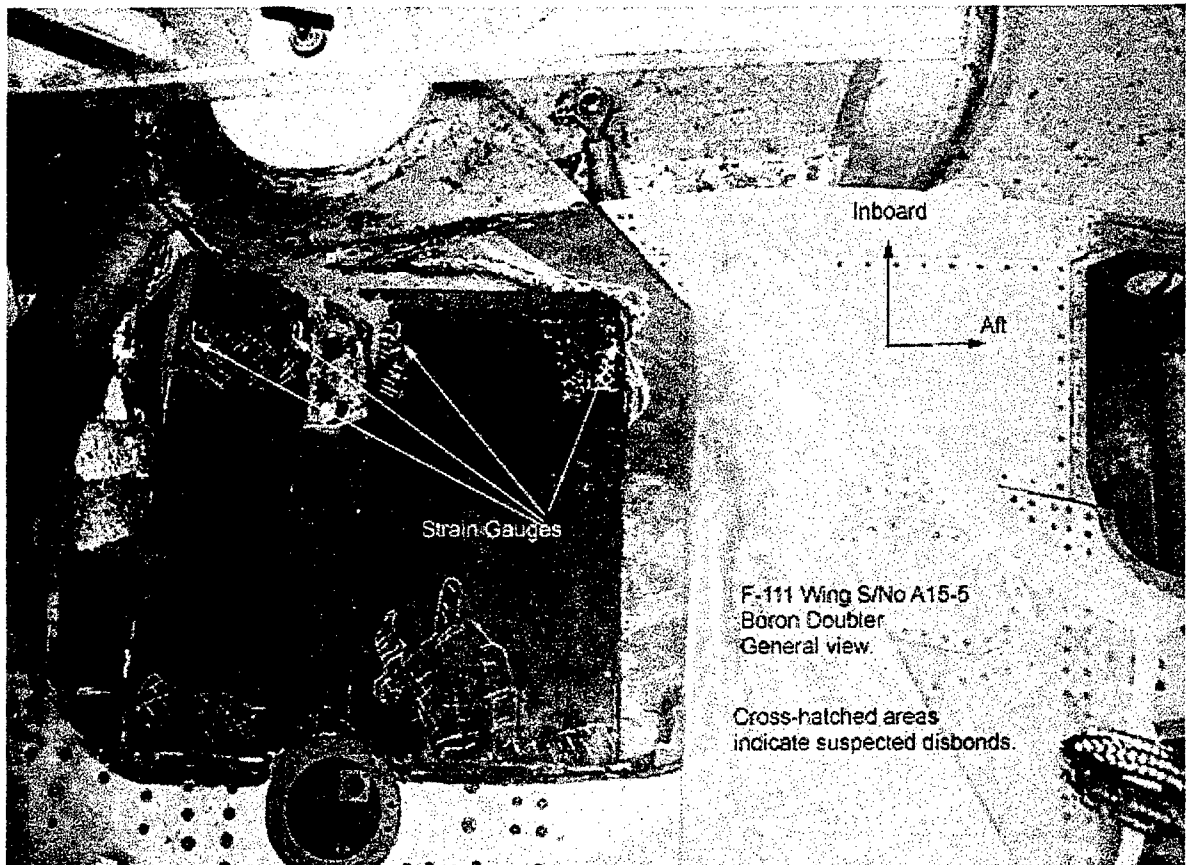
Figure 7 below shows the AMRL ultrasonic inspection results for the A15-5 doublers. Disbonds indicated by white crosshatched region.

Figure 7. Results from AMRL ultrasonic inspection – ref F-111/Wing/01.

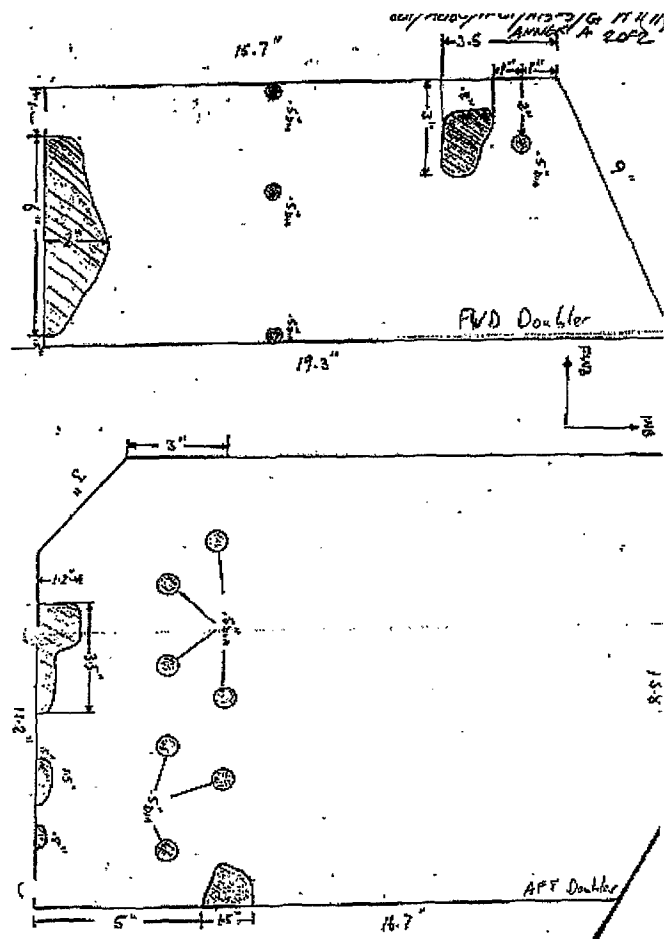
Figure 8 shows RAAF ref 501/A08C/11-01/A15-5 Pt1 (11) disbond map for A15-5 doublers after 932 AFHRS service.

Figure 8. Extract from RAAF ref. 501/A08C/11-01/A15-5 Pt1 (11).

Note that the inboard area of the FWD doubler was reinspected and no disbonds were found there (RAAF ref. 501/A08C/11-01/A15-5 Pt1 (12)).
