# Repair of Damage to Marine Sandwich Structures: Part I – Static Testing

Rodney Thomson, Raoul Luescher and  
Ivan Grabovac

DSTO-TR-0736

*October 1998*

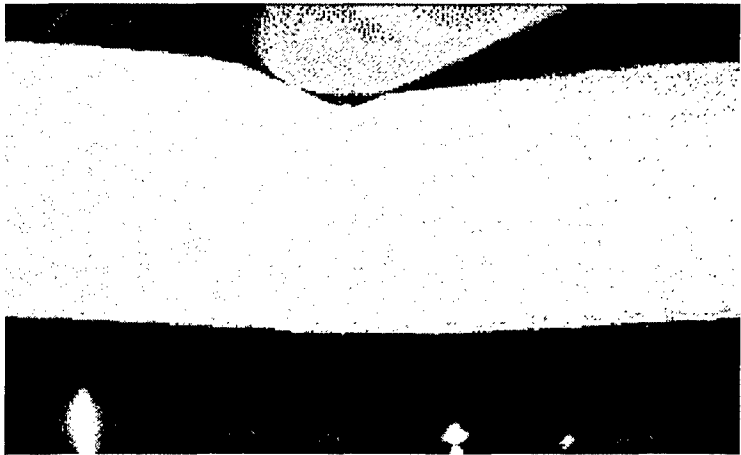
Figure 12: Typical local skin wrinkling failure mode.

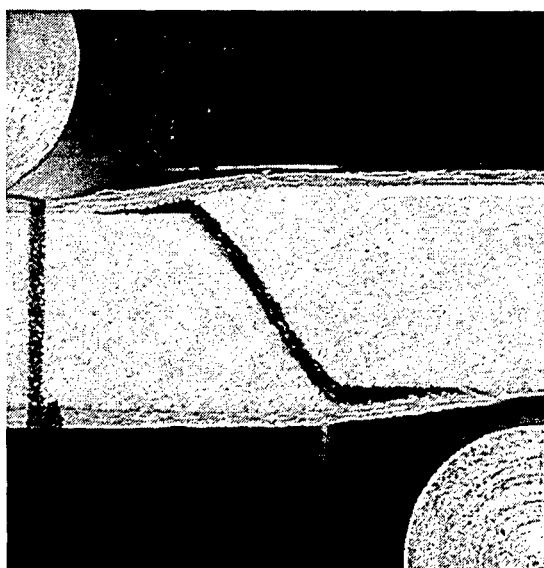
Some variability was observed in the behaviour of the repaired specimens tested in the normal position. The maximum load achieved was influenced by the integrity of the bond between the existing skin and the replacement core. All specimens failed through core shear, which initiated from a defect in the bondline in some of the specimens. The load displacement behaviour of a typical repaired specimen that failed under core shear is shown in Figure 14. The additional ply in the repaired skin in the region under the loading point also helped to prevent local failure through skin wrinkling. As shown in Figure 14, the core shear failure occurred between one support and loading point at a 45° angle (in the direction perpendicular to the maximum tensile stress). Core shear failure was characterised by sudden, catastrophic failure of the specimen. The skin was usually debonded from the core at either end of the shear failure.

Figure 14: Typical core shear failure in the normal position for specimens repaired using the RAN Type B method.

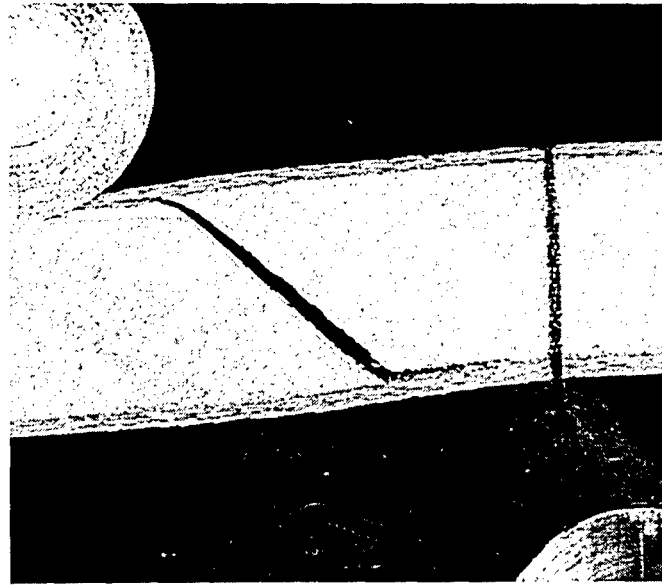
A large degree of variability was observed in the behaviour of the repaired specimens in the inverted position. Most specimens failed through core shear but the maximum load carried depended on the integrity of the bondline. In a number of specimens, shear failure initiated from a visible defect in the bondline, an example of which is shown in Figure 15. One specimen in which the void covered approximately 50% of the bondline carried only 60% of the reference load. The position of the void as well as the void size influenced the load carried by the specimen. Other specimens suffered debonding of the original skin from the replacement core which, being under compression, proceeded to buckle as shown in Figure 16. One specimen failed through local skin wrinkling under the loading points.

*Figure 15: Shear failure of a RAN Type B repaired specimen in the inverted position initiating from a defect in the bondline.*

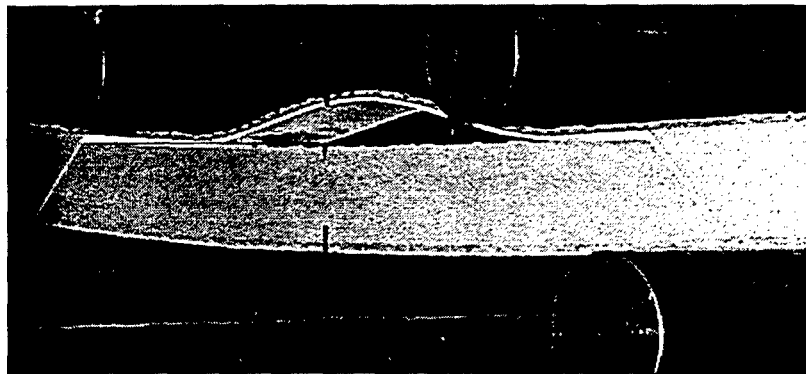
*Figure 16: Typical debonding failure of a RAN Type B repaired specimen in the inverted position.*

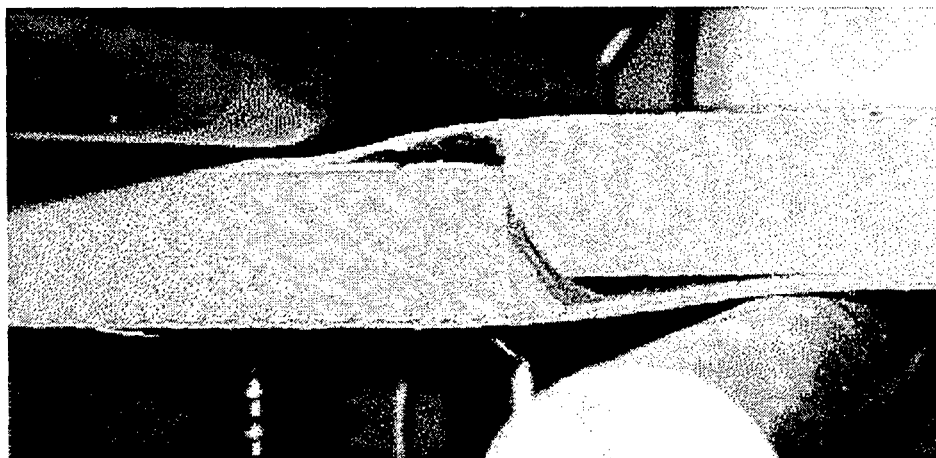
The behaviour of the repaired specimens tested in the normal position was consistent with all specimens achieving a similar maximum load. Two specimens failed through local skin wrinkling while the remainder failed through core shear. The extra ply in the skin due to the repair in the loaded region helped prevent local skin wrinkling failure. One specimen was deemed to fail prematurely due to the presence of a void in the join between the existing and replacement core, as shown in Figure 17. This specimen failed at a load approximately 10% lower than the average. It was noted that in most of

*Figure 17: Failure of modified Type B repaired specimen from a defect in the bondline.*

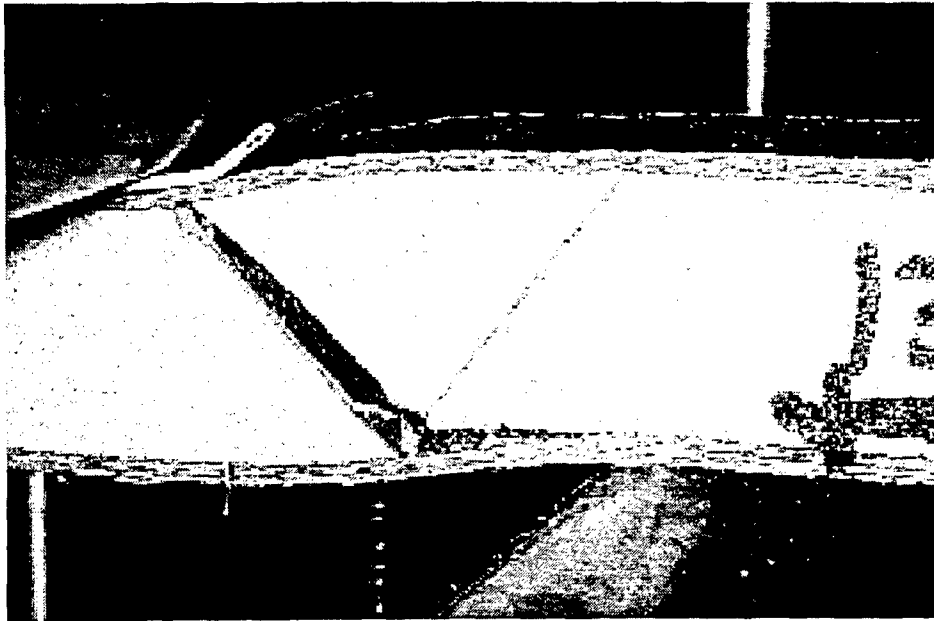
The repair specimens tested in the normal position exhibited consistent behaviour. Just over half of the specimens failed through core shear while the others suffered interface failure between one of the 45° bondlines and the core, as shown in Figure 19. This mode of failure usually occurred in the core directly next to the bondline unless there was a void or porosity in the adhesive in which case it could run through the bondline. In most of the shear failure specimens, failure initiated from a crack in one of the 45° bondlines, as shown in Figure 20. It was observed that the adhesive failed under tension resulting in a crack which then propagated slowly into the core until catastrophic growth and failure occurred. The other shear failure specimens may have failed through a similar means which was not visible on the specimen edges.

Figure 19: Typical bondline interface failure of a RAN Type C repaired specimen tested in the normal position.

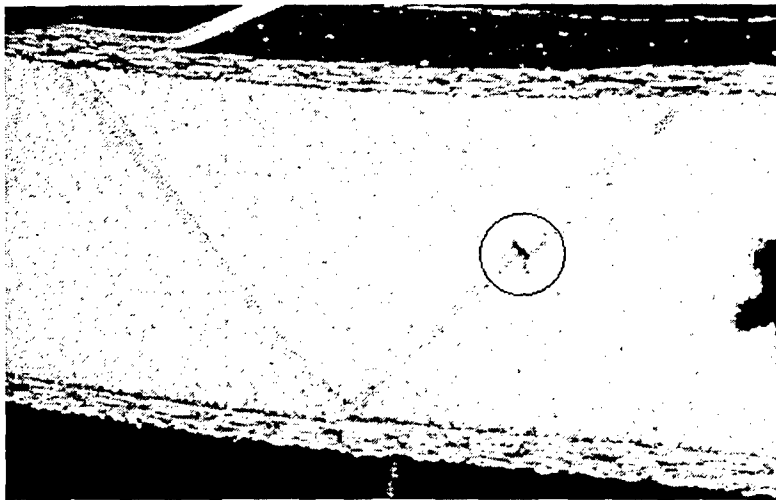
Figure 20: The crack (circled) which developed in the bondline in a RAN Type C repaired specimen tested in the normal position.

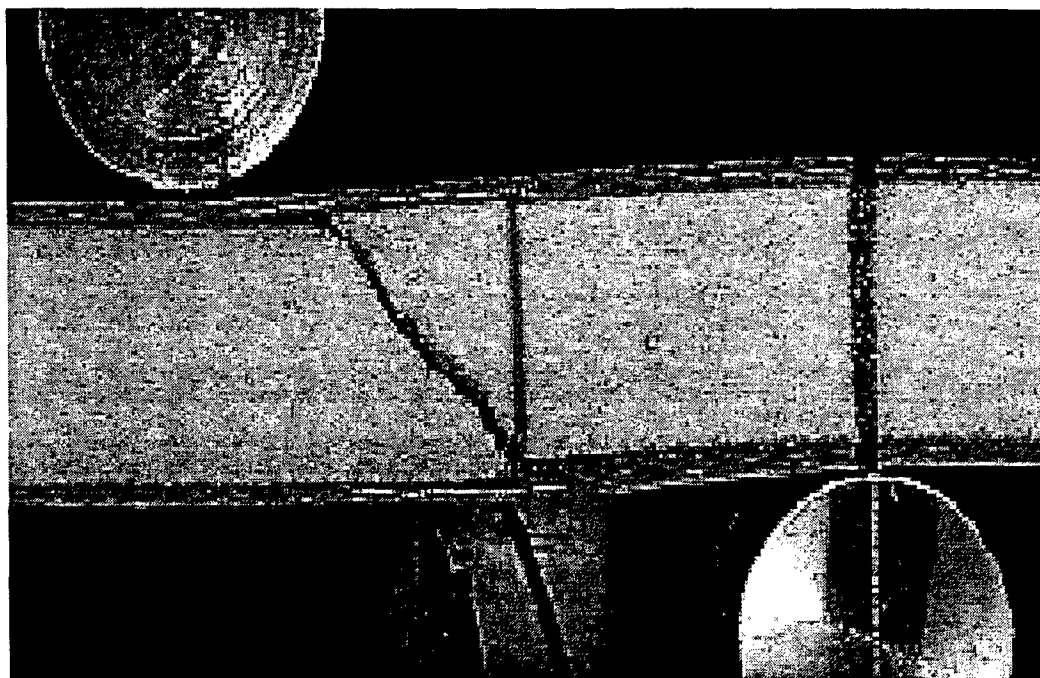
The repaired specimens tested in the normal position reached similar maximum load and failed through core shear which usually occurred as shown in Figure 21, running

through the bottom of the join in the core. One specimen failed through local skin wrinkling under the loading points.

*Figure 21: Typical shear failure of a modified Type C repaired specimen tested in the normal position.*

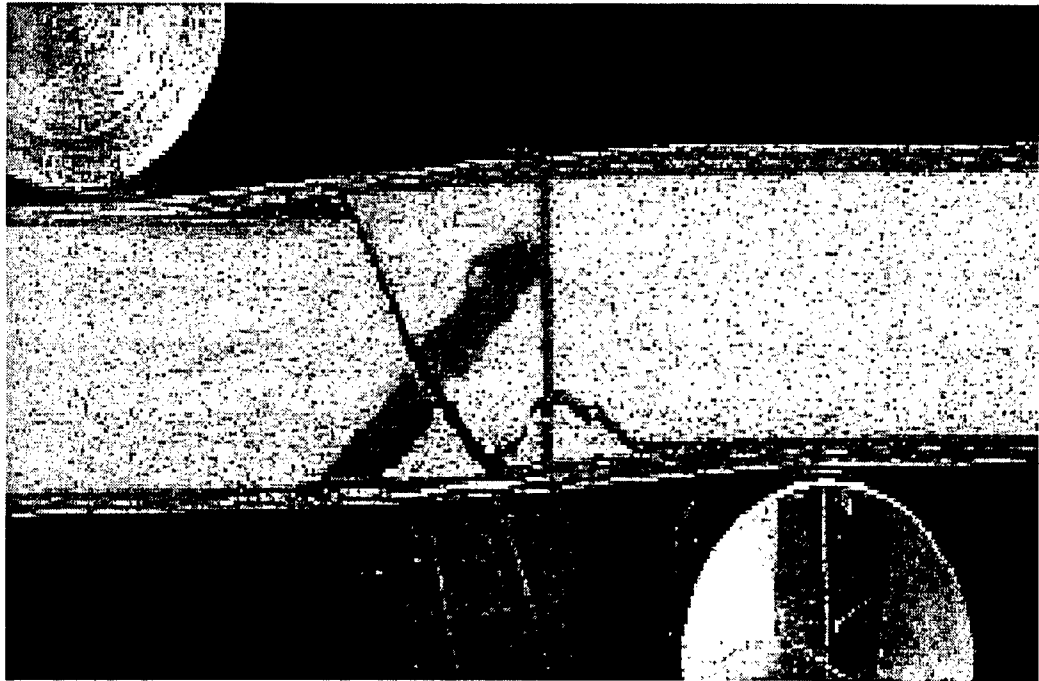
The behaviour of the repaired specimens tested in the inverted position was consistent with all specimens achieving a similar maximum load before failing through core shear. In most specimens, a cracking noise was heard at 85% - 95% of the ultimate failure load associated with a crack developing in the adhesive that had filled the injection hole (refer to Figure 8). When tested in the inverted position, this column of adhesive, which was at an angle of approximately 45°, was loaded in tension. Thus, this adhesive column failed under tension in a similar manner to the 45° bondline in many of the RAN Type C repair specimens tested in the normal position. The presence of the crack created a stress concentration in the foam core which then proceeded to fail. This effect was observed in three specimens in which the column of adhesive was visible on the edge, as shown in Figure 22. It was likely that every specimen would have had an injection point on at least one end since they were at 60 mm spacing and the specimen width was 40 mm.

Figure 22: Typical failure of a modified Type C repaired specimen tested in the inverted position showing failure initiation from a crack in the injection adhesive.
