AFRL-PR-WP-TR-1998-2119

Investigation of TESCOM Driveshaft Assembly
Failure

James A. Kenyon

October 1998

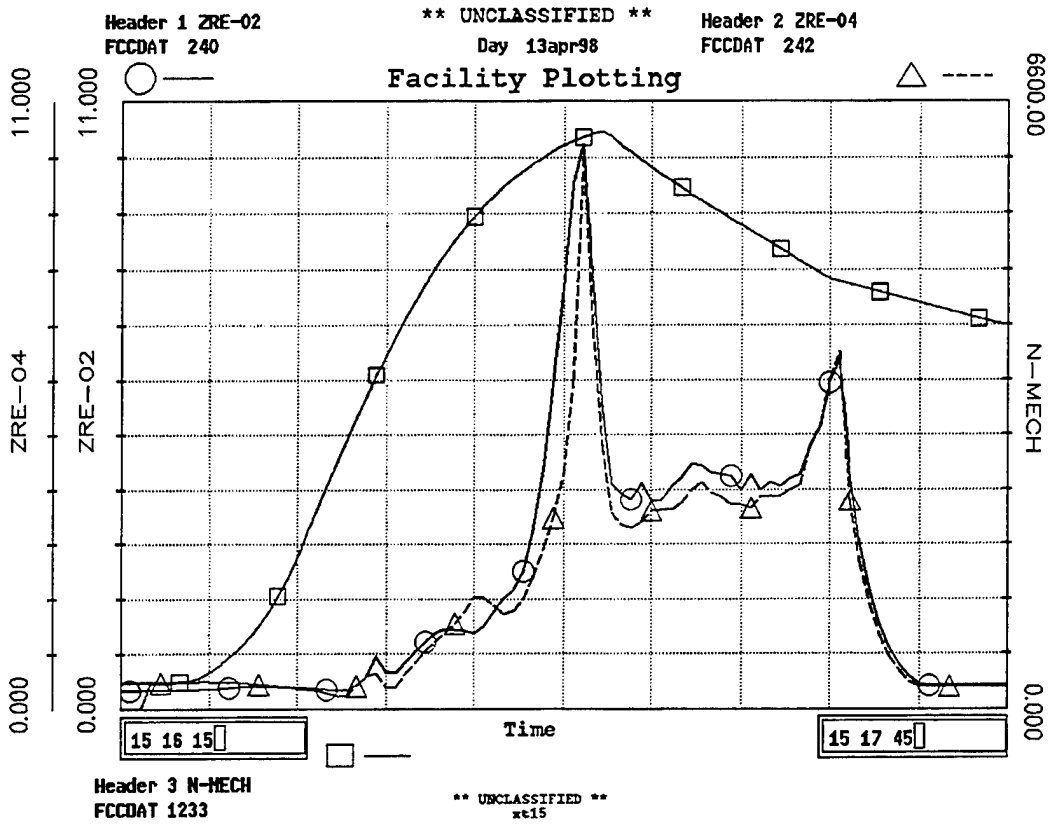
Figure 2.2. Jackshaft vibrations during the second MIN SPEED run.

The second attempt at mechanical checkout was started at 15:16. High vibrations again occurred near the 6150 rpm critical speed. However, the jackshaft proximity probes reached a sharp peak of more than 10 mils and suddenly dropped off to a steady amplitude of approximately 4 mils p-p. Drive system vibration levels during the second run are shown in Figure 2.2. Once again, ZRE-02 and ZRE-04 represent the proximity probes on the jackshaft. Proximity probes on the test compressor indicated vibrations in excess of 10 mils, and accelerometer amplitudes from the compressor suddenly dropped. Again, it is unknown whether the control computers issued a MIN SPEED command. Approximately 3 seconds after the change in signals, one of the programmable logic computers (PLC2) initiated an E-STOP command, and the compressor began to decelerate from 6250 rpm at a rate of approximately 70 rpm/sec. The reason for the E-STOP command from PLC2 has not been determined. Twenty-two seconds after the E-STOP command was issued, jackshaft proximity probes and compressor accelerometers suddenly blossomed again and then dropped to less than 1 mil p-p. Compressor proximity probes dropped to less than 5 mil p-p. Strain gage signals from the test compressor also ended at this time. The gearbox and compressor speed signals began to diverge, and each coasted to stop uneventfully at different rates. The MIN SPEED condition was not reached during the second run, which ended at approximately 15:18. Vibration amplitudes will be discussed in more detail in Section 3 of this report.

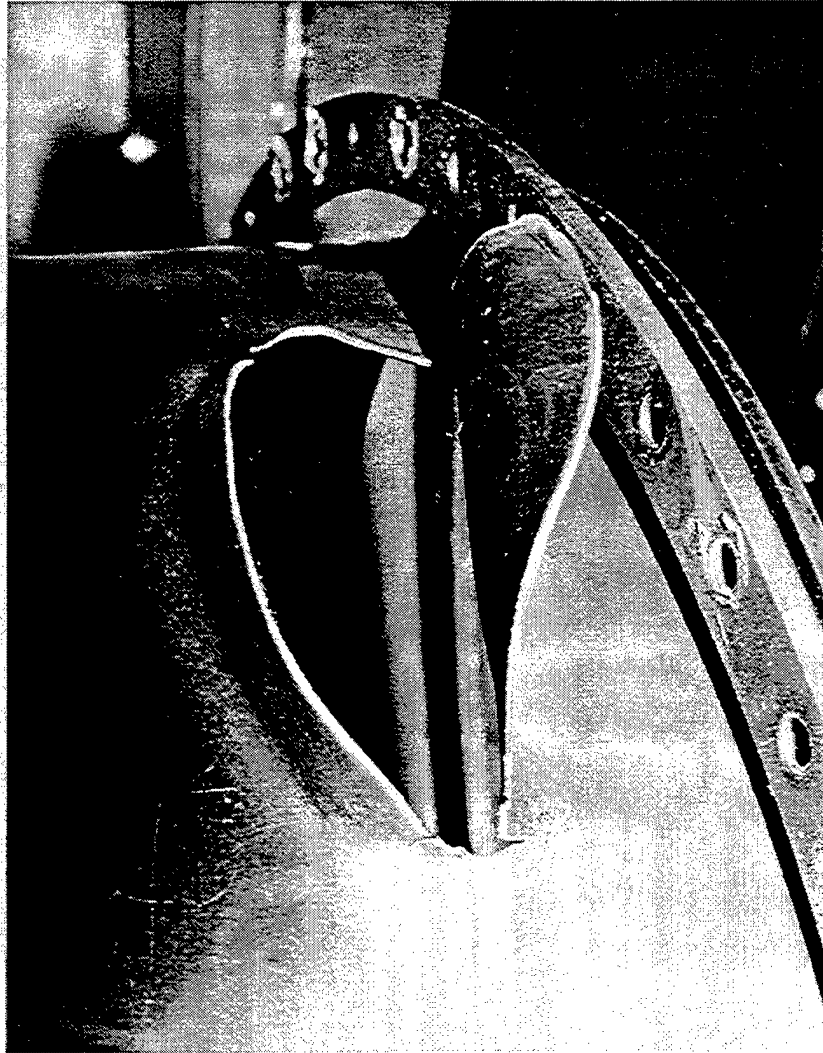
Figure 3.1. Photograph of hole in inner exit flow path.

A visual inspection of the test compressor and drive system was performed. During visual inspection from the gearbox area, pieces of the driveshaft assembly could be seen lying in the duct comprising the inner exit flow path. The outer exit flow path was opened, and an oval hole measuring 6 inches by 2.5 inches was found in the inner exit flow path at about the 4 o'clock position, aft looking forward. A photograph of the hole is shown in Figure 3.1. The inner exit flow path was opened, and the driveshaft assembly was found in three pieces. Two of these pieces were lying side by side in the bottom of the inner exit flow path, and the third piece, the spline portion of the spline shaft adapter, was still in the TESCOM main shaft. The pieces of the driveshaft assembly were removed from the test chamber for detailed inspection. A photograph of the pieces recovered from the inner exit flow path is shown in Figure 3.2. The facility drive system was also inspected in detail.

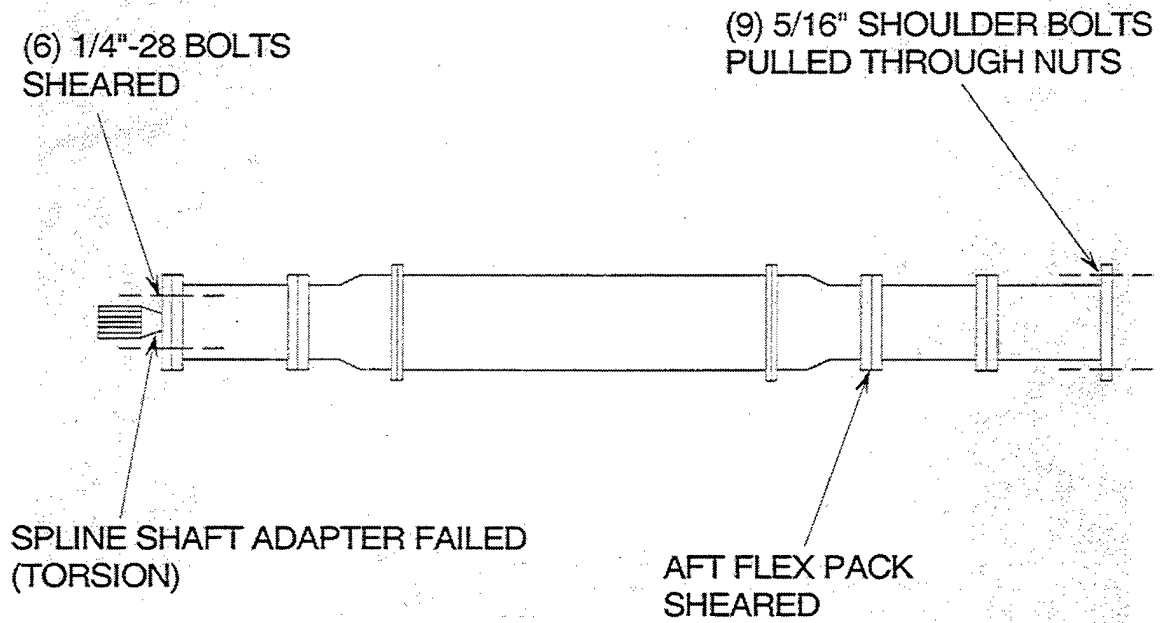
Figure 3.3. Driveshaft assembly failure points.

Inspection of the driveshaft assembly revealed three points of failure. These are shown in Figure 3.3. One of these was the connection point between the high speed jackshaft and the 9-inch spacer used in the driveshaft assembly. At this point, nine (9) 5/16 inch shoulder bolts were pulled axially through the nuts securing them. A photograph of the spacer at this point is shown in Figure 3.4. The corresponding part of

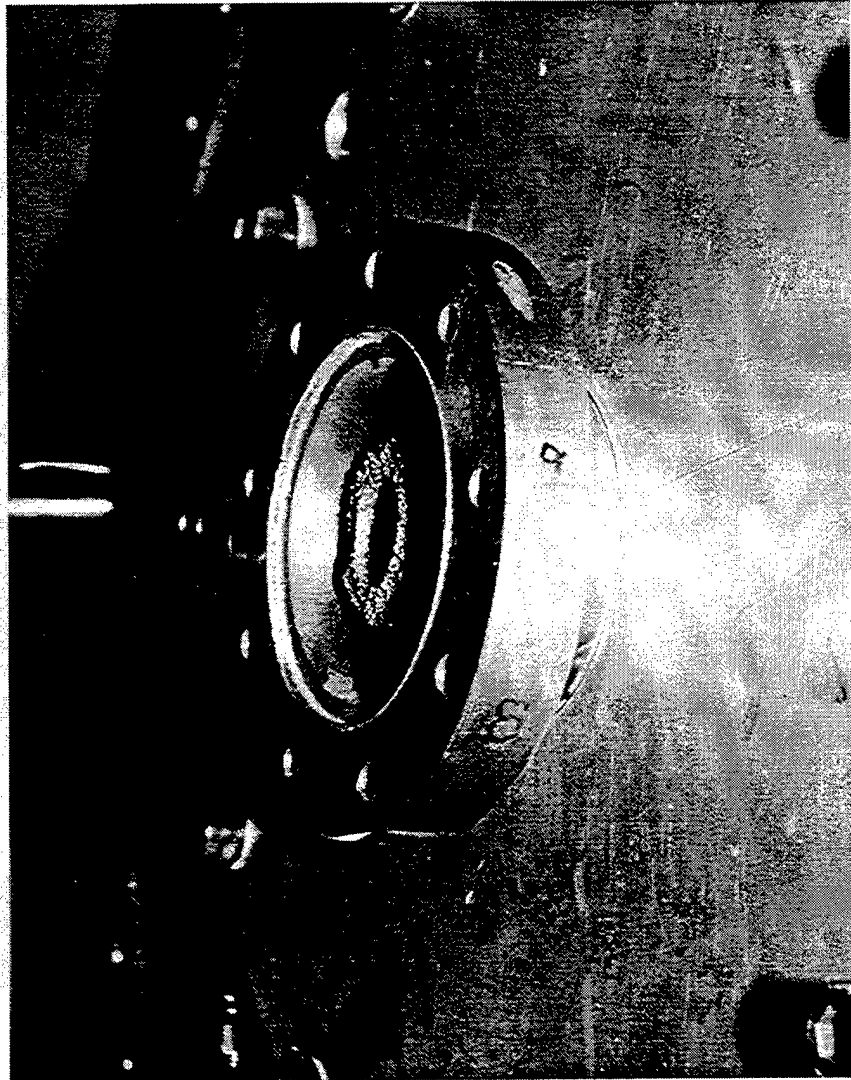
Figure 3.5. High speed jackshaft at driveshaft assembly interface.

the jackshaft is shown in Figure 3.5. The coarse gray material at the end of the jackshaft and in the center of the spacer in the photographs is the foam filler used to secure the strain gage leads. A second point of failure was the aft flex pack of the Kop-Flex coupling, which sheared as indicated in Figure 3.3. The mating sections of the failed aft flex pack are shown in Figures 3.6 and 3.7. The thin metal sheets on the interior of the pack were essentially shredded. Once again, the coarse material in the center of the flex pack pieces is the foam material used to secure the strain gages. The final point of failure was the neck of the spline shaft adapter connecting the driveshaft to the compressor shaft. This location is indicated in Figure 3.3. The neck of the spline shaft adapter failed in torsion, and the six (6) ¼ inch - 28 bolts securing the spline shaft adapter to adapter 1 and the forward end of the Kop-Flex coupling were sheared. Figure 3.8 shows a photograph of the portion of the adapter still connected to adapter 1 and the Kop-Flex coupling. The spline portion of the spline shaft adapter and bolts remained in the compressor main shaft, as shown in Figure 3.9. These were easily removed with no apparent damage to the female spline in the compressor shaft.

The facility drive system was inspected for damage. The end of the high speed jackshaft that mated with the driveshaft assembly has a precision female rabbet measuring 3.600/3.6016 inches diameter. The rabbet had been worn out to approximately 3.680 inches, depending on where the measurement was taken. This section of the high speed jackshaft was removed for repair. The labyrinth seal was removed and found to have rubbed against the high speed jackshaft. The damage was minor and repairable.

The damaged areas of the drive system were repaired. The rabbet end of the high speed jackshaft was welded using AMS 4130 to build up the damaged surface and machined to original tolerances. The rubbed labyrinth seal was cleaned up. The pads on the no. 1 pedestal bearing were replaced as a precautionary measure due to the high vibrations experienced during testing. The drive system was reassembled and a no-load test was performed. No problems were indicated during testing. A new Kop-Flex coupling was designed and ordered.

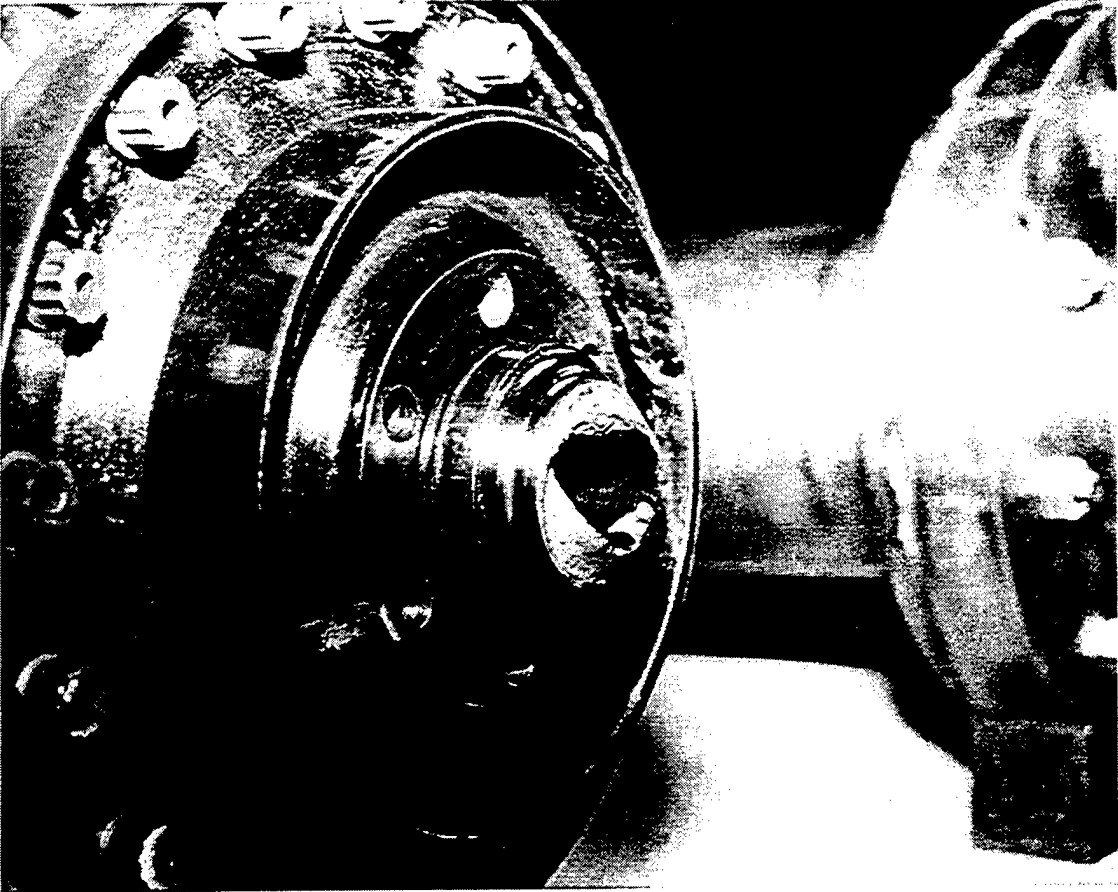
Figure 3.8. Aft portion of failed spline shaft adapter which remained with the drive system assembly.

The spline portion of the spline shaft adapter removed from the compressor main shaft is shown in Figure 3.10. The fracture surface was inspected under 10X magnification, Figure 3.11. No striations indicative of cyclic loading were visible. Therefore, the failure was apparently a result of a single overload. Some ductile deformation, seen in Figure 3.8, occurred prior to final brittle fracture.

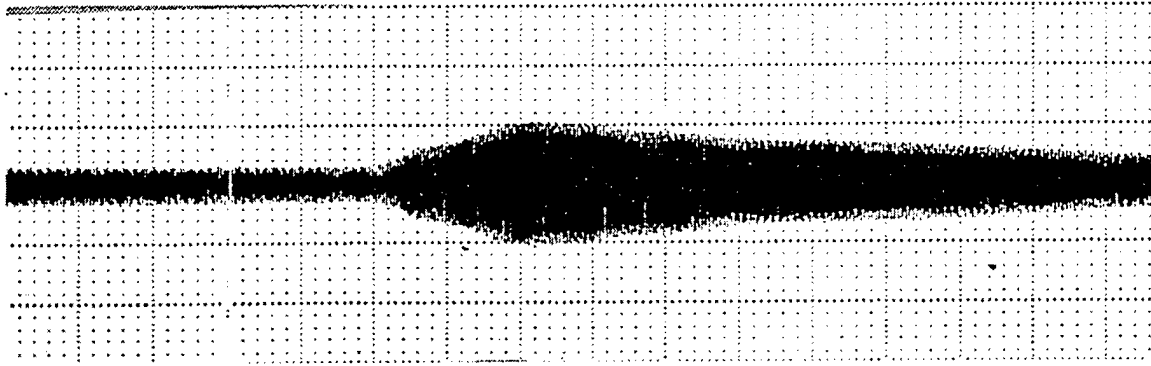
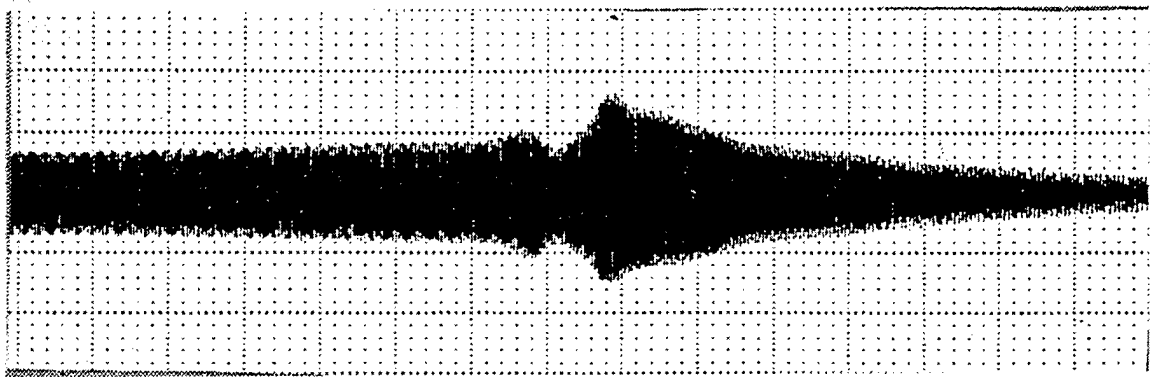
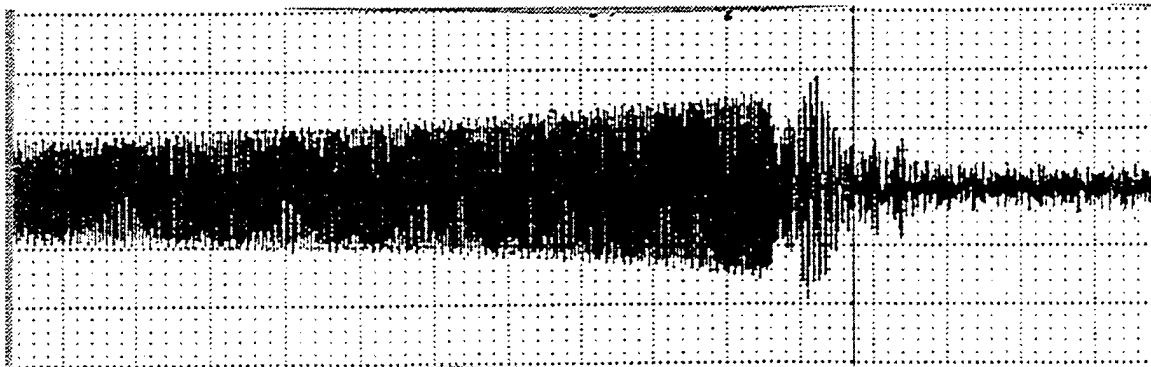
Figure 3.12. High speed jackshaft proximity probe time histories showing amplitude increase with each pass.

As previously discussed, proximity probes on the jackshaft indicated high vibrations indicative of a shaft critical speed at approximately 6150 rpm. The responses from one of these probes are shown for both MIN SPEED runs in Figure 3.12. The amplitude of the vibration at the shaft 1/rev frequency was approximately 7.75 mils during the acceleration phase of the first run and approximately 10 mils during deceleration. In both cases, the vibration amplitude was well above the alarm limit of 5 mils set for the test. Moreover, the maximum amplitude of the proximity probe increased with each successive transit through this critical, indicating cumulative damage to the spacer/coupling. This result demonstrates that damage initially occurred during the first

MIN SPEED run. The driveshaft assembly passed through this critical three times before failure.

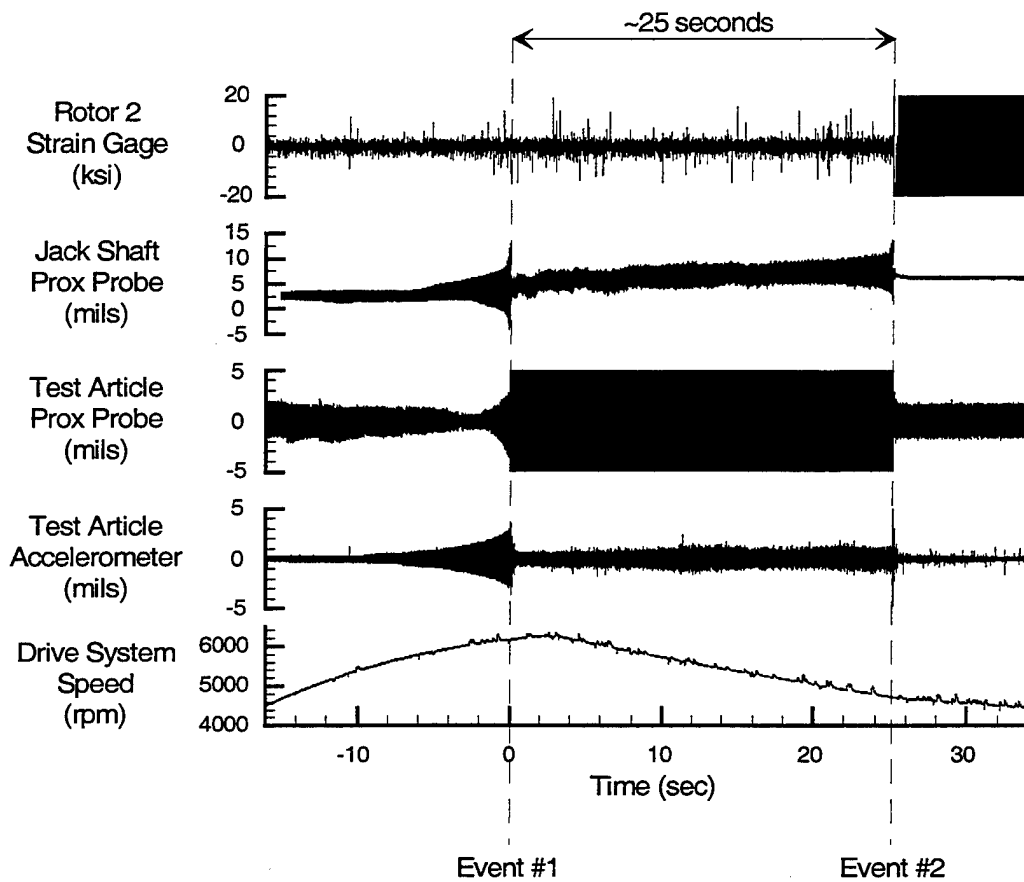
Figure 3.13. Time histories of pertinent transducers.

Data from the second MIN SPEED run indicated that the failure consisted of two distinct events. The time histories of several pertinent signals are shown in Figure 3.13 to confirm this. During the acceleration to minimum speed, accelerometer and proximity probe signals began to rise steadily during the period from -2 seconds to 0 seconds. During this same period, test compressor and drive system speeds were synchronous at approximately 6100 to 6150 rpm. Compressor accelerometers and proximity probe signals all indicated a maximum of approximately 5 mils p-p displacement. Drive system proximity probes near the jackshaft blossomed sharply to over 15 mils p-p. Facility monitoring computers only detected 10 mils p-p (Figure 2.2) because the blossom occurred too rapidly to be accurately computed with fast Fourier transform techniques used in the data processing algorithm. All of the instrumentation signals were dominated by the 1/rev frequency.

The data shown in Figure 3.13 indicates that the failure began with Event #1 at 0 seconds. At that point, the flex pack on the aft end of the Kop-Flex coupling began to fragment. For approximately 25 seconds, or 1100 to 1250 cycles according to the proximity probes, the damaged flex pack introduced a severe imbalance to the system, causing a subsynchronous backward-traveling whirl as evidenced by the 0.5/rev frequency in the proximity probe signals. After 25 seconds, Event #2 occurred. The flex pack joint failed entirely, leading to the failures at the spline shaft adapter and at the interface between the 9-inch spacer and the jackshaft. Once decoupled, the test article and drive system coasted down separately to 0 rpm. Since the driveshaft assembly served as the strain gage wireway, strain gage leads were broken and strain gage signals were lost when the driveshaft assembly failed.
