**US Army Corps  
of Engineers**

USACERL Technical Report 99/28  
February 1999

# **Engineering Life-Cycle Cost Comparison Study of Barrier Fencing Systems**

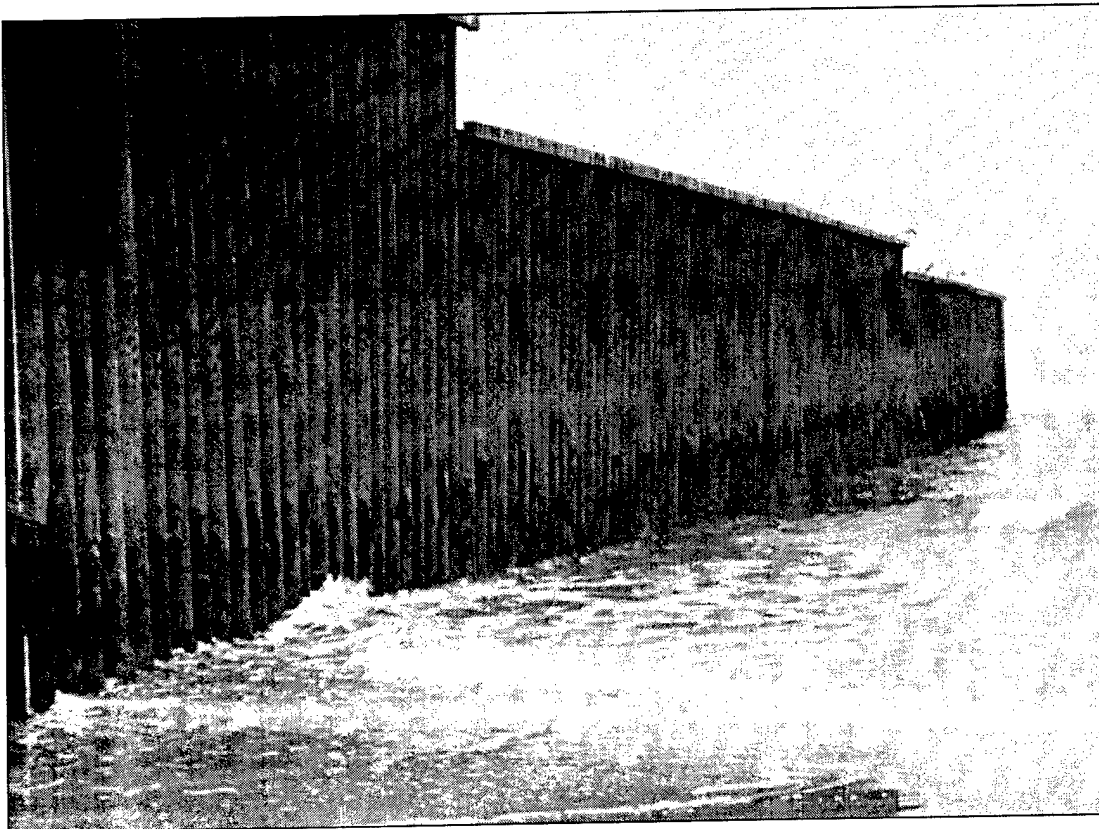
The first section of primary barrier is the ocean fence shown in Figure B.1. This section has severe corrosion from saltwater exposure. Figure B.2 shows the first subsection, which is usually in contact with sea water except at low tide. Subsection 1 is constructed of hollow vertical steel poles 6 in. in diameter, inserted 5 to 6 in. apart in the sand. The poles are Schedule 80 or 120 and are welded together at the top with 4x6-in. steel bars and buried 12 to 15 ft in the sand. Some poles are not equipped with endcaps. Therefore, some poles are exposed to salt and sand both internally and externally. The fence is approximately 12-ft tall on the beach. Blistering on the poles is evident along with algae and barnacle deposits. The metal has an orange color on surfaces that regularly contact the sea water during high tide.

Figure B.1. Sea water corrosion on border fence.

have been reinforced with concrete to prevent dig-under breaches. The subsection of the fence in contact with saltwater will need to be replaced in 3 to 5 years because of severe corrosion. The other subsections near to the water will require replacement within several years. Cathodic protection should be used with the replacement fence components where applicable. The replacement fence on the embankment and beach will need to be built on a concrete foundation.

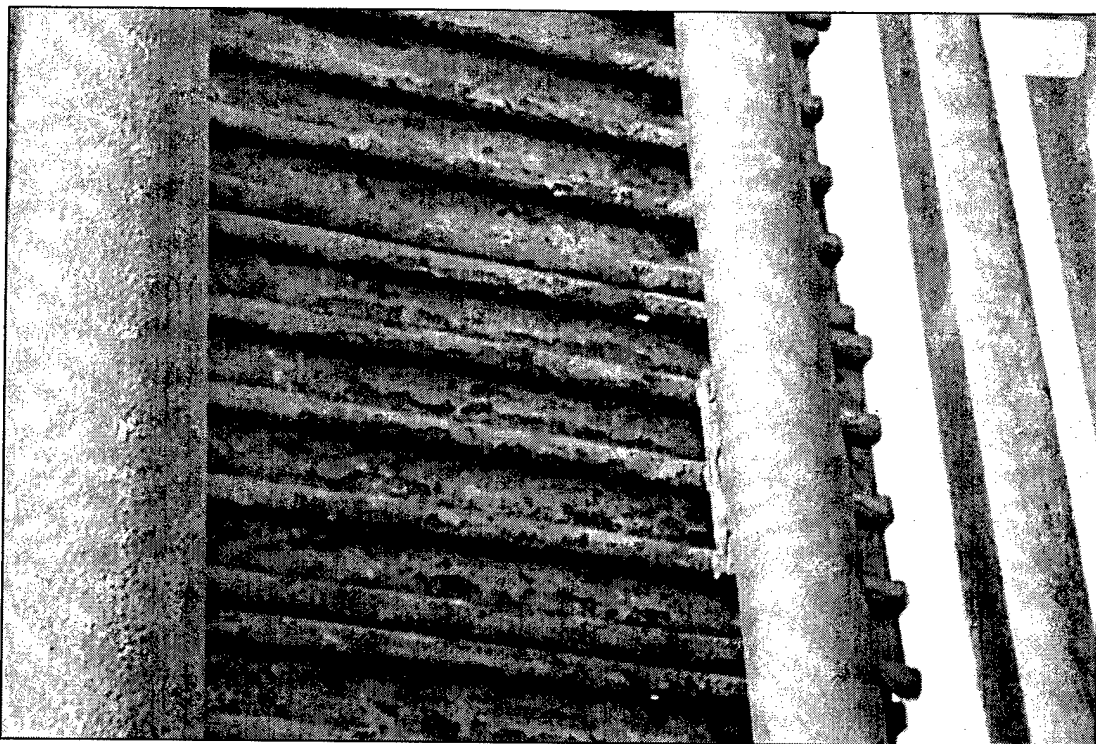
The landing mats and square pipes are heavily corroded with flaking on the surfaces as shown in Figure B.2, which also shows welds that are broken from the thermal stresses on the landing mats. No paint remains on the landing mats. Figure B.3 shows the landing mat section going up the embankment to a chain link fence. This subsection is heavily corroded from the salty ocean air. Erosion and digging under the fence are major problems for the loose sandy soil on the steep embankment. Figure B.4 shows an area where the bottoms of the fence

Figure B.2. Welds on landing mats are broken from thermal stresses.

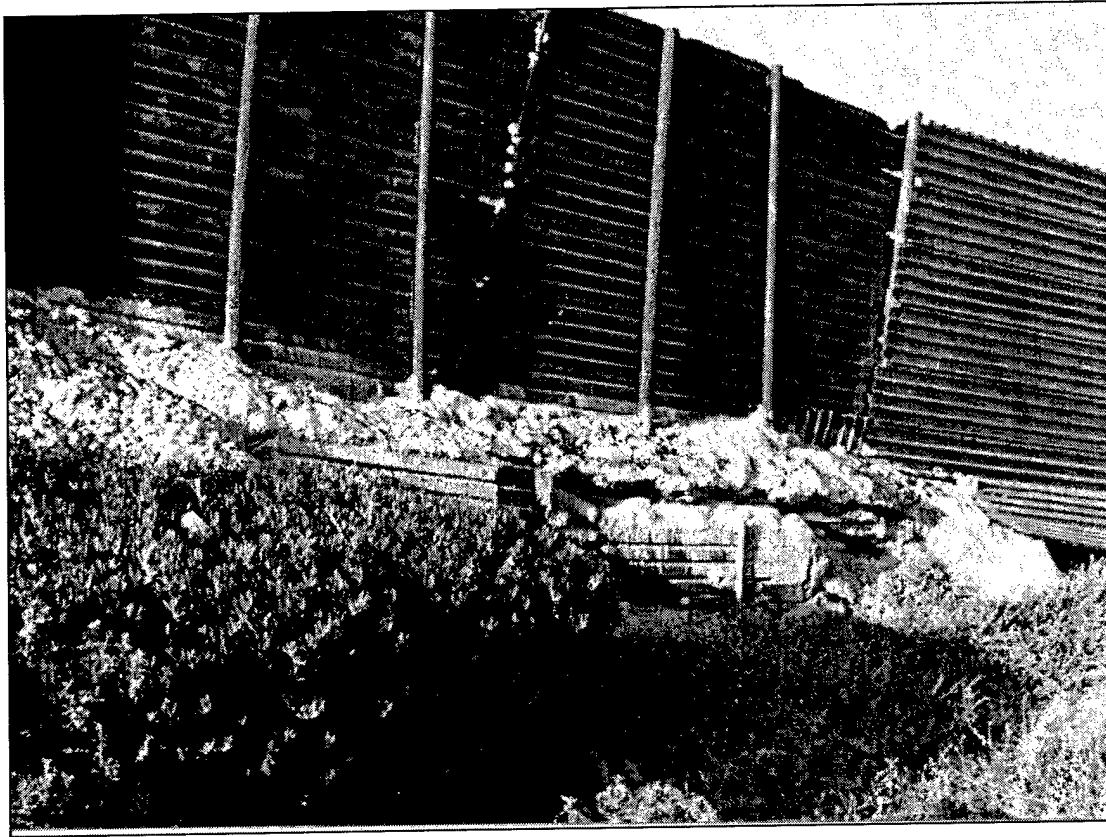
Figure B.4. Concrete poured into holes under the fence as a result of dig-under breaches and erosion of the loose beach sand.

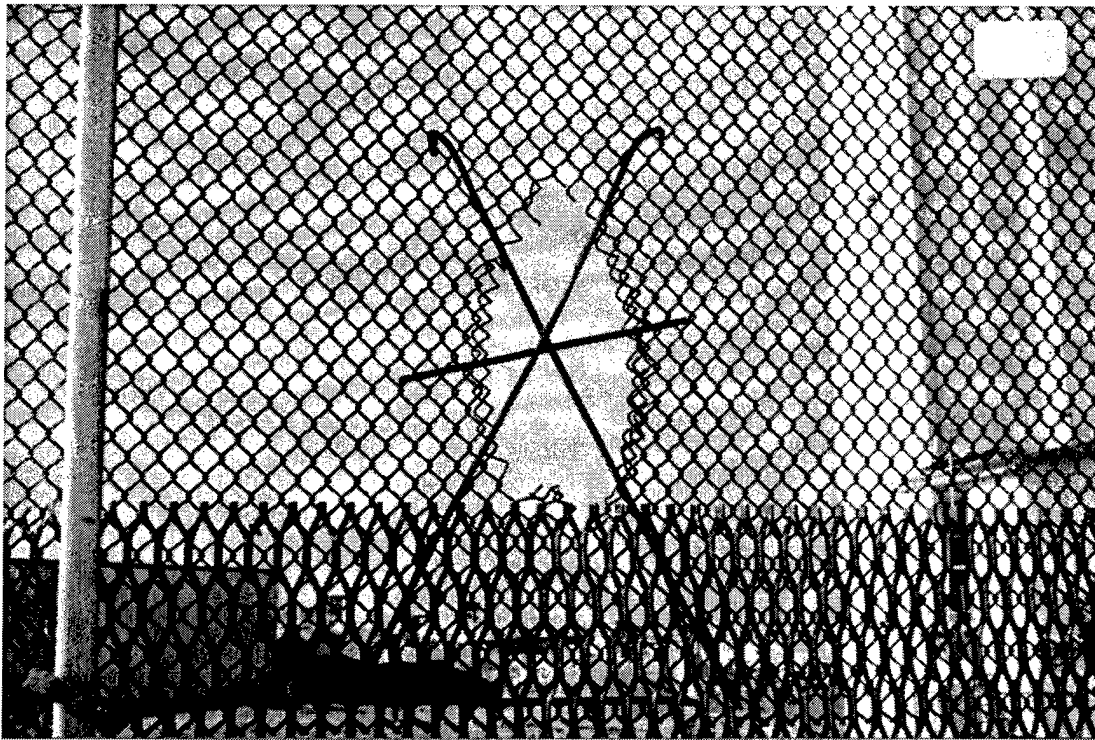
Figure B.6. Ad-hoc repairs to the chain link fence.

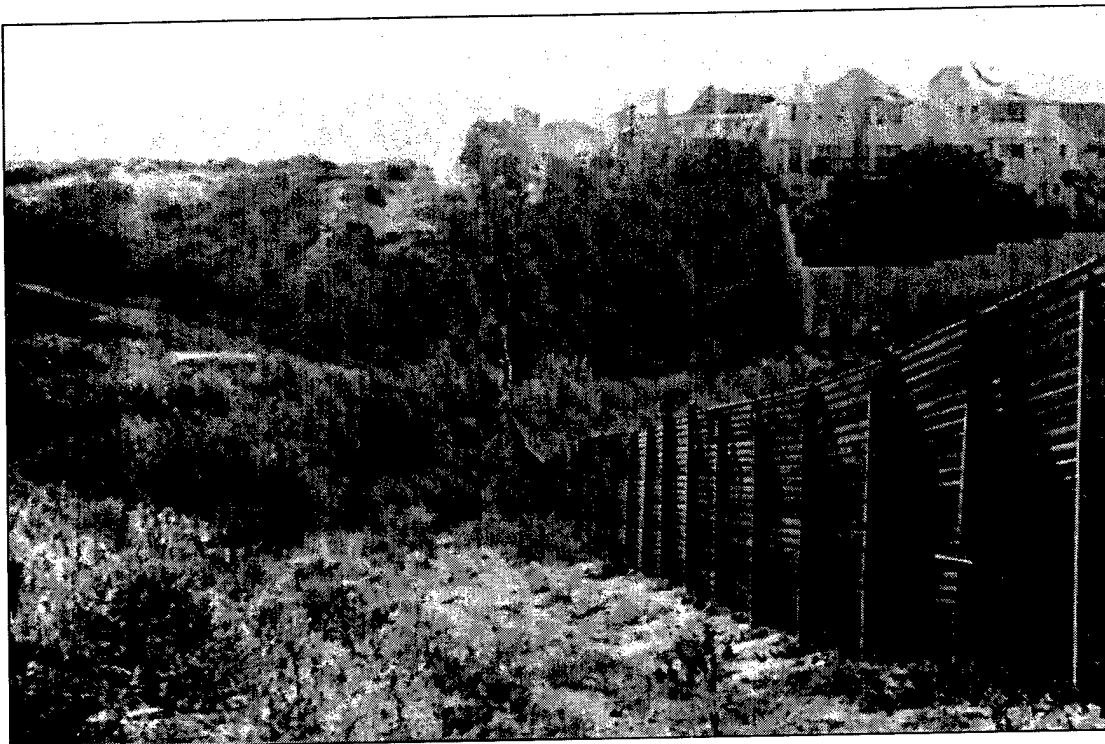
Figure B.7. Fence is bowed from thermal expansion as it extends inland.

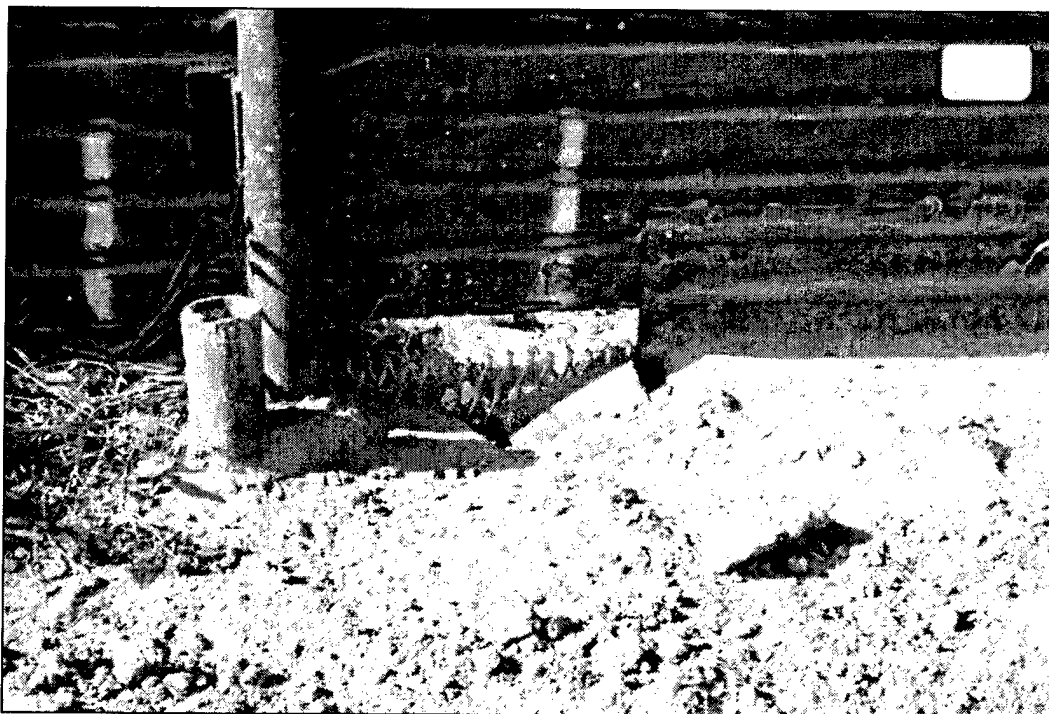
Figure B.9. Dig-under and cut pipe repairs 1,000 ft inland.

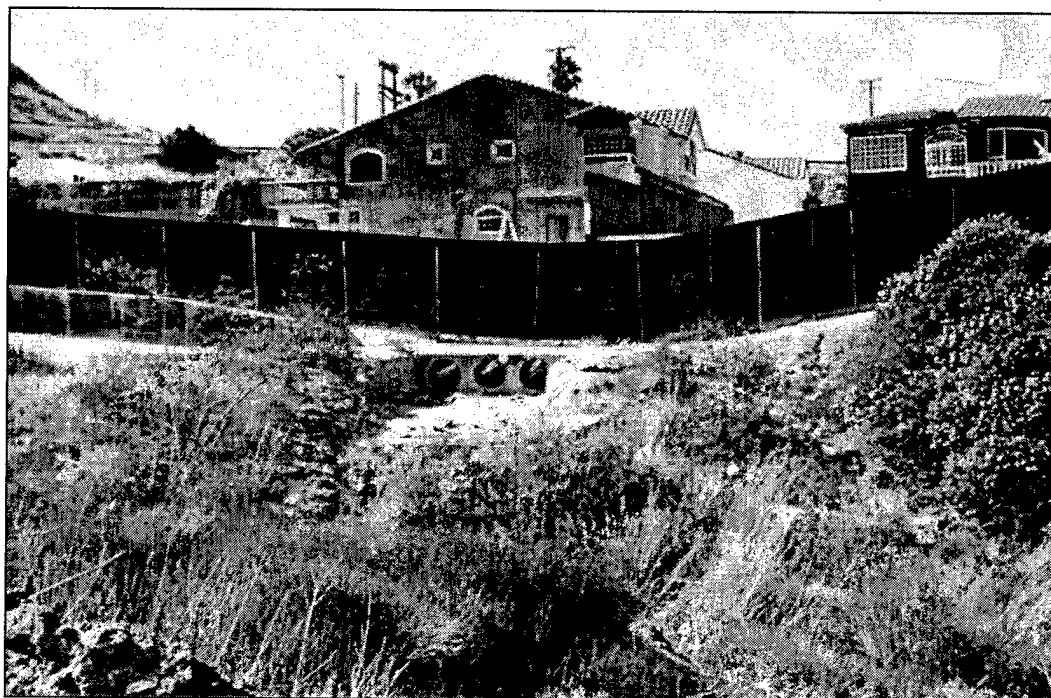
Figure B.10 shows drainage tubes under the fence at the bottom of the second hill. These tubes are a high traffic area for crossing. Drainage from rain and sewage flows through the tubes and would clog if gates were installed. The trash could then pile up against the primary barrier. This pile up not only would put an added load on the fence but also could act as a ramp if compacted.

Figure B.10. The high traffic through the drainage tubes under the fence has buffed the metal interior to a shine.

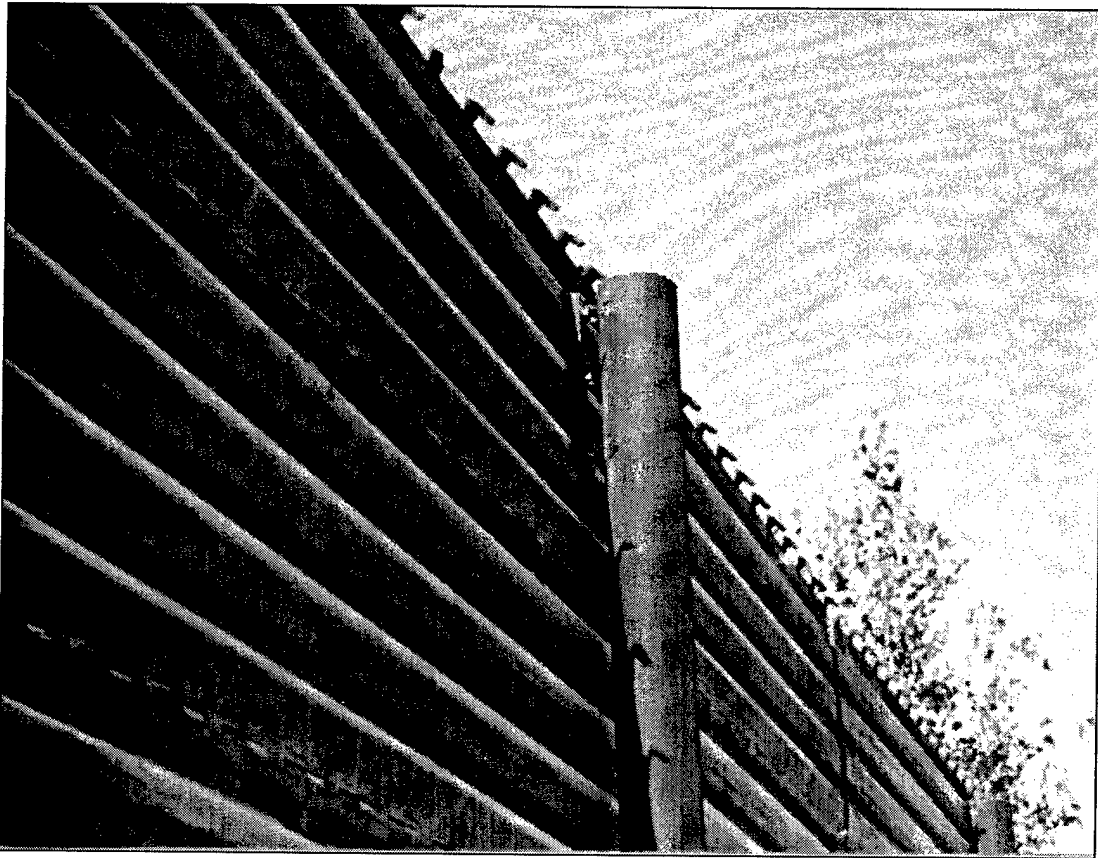
Figure B.12. Welds between the mat and poles are broken from thermal stresses.

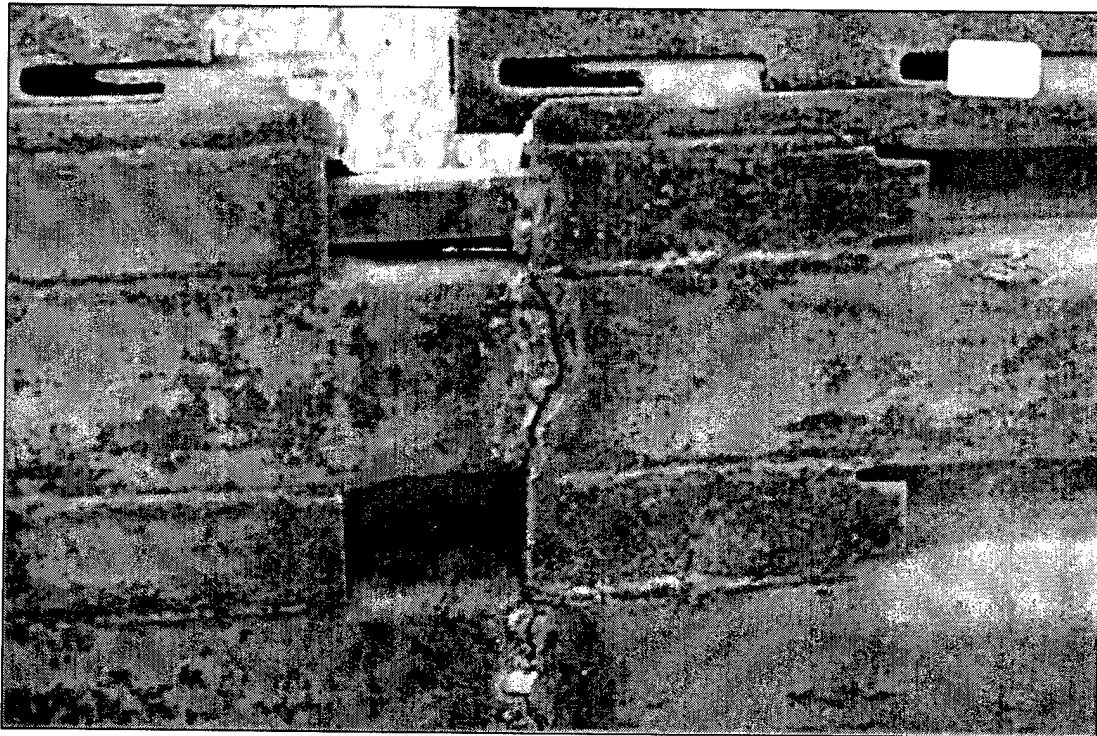
Figure B.13. Broken welds between mats and a repair made by welding one side of the square attachment pin.

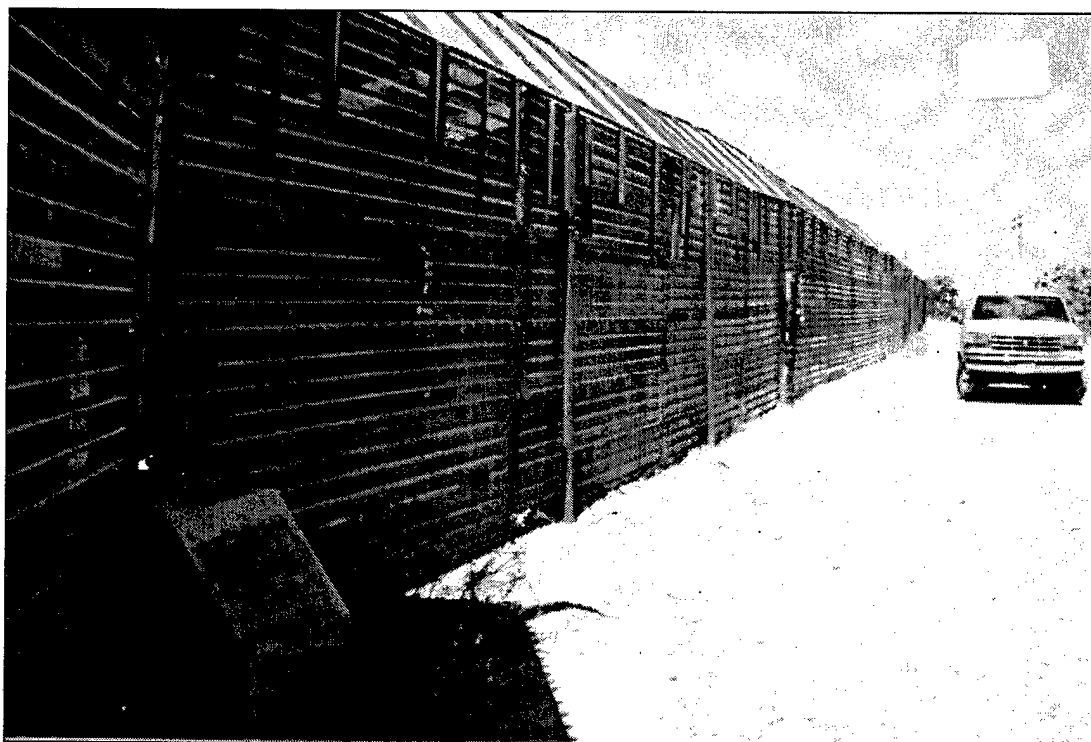
The Tijuana levee is east of the sewage plant. The fence borders the levee and extends past the old truck entry point to the San Ysidro border entry point. The area shown in Figure B.16 is another high traffic area where the BP has rein-

forced the fence. Angled extensions have been added to the top of the fence making it well over 10-ft tall. The support poles for the fence are 3.5-in. diameter pipes (not the well casings) that are welded to the mats only at the end of the pipe. The poles are positioned nearly 12-ft apart on center, which is not sufficient to properly support the weight of the landing mat sections. The pole behind the monument is only 2.5 in. in diameter, which is inadequate to support the weight of the fence. The sections are seven panels high, weighing approximately 1,260 lb. The ground along the levee is firm, so poles have a stable footing. The fence extends from the levee monument down a small hill to the old U.S.-Mexico truck entry point shown in Figure B.17. The secondary landing mat fence starts behind the BP vehicle parked in the shade west of the old gate. The fence runs parallel to the primary barrier. Figure B.18 shows the additional deterrents added to the secondary fence, which is six panels high with two panels in the overhang. Two-ft wide sheet metal is attached to the fence about 5-ft above the ground. In addition, the overhang is capped with 6- to 7-in. diameter PVC pipe, which does not allow anyone climbing the fence to grip the top. The secondary fence appears rusted but not damaged.

Figure B.16. Fence along the Tijuana levee.

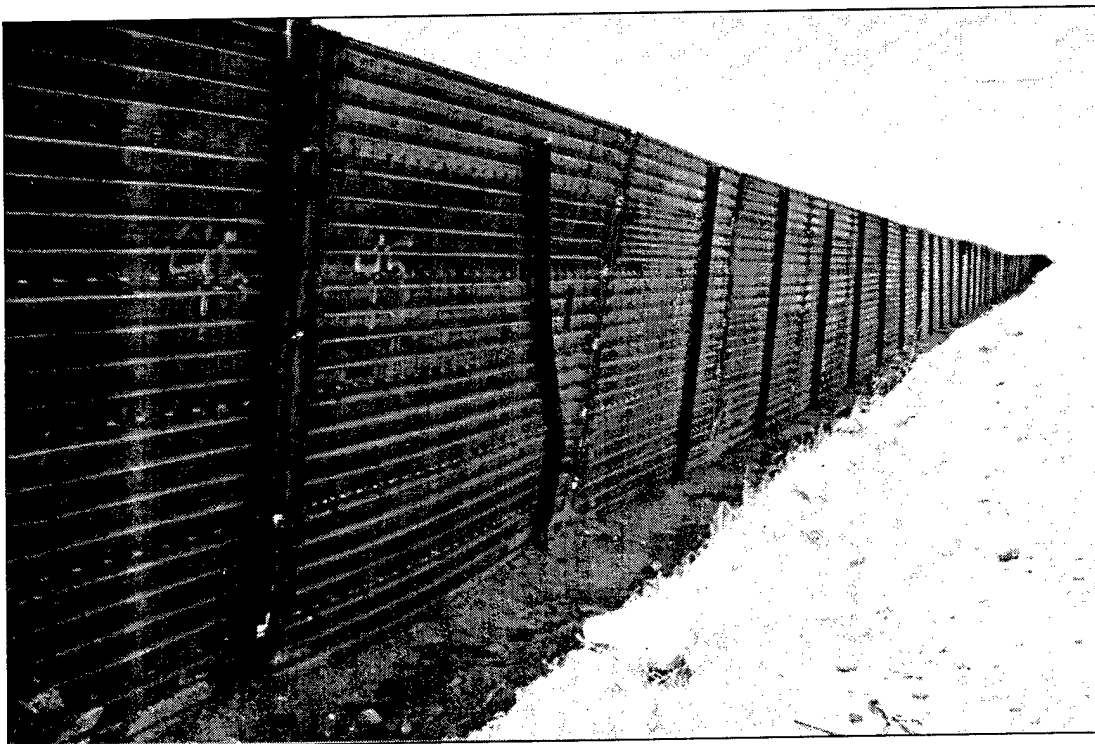
Figure B.21. Fence running between the hills and the Tijuana Airport is repaired from a truck collision on the Mexican side.

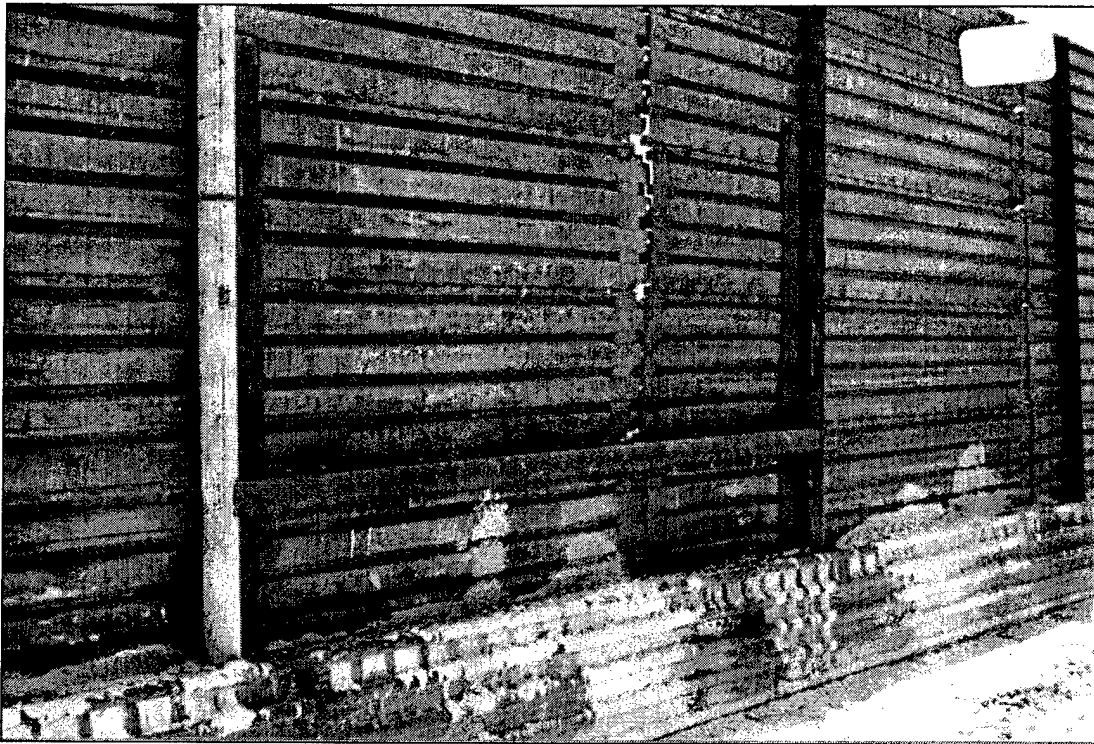
Figure B.24. Repairs to fence damaged by cutting and disassembly.

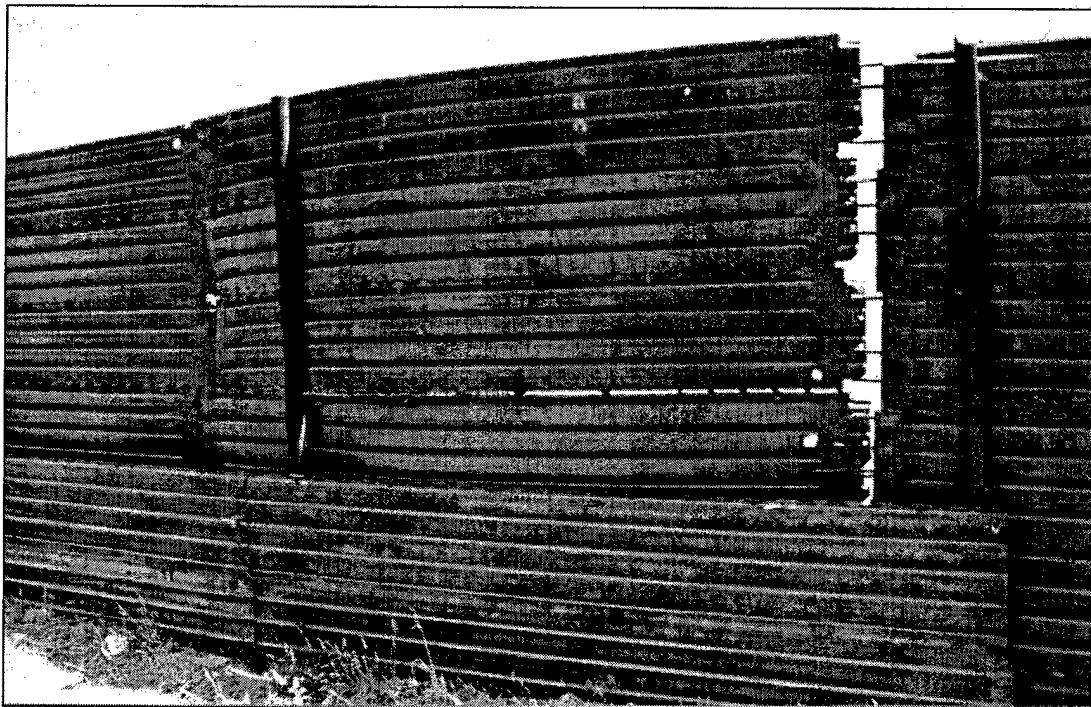
Figure B.25. This fence is still intact after being damaged by car ramming.

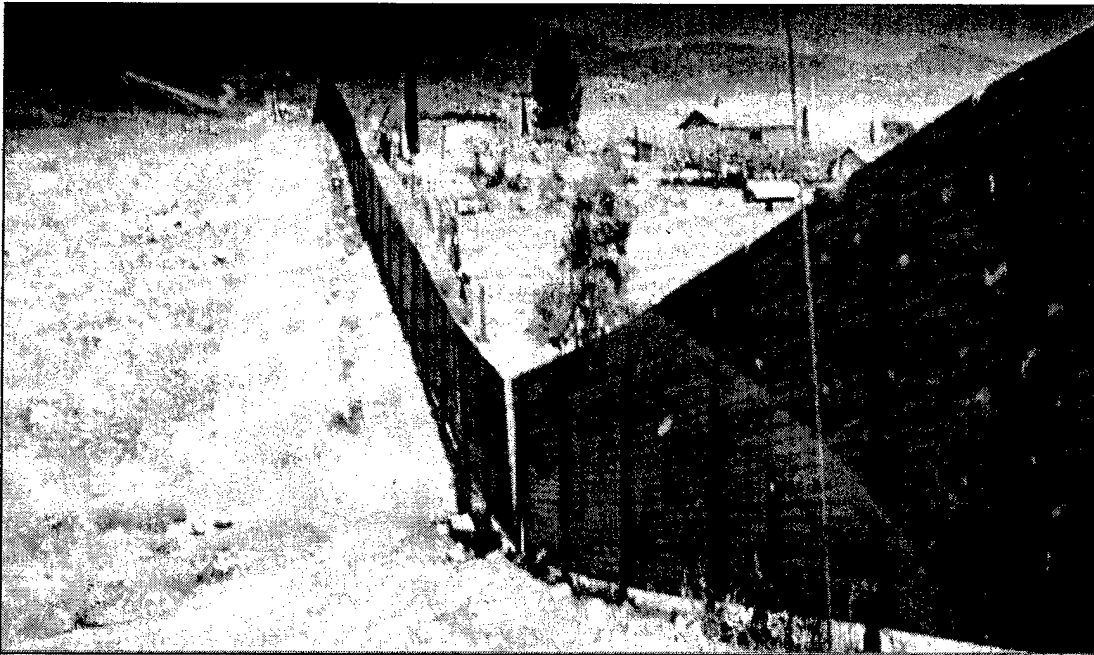
The final mile of fence running to the Otay hills is shown in Figure B.26. The hilly terrain makes fence construction difficult. Gaps at the base of the fence (seen in Figure B.27) show the ease with which fence penetration can occur by burrowing under. The loose soil erodes easily from the fence footings. A break between sections is also seen at the bottom of the hill. Figure B.28 shows the end of the fence looking into Mexico. Pathways worn by walking and driving around the fence (at the left of the picture) are visible to onsite inspectors. The inland expansion of Tijuana is shown in the distance.

Figure B.27. Gaps exist under the fence, and a break in the section is seen at the bottom of the hill.
