**Report No. CG-D-01-99, II**

**Investigation of Fuel Oil/Lube Oil Spray Fires  
On Board Vessels**

**Volume II**

**Incident Databases**

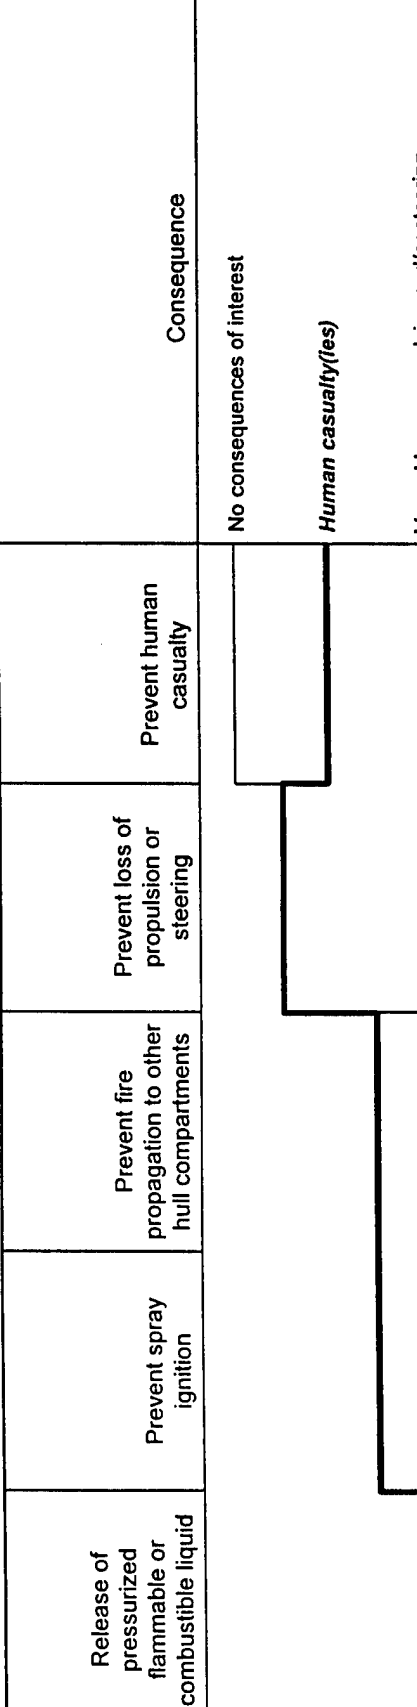
| DESCRIPTION | ACTIONS | CAUSES |
|---|---|---|
| <p>MEMBER A AND MEMBER B WERE ASSIGNED TO FIX A LEAK IN THE MESSDECK HEATER LINE. HEATER SYS HAD TO BE FLUSHED FREE OF FLUID TO REPAIR MESSDECK HEATER. MEMBER B DISCONNECTED THE RETURN LINE TO THE ENGINE AT THE VALVE AND LEFT RETURN VALVE OPEN SO FLUID WOULD DRAIN INTO THE BILGE. SUPPLY LINE WAS LEFT CONNECTED AND VALVE OPEN. WHILE THESE MEMBERS WORKED, AN INSPECTION WAS BEING DONE BY MEMBER C AND VISITING MEMBER D. MEMBER A HAD DISCONNECTED THE SUPPLY LINE FROM THE MESSDECK HEATER AND HAD AN AIRHOSE WITH APPROX 100 PSI SUPPLIED TO IT. THEY WERE READY TO FLUSH THE SYS. MEMBER A PRESSURIZED THE SYS WITH AIR, MEMBERS C AND B OBSERVED THE SYS PRESSURIZE AND STARTED TO SPRAY ETHYLENE GLYCOL FROM THE EXPANSION TANK OVERFLOW TUBE AND RETURN LINE AT THE BASE OF THE ENGINE, WHICH WAS DISCONNECTED FROM THE RETURN VALVE AND POINTED UP. MEMBER C TOLD MEMBER B TO SECURE SUPPLY VALVE TO ENGINE. AS HE SECURED VALVE HE WAS SPRAYED IN EYES AND ON CLOTHES. MEMBER B WAS LED TO AN EMERG EYE WASH STATION AND ASSISTED BY A STATION EMT AND LATER BROUGHT TO THE LOCAL HOSPITAL ER.</p> | <p>MEMBERS A AND B WERE COUNSELED ON THE PROPER PROCEDURES FOR THIS JOB. THE IMPORTANCE OF SAFETY GEAR HAS BEEN STRESSED. A LOW PRESSURE NOZZLE (UP TO 30PSI) HAS BEEN PURCHASED TO USE.</p> | <p>THERE ARE THREE ERRORS WHICH LED TO MISHAP: 1. THERE WAS NO USE OF SAFETY GEAR (EYE PROTECTION). 2. THE SUPPLY VALVE TO THE ENGINE WAS LEFT OPEN, CAUSING FRESH WATER SYS TO CIRCULATE AND EMPTY OUT OF THE DISCONNECTED RETURN LINE. 3. THE AIR PRESSURE USED WAS EXCESSIVE FOR THIS JOB.</p> |

| Event Number:<br>94031001<br>(MISREP18) | Event Characterization | |
|---|---|---|
| Cause | Crew was flushing all liquid from the system to repair a leak. One crew member used 100-psig air supply to help purge the system, but other members observed ethylene glycol spraying out the overflow tube for the expansion tank. While attempting to stop the spray, a crew member was sprayed in the eyes and on clothing | |

| Event Number:<br>94031001<br>(MISREP18) | Event Characterization | |
|---|---|---|
| Corrective Action to Prevent Recurrence | Crew members were counseled on the proper procedures for this activity. The importance of wearing safety gear was stressed. Also, a low pressure nozzle (about 30 psig) was purchased to use during similar activities | |

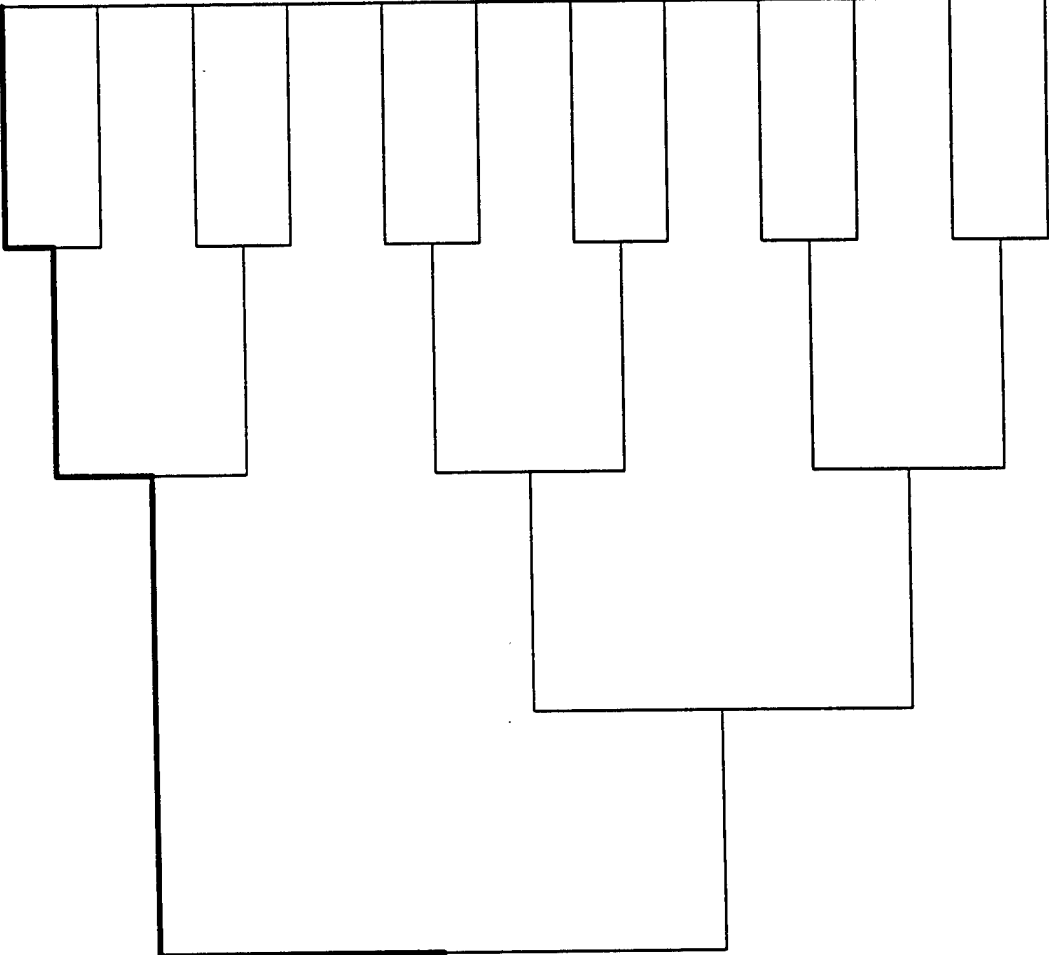
| DESCRIPTION | ACTIONS | CAUSES |
|---|---|---|
| LAUREL U/W FM HOMEPORT ENR ST. MARY'S RIVER, GA FOR SKED ATON WORK W/BOTHMDE'S O/L TURNING FOR 200 SRPM'S. IN APPROX POS 20-29.2N 081-19.6W EOW SMELLED FUEL OIL AND FOUND FUEL LEAKING FROM #2 MDE GO-NO-GO FUEL FILTER BETWEEN HOUSING AND FLANGE SHIELDING. FLANGE SHIELDING IS WRAPPED AROUND FILTER HOUSING AND COVER TO PREVENT FUEL FROM SPRAYING ONTO HOT ENGINE AND PERSONNEL. EOW SECURED #2 MDE AND FUEL SUPPLY VALVE, BROKE OUT FIRE FIGHTING EQUIPMENT AND NOTIFIED BRIDGE OF MAJOR FUEL OIL LEAK. GENERAL QUARTERS SET. FUEL LEAK (APPROX 15 GALS) DID NOT IGNITE AND WAS WIPED UP W/RAGS. FUEL THAT MADE ITS WAY INTO BILGES WAS PUMPED THROUGH OWS. | REPLACED ALL 4 FILTER COVER GASKETS W/HAND CUT GASKETS MADE FROM .125 INCH THICK OIL PAPER AS INTERIM REPAIR. ALL 4 WERE FOUND SIMILARLY DETERIORATED. THESE GASKETS WERE INSTALLED APPROX 3 MONTHS AGO AND SHOULD NOT HAVE SHOWN ANY DETERIORATION. NSN 5330-00-121-2653 DATED 01.92 APPEARS TO MATCH ORIG EQUIP MANUFACTURER'S PART AND WILL BE INSTALLED AS PERMANENT REPAIR. INCORRECTLY MFG GASKETS DISCARDED. UNIT PMS PROCEDURES CHANGED TO INCLUDE VISUAL INSPECTION BY MAIN PROP CHIEF PRIOR TO INSTALLATION. | IMPROPER MANUFACTURE OF GO-NO-GO FUEL FILTER COVER GASKET. FILTER ASSY APL: 48900050A1. UPON REMOVAL OF COVER FOUND GASKET SEVERELY DETERIORATED. GASKET APPEARS TO BE MADE FROM RUBBER MATERIAL THAT IS NOT FUEL RESISTANT. GASKET CONTRACT DLA 500-89-W-B046 DTD 5.89) IS SOFT AND PLIABLE AND CRUSHES UPON INSTALLATION. THIS GASKET DOES NOT MEET SPEC DIMENSIONS LISTED IN FED LOG AND DOES NOT APPEAR TO MEET MATERIAL SPECS. GASKET W/SAME NSN DTD 01/92 MATCHES ORIG EQUIP MANUFACTURER'S PART AND IS SEMI-HARD AND KEEPS ITS FORM WHEN INSTAL. |

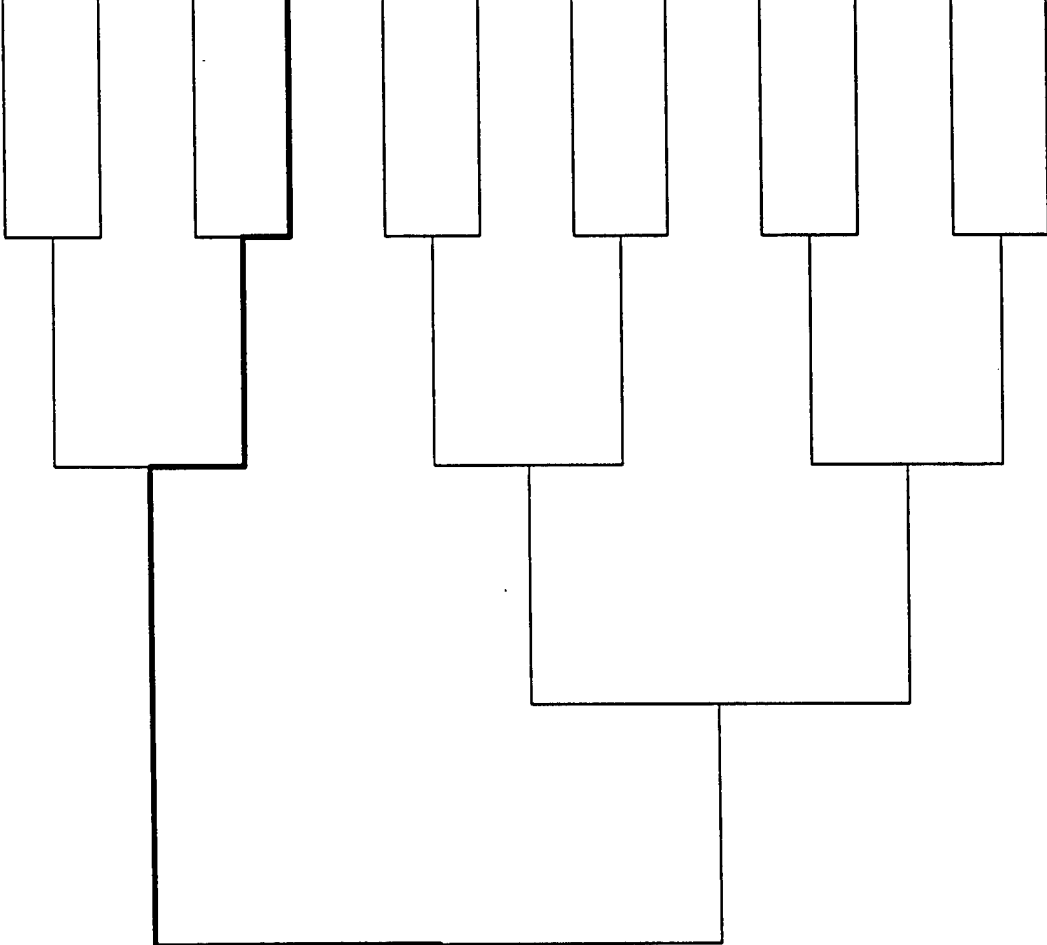
| DESCRIPTION | ACTIONS | CAUSES |
|---|---|---|
| WHILE MAKING ROUNDS AT 0119, OILER DISCOVERED A F/O LEAK IN THE #2 MDE. THE F/O SUPPLY LINE TO #8 CYLINDER HAD CRACKED AND WAS SPRAYING F/O ONTO #1 MDE'S EXHAUST MANIFOLD. THE OILER IMMEDIATELY SECURED THE #2 MDE VIA E-STOP ON THE LOCAL GAUGE BOARD. THE OILER NOTIFIED THE EOW AND THEN NOTIFIED THE BRIDGE. EOW SECURED #1 MDE. THE BRIDGE SOUNDED GENERAL QUARTERS AND SET THE MAIN SPACEFIRE DISCIPLINE. THE ECC WATCH SPRINKLED BUILDINGS WITH INSTALLED AFF SYSTEM PUTTING 1' OF FOAM ABOVE THE ENGINE ROOM TANK TOPS. WHILE PREPARING THE FIRETEAM ON TUG FOC'SLE, THE #1 HOSE TENDER ENERGIZED HIS OBA CANISTER WHILE IT WAS STILL IN THE STANDBY POSITION. THE EO NOTICED THE PROBLEM AND STARTED TO ASSIST. AS HE EXAMINED THE OBA, THE SEAL BLEW SPRAYING HOT GAS/CAUSTIC SODA ONTO THE WO'S RIGHT EYE AND CHEEK. THE EMT FLUSHED THE EYE AND SKIN AND USED CITRIC ACID FROM A ORANGE AS A NEUTRALIZER, AT 0336, AFTER THE ENGINE ROOM WAS SECURED AND #1 MDE PLACED ON LINE, THE SHIP DEVERTED TO ERIE, PA. UPON ARRIVAL AT ERIE THE EO'S EYE WAS EXAMINED BY A HOSPITAL EMERGENCY ROOM DOCTOR. AFTER A COMPLETE HOSPITAL EXAM, THE EO WAS TRANSPORTED TO A LOCAL OPHTHOLOGIST FOR A DETAILED EXAM. NO DEBRIS OR PERMANENT DAMAGE TO THE EYE WAS EVIDENT. | DO NOT DEVIATE FROM PRACTICED PROCEDURE. OBA CANISTER WILL ONLY BE PLACED IN STANDBY POSITION AFTER GEAR CHECK PHASE OF DRESS OUT. ON SCENE LEADER WILL ASSIST AND ENSURE COMPLIANCE. COMMUNICATIONS BETWEEN FIRETEAM MEMBERS AND FIRETEAM LEADERS MOST IMPORTANT; ENTIRE TEAM MUST BE AWARE OF THEMSELVES, EACH OTHER, AND THE STATUS OF THEIR EQUIPMENT (PPE). DO NOT OVERACT, REMAIN CALM AND PROCEED AS DRILLED. | PERSONNEL ERROR - THE HOSE TENDER WAS EXPERIENCING GREAT ANXIETY WITH OUT OUTWARDLY SHOWING IT; THE HOSE WAS DISORIENTED. HOSE TENDER FAILED TO SEAT OBA CANISTER BEFORE ACTIVATING. ONCE ACTIVATED INTERNAL PRESSURE CAUSED FOIL SEAL TO RUPTURE. STRESS AND FATIGUE OF THE HOSE TENDER WERE CONTRIBUTING FACTORS. |

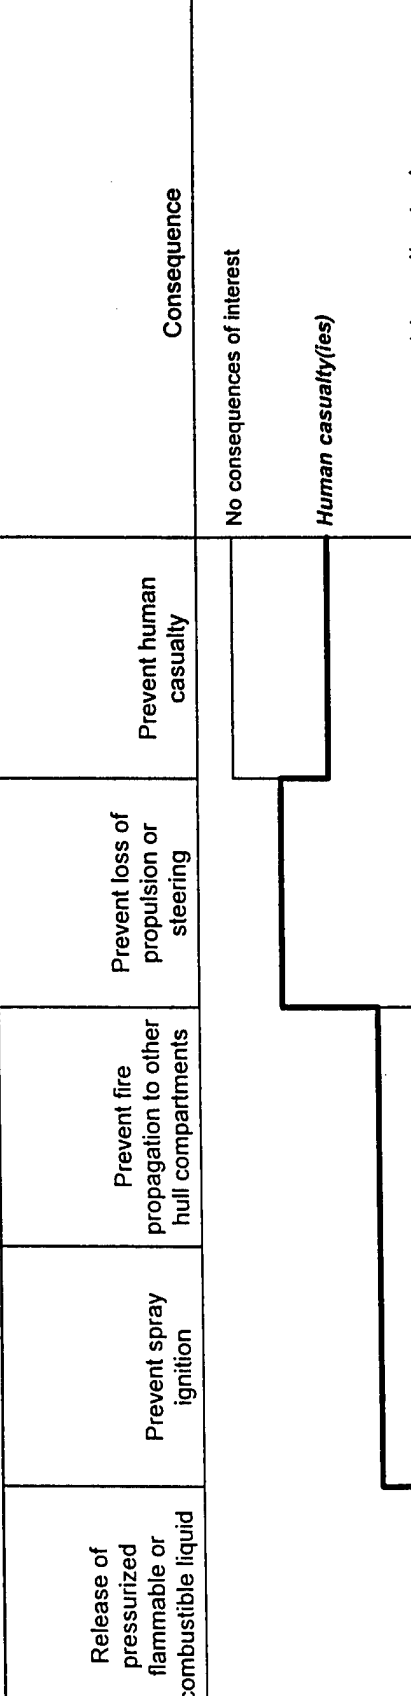
| DESCRIPTION | ACTIONS | CAUSES |
|---|---|---|
| SNM WAS INSTALLING FLANGE SHIELDING ON PORT RED GEAR LUBE OIL COOLER INLET VALVE. TO MAKE THE JOB EASIER, SNM ATTEMPTED TO REMOVE VALVE HANDLE. AFTER REMOVING 2 SCREWS BELIEVED TO HOLD ON THE THE VALVE STEM, HE SHOOK HANDLE TO PULL IT OFF VALVE STEM. HE HAD ACTUALLY REMOVED THE VALVE STEM SECURING PLATE. WHEN HANDLE SHOOK, HANDLE AND STEM SHOT OUT OF VALVE. SOLID STREAM OF OIL SPRAYED OUT OF THE 3/4 INCH DIA. VALVE STEM HOLE COVERING THE SNM WITH OIL AND SPRAYING OIL INTO THE MACHINERY SPACE. SECOND FN SPOTTED CASUALITY AND REPORTED TO CONTROL. EOW ASKED FOR A REPEAT IN BISBELIEF. AFETR CONFIRMING THE REPORT OOD WAS CONTACTED. | DEPARTMENTAL TRAINING | SNM LACKED KNOWLEDGE OF VALVE STEM ASSEMBLY AND FAILED TO ASK FOR ADVICE ON THE DISASSEMBLY. SUPERVISION WAS ALSO UNAWARE OF SNM ACTIONS. |
