# NATIONAL TRANSPORTATION SAFETY BOARD

## AIRCRAFT ACCIDENT REPORT

IN-FLIGHT ICING ENCOUNTER AND  
UNCONTROLLED COLLISION WITH TERRAIN  
COMAIR FLIGHT 3272  
EMBRAER EMB-120RT, N265CA  
MONROE, MICHIGAN  
JANUARY 9, 1997

**Abstract:** This report explains the accident involving an EMB-120RT, operated by COMAIR Airlines, Inc., as flight 3272, that crashed during a rapid descent after an uncommanded roll excursion near Monroe, Michigan, on January 9, 1997. Safety issues in the report focused on procedures for the use of ice protection systems, airspeed and flap configuration information, stall warning/protection system capabilities, operation of the autopilot in icing conditions, aircraft icing certification requirements, and icing-related research. Safety recommendations concerning these issues were addressed to the Federal Aviation Administration and the National Aeronautics and Space Administration.

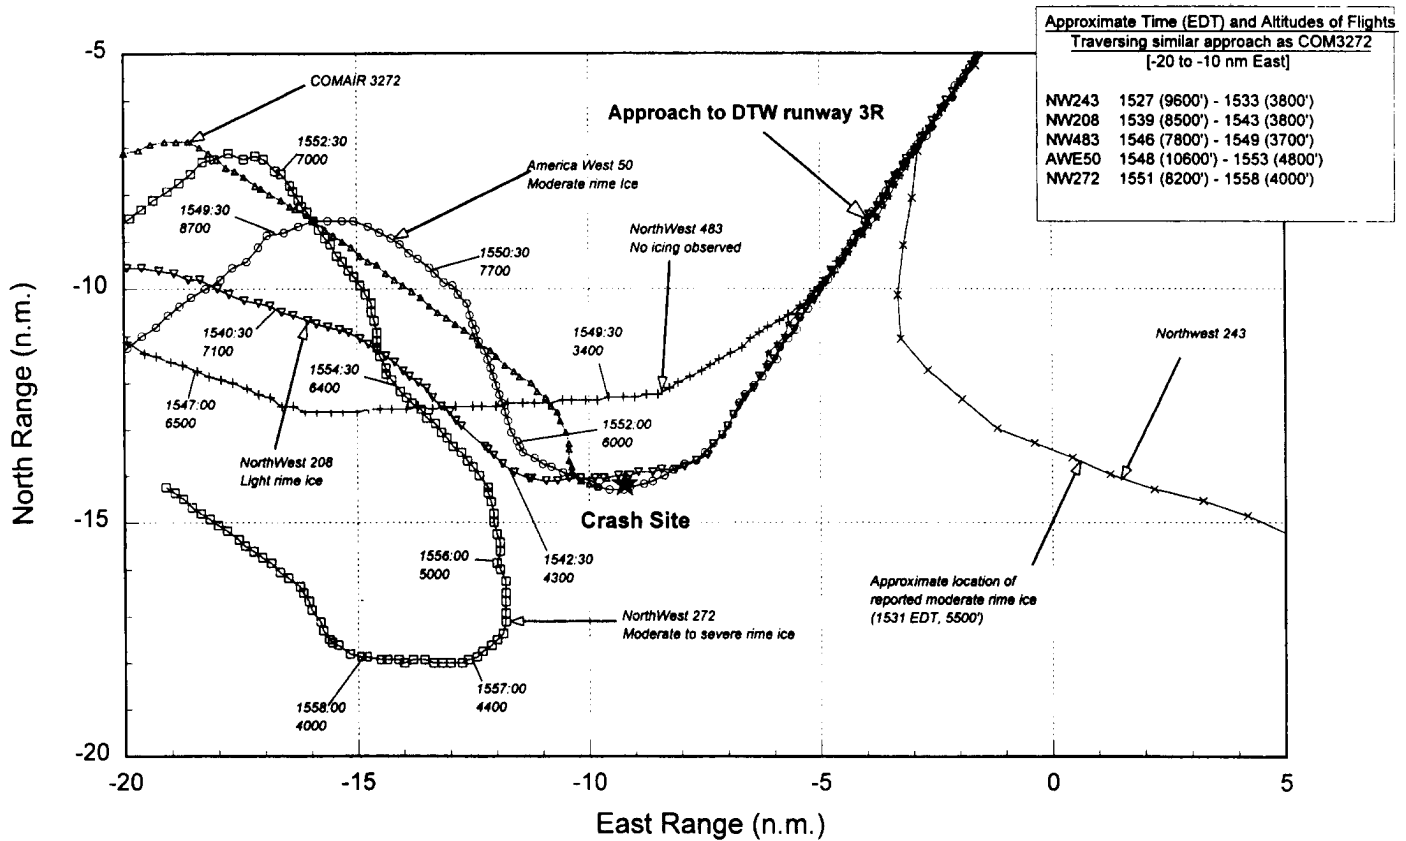
Figure 7.--Ground tracks of aircraft.

<sup>62</sup> A review of the ATC tape transcripts and radar data indicated that about 1½ minutes after the accident, NW flight 272 was descending through 5,000 feet on its way to its assigned altitude of 4,000 feet msl, when ATC advised the pilots of NW flight 272 “its gonna be quite a bit of a delay for you...turn right heading two five zero.” When the pilots of NW flight 272 queried the controller about the length of the delay, the controller stated “I just lost an airplane, I believe.” Between 1556:40 and 1557:47, ATC instructed the pilots of NW flight 272 to turn right to headings of 270° and 360°. At 1558:03, the controller issued the pilots of NW flight 272 a frequency change. When the pilot of NW flight 272 contacted ATC on the different frequency, the airplane was level at 4,000 feet msl; the pilots requested and received a higher assigned altitude because of the ice accumulation.
