TARDEC

No. 13766

Laser Damage Testing of Molybdenum Shutter

May 1999

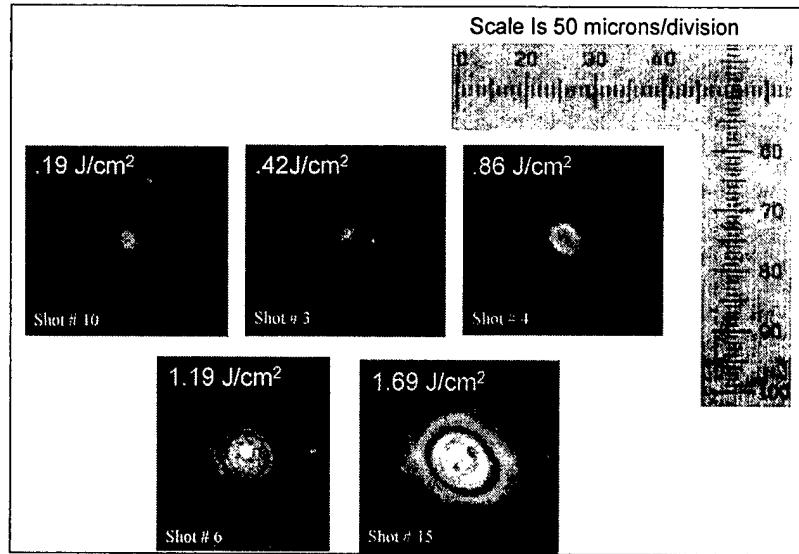
Figure 5. Damage with Increasing Fluence

4.3 While testing the Molybdenum sample we noted that the damaged area increased as the fluence increased. This is illustrated in Figure 5. We also determined that the damage spot size increase is directly related to the increase in input fluence. For example: for site 15 the fluence was 1.69 J/cm² and the area of the damage spot was 159

4.4 After examining the damage sites, it was apparent that several of the damage sites had a ring or halo surrounding the primary elliptical damage site. This effect was seen for input fluences greater than or equal to 1.19 J/cm². It was postulated that this ring was caused by a laser-induced shockwave. The ring may be the result of a shock propagating out from the center of the damage site, ejecting coating material at the peak of the first crest. The dark ring may be coating left intact at the first minimum.

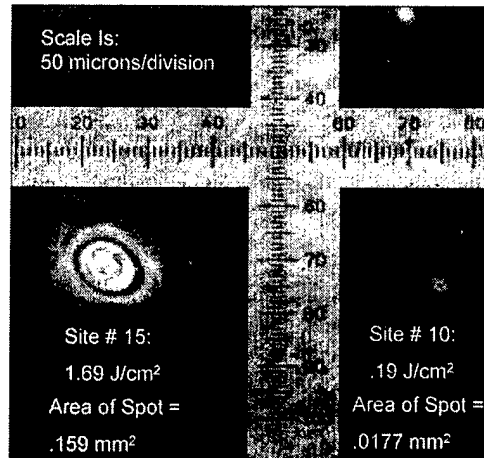
Figure 6. Comparison of Damage Spot Areas

mm² and for site 10 the fluence was 0.19 J/cm² and the area of the damage spot was 0.0177 mm² (see Figure 6). The ratio of the two site's fluences (8.90) and damage spot areas (8.98) was nearly identical.
