**C-130 Broad Area Review (BAR)**

**ADDENDUM**

**King 56 Salvage**

25 August 1998 Addendum  
to the 15 January 1998 Report

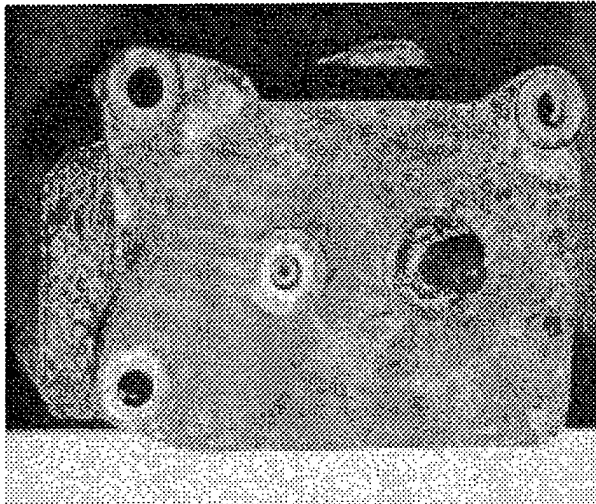
*Fuel Shutoff Valve Motor #1 in "close" Position*

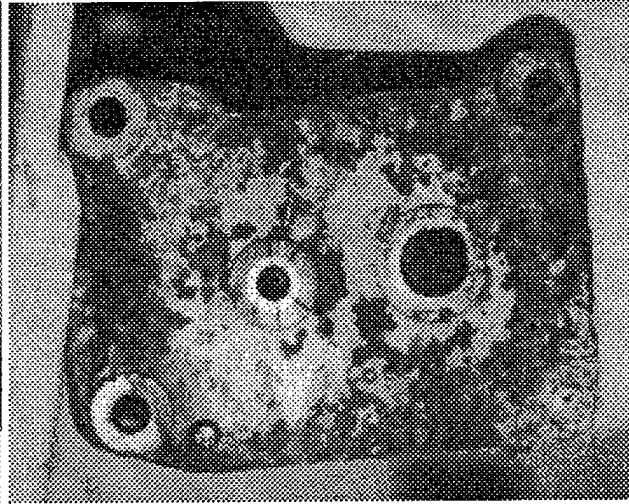
*Fuel Shutoff Valve Motor #3 in "open" Position*

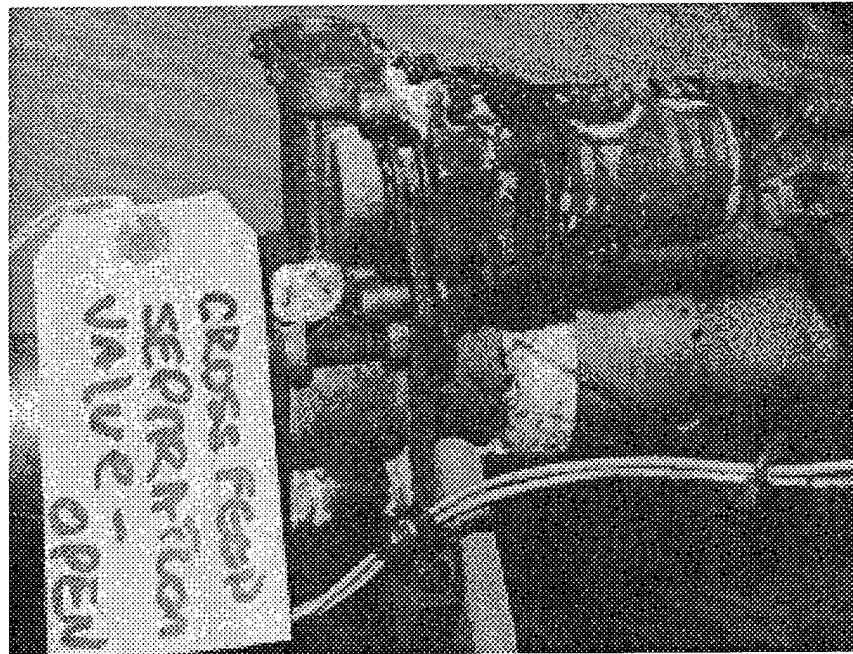
*Crossfeed Separation Valve - Found Open*

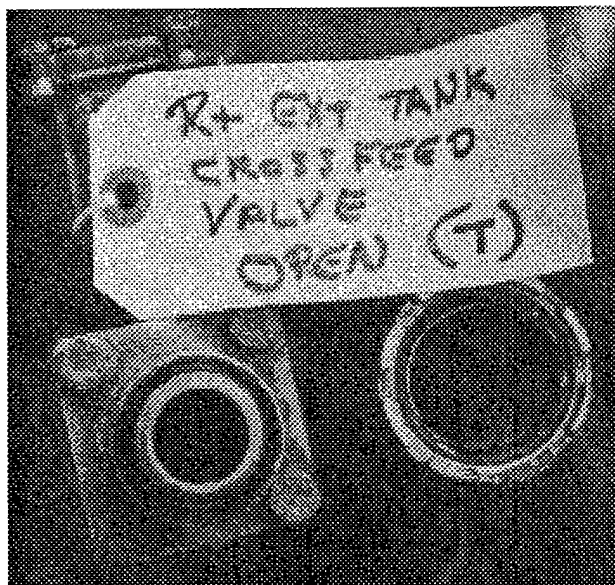
*Right External Crossfeed Valve - Found Open*

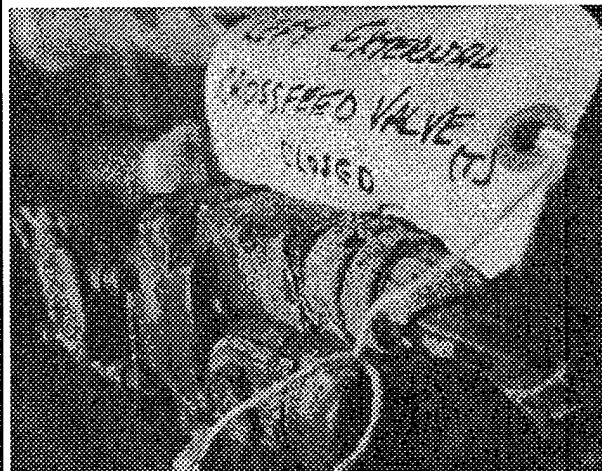
*Left External Crossfeed Valve - Found Closed*

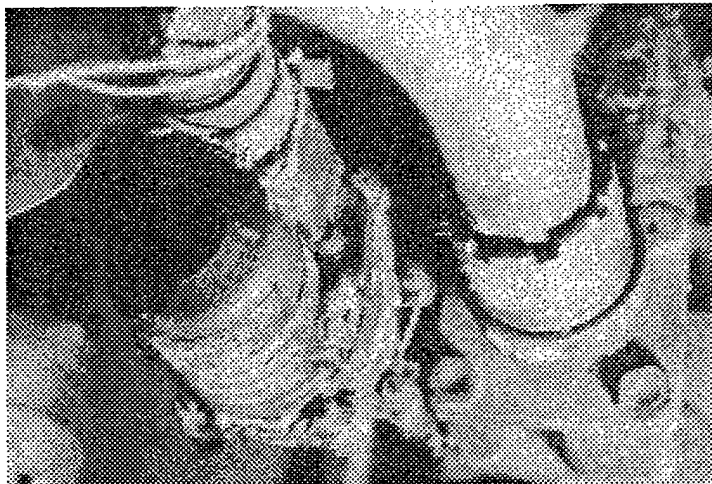
*Left Auxiliary Crossfeed Valve – Found Closed*
