Technical Report ARWEC-TR-99002

**METALLURGICAL FAILURE ANALYSIS OF THE M230
MACHINE GUN BARREL – MIF-A-001-1999-I**

June 1999

U.S. ARMY ARMAMENT RESEARCH, DEVELOPMENT AND
ENGINEERING CENTER

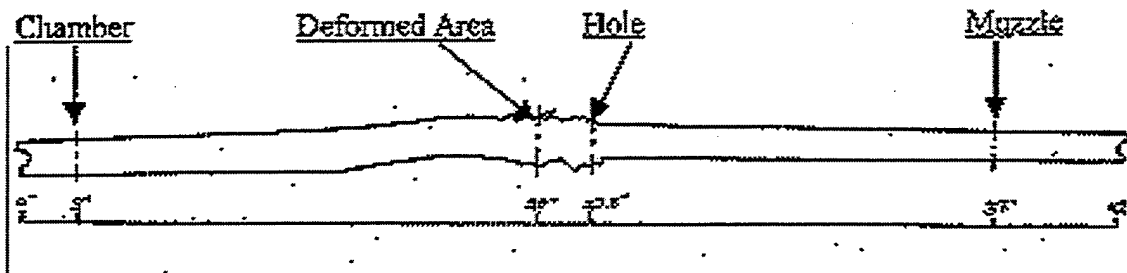
Figure 1
Outline of the failed barrel showing where metallurgical specimens were taken from

The microstructure and hardness in four areas of the barrel were examined to look for differences and changes to the original structure and hardness. The four areas analyzed were the muzzle end, through the large hole, a deformed area near the hole and the chamber end (fig. 1). Drawing no. 387-3116 calls out a maximum barrel hardness of 33 Rockwell C. Past work performed by the Failure Analysis Team at ARDEC has shown that the microstructure of the barrel is typically a tempered martensite (ref. 3).

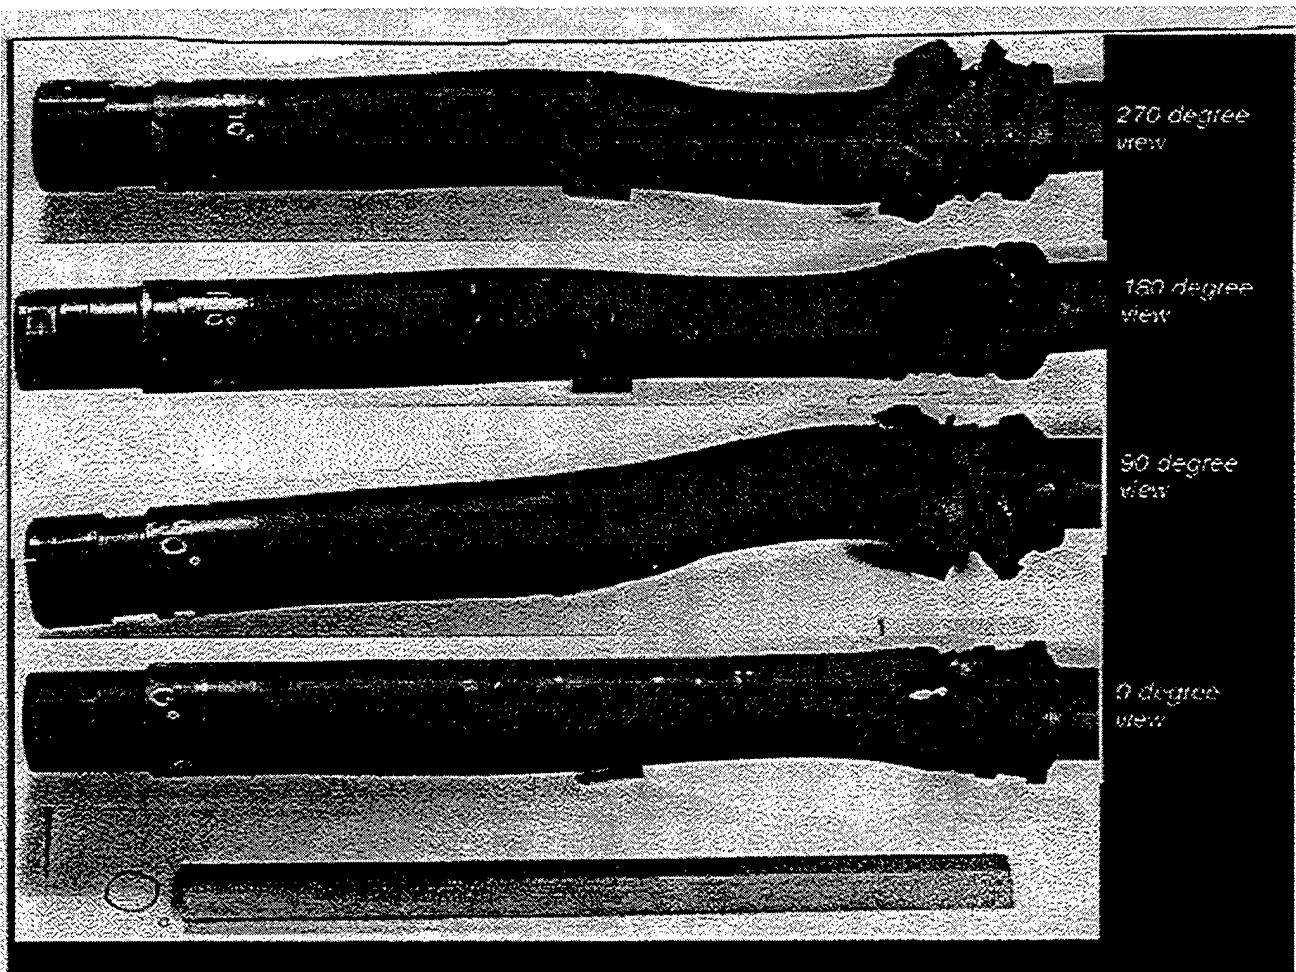
Figure 2
Chamber-end of the barrel, 360 deg view

Figure 2 shows photographs of the barrel from the chamber end to just beyond the end of the remaining barrel support (or shroud). The barrel is severely deformed and there are two puncture holes that can be seen in the 0 deg view and the 180 deg view.

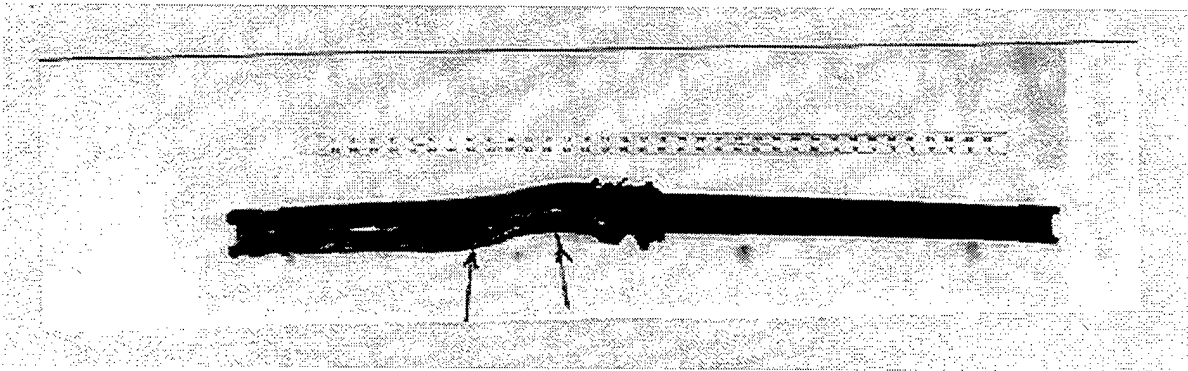
Figure 3
Sectioned M230 barrel

A photograph of the barrel after it had been cut along its entire length is shown in figure 3. In addition to the lack of rifling between 8.5 to 21 in. from the chamber end, yielding and deformation of the barrel material was noted, see arrows. At 10.5 in. from the chamber, the wall thickness dropped down to 0.30 in. where it is normally about 0.50 in.

The fracture surfaces at the holes, where the projectiles exited, were examined. The fracture surfaces were pointed and the material was elongated nearly 100%. No brittle fracture surfaces or tensile dimples were noted. Tensile dimples are seen when a material exceeds its room temperature tensile strength. This suggests that the material did not fail due to a void or other manufacturing defect but rather from overheating, which caused it to lose most of its tensile strength yet increased its plasticity properties.

Arrows point to areas where the material has yielded.

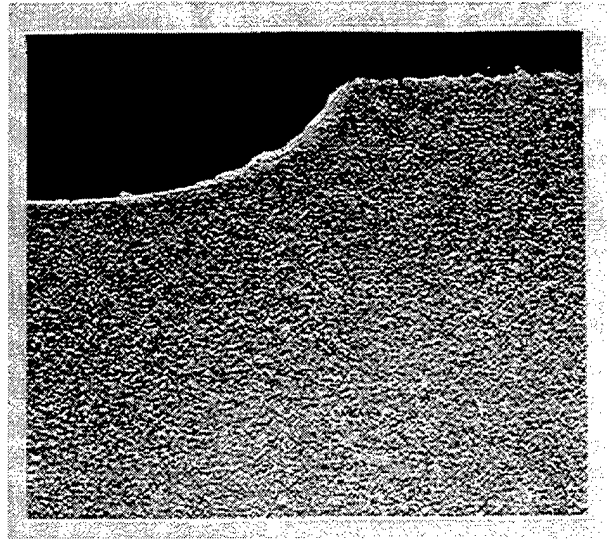
b
Magnification, 42.6x

Figure 5b (50x mag., hardness 36 Rockwell C) was taken at a low magnification to show whether the microstructure in the lands and grooves had changed due to heat. No changes are seen. Figure 5c shows this same area at high magnification, 500x. This is a mixed microstructure and the hardness is a little high per the drawing.

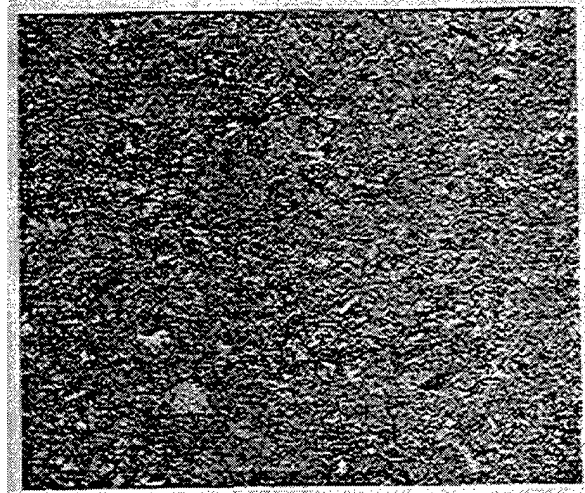
d
Magnification, 426x

Figure 5d (500x mag., hardness 30 Rockwell C) is the microstructure from the mid-wall of the muzzle region. This is a tempered martensite structure which is typical for the M230 barrel. The hardness is appropriate per the drawing.

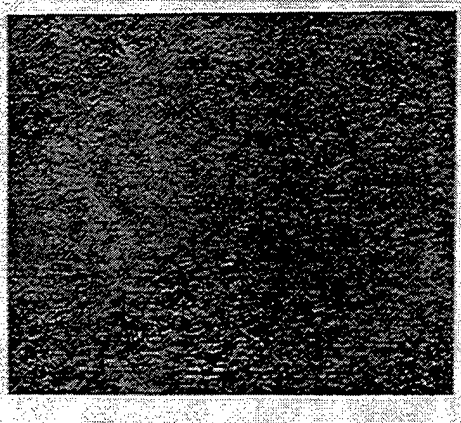
c
Magnification, 350 x

Figure 6c (500x, 53 Rockwell C) is the microstructure of the bullet exit hole. This microstructure contains bainite and untempered martensite. The presence of bainite and untempered martensite coupled with an increase in hardness from 30 to 36 Rockwell C to 53 Rockwell C can only be accomplished by heating the steel above its austenitizing temperature (~1,400°F) and then quenching. Not all areas of the gun barrel wall achieved temperatures as high or higher than 1,400°F. Some areas on the outer diameter only got warm enough to be further tempered, such as the area in figure 6d.

The change in the microstructures from tempered martensite to bainite and untempered martensite coupled with the increase in hardness values seen at the holes where the projectiles exited, supports the theory that the gun barrel steel exceeded the austenitizing temperature and then air cooled. A transformation temperature versus time (TTT) diagram is shown in figure 9. This diagram shows that the austenitizing temperature is 1390°F. The barrel may have gotten hotter than 1390°F, but with the various temperatures throughout the barrel and the subsequent variable quenching rates, it is difficult to pin down exactly how hot the barrel got in different areas.

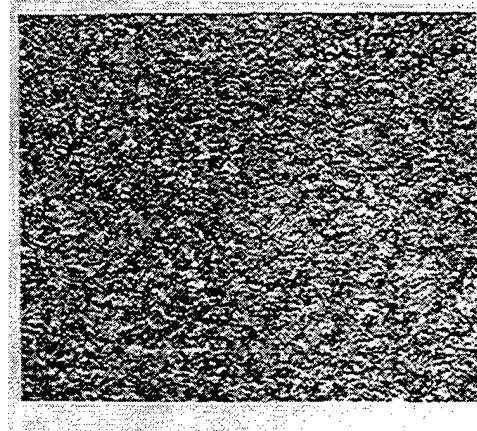
d
Magnification, 350x

Figure 6d (500x, 27 Rockwell C) is a microstructure from the mid-wall. Compare it to figure 5d and contrast it to figure 6c. This structure is a coarse, tempered martensite. However, the hardness has dropped from 30 Rockwell C (as measured in the mid-wall of the muzzle) to 27 Rockwell C. For the hardness to drop as such, this area only got heated (or tempered) to about 1,200°F. This area did not go over the austenitizing temperature of 1,390°F and then get quenched.

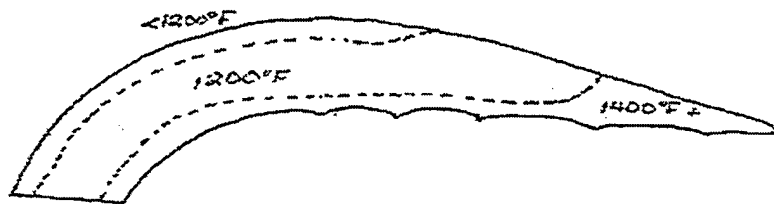
Figure 6e shows the temperature profile of this area at the time of failure. At the exit hole and along the lands and grooves, the temperature exceeded 1,400°F. The mid-wall is shown reaching a temperature of 1,200°F while the outer diameter of the barrel stayed below a temperature of 1,200°F.

e
Temperature profile of the cross-section of the hole region at the time of failure

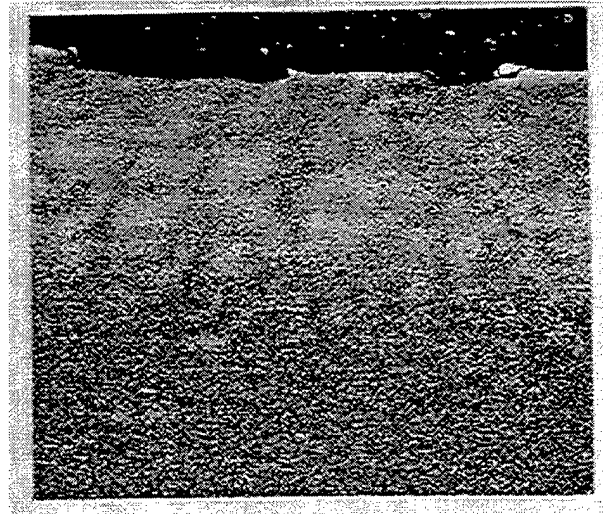
b
Magnification, 42.6x

Figure 7b (50x, 54 Rockwell C) is a low magnification photograph of the lands and grooves area. The microstructure has changed due to heat in this area, as is evidenced by the presence of both the white and dark areas. Figure 7c is the same area at high magnification. Again, as in figure 6c where the hole was located, bainite and untempered martensite are observed. This area also, exceeded the austenitizing temperature and then was quenched in air to achieve this structure and hardness.

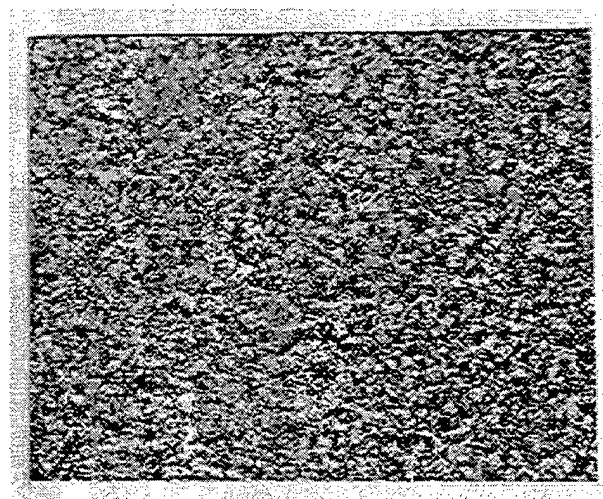
d
Magnification, 426x

Figure 7d (500x, 34.5 Rockwell C) is the mid-wall area of the deformed area. This is a mixed microstructure and it is not clear what effect the heat had on this area.

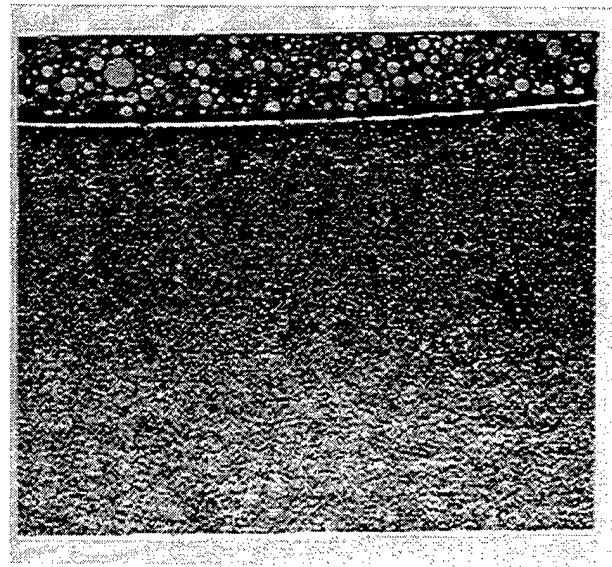
b
Magnification, 42.6x

Figure 8b (50x, 40 Rockwell C) is the microstructure at low magnification showing no general changes to the microstructure due to overheating.

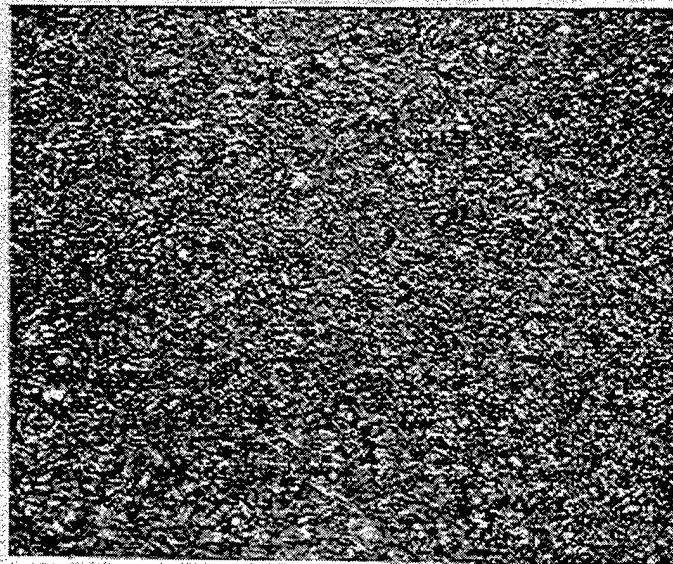
c
Magnification, 500x

Figure 8c (500x, 33 Rockwell C) is the microstructure of the barrel mid-wall at the chamber end. This microstructure is fine tempered martensite. It is comparable to the microstructure seen in figure 5d from the mid-wall at the muzzle end. No changes in the microstructure due to overheating are seen. This is a proper microstructure and hardness for the D6-AC steel alloy used in the M230 gun barrel.
