---TECHNICAL REPORT---

No. 13755

Test and Evaluation of the
LMTV Driveline
1998

U.S. Army Tank-Automotive Research,
Development, and Engineering Center
Detroit Arsenal
Warren, Michigan 48397-5000

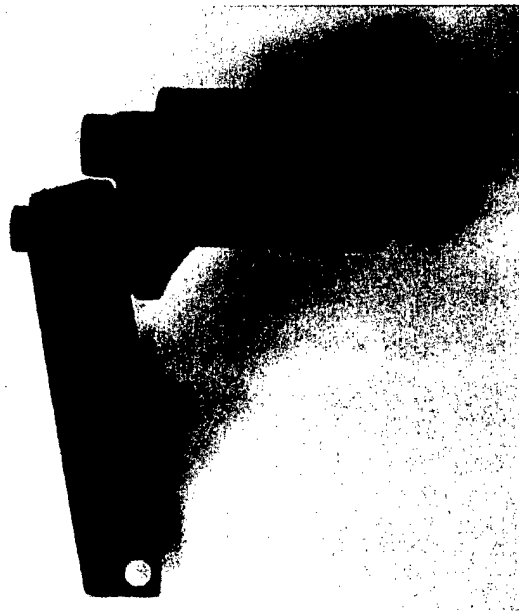
Figure 4 – Alternator Support Bracketry

Notice that the straight bracket connection to the supporting the U-bracket is such that it effectively forms a cantilever beam. This essentially leaves the far end, where much of the alternator weight resides, to flex and bend freely much as a weight placed on the end of a meter stick would react. The U-bracket bolts to the water pump in order to stop this from occurring. However, as the vehicle drives, the forces being exerted are still there which continually stress the water pump. Over time, these forces cause the pump casing to wear and potentially, as our case illustrates, fail. Of course this is dependent on many factors such as how severe the forces are that are imposed, such as hitting large bumps, and whether particularly destructive resonant frequencies are encountered. While it is possible that this failure would have occurred regardless of vehicle configuration, just looking at the supporting bracketry indicates that a more sturdy solution exists that may reduce the chance of random failures.

the water pump housing does not appear sufficient. The moments added to the bracketry by the moving vehicle could be effectively causing an early failure in the water pump housing. A redesign of this bracketry will help alleviate this problem.

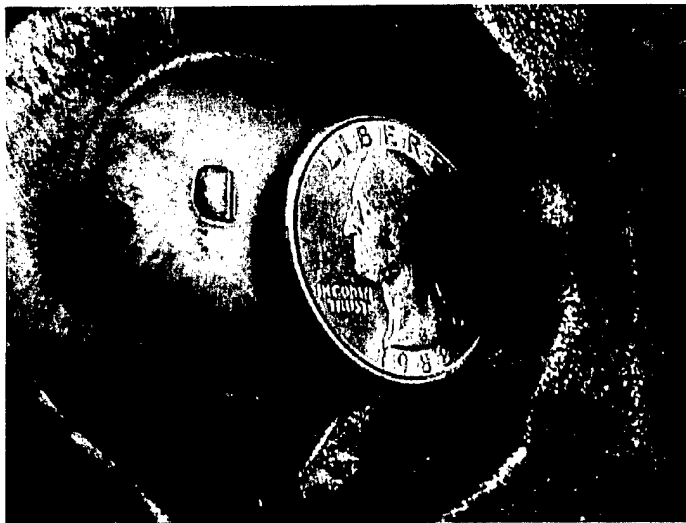
Once these items were replaced, testing began again only to notice immediately that the rear driveshaft was wobbling. One end cap on the transfer case u-joint had overheated and seized up. Inspection revealed that this failure was typical of those witnessed in the field. It is suspected that the reason this was not noticed before was do in part to thermal expansion that, when the end cap failed, caused the u-joint to be held relatively in place until it cooled off. While the shaft may not have been displaying wobbling that could be visually seen, it was likely causing excessive vibration throughout the rest of the system. It is probable that this extra vibration helped cause the premature failure of the water pump.

The wobbling itself was being caused by the space created between the end cap and the yoke. From figure 6, the amount of play that was discovered was such that a quarter would easily fit in this space. Also visible is the scoring in the metal, caused when the cap overheated, and a slight bulge in the center of the cap. Though some needles were found that were a little squished, nothing was wedged underneath the cap. The space between the yoke and end cap allowed the driveshaft to shift off center which, when spinning, displayed the wobbling motion. This failure occurred while using the Joint Clutch & Gear straightened and balanced shaft. Later analysis of the shaft indicated that it had bent drastically when the failure occurred. Refer to Appendix B for the results.

Figure 6 – Play Between the End Cap and Yoke
