Naval Surface Warfare Center Carderock Division

CARDIVNSWC-61-TR-1999/13 June 1999

Materials, Structures And Survivability Directorate
Technical Report

Investigation of a Roof Tube Failure From a Utility Boiler

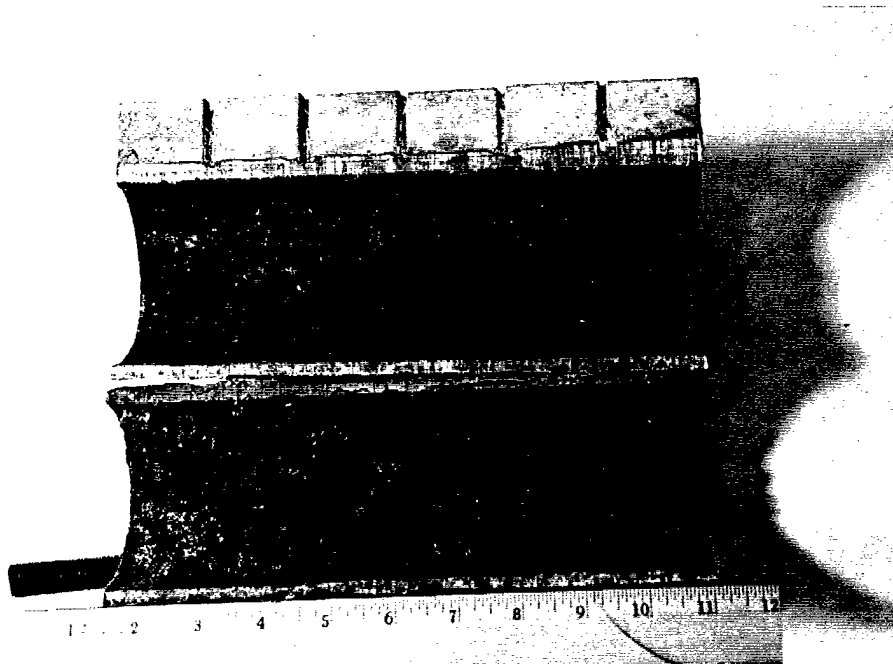
Figure 1 shows that the tube failure consisted of a one-inch longitudinal split along the hot side. This split coincided with local bulging of the tube at the hot side crown. The tube sample was cut along the longitudinal, membrane axis. Figure 2 shows that heavy deposits exist around the failure along the hot portion of the tube. A moderate amount of waterside deposition had occurred along the tube membranes; deposits were lowest along the cold portion (back side away from the flame). A side view of the respective waterside deposits (Figure 3) indicated that the hot deposit was one-inch thick in some places along the sample. The cold side deposit was approximately 0.020 inch thick near the tube membrane, while the deposit along the center of the cold side were less than 0.005 inch thick.

Figure 2 - Waterside surfaces of roof tube display heavy deposits on hot side (bottom tube half). Moderate deposits located at the tube membranes with lesser amount on the cold side.

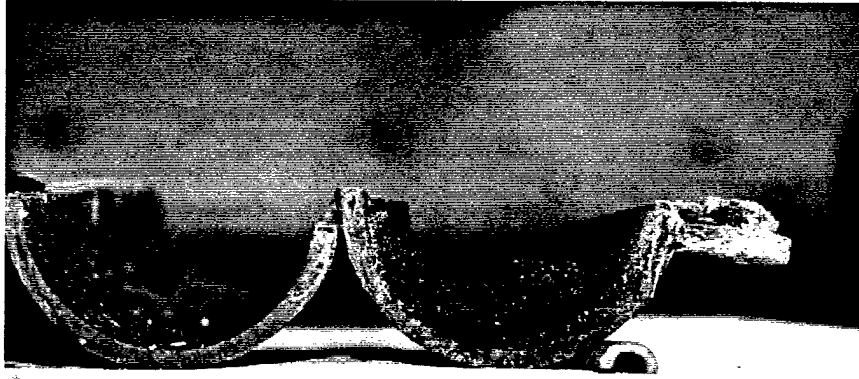
Figure 3 – Side view of tube sample reveals that hot side deposits are as much as 1.0 inch thick. Relatively little deposition was present on the cold side.

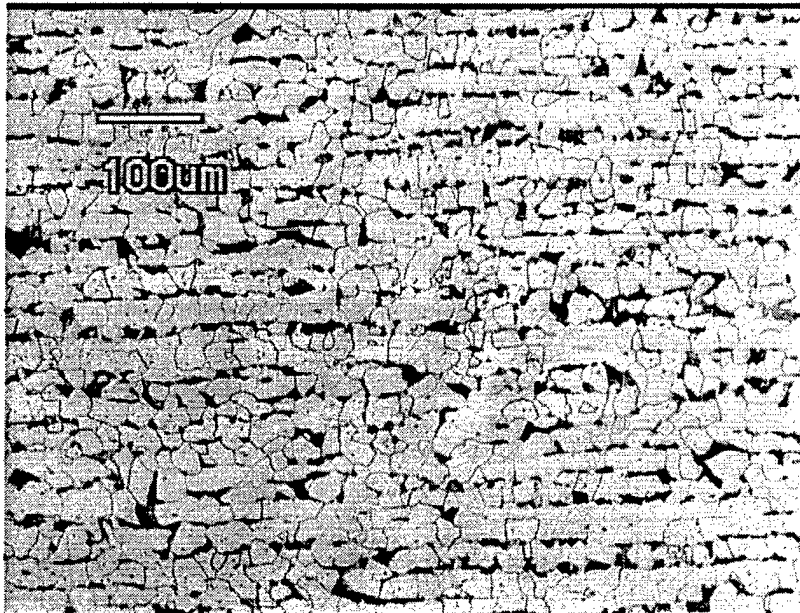
Specimens from the hot side and cold portions of the tube were selected for metallographic evaluation. The microstructure along the cold side (Figure 4) displayed a slightly banded configuration of ferrite and pearlite – a normal morphology of low carbon steel.

Figure 4 – Microstructure of the cold side displays a slightly banded ferrite morphology with pearlite. Magnification - 210X.

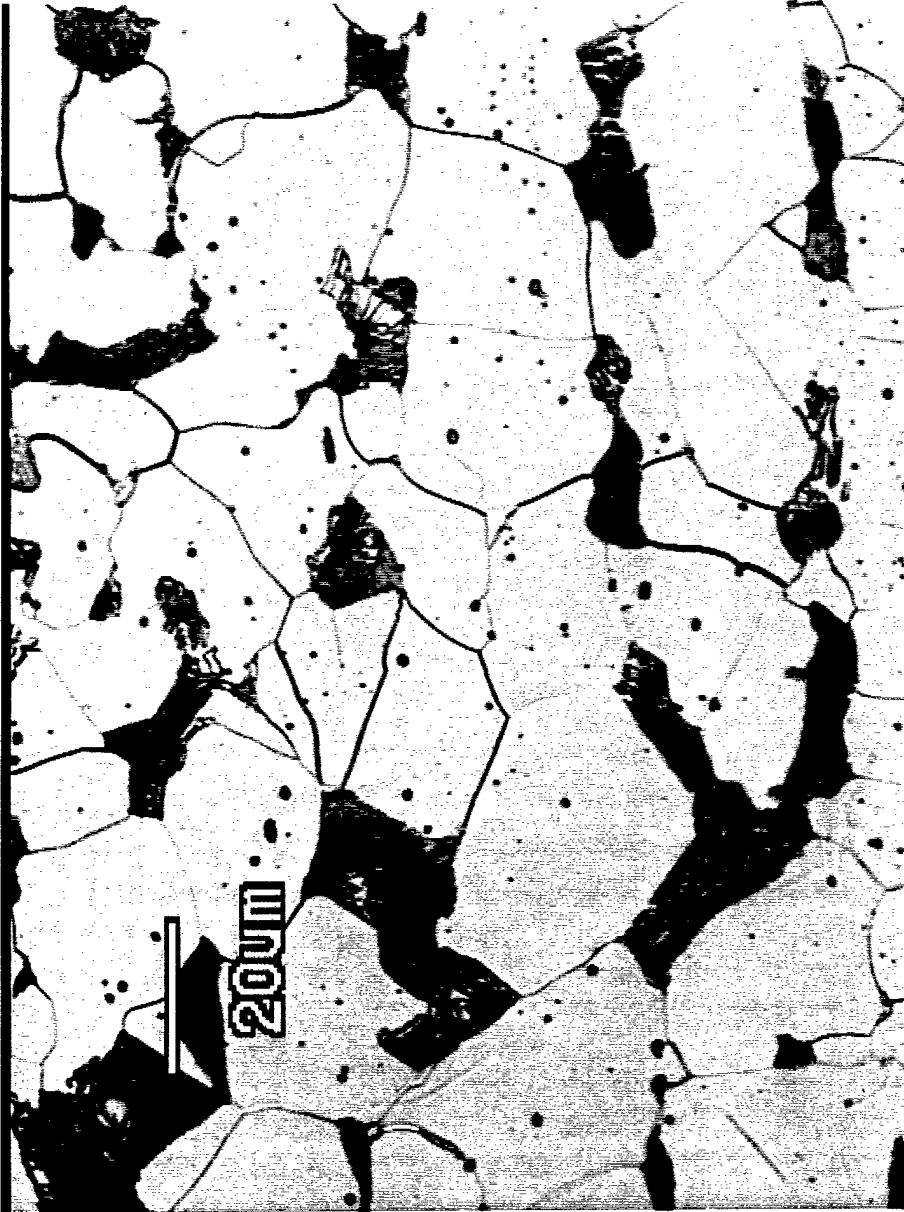
A magnified view of the cold side microstructure (180° and opposite from the failure) as shown in Figure 5 attests to the lamellar nature of the pearlite colonies in the ferrite matrix. Dark intragranular phases are observed and are likely composed of minor alloy constituents such as iron and manganese sulfides or silicates as well. The 0.004-0.006 inch thick waterside deposit, shown in Figure 6, along the cold side tended to porous. Some copper metal was located in the deposit.

Figure 5 – Magnified view of Figure 4 microstructure shows the lamellar carbides in the pearlite colonies. Spherical phases are small alloy constituents such as oxide and sulfide inclusions. Magnification - 1050X.

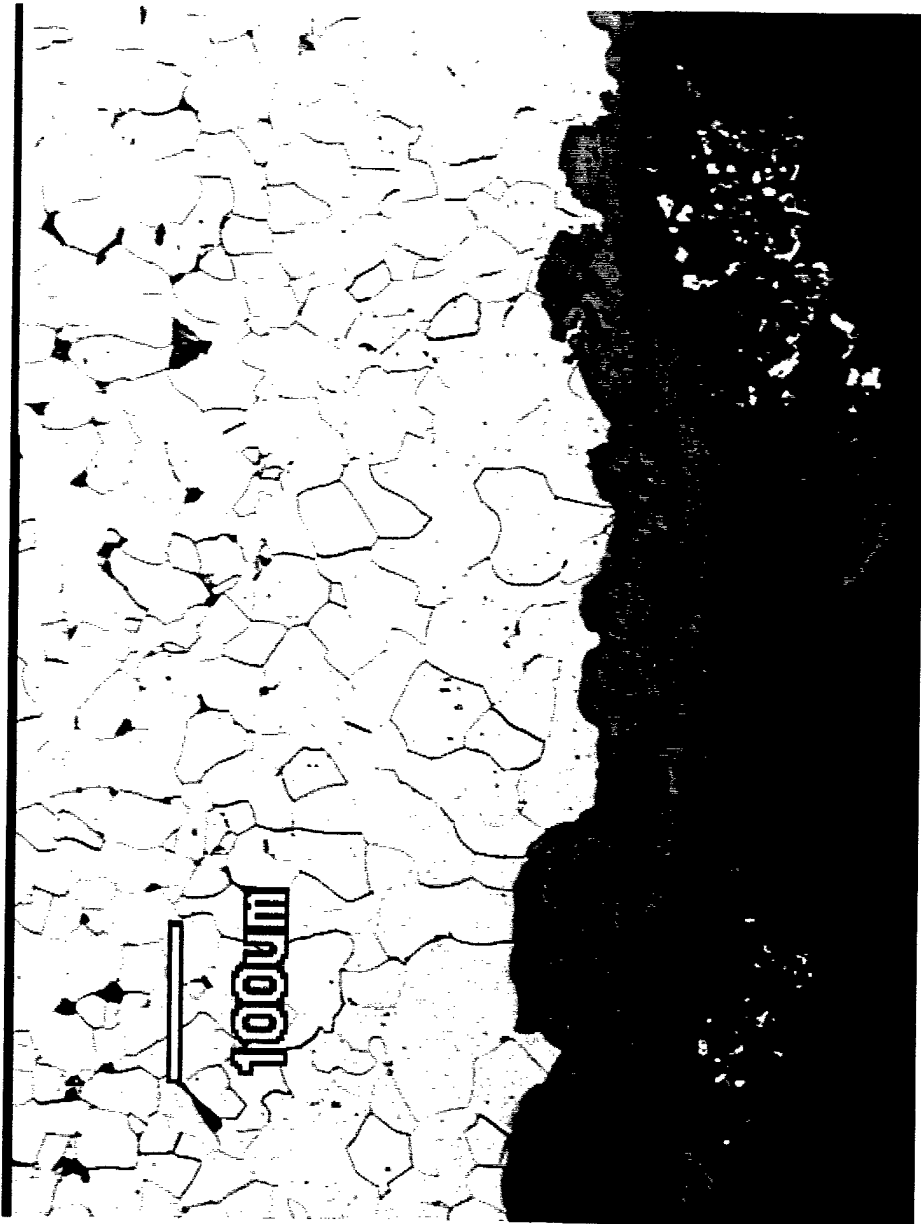
Figure 6 – Cold side oxide scale is about 0.004-0.006 inch thick, but tends to be porous. Copper metal is mixed in the deposit. Magnification - 210X.

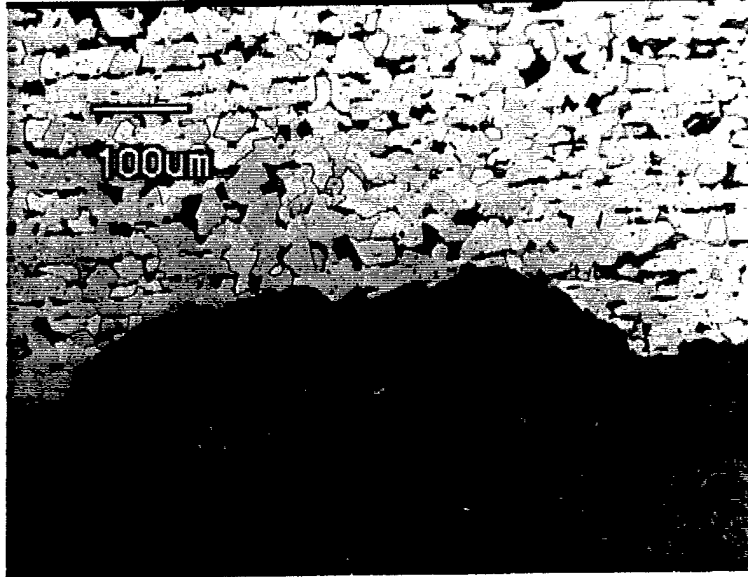
The microstructure along the hot side crown of the tube, but about 4 inches from the failure (Figure 7), discloses a relatively dense waterside deposit 0.001-0.002 inch thick with a more porous layer 0.003-0.011 inch thick. Copper metal particles are interspersed in the more porous layer. The tube substrate displays a matrix of pearlite and ferrite that shows no signs of thermal degradation as confirmed by the magnified photomicrograph in Figure 8.

Figure 7 – Microstructure along hot side crown displays a thick waterside deposit with some mixing of copper metal particles. The underlying tube matrix has not been overheated. Magnification - 210X.

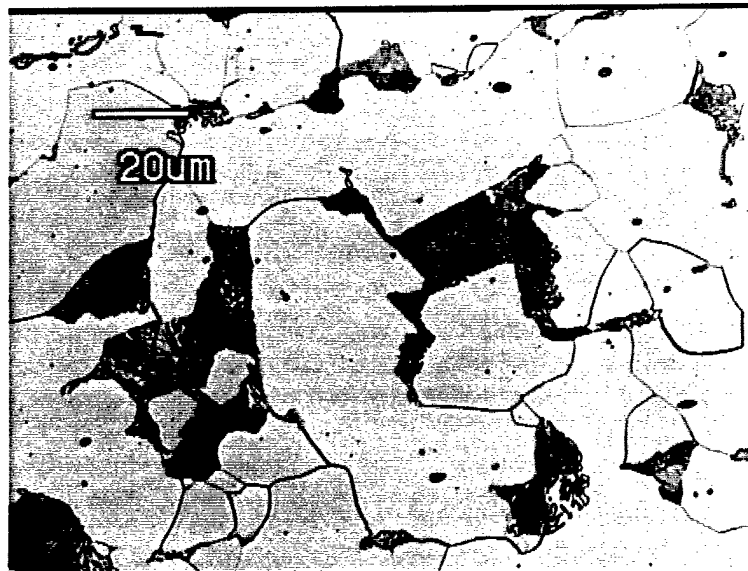
Figure 8 – Magnified view of Figure 7 shows no thermal degradation of the ferrite-pearlite tube matrix along the hot side area. Magnification - 1050X.

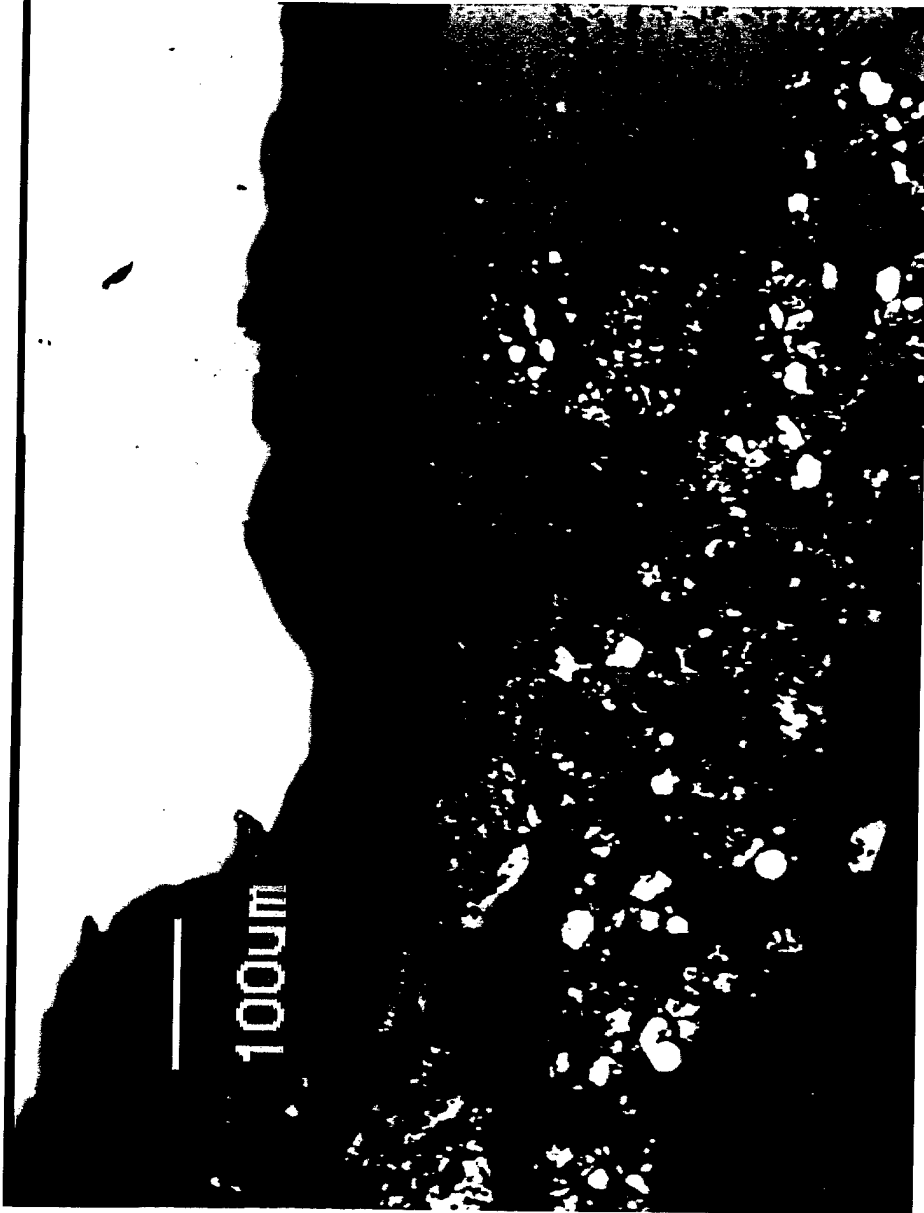
The waterside deposit in the vicinity of the failure exhibited several distinct layers of oxide (Figure 9). There was also heavy oxidation and corrosion of the waterside surface. The deposit shown in this photomicrograph is 0.024-0.028 inch thick. Some of the layers are quite dense while others are very porous. One layer exhibits a dispersion of copper metal particles while still another layer revealed needle-like, fibrous oxides. The thick, porous deposits of mainly iron oxides, copper oxides, and copper metal could have a relatively high insulating value that could provide opportunities where tube overheating could occur (Figure 10).

Figure 10 – Waterside deposit along hot side crown shows deposits containing mainly iron oxides, copper oxides, and copper metal. The high porosity of the thick deposit could provide opportunities for overheating. Magnification - 210X.

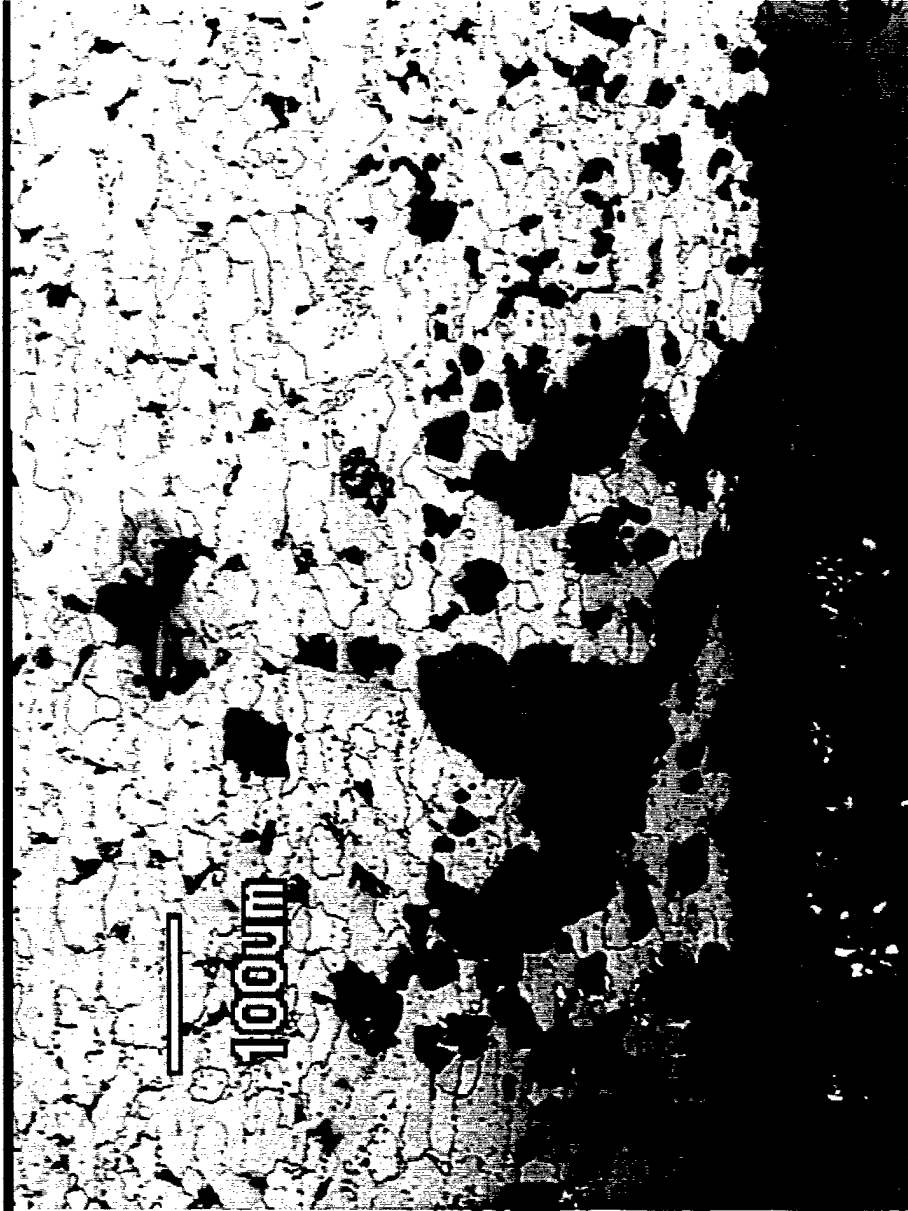
In Figure 11, the tube microstructure near the failure (~ 0.5 inch away) displayed complete spheroidization of the carbides from overheating. Voids developed at grain boundaries, particularly at three-grain junctions; these voids tend to be oriented perpendicular to the tube surface. The formation of these voids is due to long-term overheating and creep rupture. Some of the voids have grown and coalesced into larger voids and incipient microcracks; some of the largest voids have formed surface oxides. There is slight elongation of the grains as a result of tube swelling and expansion. The photomicrograph (Figure 12) shows a magnified view that clearly shows that the carbides at former pearlite colonies have fully spheroidized. Some of these carbides have dispersed into the grains. Other random carbides are present along the grain boundaries; , voids have formed at some of these grain

boundary sites. Void formation and propagation occurred in a direction perpendicular to the hoop stress.

Figure 11 – Waterside surface, hot side, near failure. Carbides in prior pearlite colonies have completely spheroidized from overheating. Creep voids have developed at grain boundaries; some of these voids have grown and coalesced. Magnification - 210X.

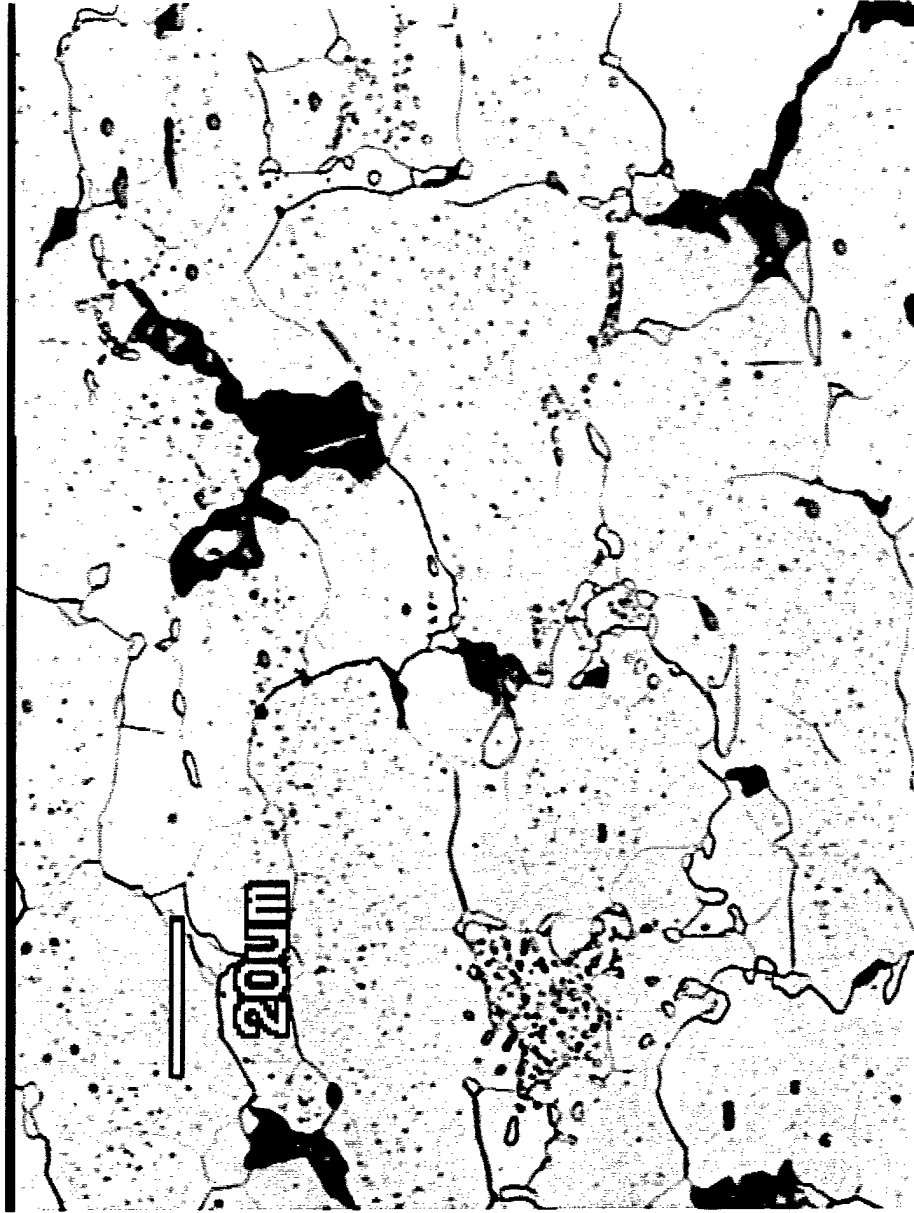
Figure 12 – Carbides are fully spheroidized from thermal degradation near failure. Voids (dark sites) have formed along the grain boundaries that are perpendicular to the direction of applied stress. Magnification - 1050X.

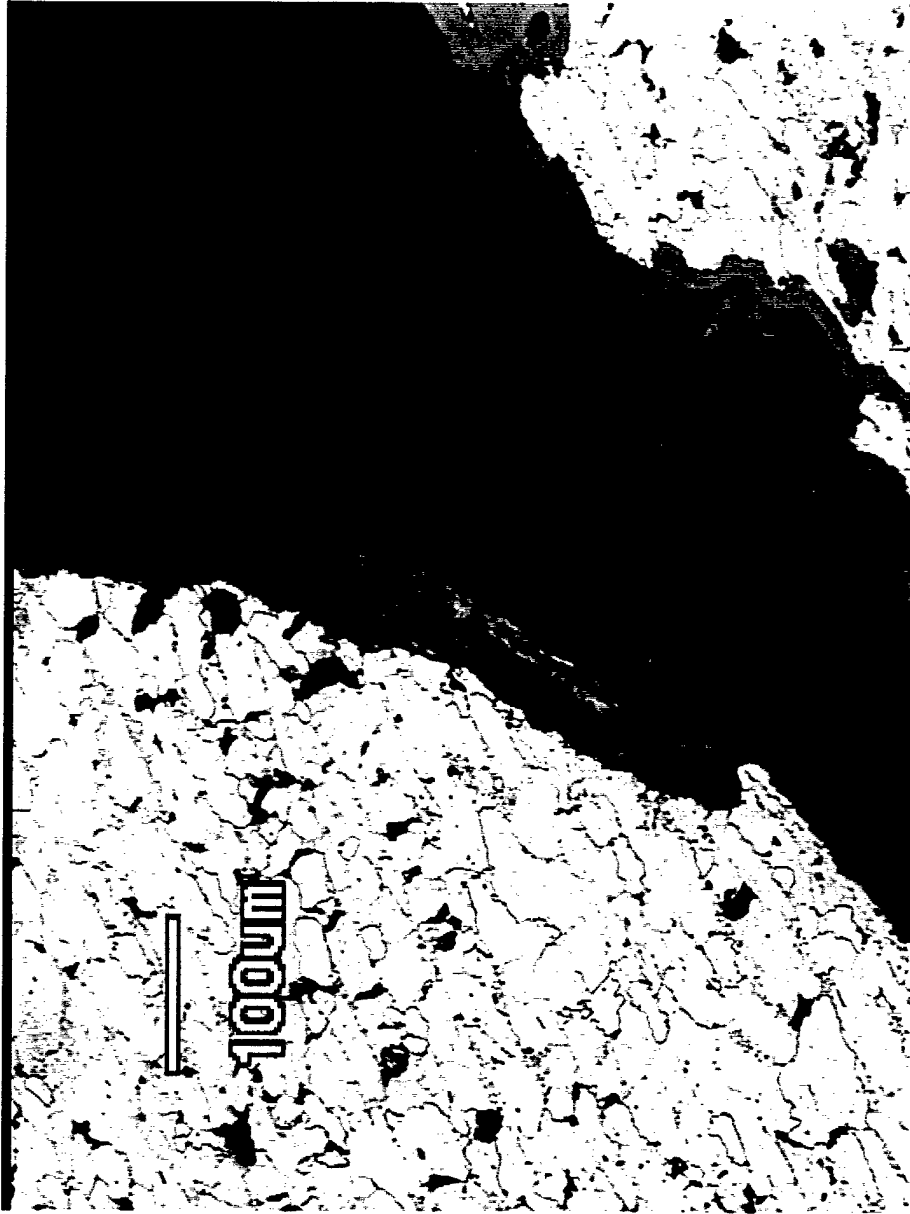
Voids initially formed at three-point grain boundaries, grew, and coalesced to form larger voids and microcracks. A few of these microcracks grew in the areas of highest stress to form macrocracks. Formation of these macrocracks increased the local applied stress, causing the cracks to grow with time. Figure 13 shows the macrocrack that led to a through-wall failure. The fracture surface is covered with a heavy oxide scale which appears to indicate that crack propagation occurred over a relatively long time. Some copper from the waterside surface has become embedded in the oxide scale.

Figure 13 - Fracture surfaces near tube midwall. The fracture surfaces are covered with a heavy oxide scale. Copper metal has been transported to this site. Creep voids found in the tube matrix along the fracture. Magnification - 210X.
