**Trial of Global Positioning  
System Based Field  
Wreckage Plotting and  
Analysis Equipment Using  
Data from a USMC F/A-18  
Aircraft Accident**

DSTO-TR-0828

**Airframes and Engines Division  
Aeronautical and Maritime Research Laboratory**

On August 20, 1998 a United States Marine Corps F/A-18 aircraft crashed at Delamere bombing range in the Northern Territory. AMRL was invited to aid in the investigation by trialing the AMRL wreckage mapping and analysis equipment at the site. The equipment was used to plot and record all wreckage of interest. Maps of the wreckage were produced on site and handed over to the accident investigation team. These rapidly produced maps, along with the experience brought with the AMRL investigators with on site wreckage examination, greatly aided the accident investigation team to expedite recovery of the site and clarify many aspects of the accident. To this end, the trial of the equipment was very successful. Following this trial, the data was used to explore the capabilities of other visualisation software, and its relevance to accident investigation. The results of this are presented during the discussion of the accident.

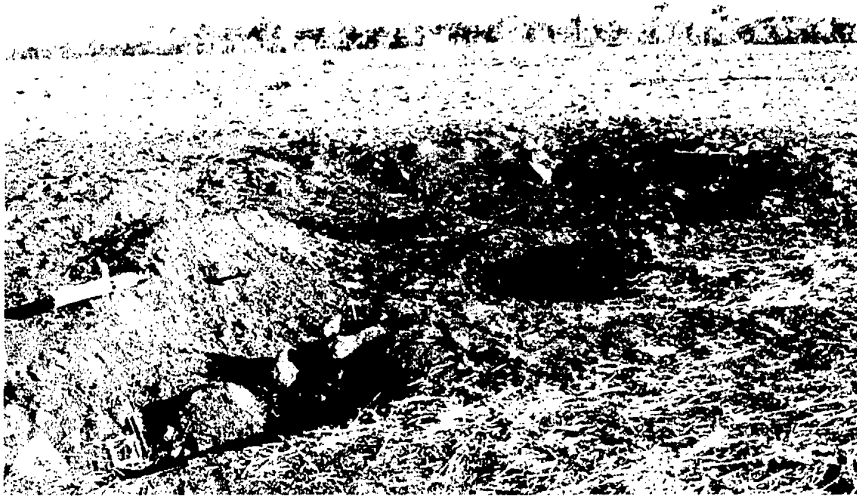
followed by mapping the positions of parts of interest immediately in and around the impact crater. Figure 5 gives an idea of the crater size and the nature of the surrounding range. The raked part of the range was devoid of trees and scrub. Beyond the raked boundary, the vegetation was mainly low trees with open grassed areas, shrubs and numerous termite mounds. Many practice bombs and other ordnance from previous missions were scattered throughout the wooded areas close to the raked part of the range.

Figure 5. The impact crater and the surrounding range. In the distance can be seen the edge of the raked range beyond which the indigenous vegetation existed (trees with an average height of 4m, and scrub) and anthills.

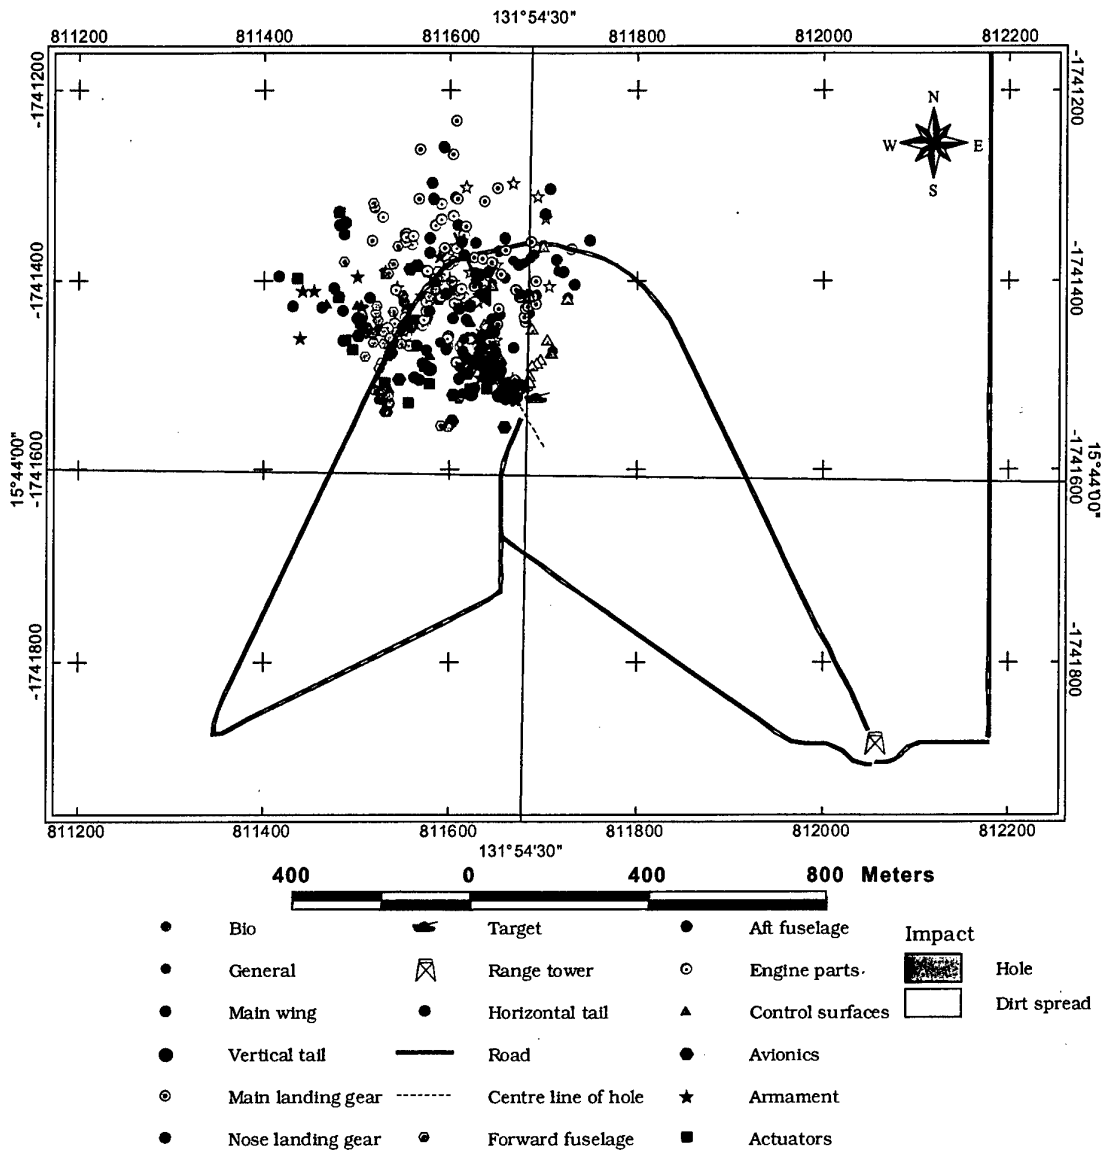
A map and legend of the wreckage site with all the mapped items shown, is presented in Figure 7. A list of the mapped items may be found in Appendix A. The map in Figure 7 indicates that the bulk of the wreckage was spread to the north west of the impact point, and that wreckage was spread over an area of about 600x600m (36 hectares). Some small heavy items were projected beyond these bounds. These were not considered significant enough to be mapped. A search back along the flight path did not find any debris that could have departed the aircraft prior to the impact.

Figure 7 Basic map of the wreckage and the surrounding land marks.

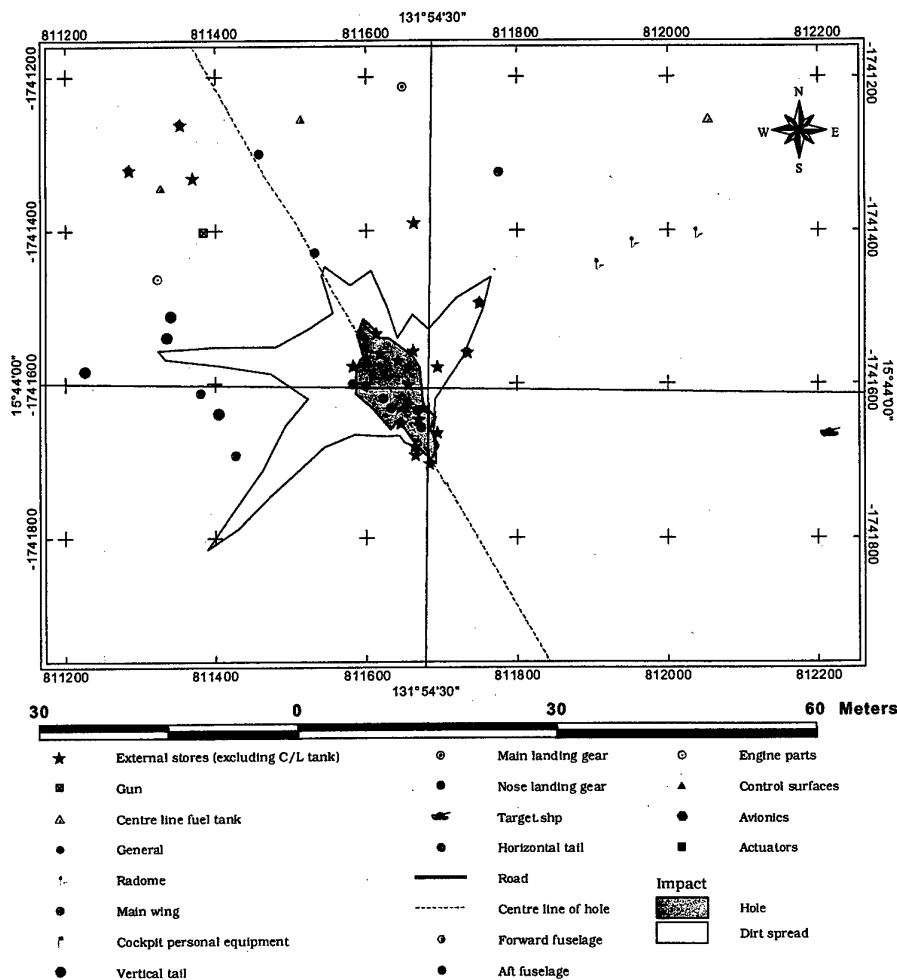
A map of the impact crater is shown in Figure 8. The impact crater was elongated in the suspected direction of the aircraft's travel. The crater was about 17.8 metres long and about 7.9 m wide at its widest point. The widest point was about 10 m from the southern end of the hole. A wing tip launcher - LAU rail part was found embedded in the ground at the southern end of the crater. Other related parts were found nearby, along with a number of wing (side unknown) parts. The ground consists of a layer of compacted topsoil overlaying a local rock known as 'coffee rock'. This rock consisted of hard ball shaped stones embedded in a softer matrix. The crater was a little over 1.5 metres deep, and had penetrated into the coffee rock layer. Very little of the wreckage was present in this crater. After mapping the crater and surrounding material of interest, the crater was further excavated to reveal any buried wreckage. This excavation failed to uncover any further major wreckage items, indicating that the majority of the wreckage had been ejected from the hole during the impact.

Figure 8 Basic map of the impact crater showing the crater shape and the shape of the dirt thrown out by the impact

- Parts of a wing tip missile and launcher were found at the southern most end of the impact crater (the leading end of the crater) indicating that the end of one of the wing tips probably impacted at this point (see Figure 8).

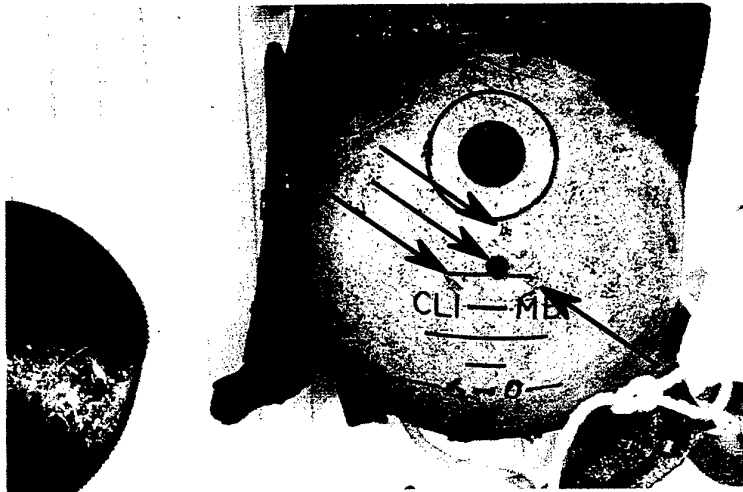
Marks from the rear pitch drive gear and its drive shaft were evident on the ADI ball. The drive shaft had punched a hole in the ball on the 80° CLIMB bar. The drive shaft, which is aligned with the longitudinal axis of the instrument, normally sits in the centre of the drive gear. This means that the hole it created in the ball was diametrically opposite to the pitch reading on the front face of the instrument. Since the scale on the ball is non linear with respect to degrees of ball rotation and reads from 0-90° climb and 0-90° descend, while using 135° of the ball rotation for each (climb and descend), then a hole at the 90° mark on the back of the ball corresponds to a reading of 30° on the front of the ball. Therefore, the hole at 80° climb on the back of the ball suggests that the ADI reading at the time of impact was 40° aircraft centre-line to the ground. The cursory examination of the remains of this instrument did not give a roll angle.

Figure 9 The ADI ball found in the field showing the hole (red arrow) punctured by the drive shaft. The three black arrows indicate indentations caused by the three screw heads adjacent to the drive shaft.

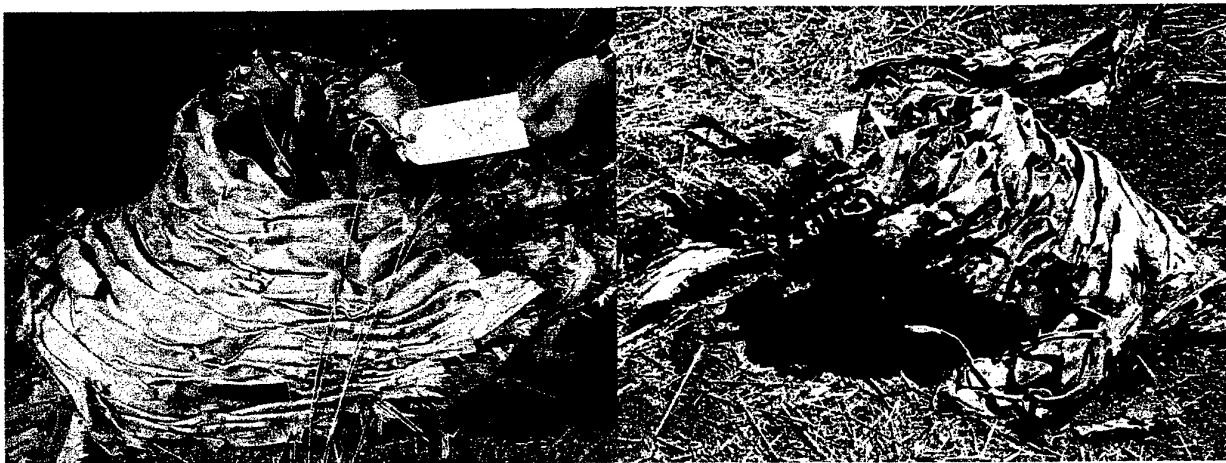
Several sections of the centre-line fuel tank were also found. These were all located to the right of the impact crater. One section consisted of parts of the aluminium alloy casing. This section (Figure 10 A & B) of casing had been concentrically crushed along the longitudinal axis of the tank. This concentric crushing of the tank along its axis suggested that the main loading was applied to the leading tip of the tank, along the longitudinal axis of the tank.

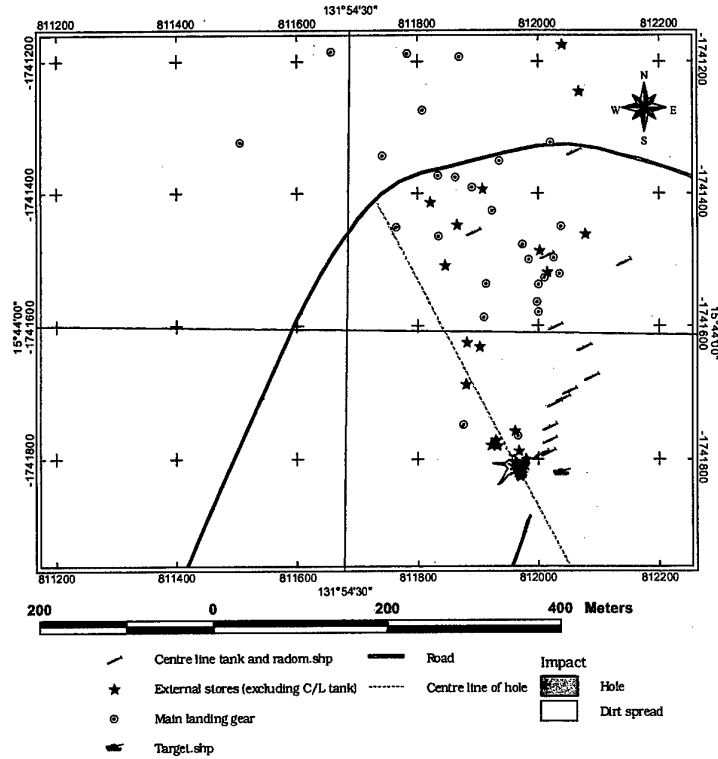
The most notable feature of the wreckage distribution was an apparent grouping of similar items, from similar sections of the aircraft, in the wreckage field. An examination of wreckage items associated with the lower section of the aircraft, such as the main landing gear and the external stores (including the centre-line fuel tank), indicated that these parts were mostly to the north (right hand side) of the projected centre-line of the impact crater, Figure 12. Those parts that were associated with the upper part of the aircraft were to the west, Figure 13. This suggests that the aircraft was rolled to the left at impact. This fact is most notable if the underbody stores are compared to the position of the gun parts. The gun is in the upper part of the nose. The external stores and the gun are both heavy items and would be expected, if the aircraft were wings level, to travel in the direction of the aircraft's momentum. Figure 14 shows that this is not the case and it is clear that some other factor caused the underbody stores to deflect to the north while the gun parts deflected to the west. It is interesting to note that the position data for the external stores, centre-line fuel tank and gun parts were all collected under either the 'armament' or 'general' theme names. Without separating out this data, the pattern was not as strongly evident as is shown in Figure 14.

Figure 12 The underbody stores, including the centre-line fuel tank and the main wheels were all deflected to the north of the expected direction of aircraft travel.

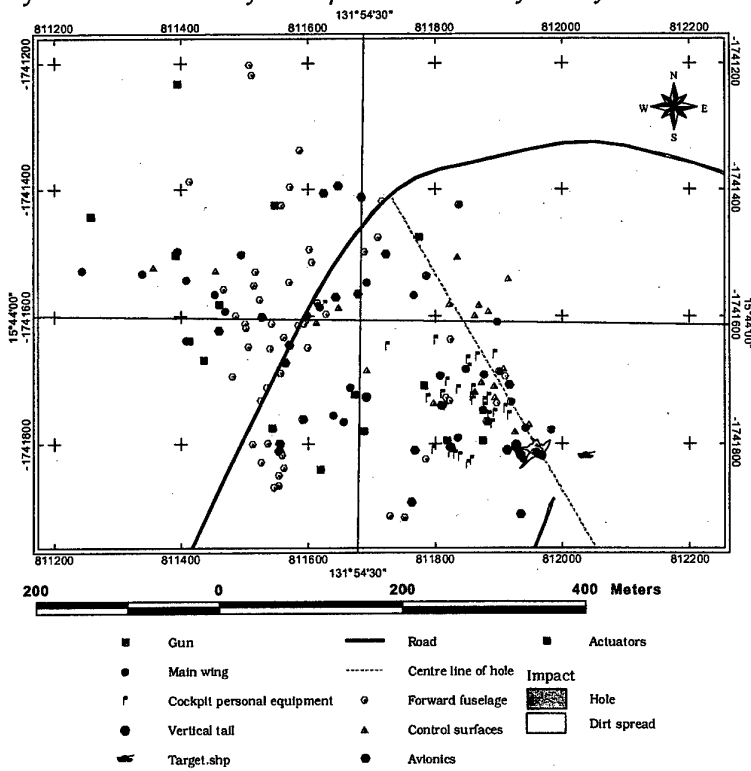
Figure 13 The wings, forward fuselage, gun, cockpit items, actuators, avionics and tail parts were all deflected to the west of the expected direction of aircraft travel.

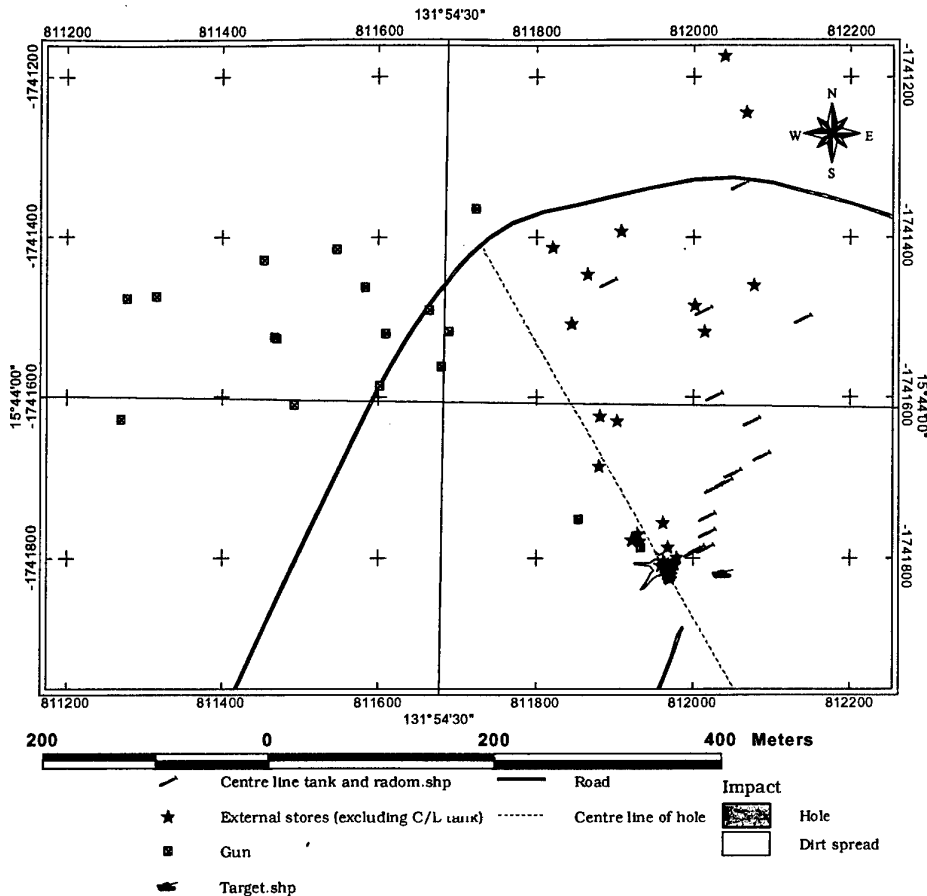
Figure 14 The gun, external stores and centre line tank showing the deflection of these heavy items to either side of the impact crater.

The cause of the deflection of items to either side is probably the result of two significant factors;

- The aircraft was banked to the left, and
- the engines, after impact travelled through the aircraft in approximately a straight line, deflecting items of the aircraft to either side.

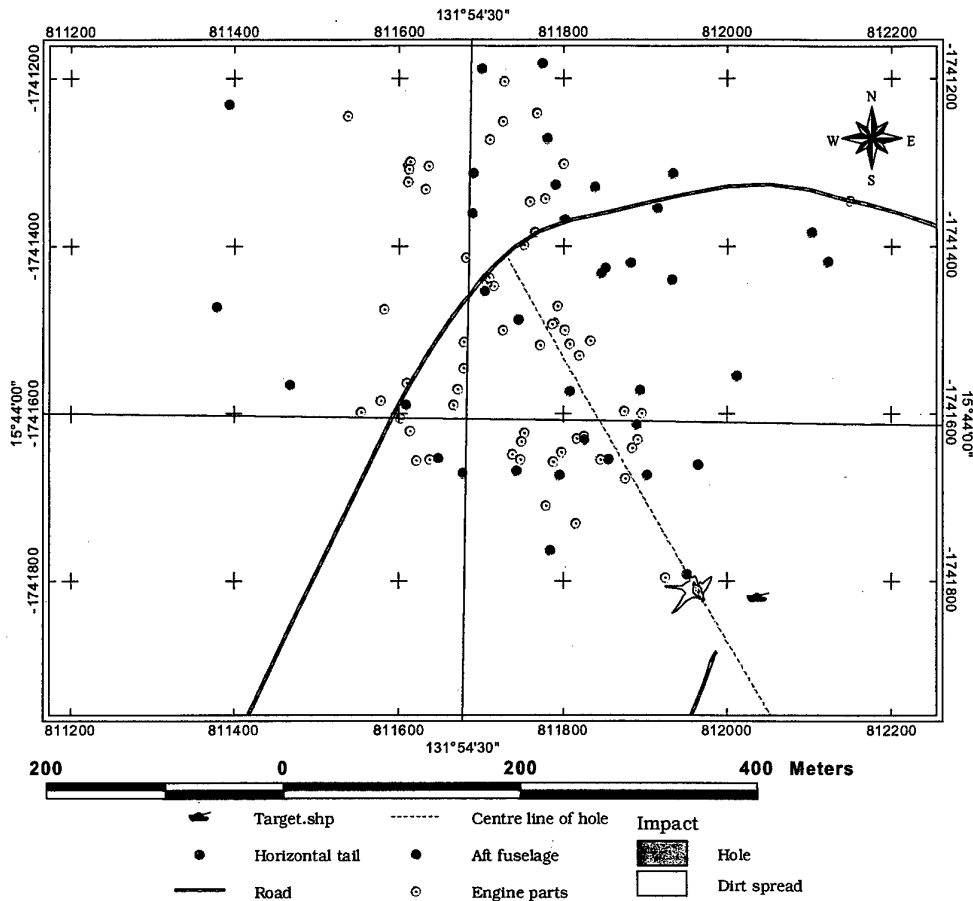
Taking the second point first: An examination of the positions of the engine parts indicated that they had mostly travelled in the approximate line of aircraft travel, Figure 15. As would be expected the high mass of the engines, along with their aft placement would probably result in these parts having the least deflection from the aircraft's heading at impact. The very highly disrupted nature of the airframe in this accident also suggests that the engines travelled through the structure. The, relatively narrow width of the impact crater suggests a low angle of attack with wings vertical. These facts are supported by the observed nature of the crushing of the centre-line fuel tank, which appeared to have been crushed along its axis. Had an angle of attack been present the crushing of the centre-line tank would have been along an axis offset by the angle of attack.

Figure 15 A map showing the engine parts, aft fuselage parts and the horizontal stabiliser parts. Note that all these parts appear to be clustered along the probable direction of aircraft travel at impact.

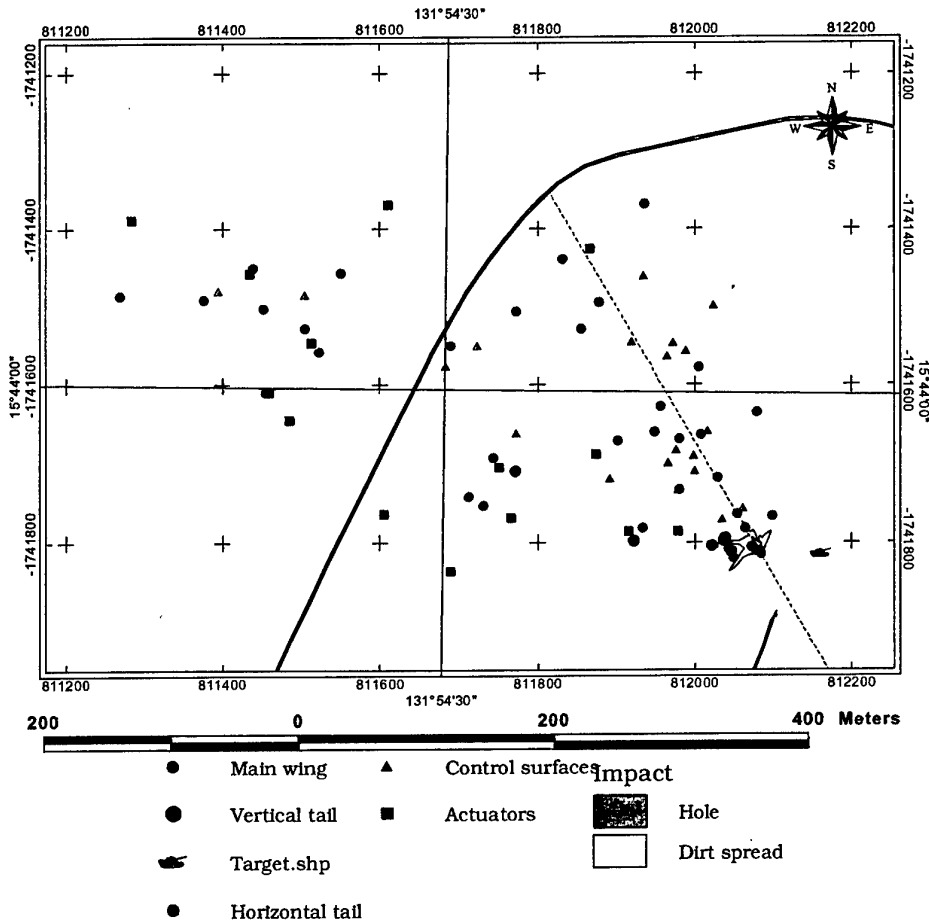
A further examination of the items mapped in Figure 15 indicates that apart from the engines and aft fuselage parts travelling along the extended centre-line of the hole, indicating the axis of travel of the aircraft at impact, the horizontal tail also appears to be along this line. This would suggest that the tail was not generating either lift or down force at the time of impact. Either of these would have been expected to deflect the aerofoils to one or the other side of the direction of travel of the aircraft – remembering that the aircraft appears to be banked at about 90 degrees to the left. This also supports the notion that the aircraft was not pulling positive angle of attack at impact. This should be compared with the wings, which were probably generating some lift resulting in deflection to the west of the crater. The vertical tails would have been on its side to the left in this scenario, and therefore should be to the west side of the crater, as they were. The actuators were also spread to the west of the centre-line also, along with the control surfaces, as these are mostly associated with the wings. These features are shown in Figure 16.

Figure 16 The positions of the lifting surfaces and associated parts indicating that the horizontal tail did not appear to be generating lift or down force at impact.

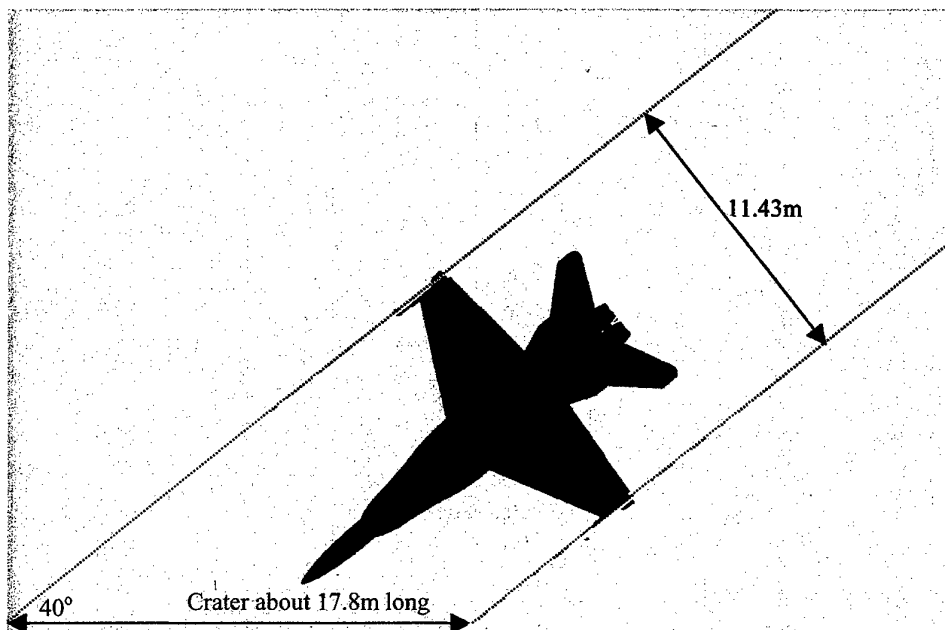
The spread of the wreckage suggested that the main momentum vector ie the direction in which the aircraft was travelling was roughly north west, and aligned with the centre-line of the impact crater. If the aircraft had impacted wings level the crater would have been of the form of a silhouette of the aircraft. Typically with wing impressions either side of the hole and an elongation of the hole depending on the angle of attack of the aircraft, the direction of travel of the aircraft and angle of the aircraft to the ground. Clearly the crater was not of this form. The analysis of the positions of certain wreckage items strongly indicated that the aircraft was steeply banked to the left at impact (probably about 90). The lack of wing impressions to the side supports this. With the aircraft banked by about 90 degrees to the left at impact, the length dimension of the hole takes on the wing form. If the width of the aircraft is considered along with the length of the hole, a calculation of the angle at which the aircraft struck the ground can be made. The geometry of this situation is shown in Figure 17. Knowing that the aircraft was 11.43m wide and the crater was about 17.8m long, and assuming that the entire length of the crater was caused as a result of the wing tip to wing tip dimension, the aircraft impact will be a reflection of the aircraft projected onto the ground from its direction of travel. Calculating this projection gives an angle that the aircraft would have made with the ground of about 40 degrees. This is supported by the evidence of aircraft attitude as suggested by the examination of the ADI.

Figure 17. A projection of the aircraft onto the ground at about 40° gives the approximate length of the impact crater.

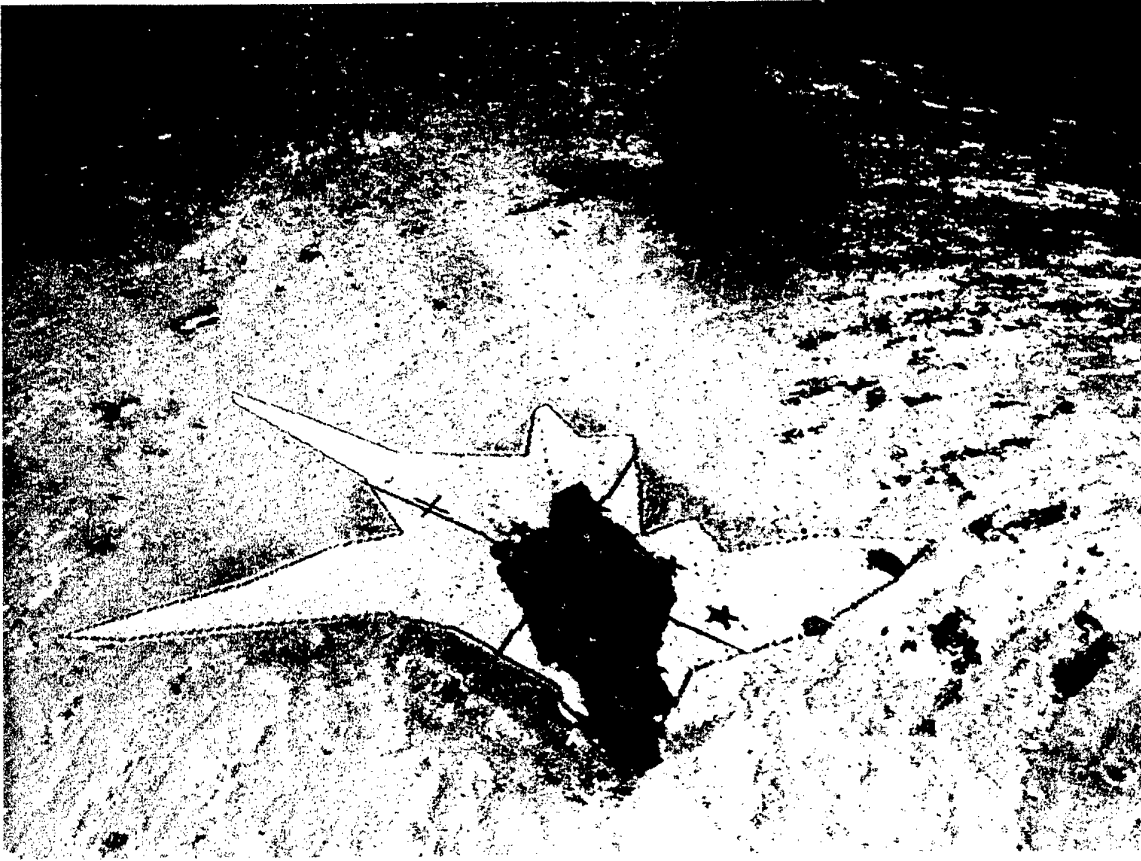
By using the map gained from the GPS data projected onto an image of the impact crater and surrounding area, it was possible to imagine the view that the pilot would have had just prior to impact. This view is from about 50m above the ground looking down the 40 degree to the ground line. Note that the target is outside this view. The view is shown in Figure 18. This imaging was prepared by using an image analysis program and a 3D program.

*Figure 18 A view of the impact crater from about 50m above the raked range from roughly along the flight path of the aircraft. A projection of the map of the impact crater and dirt spread has been placed over the image of the crater.*

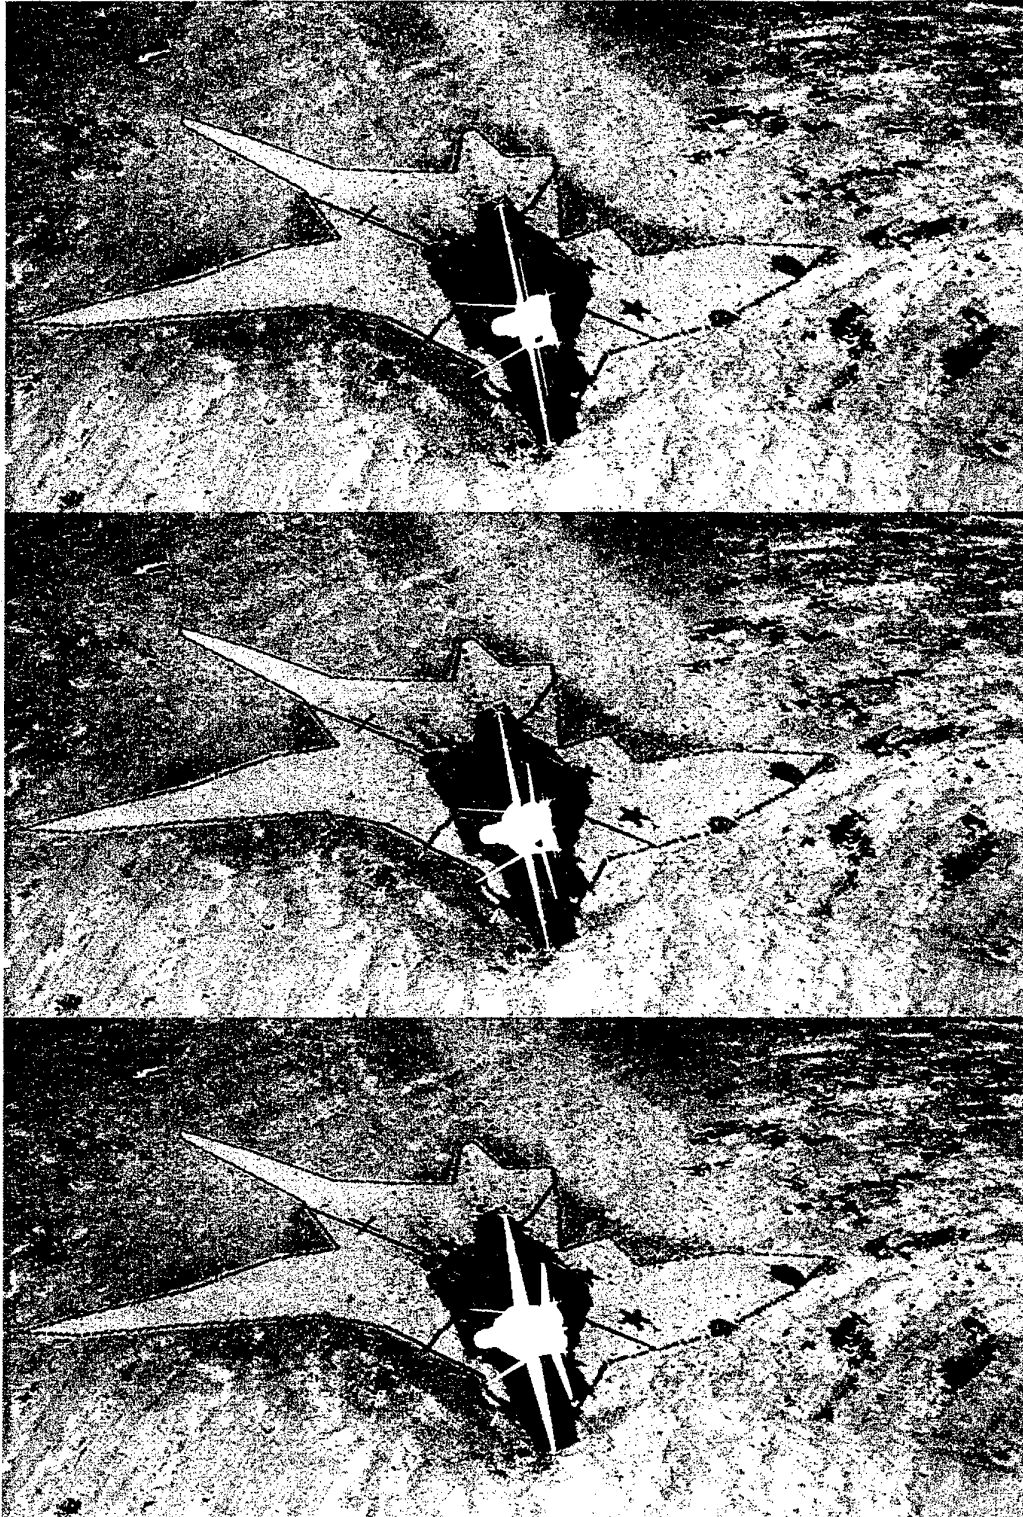
By adding a 3D model of the F/A-18 aircraft to the image shown in Figure 18, and placing the model in the suspected orientation over the hole, it was possible to determine whether the hole was consistent with the hypothesis. It is also possible to try different angles of attack to see if the projection of the aircraft is consistent with the impact crater. Three of these projections are shown in Figure 19. Although angles of attack from 0-10° appear to be possible, the ejecting debris could easily have widened the crater. This argument is not as strong when considering crater lengthening due to debris ejection. The main mass of the aircraft would have impacted the ground about the centre of the crater, resulting in widening to either side and towards the far wing tip. Since the impression made by the far wing tip is about 9m from the centre of the aircraft impact, there is considerable distance for crater lengthening without reaching the wing tip mark. Assuming perfect reflection, (ie. 40° in and 40° out of a 2m deep hole caused by a 2.5m (approx.) wide fuselage, then the widened part of the hole would be about 7.5m long). Naturally, the material exiting the crater would be wider, due to fuselage spreading, than the fuselage entering the hole and therefore the hole would be expected to be wider on the exit side. These points are consistent with the approximate length of the wide section of the crater, which is about 8.5m long, with the wider section of the hole being biased towards the furthest end.

*Figure 19 Three views of a projection of an F/A-18 on to the map and image of the impact hole. The first view is with the aircraft at a 0° angle of attack, the second at 5° angle of attack and the third at 10° angle of attack. Although all are possible the ejecting debris could easily have widened the crater.*

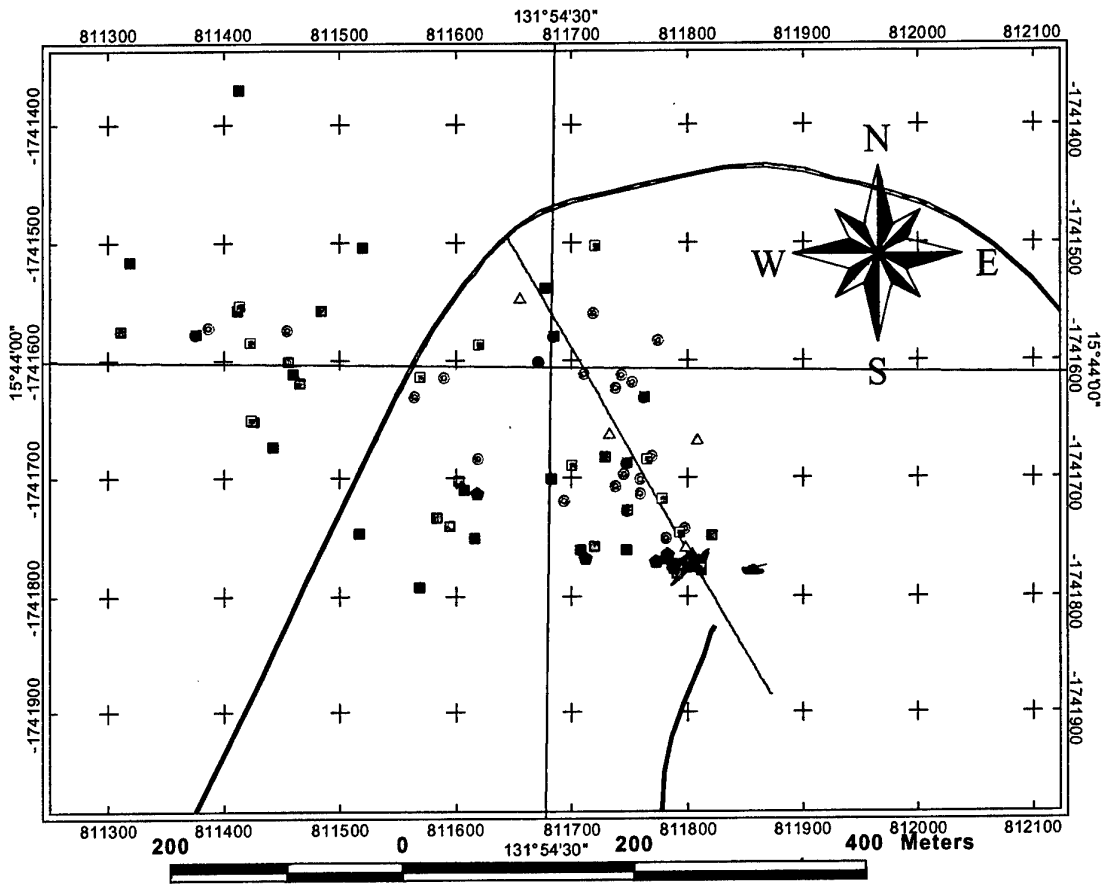
Aerodynamic surfaces and associated parts showing their trend to the north west of the aircraft line of travel.
