TECHNICAL REPORT ARCCB-TR-99016

**GRAY LAYERS AND THE EROSION OF  
CHROMIUM PLATED GUN BORE SURFACES**

**PAUL J. COTE  
CHRISTOPHER RICKARD**

SEPTEMBER 1999

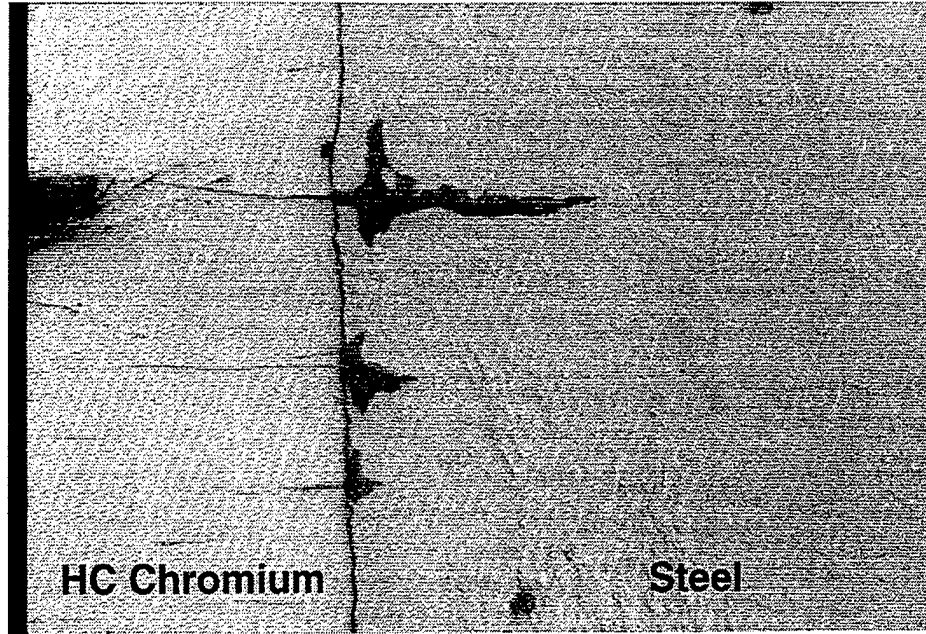
**Original 2000X**

Figure 1 is a photomicrograph showing erosion damage of specimen 1 at the chromium/steel interface after about 1200 conventional rounds. The dark areas at the tips of the chromium cracks are gas-steel reaction products. An unetched specimen was examined to more clearly delineate the reaction product, which appears as a solid gray material under optical microscopy. Metal attack clearly occurs via gas ingress through the fine cracks in the chromium plate. Energy dispersive spectroscopy indicates that the gray material is a mix of iron oxide and iron sulfide.

Figure 1. Micrograph of an unetched section of specimen 1 showing the chemical attack on steel. Note fissures are present within the steel reaction products.

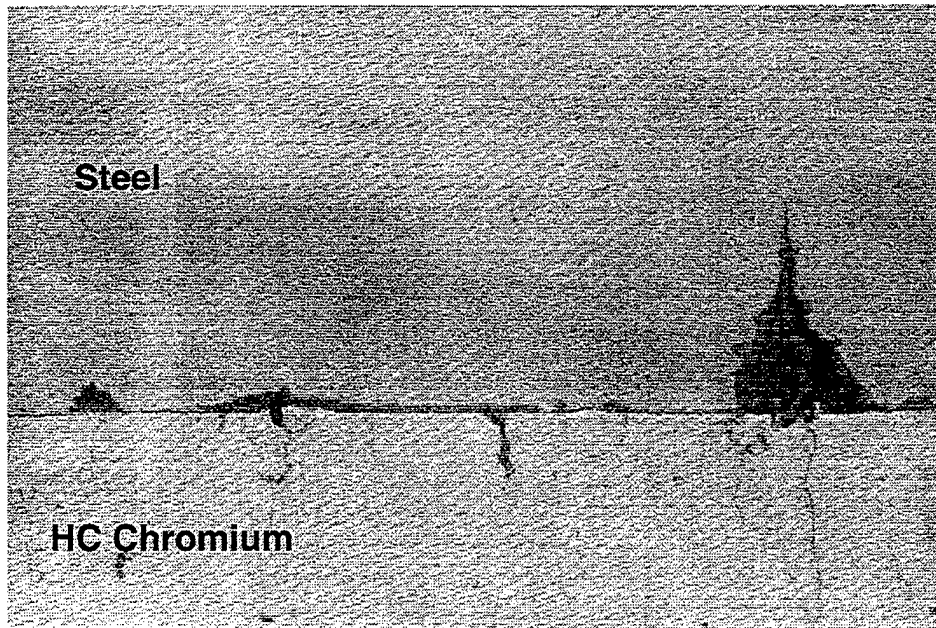
**Original 500X**

Figure 2 is an unetched micrograph from specimen 2 after approximately 80 high-temperature experimental rounds. The figure shows that the gas-steel reaction product can, in some instances, extend for large distances along the interface.

Figure 2. Micrograph of an unetched section of specimen 2 showing the chemical attack along the interface.

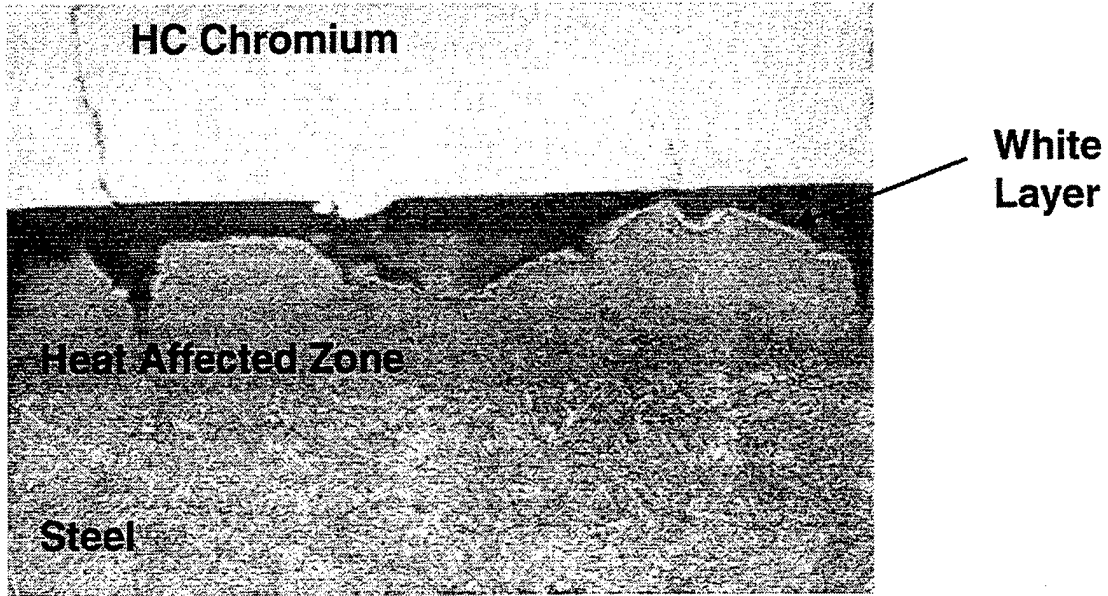
**Original 500X**

Figure 3 is a micrograph of an etched section from specimen 2. There is substantial removal of the gray material from the etching process (demonstrating that this is not a white layer), so that the pitting becomes more clearly defined. A heat-affected zone is seen in this micrograph. It can also be seen that a true white layer exists at the interface between the gray material and the steel. The white layer is only observable within heat-affected zones after etching. The gray material is partially removed by the etching process known as a Nital etch. The gray material is also removed by exposure to a drop of concentrated phosphoric acid, which leaves the surrounding steel and white layer unaffected. This ready attack by weak acid solutions is further evidence of a steel reaction product.

Another observation reflected in Figures 1 through 3 is that the decomposition pits can join up along the steel/chromium interface as the pits grow into the steel. Such chemical attack is obviously a major disbonding mechanism for chromium spallation.

Figure 3. Micrograph of an etched section of specimen 2 showing dissolution of reaction products, heat-affected zone, and white layer.

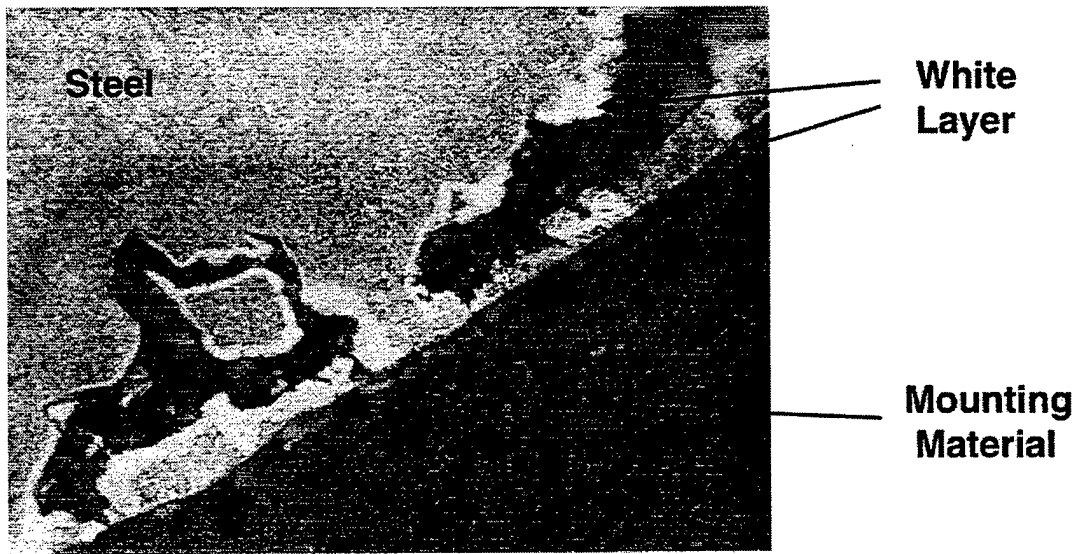
**Original 500X**

Figure 4 is a micrograph of a severely eroded area from specimen 2. There is a total chromium loss at this area, and the erosion process removed approximately a 5-mm layer of the steel at this location. A thin white layer can be seen at the steel surface, and extensive white layer formation occurs around the deep pits in the steel. This is known to represent fine-grained retained austenite stabilized by carbon and nitrogen with precipitates (primarily carbides) distributed throughout the retained austenite. The reaction products that form in the protected regions beneath the chromium a few millimeters away, as shown in Figure 3, are absent in this highly eroded area.

Figure 4. Micrograph of an etched section of specimen 2 where the chromium and an approximately 5-mm layer of steel beneath the chromium had been removed by erosion.

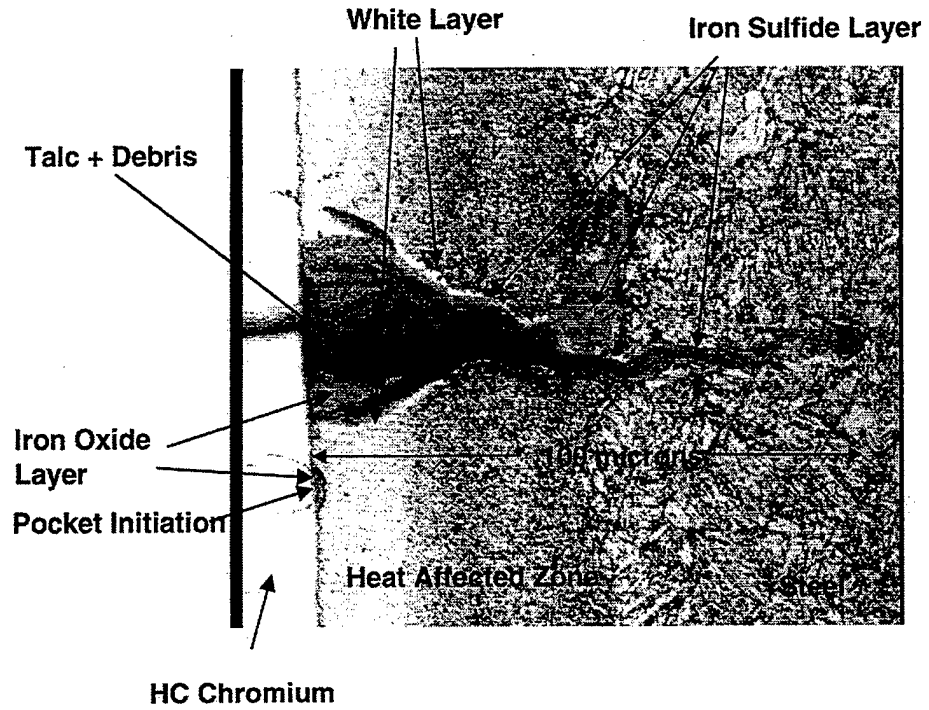
Figure 5 is a micrograph of an etched section from specimen 2 that was used for EDS chemical analysis. The chemical composition shows that the indicated compounds occur as part of the gray decomposition products. The white layer forms as a thin bright layer at the steel surface. It is known to be an austenite layer in the steel with carbide precipitates. Immediately adjacent to this white layer is an iron sulfide layer, which runs all along the pit surface and extends to the blunt tip of the pit, well beyond the heat-affected zone. The depth of the corrosion pit in the steel is approximately 100 microns. The reaction product covers the entire surface and thus forms at high temperatures during firing. At the core of the pit is a zone of iron oxide with

no evidence of sulfide. A mixture of talc and other debris is also seen in the core region in this case. Similar features are seen in all the other erosion pits on this specimen. Occasionally iron oxides and iron sulfides appear to be mixed together. The small pocket reaction zone at the tip of the fine chromium crack in Figure 5 shows the earliest stages of chemical attack. Only iron oxide is observed in this case. The initial progress of chemical attack radially into the gun tube appears to occur through fissures in the thick oxide or sulfide layers.

Figure 5. Micrograph of an etched section of specimen 2 indicating the chemical compositions deduced from EDS analysis.

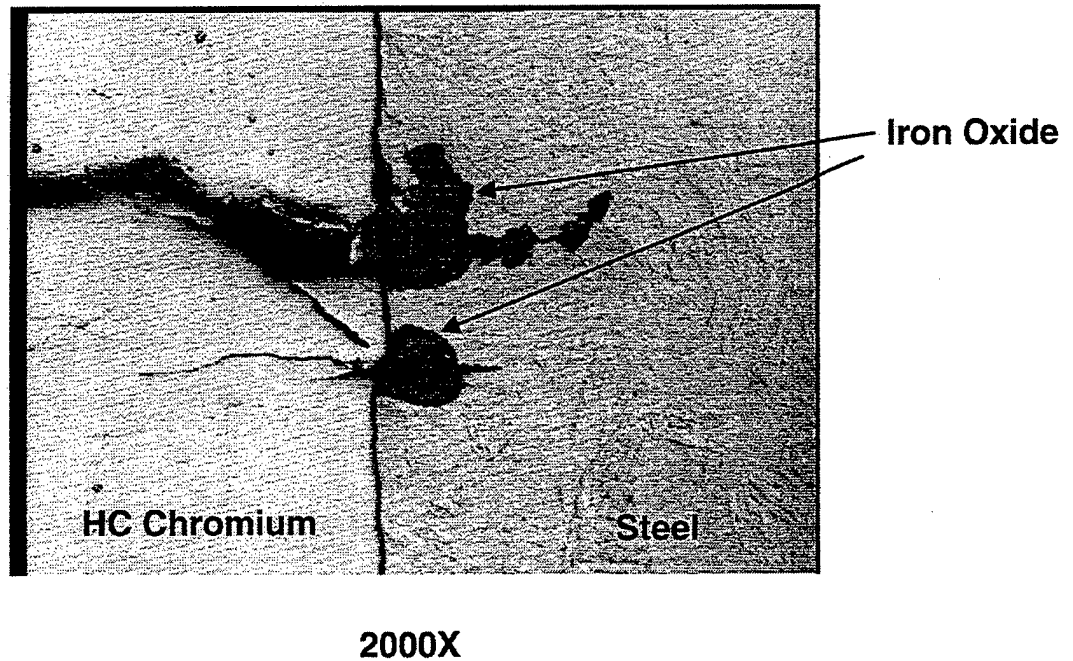
Figure 6 is a micrograph of an unetched section from specimen 3 (120-mm, 424 conventional rounds—approximately an equal mix of M829 and M829A2 rounds). Again the features are the same with gray reaction zones at the tips of the chromium microcracks. Energy dispersive spectroscopy shows the gray zones contain only iron oxide.

Figure 6. Micrograph of an unetched section of specimen 3 depicting different stages of chemical attack.

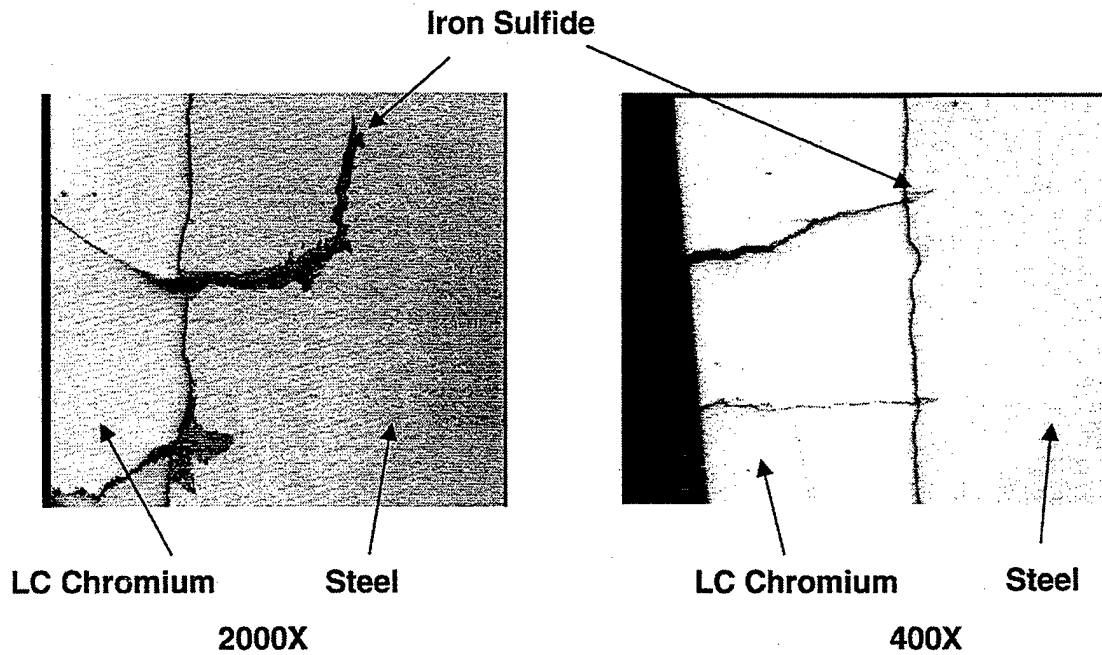
Figure 7 consists of micrographs of an unetched section from specimen 4 at 2000X and 400X. This section is from the LC plated 155-mm specimen. The numerous fine embedded cracks that occur between the major cracks with HC chromium are absent. In this case, the gray layers often exhibit a distinct yellow tint. Energy dispersive spectroscopy shows only iron and sulfur, indicating that the gray/yellow reaction zones are sulfides. The sulfur likely originates from the potassium and/or sodium sulfate used as a flame suppressant in the 155-mm.

Figure 7. Micrographs of specimen 4 at 2000X and 400X showing initiation and propagation of chemical attack.

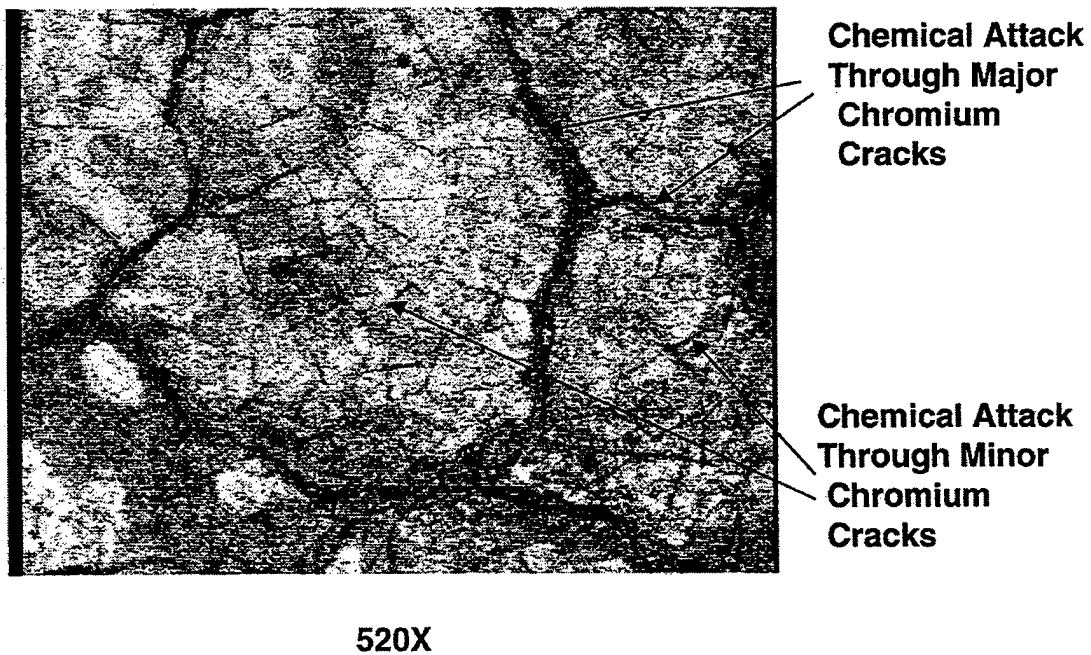
Figure 8 is a micrograph of the bore surface from specimen 2 where all of the chromium coating has been electrochemically stripped away from the steel substrate. It is seen that the entire array of large and small cracks that are present in the chromium are replicated in the erosion pattern in the steel. From this specimen orientation, all of the major fracture-like features in the steel are also solidly filled with the same dark glaze-like material (along with many of the fine crack-like features). This supports the observations regarding crack filling described above. From the previous analysis of the same tube, the dark fill material is known to be predominantly talc.

The original chromium layer in Figure 8 was heavily spalled prior to stripping this specimen. The nature of the spalling is a removal of numerous individual islands of chromium whose boundary is determined by the major chromium cracks. In the initial stages of spallation, the chromium has the appearance of being heavily pitted with many small pits visible without magnification. After stripping away the chromium, there is no evidence of pitting or spallation extending into the steel substrate; thus, the spallation of the chromium does not originate by fracture of the steel. This is in accordance with LCSM inspection of dozens of spalled regions, which show the depth of the spalls extending no deeper than the chromium/steel interface zone. Usually, in both the LC and HC specimens, fragments of chromium are observed adhering to the steel at the flat bottom of the spalled regions showing that the spallation originated from metal failure in the chromium or at the chromium/steel interface region.

Figure 8 also shows that the erosion of the steel occurs as closed paths around rounded chromium islands. These paths extend into the steel as chemical attack drives the "heat-checking" process through the chromium cracks and into the steel. It has been observed that the depth of penetration of damage can be orientation-dependent (ref 5).

The propagation of damage through the chromium and into the steel is clearly by chemical attack of the steel beneath the chromium. Figure 8 illustrates that the damage to the steel substrate is a high-temperature etching process so that the chromium plate serves, in effect, as an etching mask. Chemical attack forms relatively large, often isotropic volumes of reaction product at the chromium crack tip. The terms "pocket erosion" and "mushrooming" have been coined for the advanced stages of this phenomenon (ref 1) in gun tubes. A similar phenomenon, termed "ballooning oxidation," occurs with hot corrosion beneath coating cracks in gas turbines (ref 12). There are also indications that the gray layers can propagate along grain boundaries by occasional observations of fine lines of gray reaction products extending from the main erosion pits.

Figure 8. Micrograph of specimen 2 steel/chromium interface plane after electrochemical removal of all chromium in this area. Note the depth of penetration of the corrosion zones into the steel should vary roughly with the widths of the corrosion gaps at the surface.
