MODIFICATIONS TO THE TUBE-LAUNCHED, OPTICALLY TRACKED, WIRE-COMMAND MISSILE LAUNCHER FOR THE BRADLEY FIGHTING VEHICLE SYSTEM

Report Number 98-165

June 25, 1998

**Office of the Inspector General
Department of Defense**

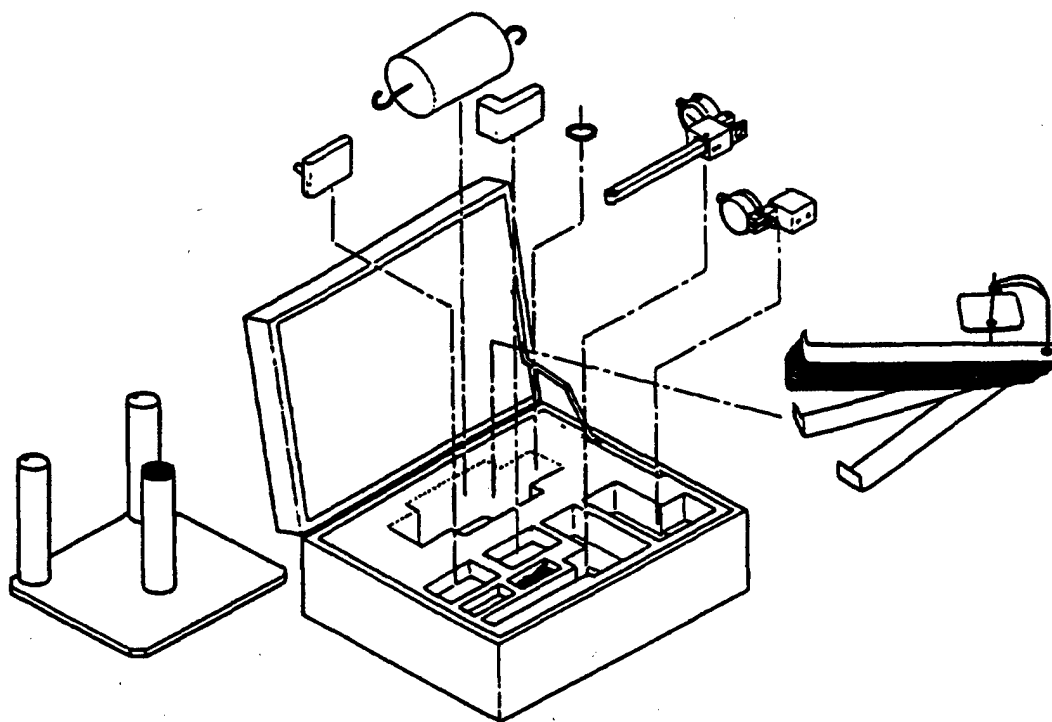
Figure 2. Switch Adjustment Gauge Set

ACU Final Assembly and Testing. Final assembly and testing of the ACU requires a switch adjustment gauge set, part 1366078, to ensure proper alignment of the ACU. The gauge set comprises gauge assemblies, tools, and fixtures as shown in Figure 2.

The gauge set is used to align and test umbilical and motor stop switches within the ACU. Those switches must be set to precise tolerances to satisfy design specifications and meet minimum in-process quality assurance inspection points required by the DMWR.

Required Test Equipment. The program office did not enforce the use of special test equipment required by the DMWR to test the modified TOW missile launcher. The DMWR specifically identifies the special tool kits, jigs, test measurement, and diagnostic equipment required to check the operation of the TOW missile launcher. For example, the DMWR specifically requires the use of the switch adjustment gauge set; the setscrew adjustment gauge; and the boresight alignment fixture, as discussed above.

Use of TOW 2 Subsystem Support Equipment. Instead of the required test equipment, the field modification teams used the TOW 2 subsystem support equipment supplemented by the Raytheon-manufactured Bradley Fighting Vehicle System turret logic emulator to perform quality assurance testing of the modified TOW missile launcher. The equipment provided off-vehicle direct support level testing of the TOW missile launcher. The capability of the Raytheon Systems Company test equipment was not sufficient to satisfy the quality assurance testing requirements of the DMWR.

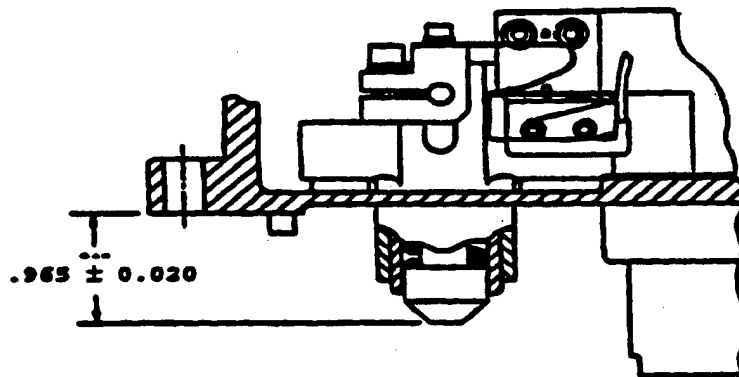
Figure 3. Umbilical Switch Specification

Alignment of Umbilical Switches. The DMWR requires the gauge set to align and test the ACU umbilical switches S1, S2, S3, and S4. Switches S1 and S2 are associated with the inboard launcher tube, while S3 and S4 are associated with the outboard launcher tube. The S2 and S4 switches, when activated, signal that a missile is present. The S1 and S3 switches, when activated, signal that a missile has been selected. According to the design specifications, those umbilical switches should be aligned to activate when the bottom of the holdback pin plunger is 0.965 inches, plus or minus 0.020 inches, from the bottom of the ACU housing as shown in Figure 3.

The S1 through S4 gauge assembly of the gauge set is used to measure the depth of the holdback pin plunger at the time the umbilical switches have been activated.

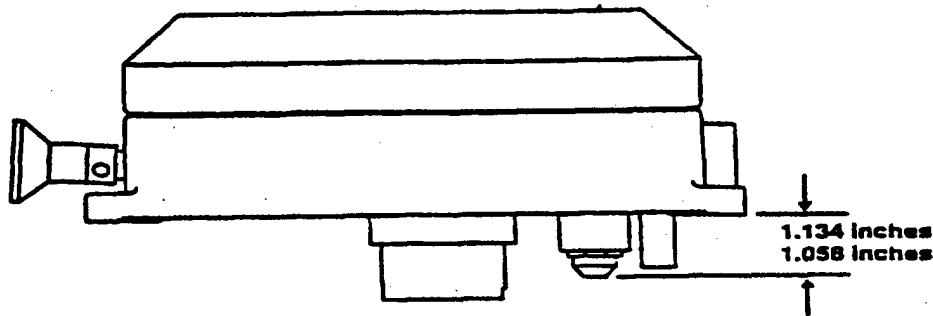
Figure 4. Holdback Pin Plunger Depth Specification

Alignment of Motor Stop Switches. The DMWR requires the gauge set to align and test motor stop switches S5 and S6. The S5 switch is the electrical limit switch for the extend function of the ACU motor. The S6 switch is the electrical limit switch for the retract function of the ACU motor. The S5 and S6 settings affect the distance that the holdback pin plunger and umbilical cable are extended when arming the system and retracted when disarming the system. The gauge set, specifically the S5 gauge assembly is required to ensure that the holdback pin plunger depth in relation to the ACU housing is between 1.058 inches and 1.134 inches, as shown in Figure 4, in order to satisfy design specifications.

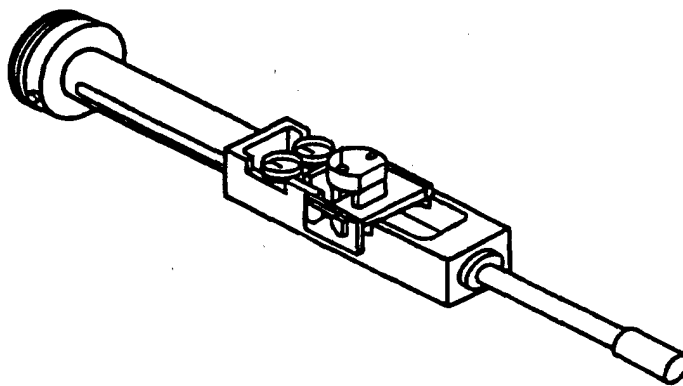
Figure 5. Setscrew Adjustment Gauge

Setscrew and Stop Block Adjustments. A setscrew adjustment gauge, part 12295912-40101-5 (shown in Figure 5), is required to perform the setscrew

and stop block adjustments to ensure that they meet the design specifications. The setscrew is to be set between -0.0005 inches and 0.0005 inches; and the stop block is to be set between 0.002 inches and 0.001 inches.
