**F-111 Bonded Panel Repair
Status**

DSTO-TR-0803

**Maritime Platforms Division
Aeronautical and Maritime Research Laboratory**

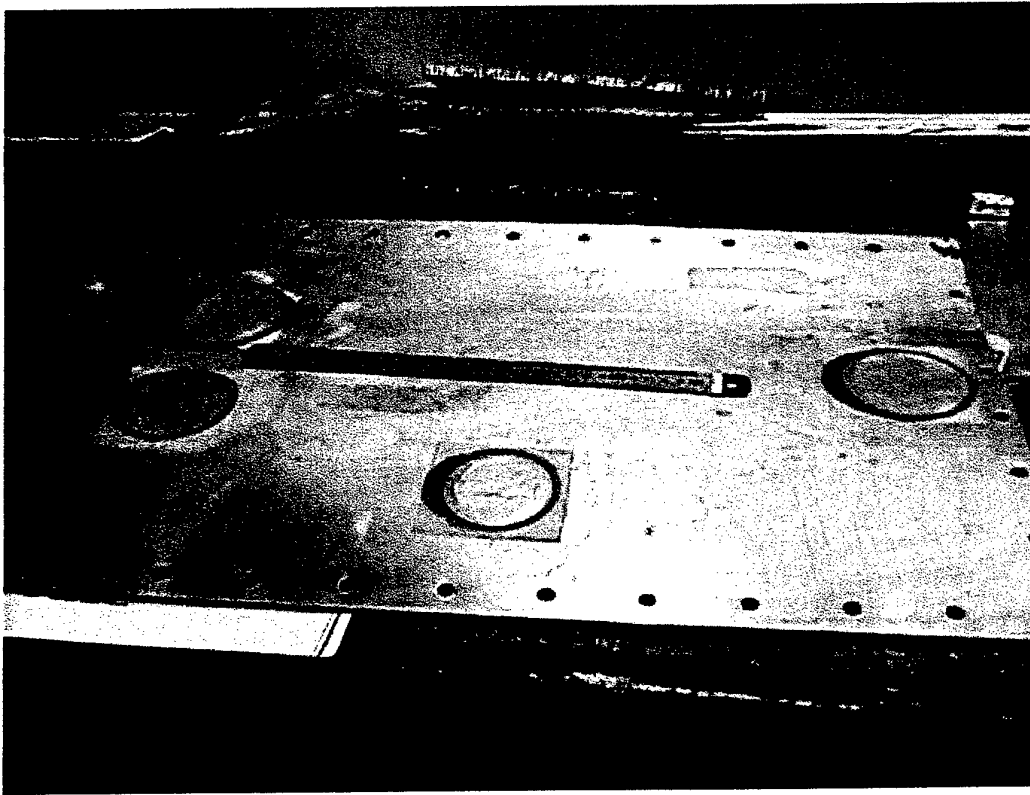
The first case in which this problem arises is when honeycomb panels with pre-existing injection repairs have a metal patch applied. The Engineering Standard C5033 indicates that a metal patch should be placed over existing injection repairs after NDI inspection and moisture removal. This procedure is conducted to provide environmental protection and structural strength to the honeycomb panel. Typically a tap test identifies the damaged region and skin is removed from this area. If the core is intact then moisture removal is undertaken and a patch is applied. In some instances further damage to the panel occurs during drying of the panel at 110°C. This damage is caused by steam pressurisation. Figures 1 and 2, however, provide a good example of the extent of the damage that occurs during the vacuum bag curing of the FM-300 adhesive when the structural metal patch is bonded.

Figure 1.0 Structural metal patches bonded over injection repair areas of a honeycomb panel. Patches bonded at 160°C using FM-300. The ruler is 350mm long.

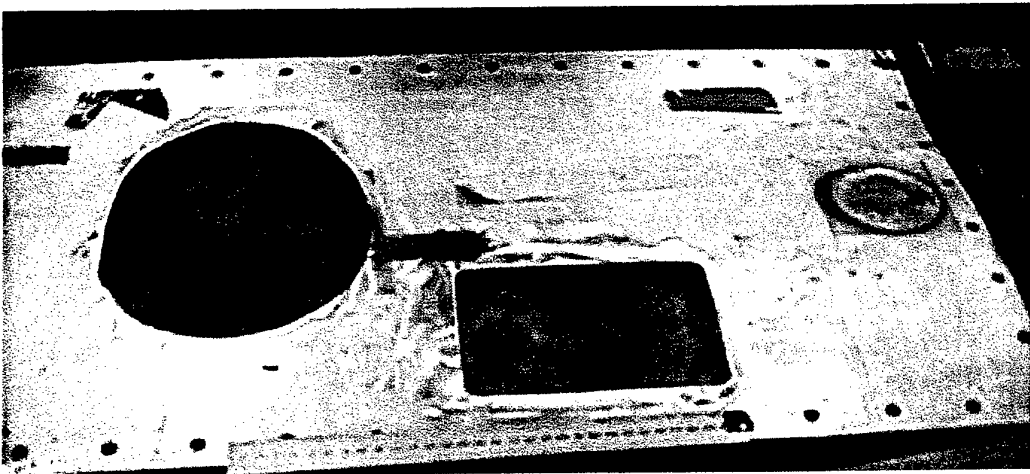
Figure 2.0. The areas that had to be routed from the panel in Figure 1.0 as a result of disbond failure occurring during the cure cycle of the adhesive required for the patch application to the pre-existing injection repairs. The ruler is 350mm long.

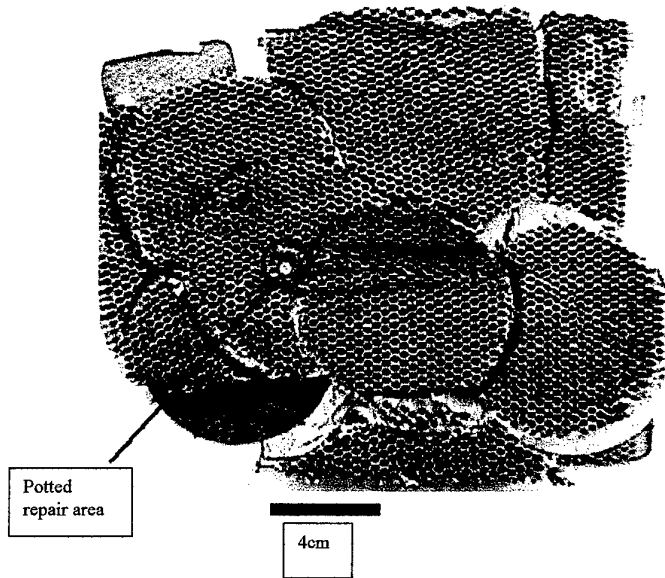
In the second example a potted repair was performed on an F-111 fuel tank. The initial repair involved riveting and potting a partially debonded patch as shown in figure 3. The damaged area was initially only 2cm in diameter. Subsequently, a series of holes were drilled for injection repairs to rebond the partially debonded patch, as shown in figure 4. A second patch to repair the rivet and potted repair in figure 3 was cut around the defective patch, thus reducing the required overlap length of the repair patch. The moisture removal procedure, refer section 4, extended the damage, leading to a full skin and core removal of approximately 25cm x 25cm. The repair shown is in figure 5. The repair requires a request for disposition/request for waiver(RFD/RFW).

Figure 3.0 The initial repair of an F-111 fuel tank. This involved riveting and potting a partially debonded patch. This area was initially only 2cm in diameter.

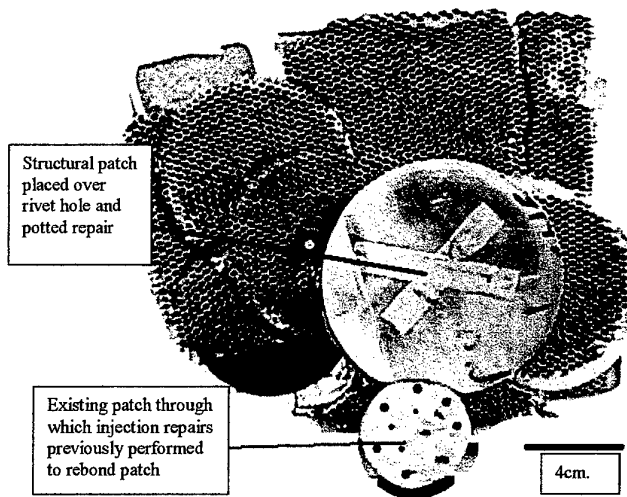
Figure 4.0 The second stage of the F-111 fuel tank repair. Injection repairs attempted to rebond the partially debonded patch. A second patch to repair the rivet and potted repair in Figure 3 was cut to fit around the defective patch, reducing the required overlap specified by the repair document.

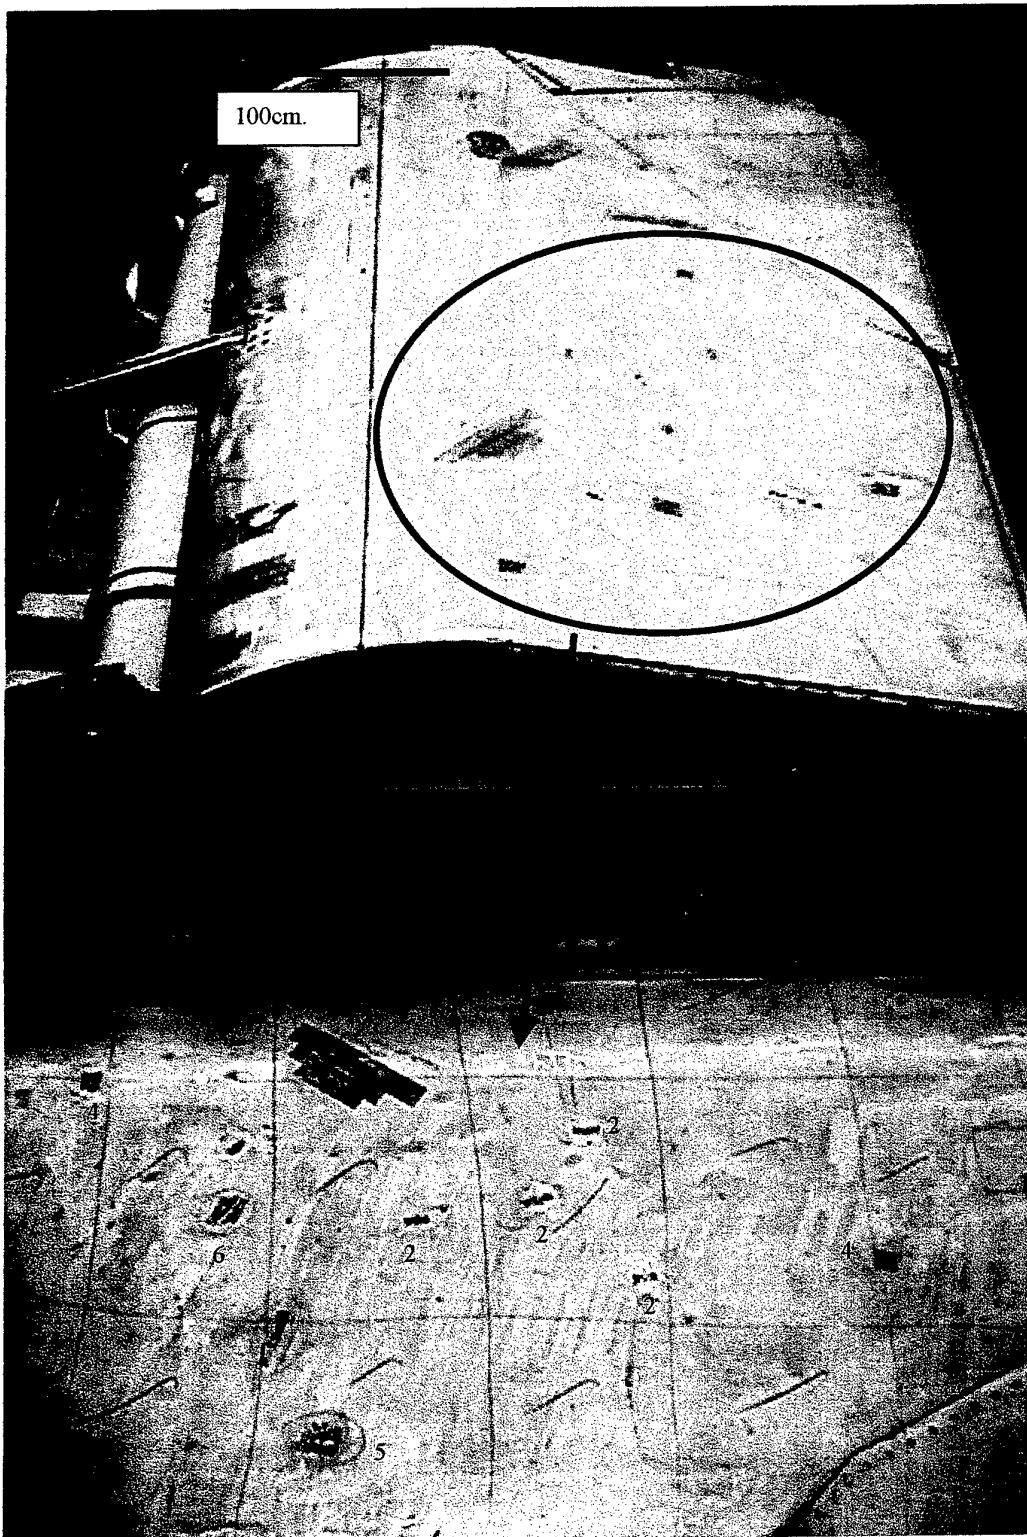
Figure 7.0 An example of the potential number of injection repairs, which may be associated with one F-111 honeycomb bonded component. Injection repair hole numbers are indicated. None of these repairs had been protected with a structural patch.

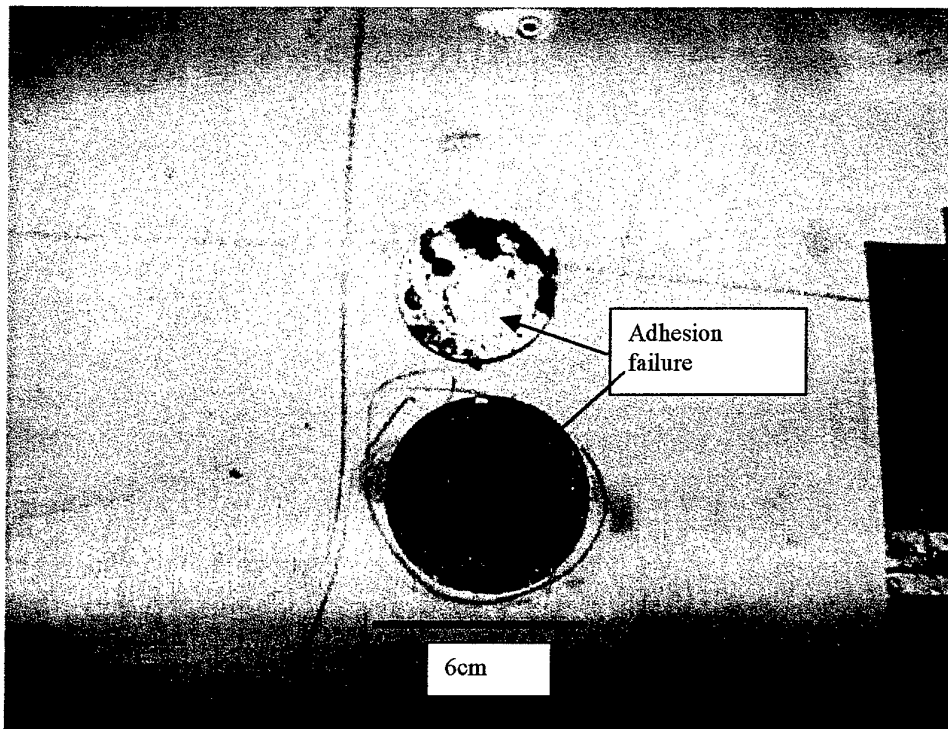
Figure 8.0 Adhesion failure surrounding an injection repair

regions around an injection repair have experienced obvious environmental degradation. In Figure 8 adhesion failure between the core and skin has occurred around an injection repair. In Figure 9.0 the adhesive-core fillet bonds have failed over an extensive area around the injection repair site as a result of penetration of water through the injection repair between the adhesive and core bond.

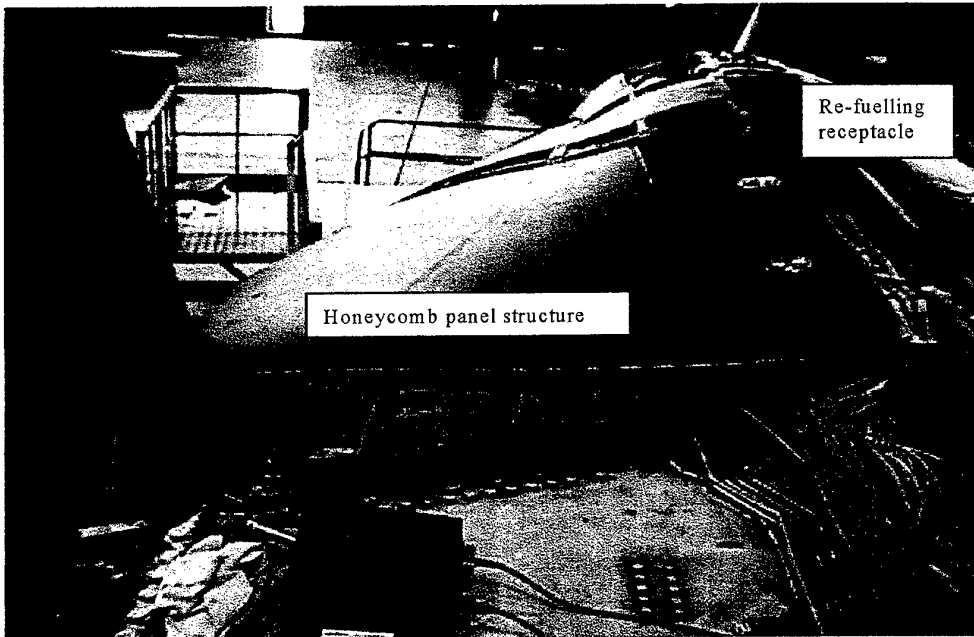
Figure 10 shows a region of the F-111 where honeycomb panel damage has a high probability of occurring. The large panels in the vicinity of the mid-air re-fuelling pod often will experience damage as the re-fuelling arm approaches the aircraft. These panels are riveted in place and require in-situ repair. Attempting to repair large panel areas has the problem of designing repairs outside repair manual specification together with the problem of moisture removal. Large repairs in-situ will also encounter difficulties in distributing a uniform heat over the entire repair region due to heat-sinks in the structure. Figure 11 also shows a difficult to access region of the F-111 weapons bay where a repair has to be undertaken. This is also a region where panel replacement would not be a viable option.

Figure 10. The large honeycomb panels in the vicinity of the re-fuelling area on top of the F-111. These panels must be repaired in situ and are susceptible to damage during the mid-air re-fuelling procedure.

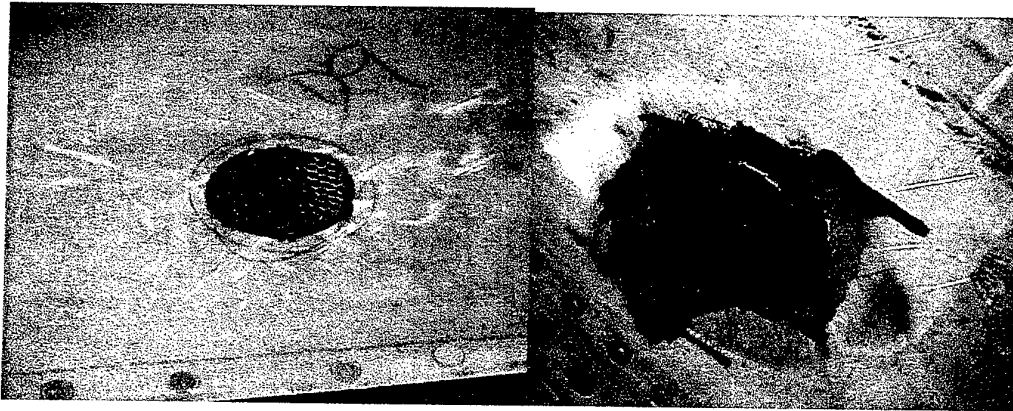
Figure A-6 The two pictures indicate that the plug bonded in position after the initial adhesive curing step. Note in the left-hand picture the foaming adhesive has not expanded correctly and voids exist between the plug and routed core. In the right hand side picture the foaming adhesive has expanded correctly. The foaming adhesive came from the same batch.
