OFFICE OF THE INSPECTOR GENERAL

CONTRACT QUALITY ASSURANCE AND PRICING  
PRACTICES FOR PATRIOT MISSILE PROCUREMENTS

Report No. 95-252

June 26, 1995

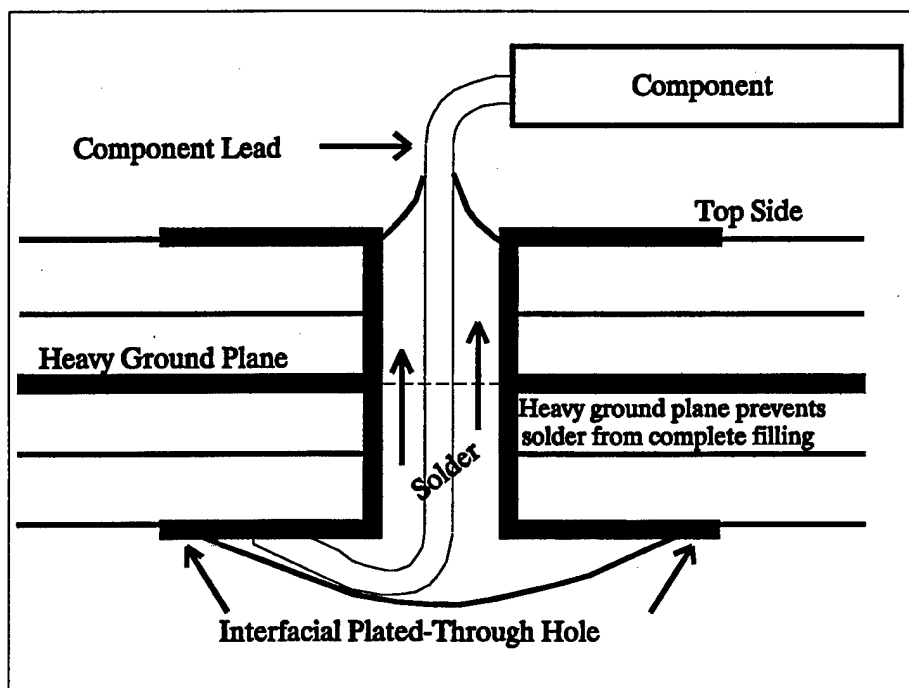
**Cross Section View of Upward Solder Flow Through a Multilayer Circuit Board**

**Multilayer Circuit Boards.** Patriot guidance systems contained 39 multilayer circuit boards and the related ground units contained 1,760 similar boards. Those multilayer circuit boards were formed by compressing from 2 to 16 single-layer circuit boards into one unit. They were further formed by connecting the interfacial plated through-holes of a single-layer circuit board to through-holes of the other single-layer circuit boards in the multilayer unit. As depicted on page 4 of this report, electronic components are inserted in the plated through-holes and connected by osmotically flowing the solder from the bottom toward the top of the multilayer circuit boards.

**Audit Results.** The allegation was substantiated. Raytheon did not completely solder the electrical connections to the top side of those circuit boards according to contract requirements. However, no adverse impact was determined. When MICOM determined that the contract requirements were not met, it issued a contract waiver relieving Raytheon from that requirement to avoid delays in the delivery of the Patriots.

**Inspections, Quality, and Reliability.** MICOM issued a contract waiver that canceled the requirement for achieving topside solder. That waiver made the related inspection requirement uncertain. We found no evidence that quality or reliability problems occurred because of the lack of the inspections. The multilayer circuit boards were routinely subjected to environmental, shock, vibration, and final acceptance tests before Government acceptance. No faults were found during those tests that could be attributed to the lack of complete topside solder.
