| <div style="border-bottom: 1px solid black; display: inline-block; margin-bottom: 5px;">DEC 93-12</div> DOCUMENT IDENTIFICATION<br>DEC 93 | | DISTRIBUTION STATEMENT A<br>Approved for Public Release<br>Distribution Unlimited | | | | | | | | | | | | | | | | | | | | | | | | | | | | | | | | | | | | | | | | | |

- UH-1
- H-60
- AH-1
- AH-64
- H-47D/E
- OH-58A/C
- OH-58D
- Fixed Wing

This report is in nine sections. Section I describes overall Army aviation experience. Sections II through IX provide overviews of the accident experience of each aircraft system, along with synopses of selected accidents and accident-prevention measures. Note that these synopses do not necessarily reflect all factors contributing to the accident; they concentrate on the primary cause or risk management failure.

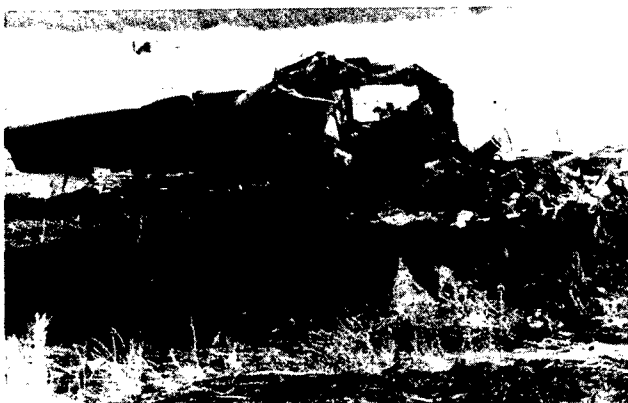
**Scenario 1.** During a day NOE training mission, the main rotor blades struck the edge of an earthen berm. After repeated blade strikes with the ground, the fuselage impacted the ground, pivoted on its nose, and came to rest in a small gully. Postcrash fire consumed the major portion of the aircraft.

■ **Result:** Two fatalities, a destroyed aircraft, and a cost of \$3,122,704.

■ **Cause:** The crew failed to follow the general rules and principles for terrain flight found in TC 1-211: ATM Utility Helicopter, UH-1; TC 1-201: Tactical Flight Procedures; and the operators manual.

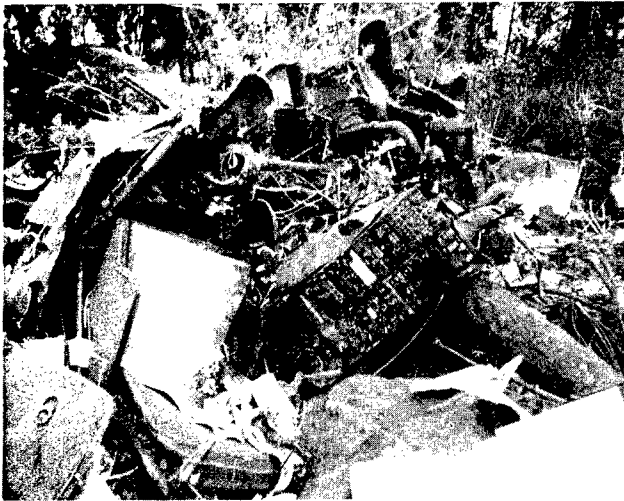
**Scenario 1.** Aircraft departed a 6,700-foot mountain peak and was observed to yaw excessively while on climbout. The aircraft then crashed unobserved, 700 feet down the slope. The aircraft and crew were not found until the next day.

■ **Cause:** Suspect partial or complete engine failure based on evidence presented by the

surviving crewmember. Pilots had indicated they were having a problem, and he had observed a rapid decrease in rotor and engine RPM. The surviving crewmember was not located until the next day because—

**Prevention techniques and procedures:** The tear-down analysis could not determine the cause of engine failure in this case. CCAD will continue analyzing crash-damaged components for failure. Commands need to recognize the importance of flight following on single-ship missions, especially if the aircraft has no ELT installed or minimal survival radio availability has been waived. ELTs are not required by Army regulation, but they should be on board aircraft when they are authorized and available. If units have ample supplies of survival radios, they should be issued to all crewmembers as required by AR 95-3. Quick rescue can save lives.

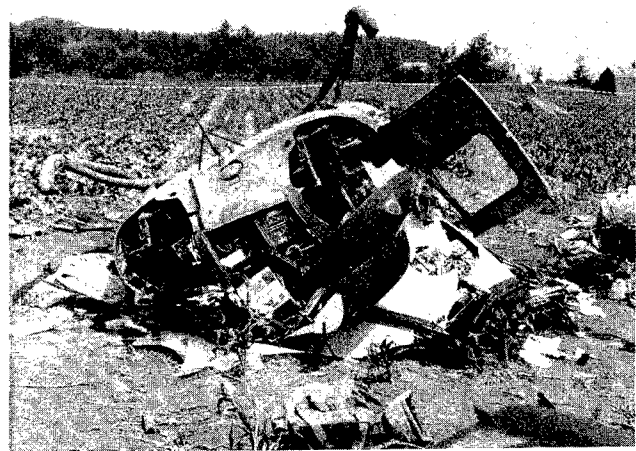
**Scenario 2.** The crew was on a return flight to base camp, under NVDs. On approach, the aircraft experienced several compressor stalls. The PC elected to shoot a shallow approach with minimum power to the ground. As the aircraft was about to touch down, the engine failed. The aircraft yawed left, the right skid contacted the ground, and the aircraft rolled over, coming to rest on its side.

■ **Result:** A destroyed aircraft and a cost of \$925,529.

■ **Cause:** Aircraft had been flown in a desert environment for a period of 60 days, sustaining sand erosion to the internal components of the engine and subsequently causing the engine to lose power and fail.

**Prevention techniques and procedures:** Although it is hard to predict when an engine will fail, pilots should consider all engine compressor stalls as a warning of impending engine failure and be prepared to land without power. Frequent engine flushes should be performed on aircraft operating in sandy environments.

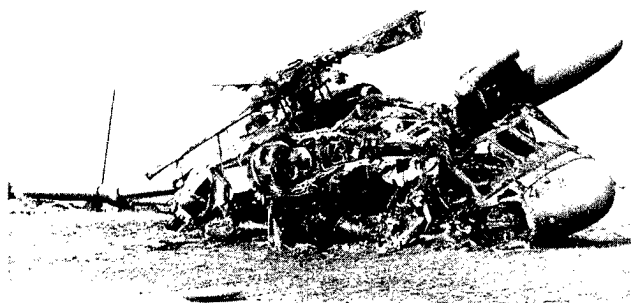
**Scenario 1.** During a night approach, the UH-60A aircraft struck the ground in a nose-high, right-side-low attitude. The 230-gallon right external tank ruptured on impact, engulfing the aircraft with fire.

■ **Result:** Four fatalities, four injuries, a destroyed aircraft, and a cost of \$6,118,900.

■ **Cause:** The external stores support system (ESSS) with extended range fuel system (ERFS) was not designed with adequate safeguards to prevent an out-of-balance condition or a system to alert the crew to the fuel status in each tank.

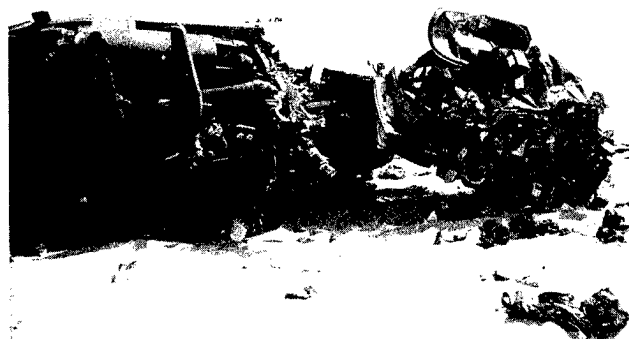
ing to his planned en route altitude of 100 feet AGL. He did not inform the other crewmembers of his intentions or ask for their assistance to verbally warn him when he passed through 100 feet AGL. The PI did not arrest his descent, and the aircraft impacted a 22-foot-high sand dune with a 200-foot-per-minute rate of descent at 69 KIAS.

■ **Result:** Five injuries, a destroyed aircraft, and a cost of \$4,854,587.

■ **Cause:** The crew failed to recognize and stop the descent for the following reasons:

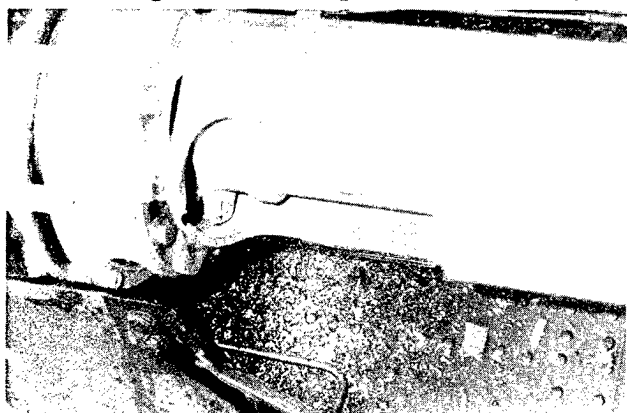
frequency whine and decided to return to pad. While executing a left turn, they heard a loud "bang." Crew landed aircraft with little forward motion to a dry river bed, damaging the FLIR turret. After shutdown, the crew found that the No. 1 engine high-speed shaft coupling had failed, allowing the shaft to separate from the engine.

■ **Result:** Damage cost of \$362,114.

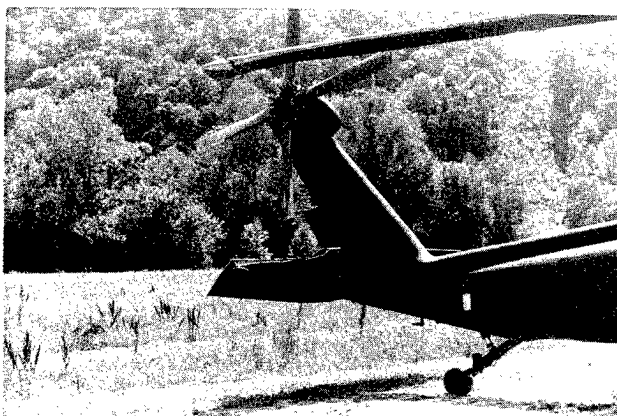
**Scenario 1.** Crewmembers were under NVDs as the aircraft departed the NOE route en route to the airfield. The PC became momentarily fixated on a bridge that was not on the crew's map. The PI on the flight controls began a climb and sighted wires at very close range. He pitched the aircraft's nose up in order to "belly" into the wires. The aircraft struck high-power lines and the crew executed an emergency landing to a grass airstrip.

■ **Result:** Damage cost of \$1,007,500.

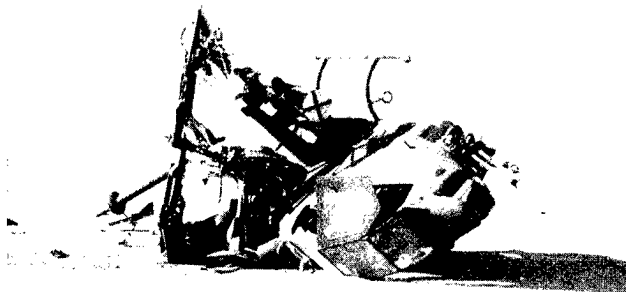
**Scenario 1.** While attempting an NVG departure from a sandy, dusty area, the crew became disoriented in brownout conditions and rolled the aircraft onto its right side. A small postcrash engine fire erupted but was quickly extinguished by ground personnel.

■ **Result:** A destroyed aircraft and a cost of \$1,500,000.

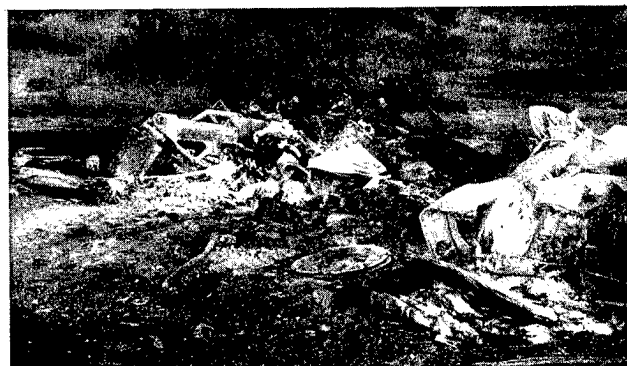
**Scenario 2.** At 100 feet AGL and 30 to 50 knots during the third sortie on a day aerial gunnery exercise, the T53-L703 engine of the armed AH-1F overheated and failed while en route to the gunnery range from a forward rearming and refueling point. The crew was operating the aircraft in the avoid area of the height-velocity diagram and was unable to execute a successful emergency landing.

■ **Result:** Two fatalities, a destroyed aircraft, and a cost of \$5,913,739.

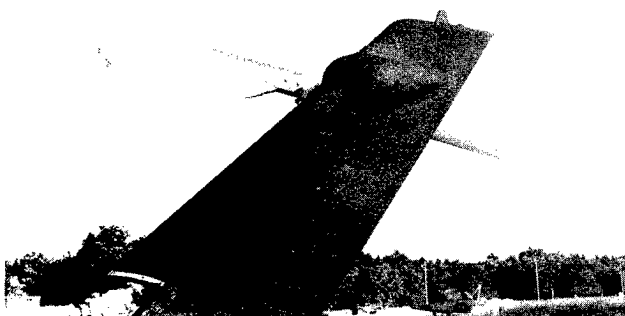
of the aircraft was about 5 feet above the trees. The crew had maintained their position for about 1 minute when a slight gust of wind came over the ridgeline. To maintain hover position, the pilot made a slight control input to counteract the wind. As he made the input, the crew heard a buzzing or humming noise and felt a high-frequency vibration in their seats. Realizing something was wrong, the pilot on the controls immediately increased altitude, gained forward airspeed, and began returning to the FARP. Once he gained altitude, the buzzing noise stopped, but the high-frequency vibration continued. The crew landed at the FARP and shut down the aircraft.

■ **Result:** Damage cost of \$12,601.

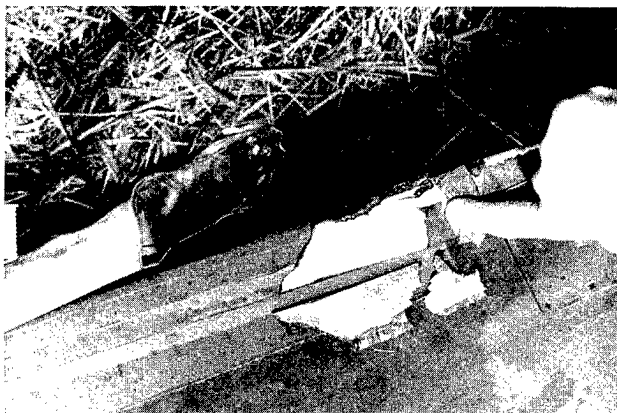
**Scenario 2.** Upon completion of a normal shut-down, the PC discovered damage to both main rotor blades. The damage appeared to be confined to the outboard 3 feet of both blades. The crew suspected a tree strike based on small particles of bark and green stains found in the area of the damage.

■ **Result:** Damage cost of \$230,864.

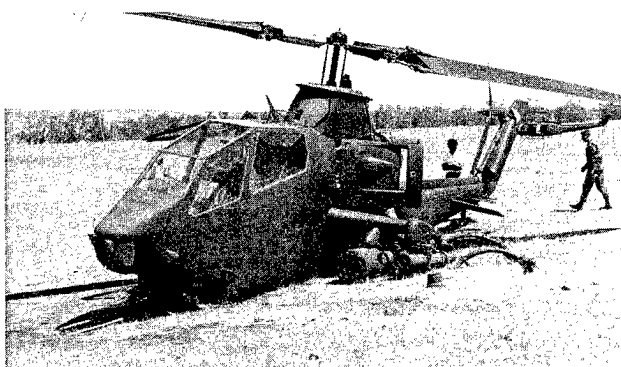
**Scenario 1.** The aircraft was in cruise flight, level at 6,500 feet MSL and at 120 knots on the return leg of an instrument training flight when the No. 1 hanger bearing overheated and failed. As a result, the No. 1 section of the tail rotor drive shaft rubbed against the drive shaft tunnel and was severed. The continuity of the tail rotor drive system was interrupted, causing a loss of effective antitorque control. As the PC fought to regain

aircraft control, the aircraft lost 4,500 feet of altitude. At 2,000 feet MSL, the pilot selected a landing site. At 100 feet AGL, the PC decelerated the aircraft, and at 15 feet AGL, he pulled the collective all the way up. The aircraft landed hard, bounced one time, and came to rest on its belly, leaning on the left wing pods.

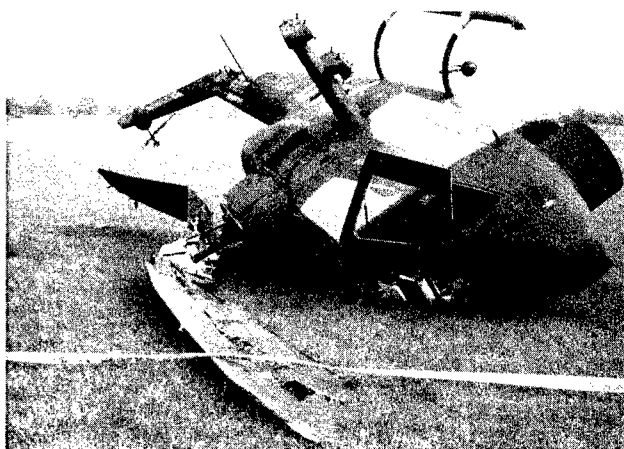
35 to 45 degrees. At this point, the IP interpreted the large yaw as an indication of an engine failure. At 40 to 45 feet AGL, the IP initiated an autorotation by reducing the throttle. Immediately after closing the throttle, the IP began applying collective pitch and simultaneously trying to level the aircraft. The aircraft touched down with low rotor RPM, moved laterally to the right, rolled over, and came to rest on its right side.

- **Result:** Damage cost of \$192,316.

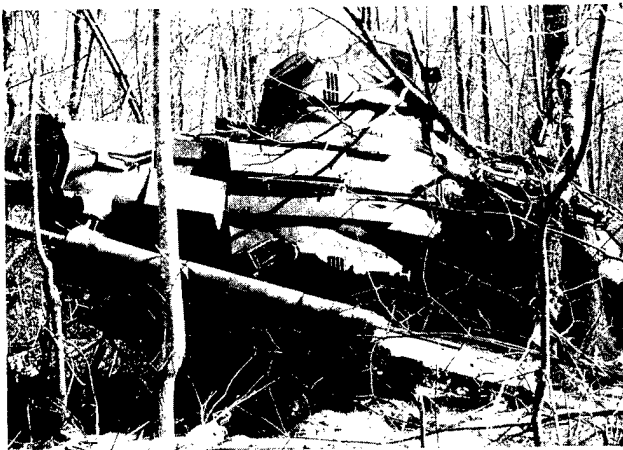
**Scenario 1.** The accident aircraft was Chalk 3 in a night, multiship, deep-attack, battalion training mission. The back-seater was using the pilot's night vision system (PNVS), and the front-seater was using the target acquisition designation sight (TADS) during battle-position operations. While in an out-of-ground-effect (OGE) hover, the aircraft entered a left, rearward, descending drift and struck trees with the main and tail rotor systems. The aircraft then began an uncontrolled right spin and impacted the ground on its right side in a nose-low attitude.

■ **Result:** One injury, a destroyed aircraft, and a cost of \$10,765,536.

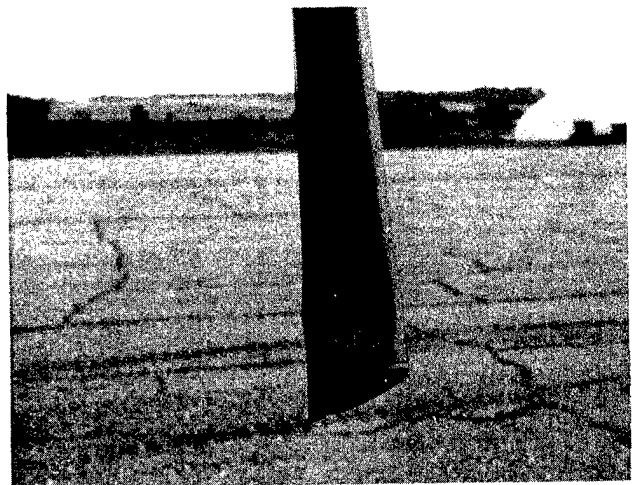
**Scenario 2.** After completing a situational training exercise, the crew arrived at the battalion forward arming and refueling point (FARP) and established an OGE hover. While waiting for the ground guides, the crew allowed the aircraft to descend into a tree. Neither the PC nor PI detected the descent or the contact with the tree. The PC initiated a go-around when he noticed that the radar altimeter was indicating zero altitude. On the next approach, the crew landed at the FARP and received hot refueling. After completing the refueling operations, the crew departed for their home station. During the postflight inspection, the PC found damage to the stabilator and the four tail rotor blades.

■ **Result:** Damage cost of \$90,415.

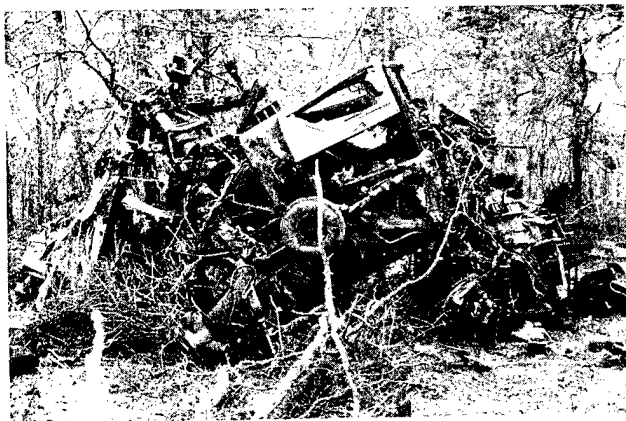
**Scenario 1.** While attempting a night visual flight rules (VFR) departure and climbout from an unattended airfield, the aircraft entered into instrument meteorological conditions (IMC). The maintenance test pilot (MP) on the controls in the back seat experienced spatial disorientation while in a climbing right turn. The aircraft descended while in the right turn and crashed through large pine trees approximately 0.6 miles east of the point of departure.

■ **Result:** One fatality, a destroyed aircraft, and a cost of \$10,785,000.

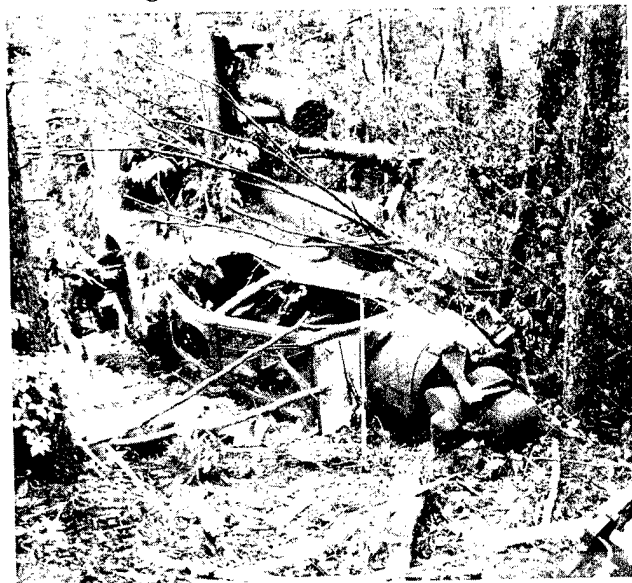
**Scenario 2.** While on a day VFR tactical training flight, the IP of Chalk 3 in a flight of three AH-64s in free cruise formation initiated a descending right turn to reposition behind Chalk 2. The aircraft descended into trees, traveling 334 feet before coming to rest on its right side.

■ **Result:** One injury, a destroyed aircraft, and a cost of \$10,688,542.

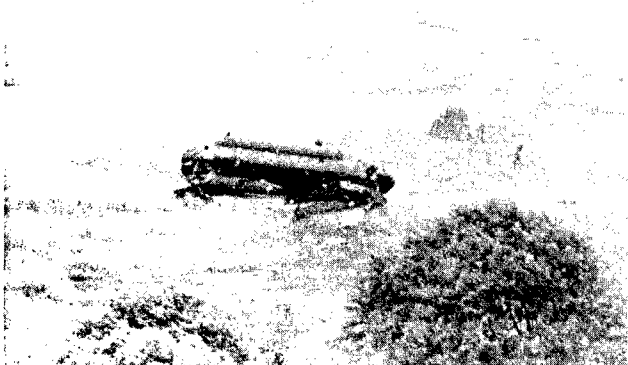
**Scenario 1.** The aircraft was operating in near-zero illumination at near-zero airspeed during a night aided, low approach to a beach landing area. The crew had closed all doors and windows in preparation for a dusty landing. At approximately 10 feet AGL, the entire crew experienced a brownout condition. The PC, in the right seat, turned the aircraft left of the intended landing direction in an attempt to maintain visual contact with the ground and the intended landing point. The PI was calling out altitude from the radar altimeter. The flight engineer instructor (FEI), stationed in the right rear of the cabin with the flight engineer (FE), told the pilots to "Hold your down!" The PC started to increase power and diverted his attention from the intended landing point to cross-check his instruments. When he looked outside again, all outside references were obscured by blowing sand and dust, and at this point the aircraft contacted the ground in a 90-degree left yaw. The aircraft rolled over onto its right side, pinning the crew chief (CE), who had been ejected through the *closed* upper cabin door. Aircraft systems were shut down, and the rest of the crew egressed unassisted. It took about 2 hours for the crew and ground troops to free the CE.

■ **Result:** One injury, a destroyed aircraft, and a cost of \$7,504,473.

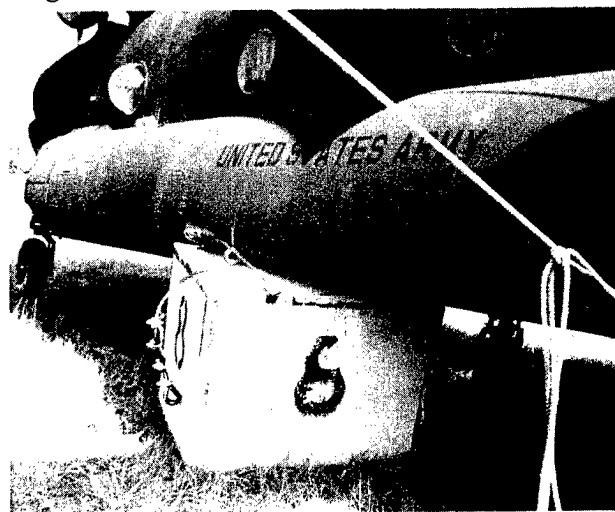
**Scenario 1.** The crew had flown several missions to a stagefield as trail in a flight of two in the early evening while it was still daylight. While making approaches to the west, the PC and PI noted a training load (a concrete block approximately 4 feet square) between the lanes at the west end. They were scheduled to fly night aided missions to the same area. A tail wind experienced during the day made them decide to change landing direction to the east for the after-dark missions. After performing several iterations of fast-rope training, the lead aircraft developed communication problems, and the lead crew suggested that the trail aircraft go ahead and they would catch up for the next traffic pattern. During departure from the stagefield, under NVGs, the trail aircraft crew allowed the aircraft's right front landing gear to contact the training load, causing the aircraft to pitch nose low. The PI quickly attempted to bring the nose up, causing vibrations in the airframe. Perceiving the vibrations to be severe, the PI elected to set the aircraft down. As the helicopter descended, the load penetrated the fuselage.

■ **Result:** Damage cost of \$157,072.

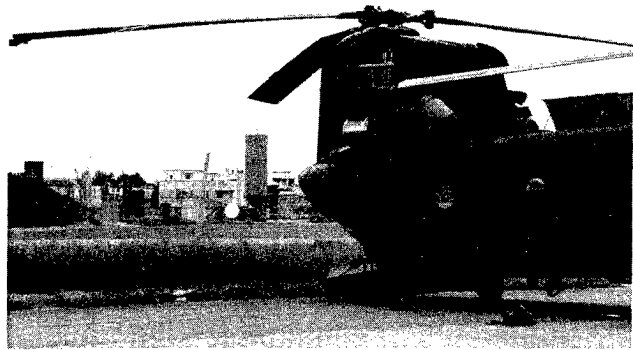
■ **Result:** Damage cost of \$70,337.

■ **Cause:** The PC, who was following the instructions of a single ground guide, taxied the aircraft too close to a light pole. The pole was within 75 feet of the aircraft, and the PC did not dismount a blade watcher in addition to the ground guide. This is contrary to the requirements of the CH-47D Operator's Manual, chapter 8.

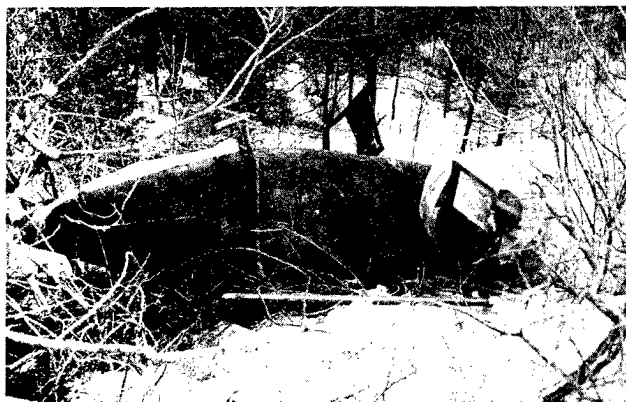
**Scenario 1.** At 40 to 50 feet AGL and 10 to 15 knots while performing an aerial reconnaissance, the PI initiated a slow, right-pedal turn and failed to anticipate the loss of tail rotor effectiveness (LTE). As a result, the aircraft entered an uncommanded right yaw that rapidly developed into a spin. The spin continued to the point that the PI lost positive control of the aircraft, and it crashed into the side of a ridgeline.

■ **Result:** A destroyed aircraft and a cost of \$92,770.

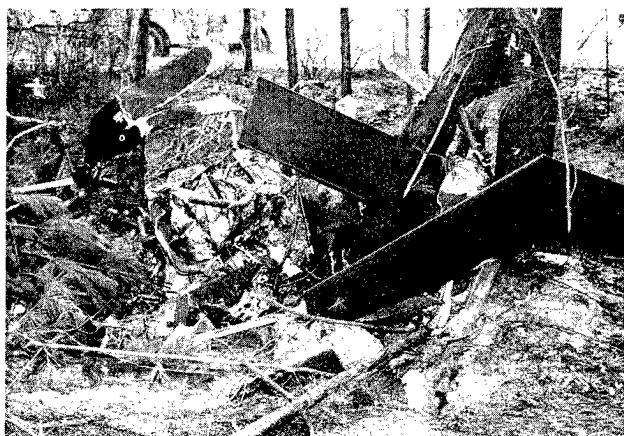
**Scenario 2.** During recovery from an NVG aerial observer (AO) training mission, the IP failed to maintain aircraft control. From an altitude of between 300 and 600 feet AGL, the aircraft descended and impacted the ground in an unusual attitude at an airspeed in excess of 100 knots.

■ **Result:** Two fatalities, a destroyed aircraft, and a cost of \$1,348,890.

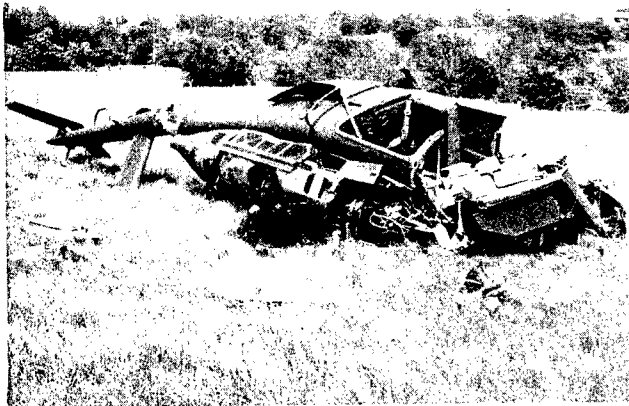
**Scenario 1.** The crew was conducting an approved zone reconnaissance training mission in accordance with TC 1-215: Aircrew Training Manual, Observation Helicopter, OH-58A/C, Task 2066. The aircraft struck a 1/4-inch wire that wrapped around the skid crossmembers. The aircraft traveled about 200 meters before crashing nose first, followed by a right rolling motion into the ground. The fuselage bounced forward about 20 feet and came to rest on its right side.

■ **Result:** One fatality, one injury, a destroyed aircraft, and a cost of \$1,304,470.

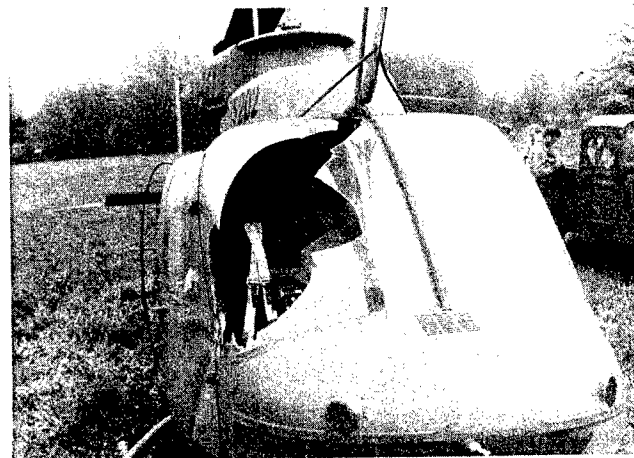
**Scenario 2:** During an NOE NVG training mission, the aircraft entered a set of six horizontally spaced wires. All wires were severed by the aircraft. The pilot made an immediate precautionary landing with power to a sloped field.

■ **Result:** Damage cost of \$113,438.
