December 1992

Army Aircraft Safety Performance

Review

UH-60
OH-58D
AH-64
MH/CH-47D

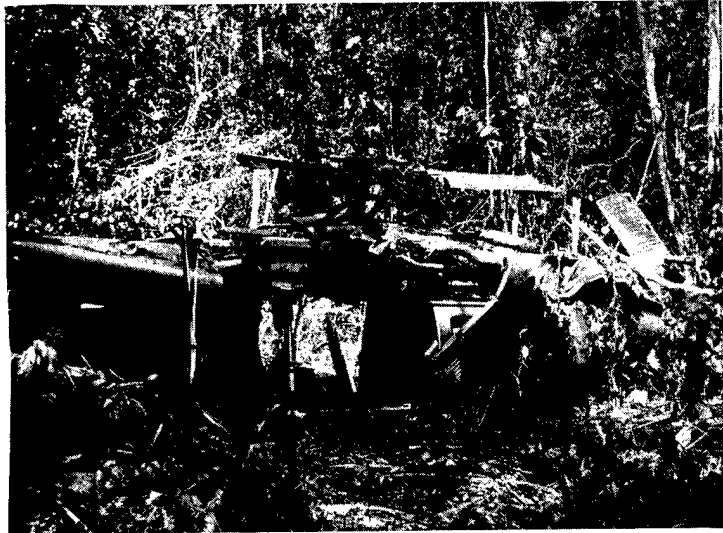
The aircraft was taking off from a confined area. As the pilot added power, the number 1 power turbine wheel in the number 1 engine failed. Due to low airspeed and high gross weight, number 2 engine power available was insufficient to maintain flight. The aircraft settled into the trees.

Cause: The engine failed due to debonding and loss of portions of the shroud segment honeycomb and filler material in the turbine case. This created an uneven surface on the stator honeycomb, which disrupted airflow around the gas generator rotor blade tips. This created a resonance frequency and stress, which caused cracking in the blade root and subsequent fracturing of the blades. Contributing to the severity of the injuries was the fact that troop seats and restraint systems had been removed from the aircraft.

Cause: Failure of number 1 turbine at an altitude, airspeed, and gross weight where single-engine power was insufficient to maintain flight.

Recommended actions: *Higher level:* Inform all assigned of this accident and provide restraint systems and seats for all occupants. *Army level:* Accelerate the application of MWO 55-2840-248-5032 for all T700-GE-700 engines, which will add a damper to the turbine blades. Develop an engine-vibration inspection to identify engines with excessive resonance-frequency vibrations.

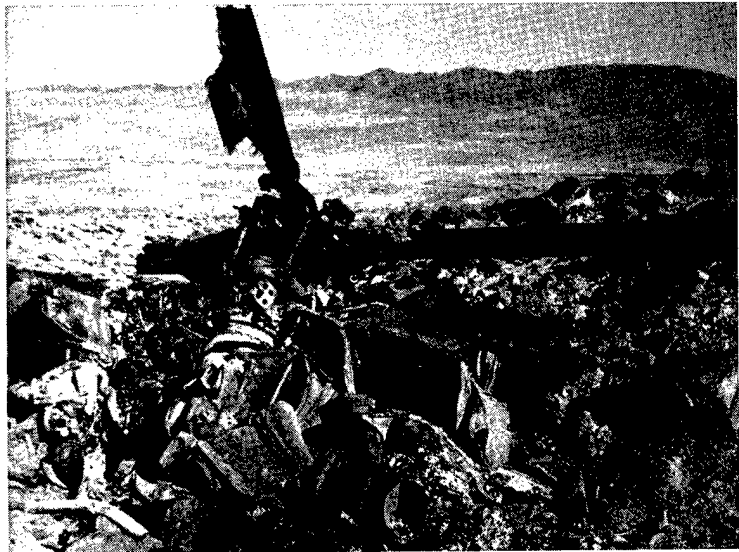
Cause: The crew failed to maintain terrain clearance. The most probable reason for this failure is that either the crew was overconfident in their ability to fly low and fast without striking obstacles, or the crew's attention was drawn to something inside the cockpit. Because of the high airspeed at low altitude, the crew had less reaction time to avoid obstacles.

Cause: Failure to maintain terrain clearance while flying low and fast.

Recommended actions: Discuss tactical flight procedures for desert and mountainous terrain, as written in TC 1-201, with emphasis on terrain flight techniques, aircrew responsibilities, navigation, and aircraft performance and handling.

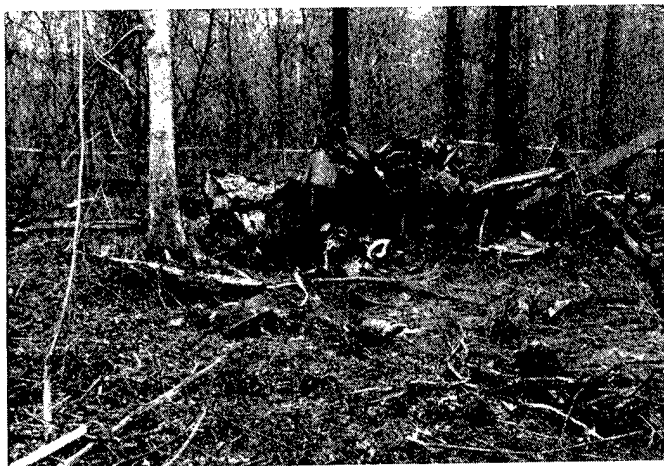
ment for the aircrews to make position reports on a common frequency, which would have alerted both accident UH-60s of their merging course. Contributing to this accident were the visual limitations associated with NVGs and the restricted field of view of UH-60 front and side windows.

Cause: Aircrews failed to see and avoid each other due to equipment design and flight-following procedures.

Recommended actions: *Higher level:* Establish flight-following procedures on a common frequency that requires position reporting. *Army level:* Improve the field of view of UH-60 pilot/copilot windscreen, side windows, and gunner's door windows.

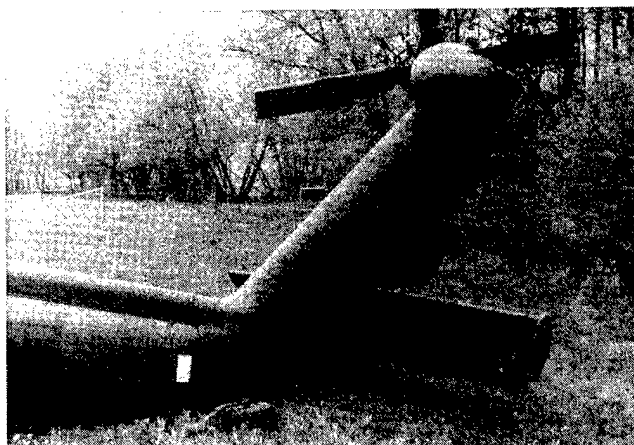
Cause: The transmission blower shaft retaining nut was improperly torqued by the manufacturer. This allowed the shaft to develop play, which eventually caused the flange splines to fail.

Cause: Failure of the transmission blower shaft splines.

Recommended actions: Army level: Issue AVUM units a flex boroscope so that a complete inspection of the drive shaft can be made.

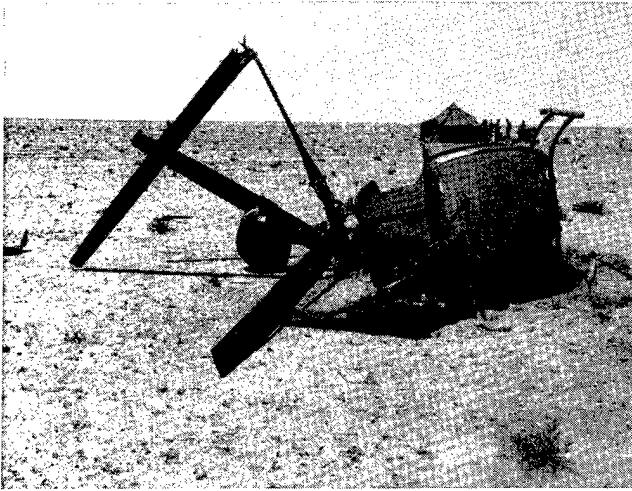
Cause: Engine failure followed by emergency landing in soft sand.

Recommended actions: Unit level: Emphasize that pilots should anticipate soft terrain when landing to unimproved areas. **Army level:** Consider changing the material of the Impeller and plain seal of the fuel boost pump. Consider incorporating into the OH-58D transition program provisions for giving pilots some level of experience in minimum ground run landing. Evaluate current emergency procedures for in-flight failures of the fuel boost pump; consider whether "land as soon as practical" should be changed to "land as soon as possible." Consider relocating the lower nose-mounted wire cutter to allow more ground clearance.

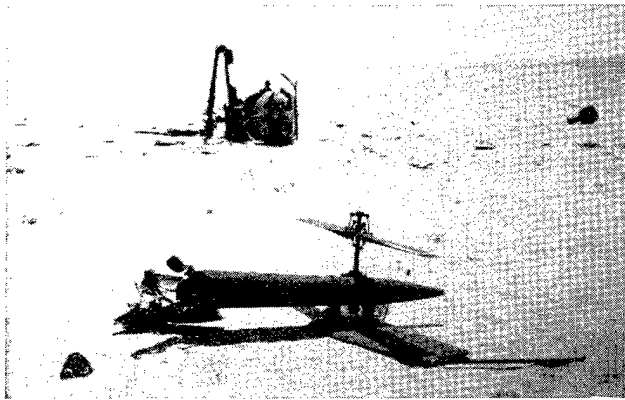
Cause: The crew failed to recognize rising desert terrain in their flight path due to (1) inadequate unit training in flying under night, aided, totally blacked out conditions; (2) haste to catch up with their sister element, resulting in their overflying the capability of their NVGs to provide adequate terrain definition under the totally blacked out desert conditions; (3) substandard NVGs, which placed the crew at a disadvantage in an already difficult situation; and (4) lack of a radar altimeter audio signal that would have warned the crew they were approaching critical proximity to the ground.

Cause: Failure to recognize rising terrain.

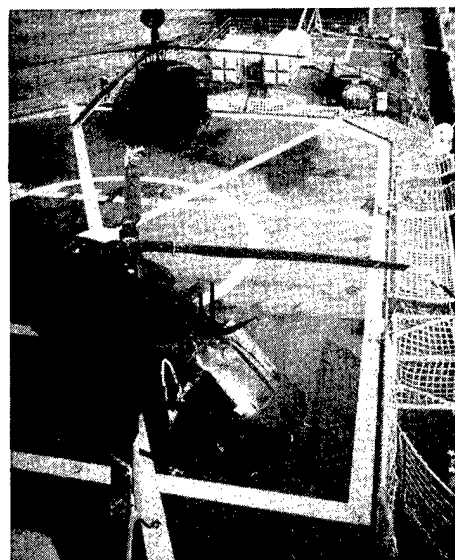
Cause: Overconfidence and inadequate procedures.

Recommended actions: *Unit level:* Inform all personnel of the circumstances of this accident, with emphasis on how overconfidence contributed. *Higher level:* Establish procedures for making decisions to allow simultaneous dual-aircraft operations from ships whose flight decks have been designated as single-spot decks.

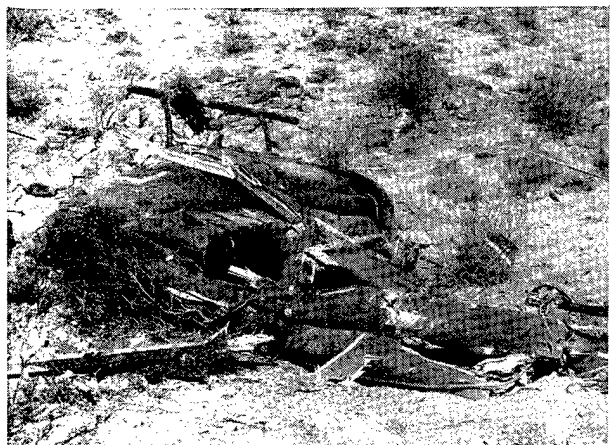
Cause: Failure to follow procedures.

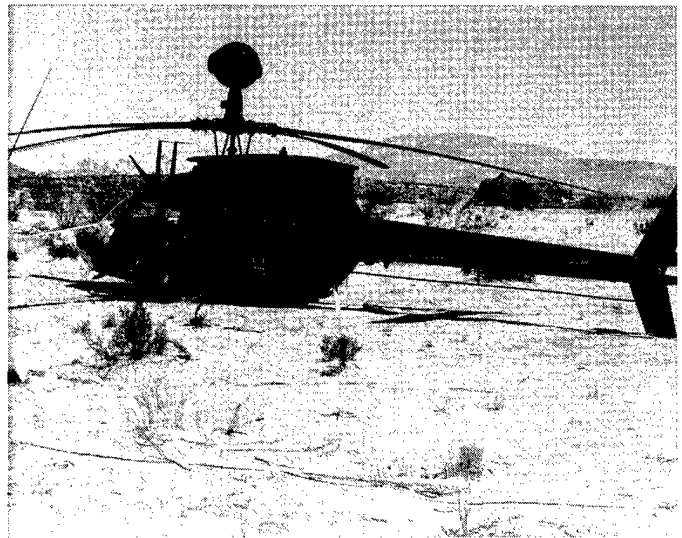
Cause: Loose "B" nut that connects fuel hose to fuel boost pump.

Recommended action: Army level: Issue a safety-of-flight message to the field requiring a one-time inspection of all fuel system "B" nuts attaching fuel hoses to the fuel boost pumps in the OH-58D.

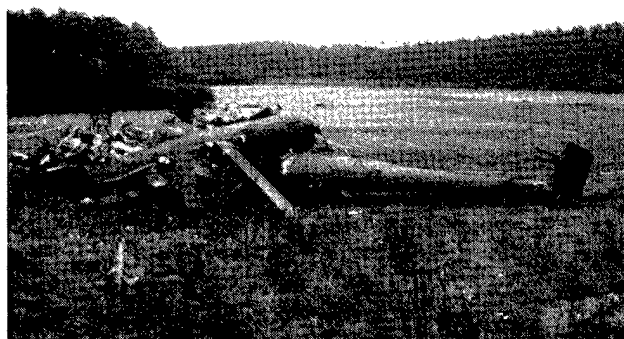
Cause: Crew failed to maintain clearance while crossing wires.

Recommended actions: Army level: Procure an obstacle-avoidance device for the AH-64 helicopter. This device should also be used in other tactical rotary-wing aircraft that commonly operate in terrain-flight mode.

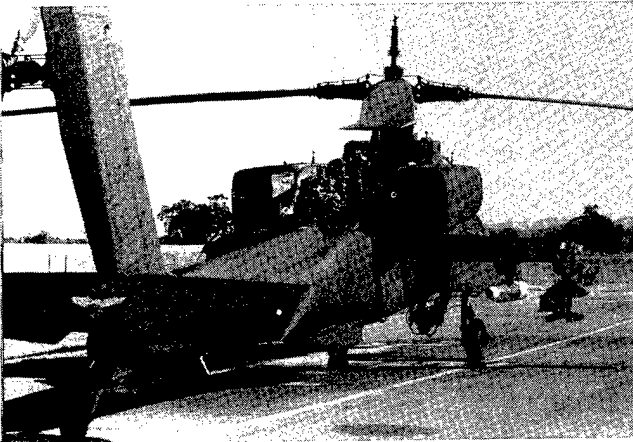
Cause: Failure of duplex bearing in forward end of power takeoff clutch due to lack of lubrication.

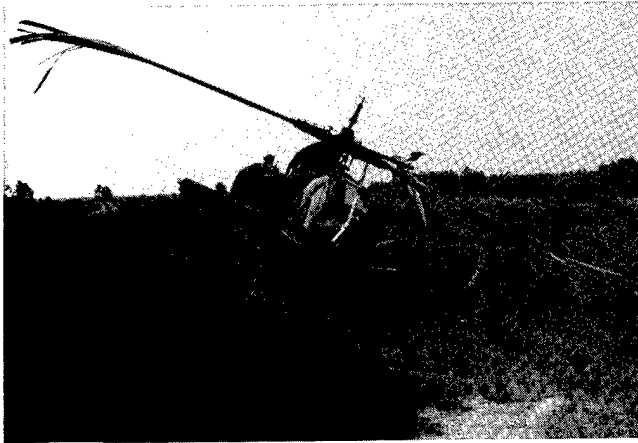
Cause: Crew failed to maintain a stabilized hover due to improper division of attention.

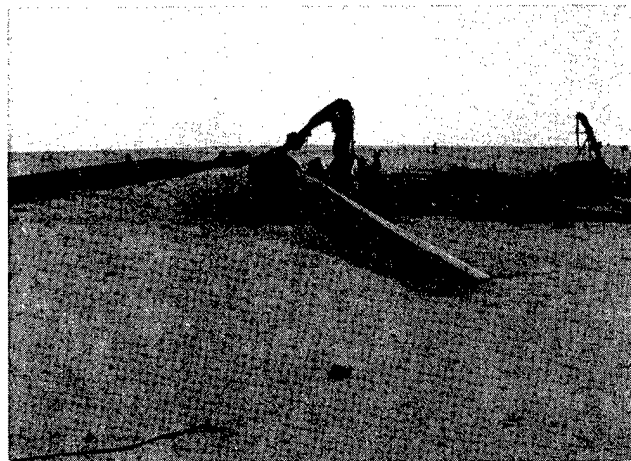
Cause: Failure of engine transmission pinion drive gear.

Recommended actions: Stress the importance of detailed crew and passenger briefings to ensure that, in the event of an emergency, all personnel understand their duties and all avenues of egress. Stress to all CH-47 crews the importance of providing all possible avenues of egress to passengers occupying vehicles on aircraft during tactical moves. Improve quality control in the manufacturing process of the identified defective gears used in CH-47D transmissions.

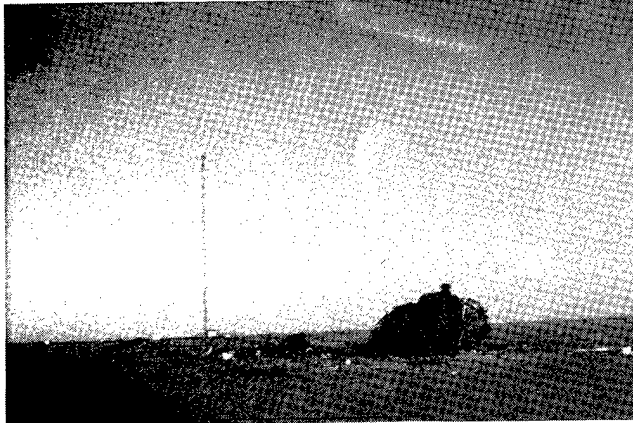
The aircraft was flying 250 feet agl at 120 knots at night along a prominent road. The crew failed to see a tower, which was marked on their map. The aircraft hit the tower 70 feet below the top and crashed. Four of five

Cause: Aircraft struck tower at night.

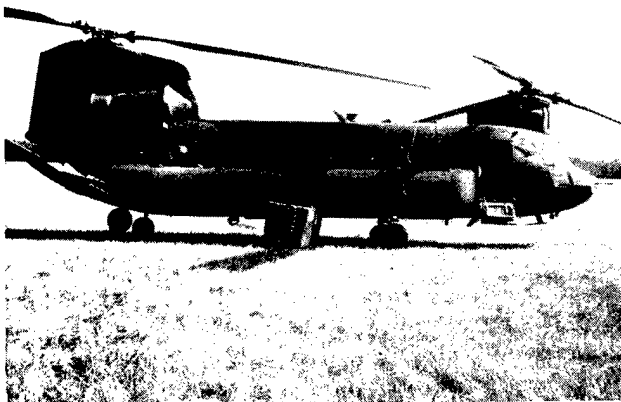
Cause: Failure to follow procedures.

Recommended actions: Emphasize how deviations from standards can result in crewmembers' attention being focused away from obstacle clearance.
