# Aircraft Mishap Facts

## Second Half FY 84 Review

### Introduction

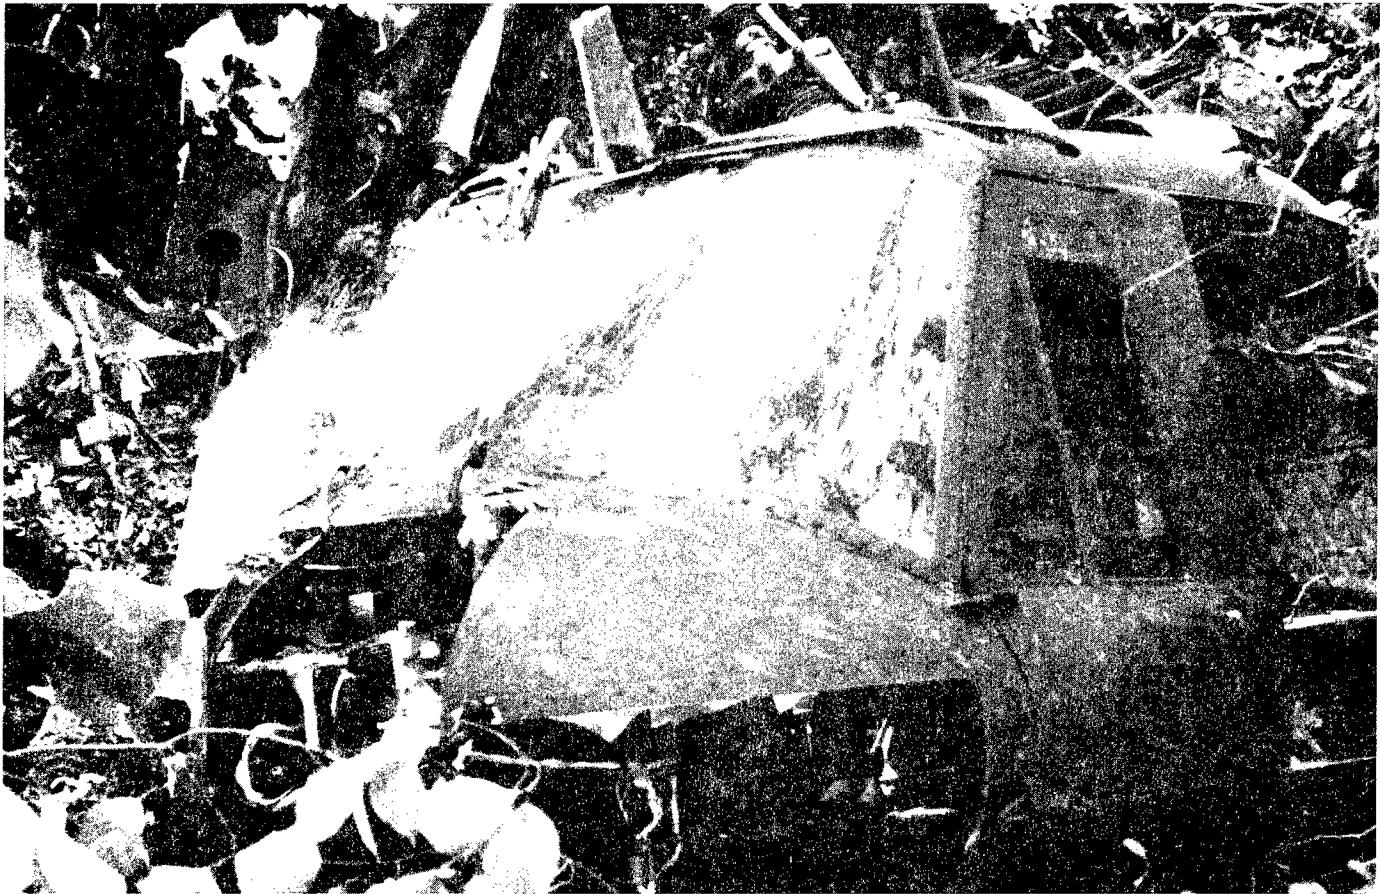
Engine rpm decreased during low-level flight, and UH-1 settled into trees.

**Cause:** The exact cause of the decreased engine performance could not be established through teardown and analysis efforts.

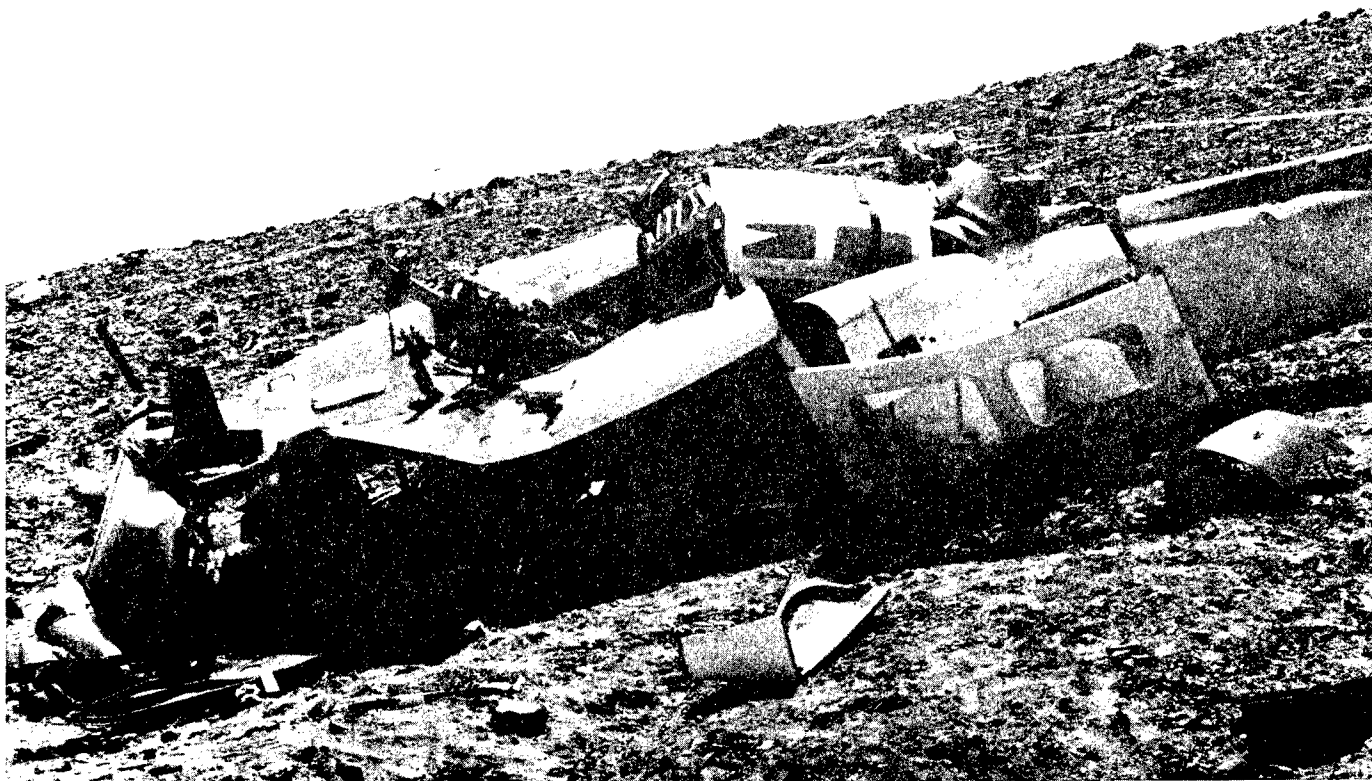
UH-1 crashed when the pitch change link clevis of the red main rotor blade broke.

**Cause:** The pitch change link clevis of the red main rotor blade broke because of long-term fatigue fracturing of the outer two-thirds of the threaded portion of the clevis. The remaining one-third of the cross-section failed due to overstress, as it

was unable to carry the load designed for the whole component. Design of the clevis was a primary factor in the failure in that the blind lightening hole prevented detection of the crack during the required magnetic particle inspection at the time of manufacture.

**DA level:** Identify all existing faulty pitch change link clevises in use and in supply stocks and remove them from service. Review contractor quality control procedures to ensure that all required actions are completed to a 100 percent accuracy level. Delete the lightening hole within the shank from the clevis design requirements. This change to the clevis design would enhance nondestructive testing inspection of the clevis by lessening the possibility of cracks going undetected within the blind hole and eliminate an existing corrosion problem within the lightening hole.

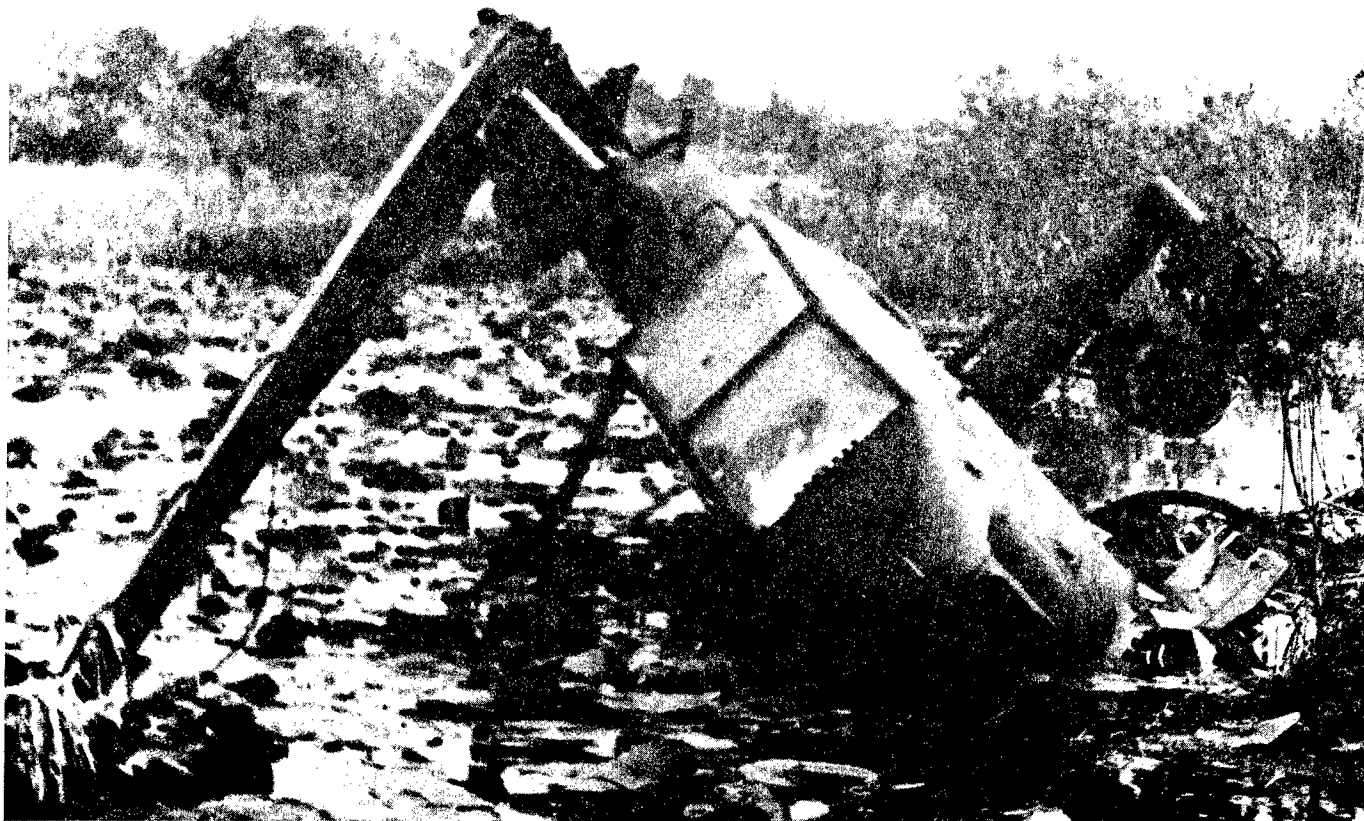
AH-1 main drive shaft failed during flight. Pilot entered autorotation and landed in a marshy area.

As the AH-1 was in cruise flight at about 1,000 feet agl, a loud bang was heard from the aft section of the aircraft, followed by a grinding noise. The aircraft yawed left, and the crew noted an increase in engine rpm and a decrease in main rotor rpm. The pilot entered autorotation and selected the best available landing site, which appeared to be a field. The pilot made a zero ground run landing to the site, which was a marshy area. As the aircraft settled into 4 feet of water, the right skid sank deeper than the left and the aircraft leaned to the right, causing the advancing main rotor blade to hit the mud and water

**Result:** \$369,176 in damages.

**Cause:** Failure of the main drive shaft was caused by insufficient lubrication. After an extensive storage period, the drive shaft was returned to the active supply channel without being inspected for adequate lubrication and without being freshly lubricated.

**DA level:** Ensure the improvement of quality control of overhauled drive shafts by inspecting and repacking, if necessary, those drive shafts with a storage history before putting them into service. Accelerate the K-flex drive shaft modification for the AH-1S, thus eliminating the necessity for lubricated main drive shafts.

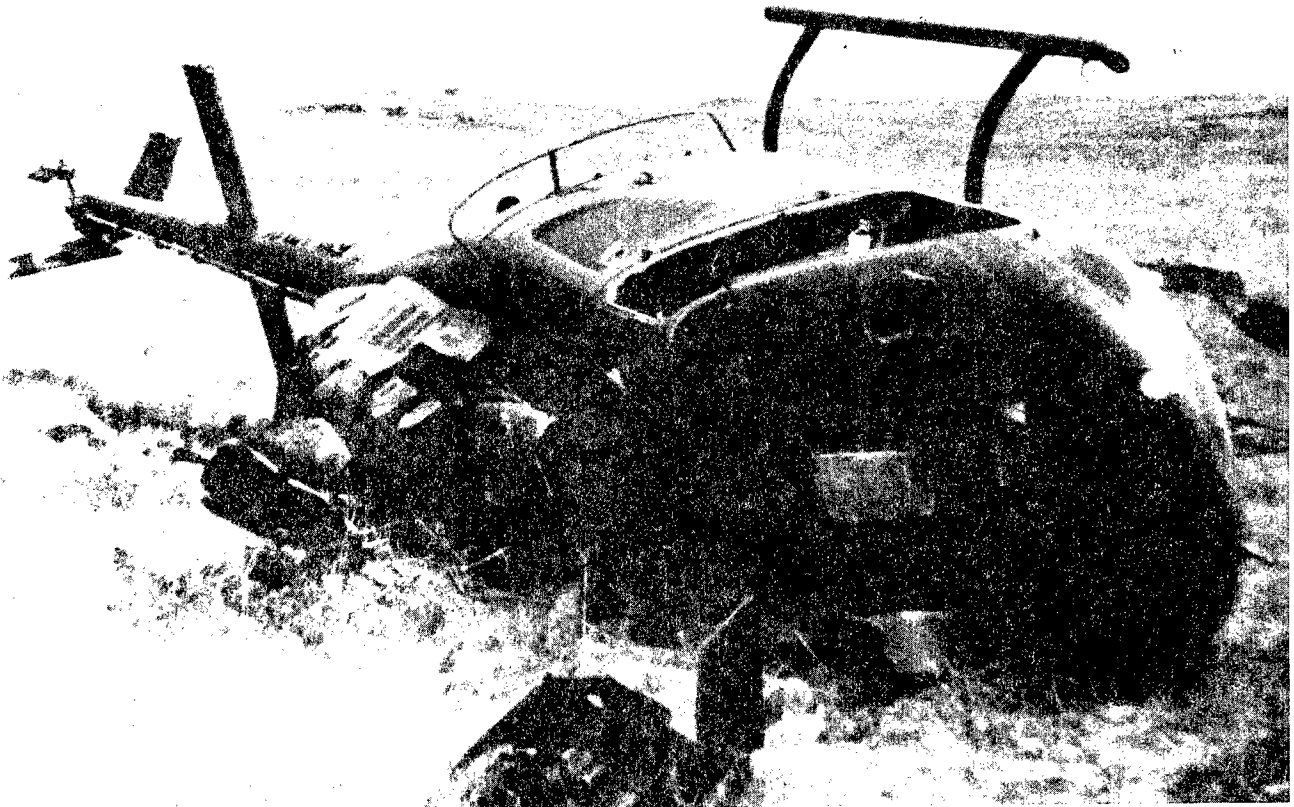
OH-58 pilot induced dynamic rollover while bringing the aircraft to a hover.

**Cause:** The pilot's attention was directed to his right rear and he induced dynamic rollover while bringing the aircraft to a hover. The pilot may have been fatigued. He had exceeded the allowable flight time for a 7-day period by 14 hours. He had just finished a 6½-hour continuous flight and had slept only 3½ hours the night before the accident.

**Unit level:** Inform personnel about the consequences of inadequate attention. Stress the need to perform all tasks in accordance with applicable rules, regulations, and basic flying techniques. Establish a definite crew rest policy and designate individuals within the chain of command to monitor and take appropriate action concerning crew rest.

**Higher level:** Ensure unit commanders establish and monitor a crew rest policy to avoid fatigue-induced errors.

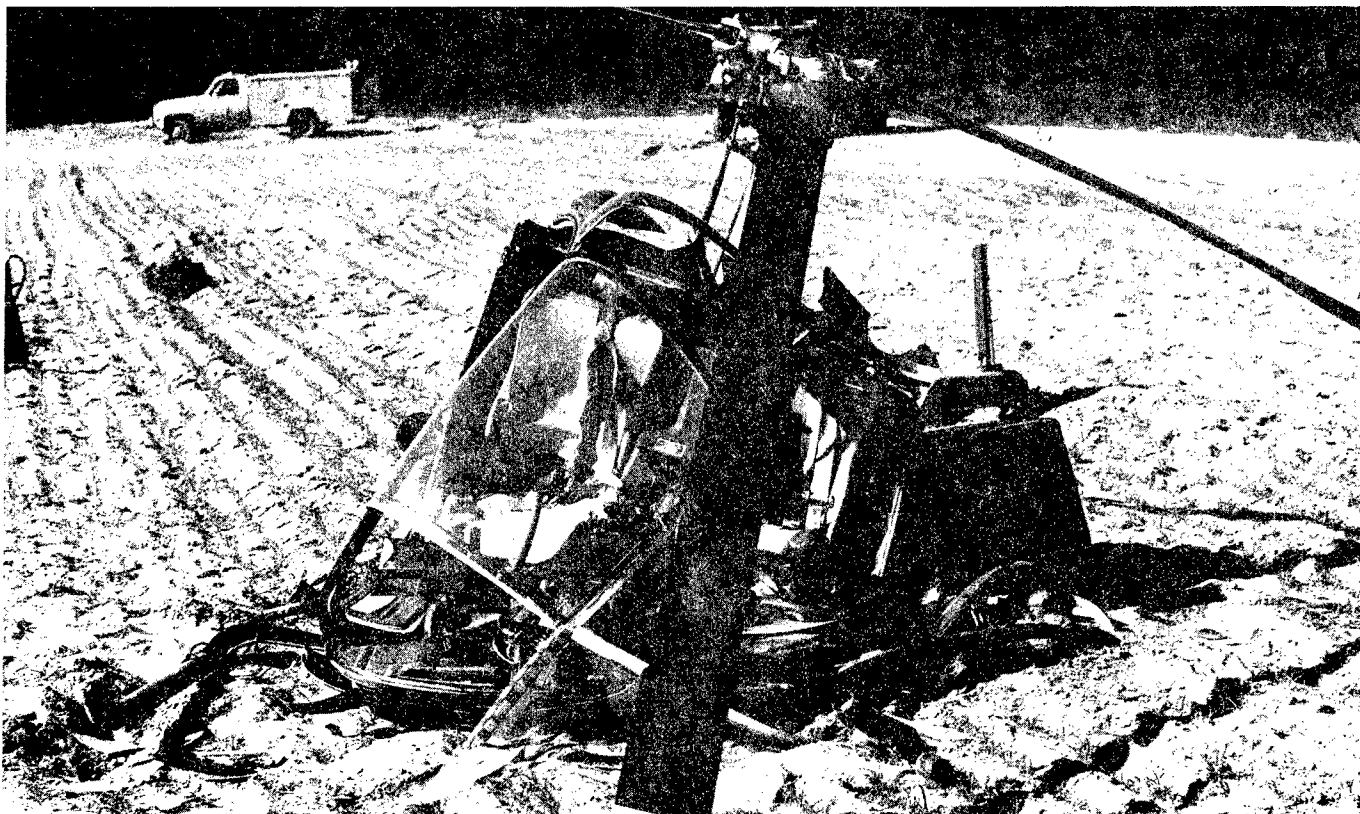
Tail rotor effectiveness was lost when an object hit the tail rotor blade of this TH-55. The student pilot did not follow correct emergency procedures and aircraft crashed.

**Cause:** When the object hit the tail rotor, the student pilot allowed cruise airspeed to fall below that required to streamline the aircraft and did not follow dash 10 emergency procedures.

**Unit level:** Brief all personnel on the importance of a thorough preflight, noting all loose or excess items which may produce damage if dislodged during flight operations. Stress the importance of accurate assessment of tail rotor malfunctions. Ensure all students are knowledgeable and capable of handling all emergencies in the TH-55 before conducting solo flights.

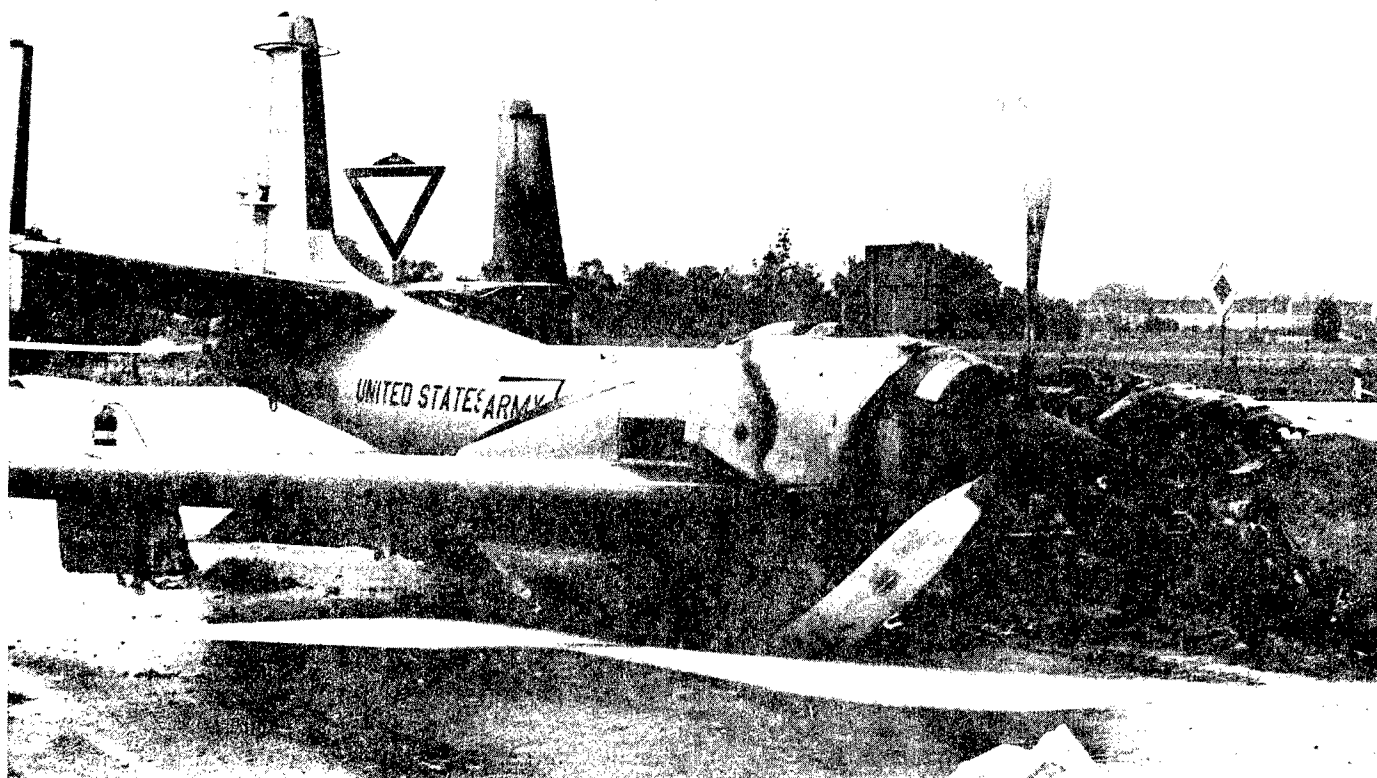
This Mohawk hit a flock of seagulls during takeoff. The pilot and technical observer ejected when the No. 1 engine quit.

**Cause:** The tower operator did not give the pilot a complete bird advisory, which should have included the estimated number of birds. The pilot did not ask about the number of birds because he thought they were "spooked" and would be out of the way during the takeoff.

**Unit level:** Emphasize to air traffic controllers the importance of issuing complete advisories in accordance with the Air Traffic Control Handbook in order to provide pilots with the most complete information available concerning the advisory/condition. Emphasize to aviators the importance of ensuring that when they are issued an advisory that may affect safe aircraft operation they either receive complete information or obtain appropriate information concerning the advisory/condition.

**Higher level:** Continue to take action to eliminate/reduce the potentially hazardous concentrations of birds from the airfield runway environment.
