UH-1 MATERIEL MALFUNCTION/FAILURE MISHAP EXPERIENCE

1 July 1973 - 31 July 1977

Applied Research Division
Directorate for Technical Research and Applications

DOC 77-07

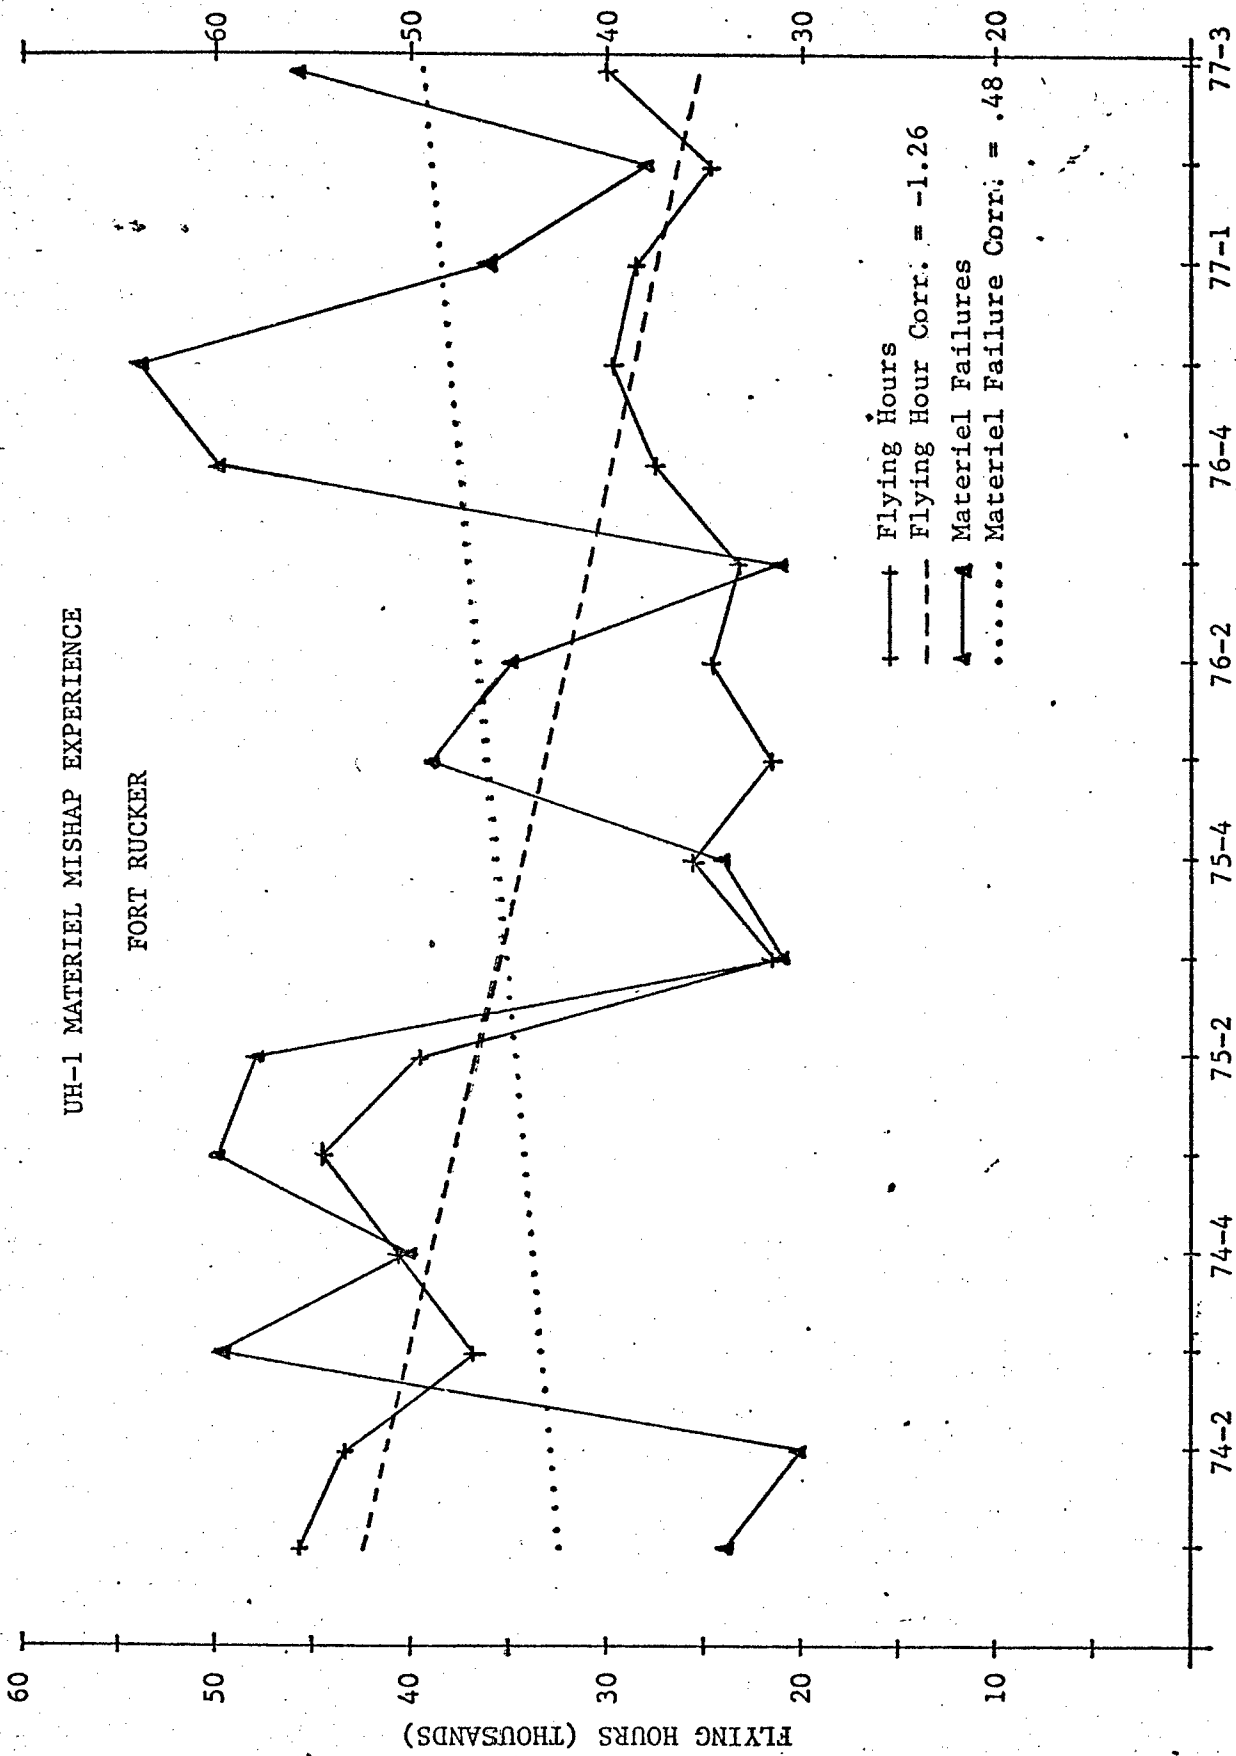
Figure 1

Figure 1, which compares the number of flying hours with the number of materiel caused mishaps by quarters at Fort Rucker, shows an increasing trend in materiel malfunctions/failures and a decreasing trend in flying hours.

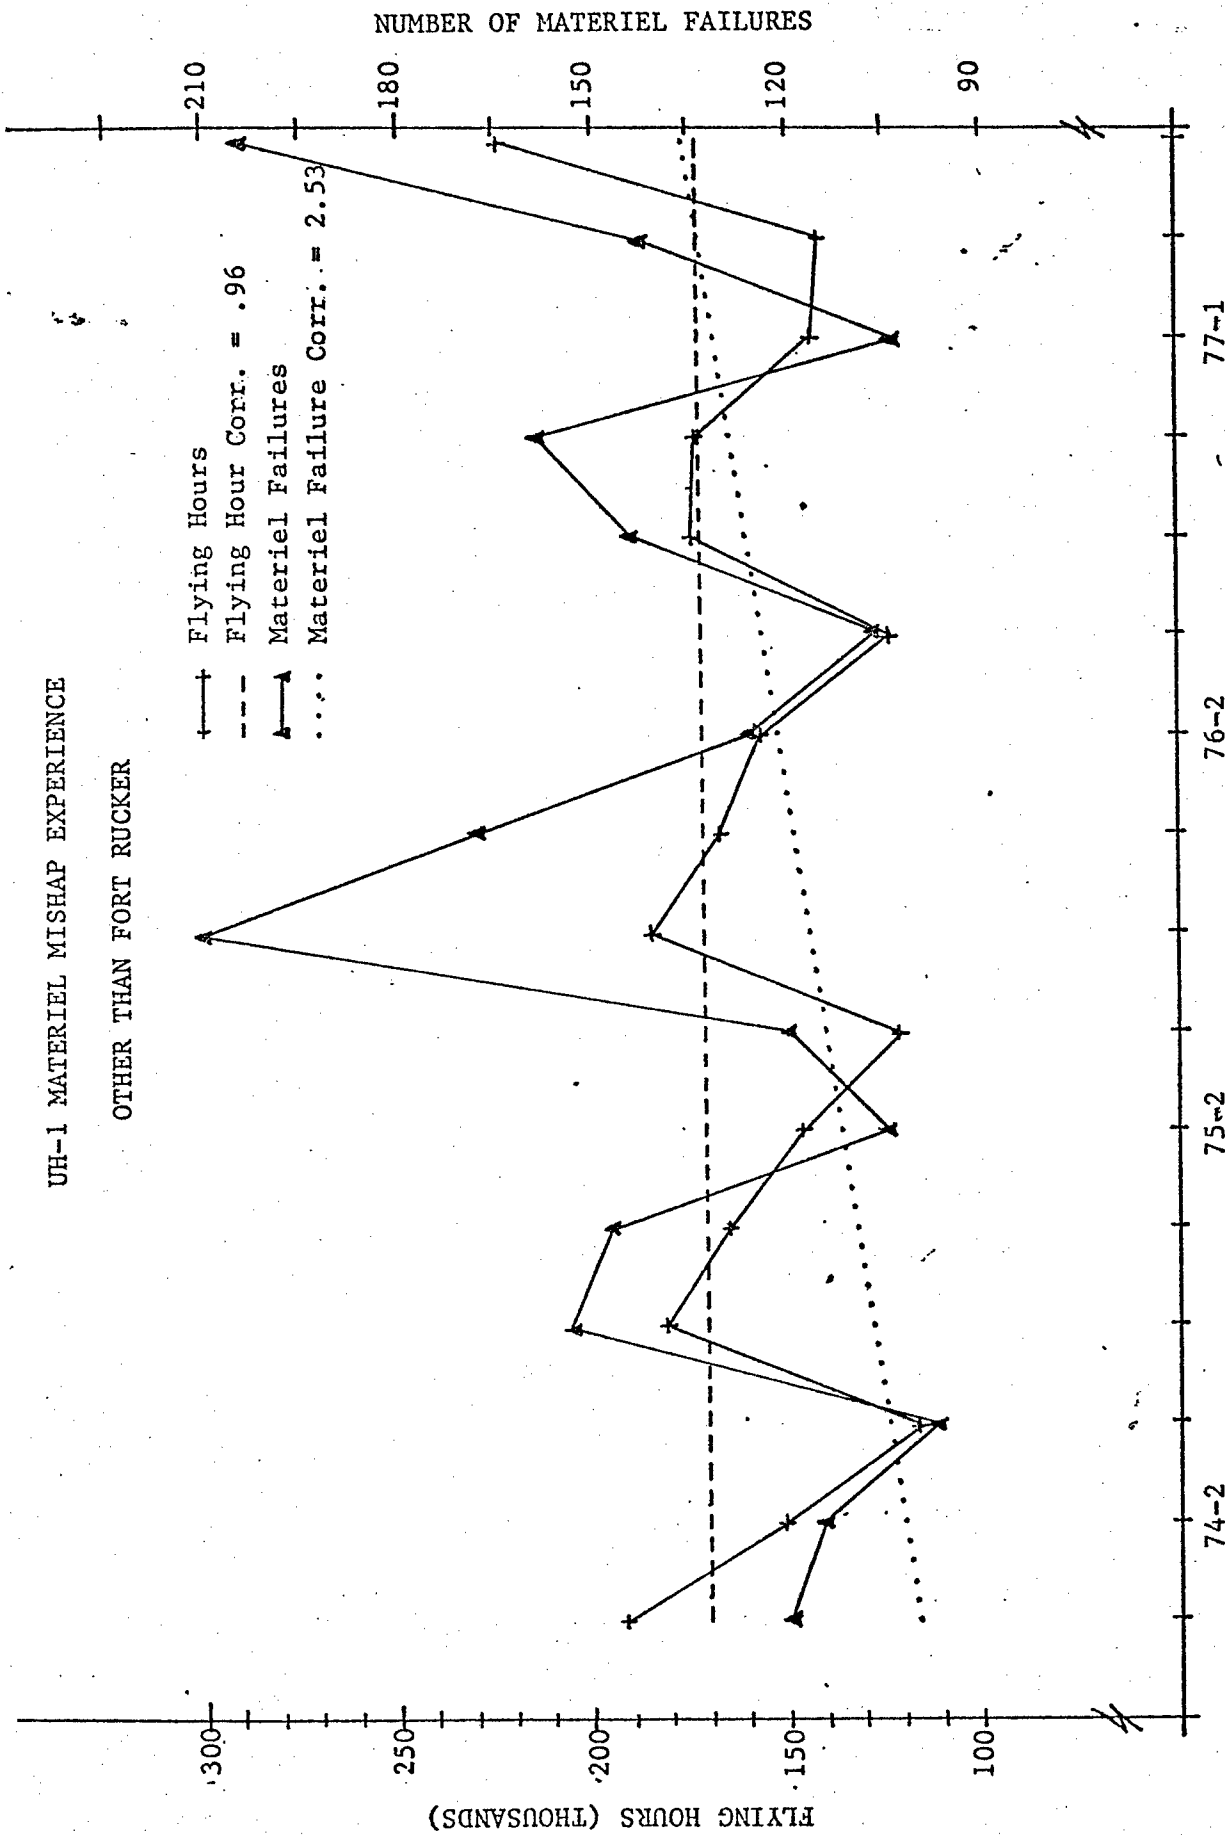
Figure 2 compares the number of flying hours with the number of materiel caused mishaps by quarters other than Fort Rucker. This figure shows an increasing trend in materiel malfunctions/failures and a steady trend in flying hours.

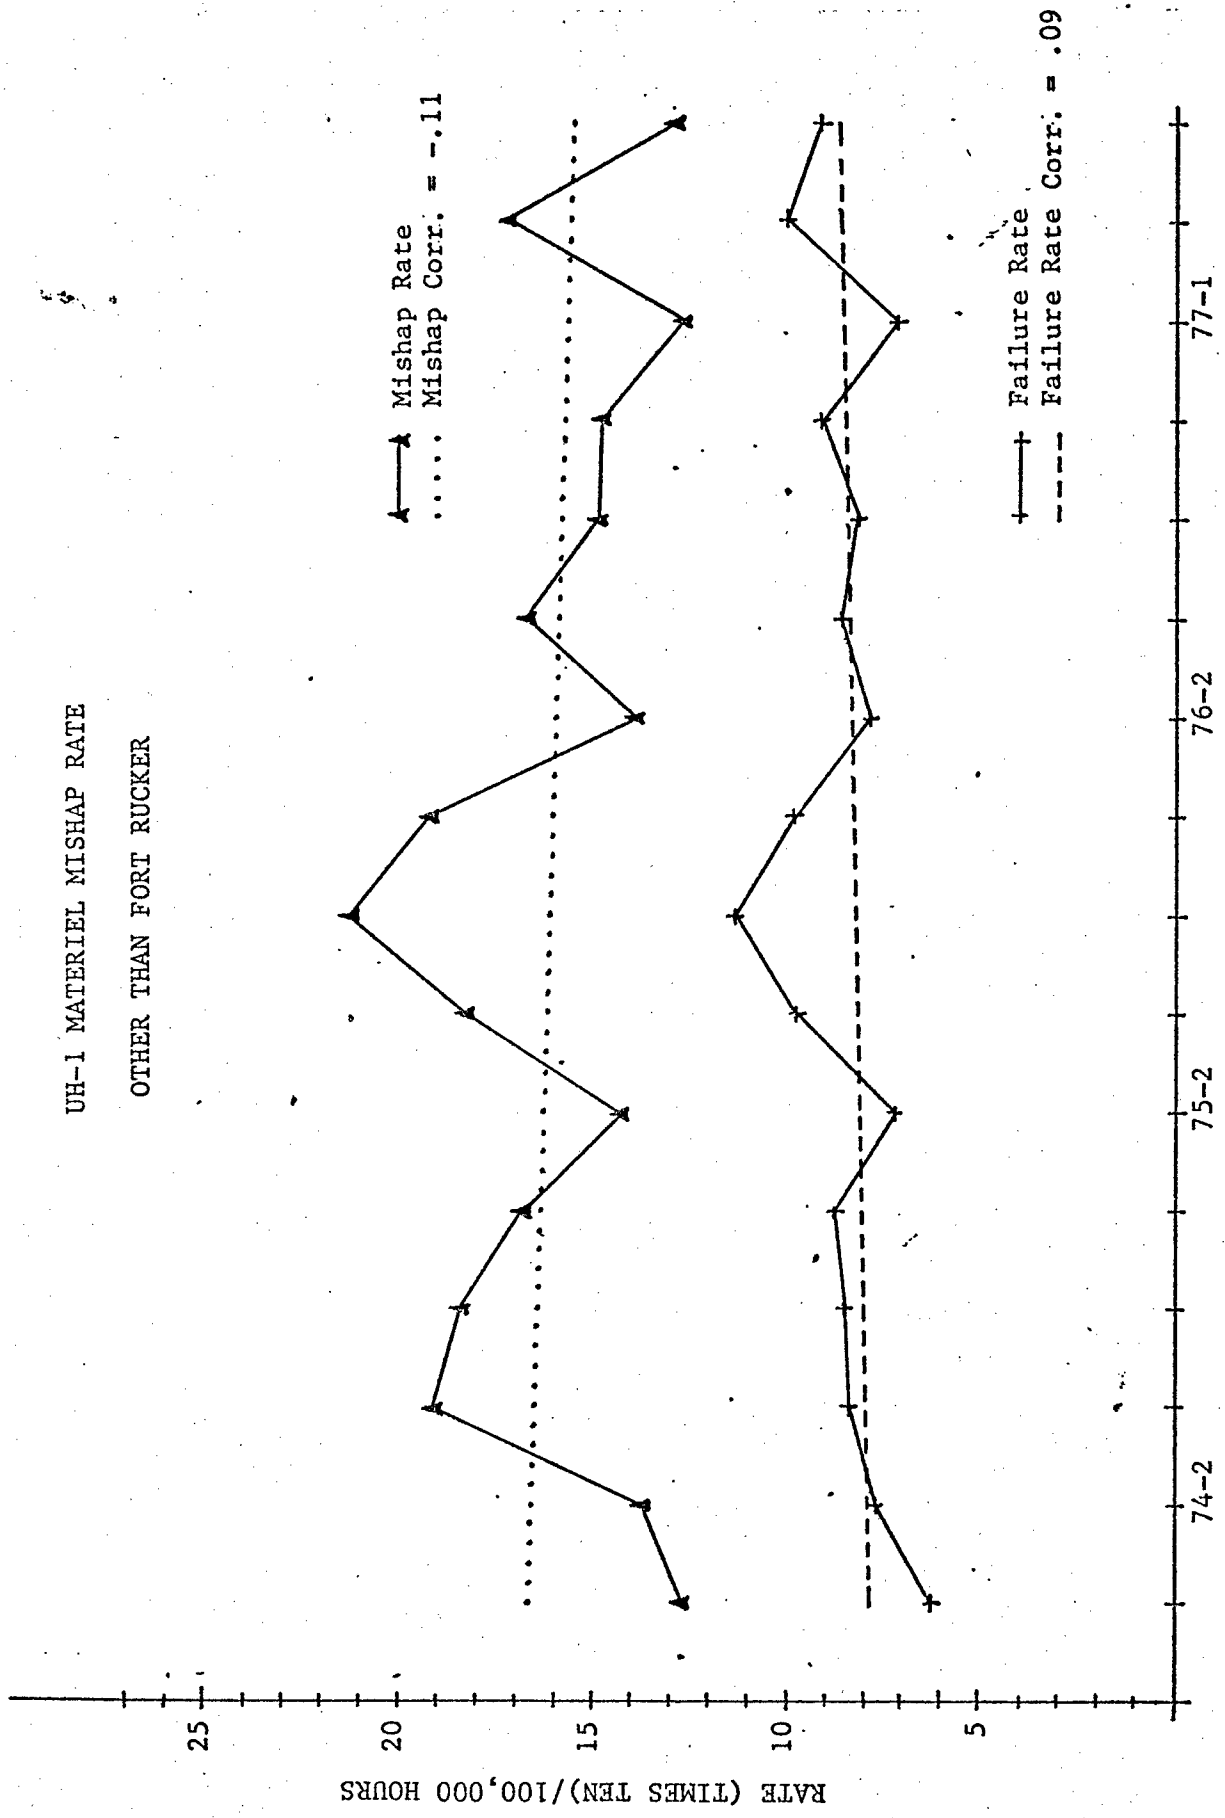
Figure 4 represents a comparison of the rates of materiel caused mishaps with total UH-1 mishaps other than Fort Rucker. The trend lines show that the materiel caused mishaps show an increase but are still well below that of total mishaps indicating that other cause factors have not been reduced.

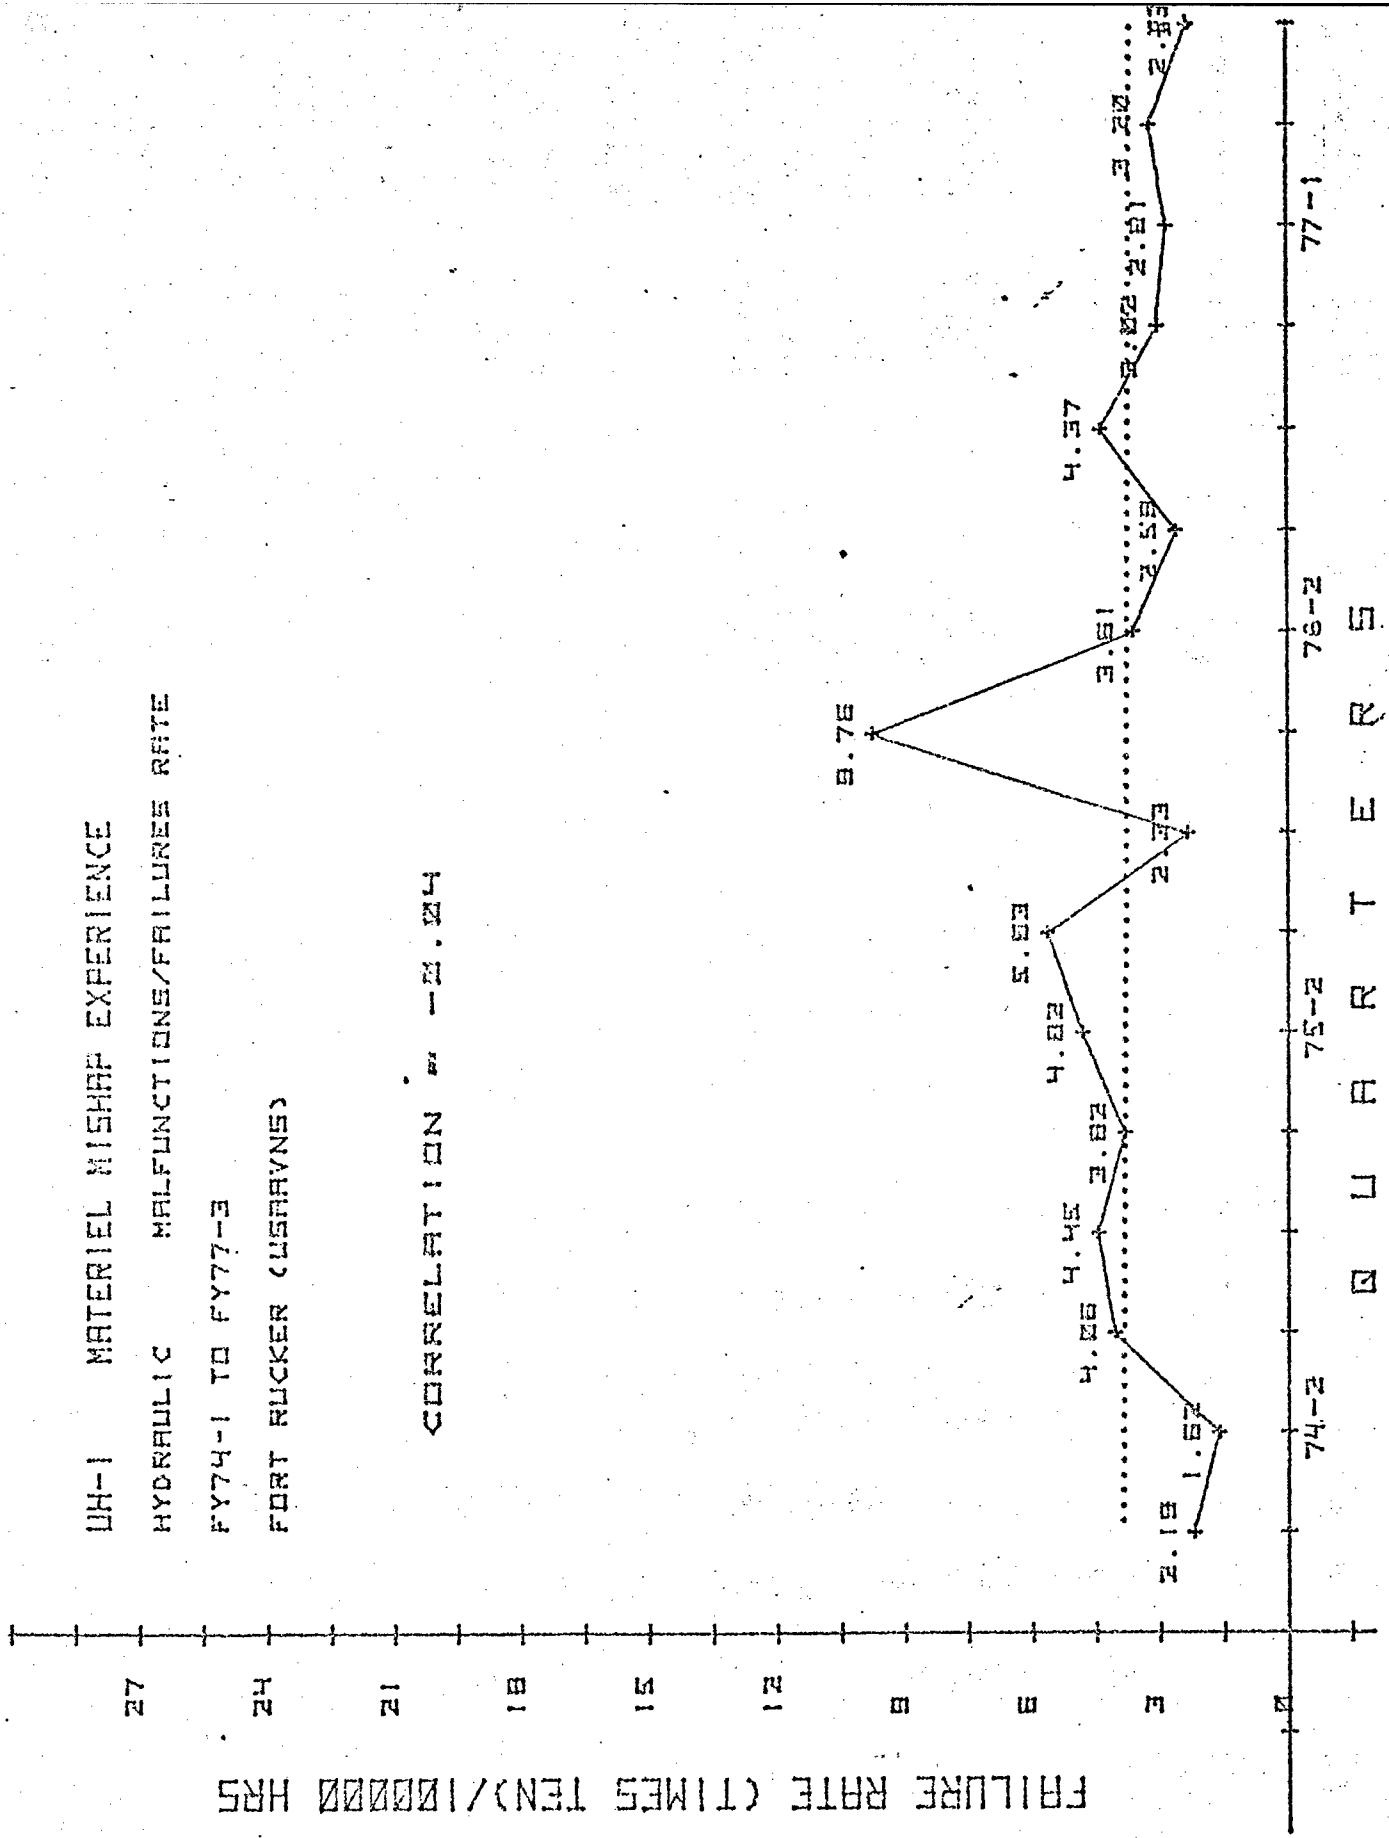
The hydraulic system malfunction/failures were the cause of 186 or 24.9% of the 746 UH-1 materiel caused mishaps. Figure 5 shows a very slight increasing trend over the study period, with the last four quarters showing a decline. The highest rate of 97.6/100,000 hours was achieved during first quarter FY 76. This large increase was due to increased malfunction/failure of the flight controls during this quarter. The

malfunctions/failures were in the pressure switch, the irreversible valve and the servo cylinders. The lowest rate occurred during 2nd quarter FY 74 of 16.2/100,000 hours. Hydraulic system materiel caused mishaps for the entire period occurred at a rate of 36.6/100,000 hours. This system accounted for 186 precautionary landings or 26% of the UH-1 materiel caused precautionary landings.

91 or 49% of the materiel caused hydraulic mishaps were a result of the malfunction/failure of a pressure switch (FSN 5930-00-646-3495). This represents 13% of the UH-1 materiel caused precautionary landings.

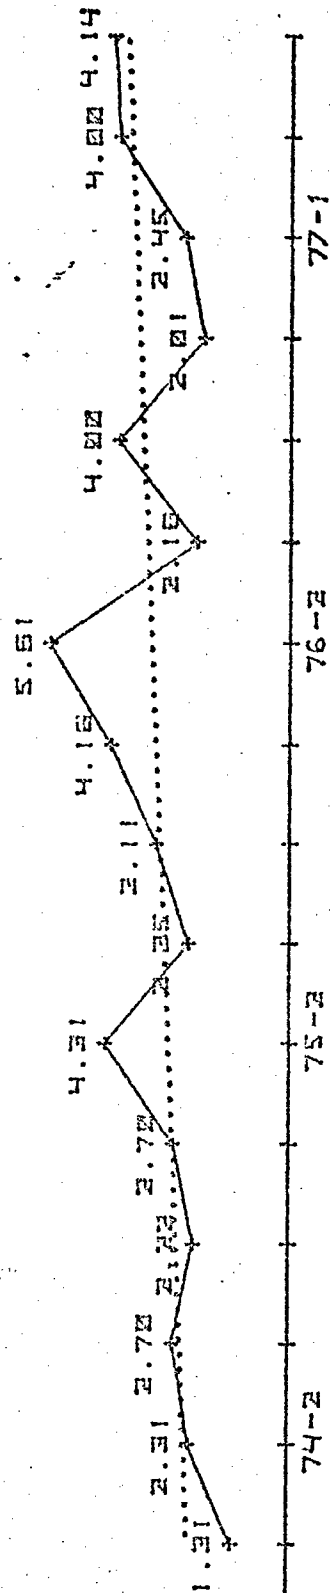
The engine/power plant system malfunctions/failures were the cause of 155 or 20.8% of the UH-1 materiel caused mishaps. Figure 6 shows a slight increasing trend over the study period. The highest rate of 56.1/100,000 hours occurred in 2nd quarter FY 76. The lowest rate of 20.1/100,000 was achieved in FY 7T. Engine/power plant system materiel caused mishaps, for the entire period, occurred at a rate of 30.5/100,000 hours. This system accounted for:

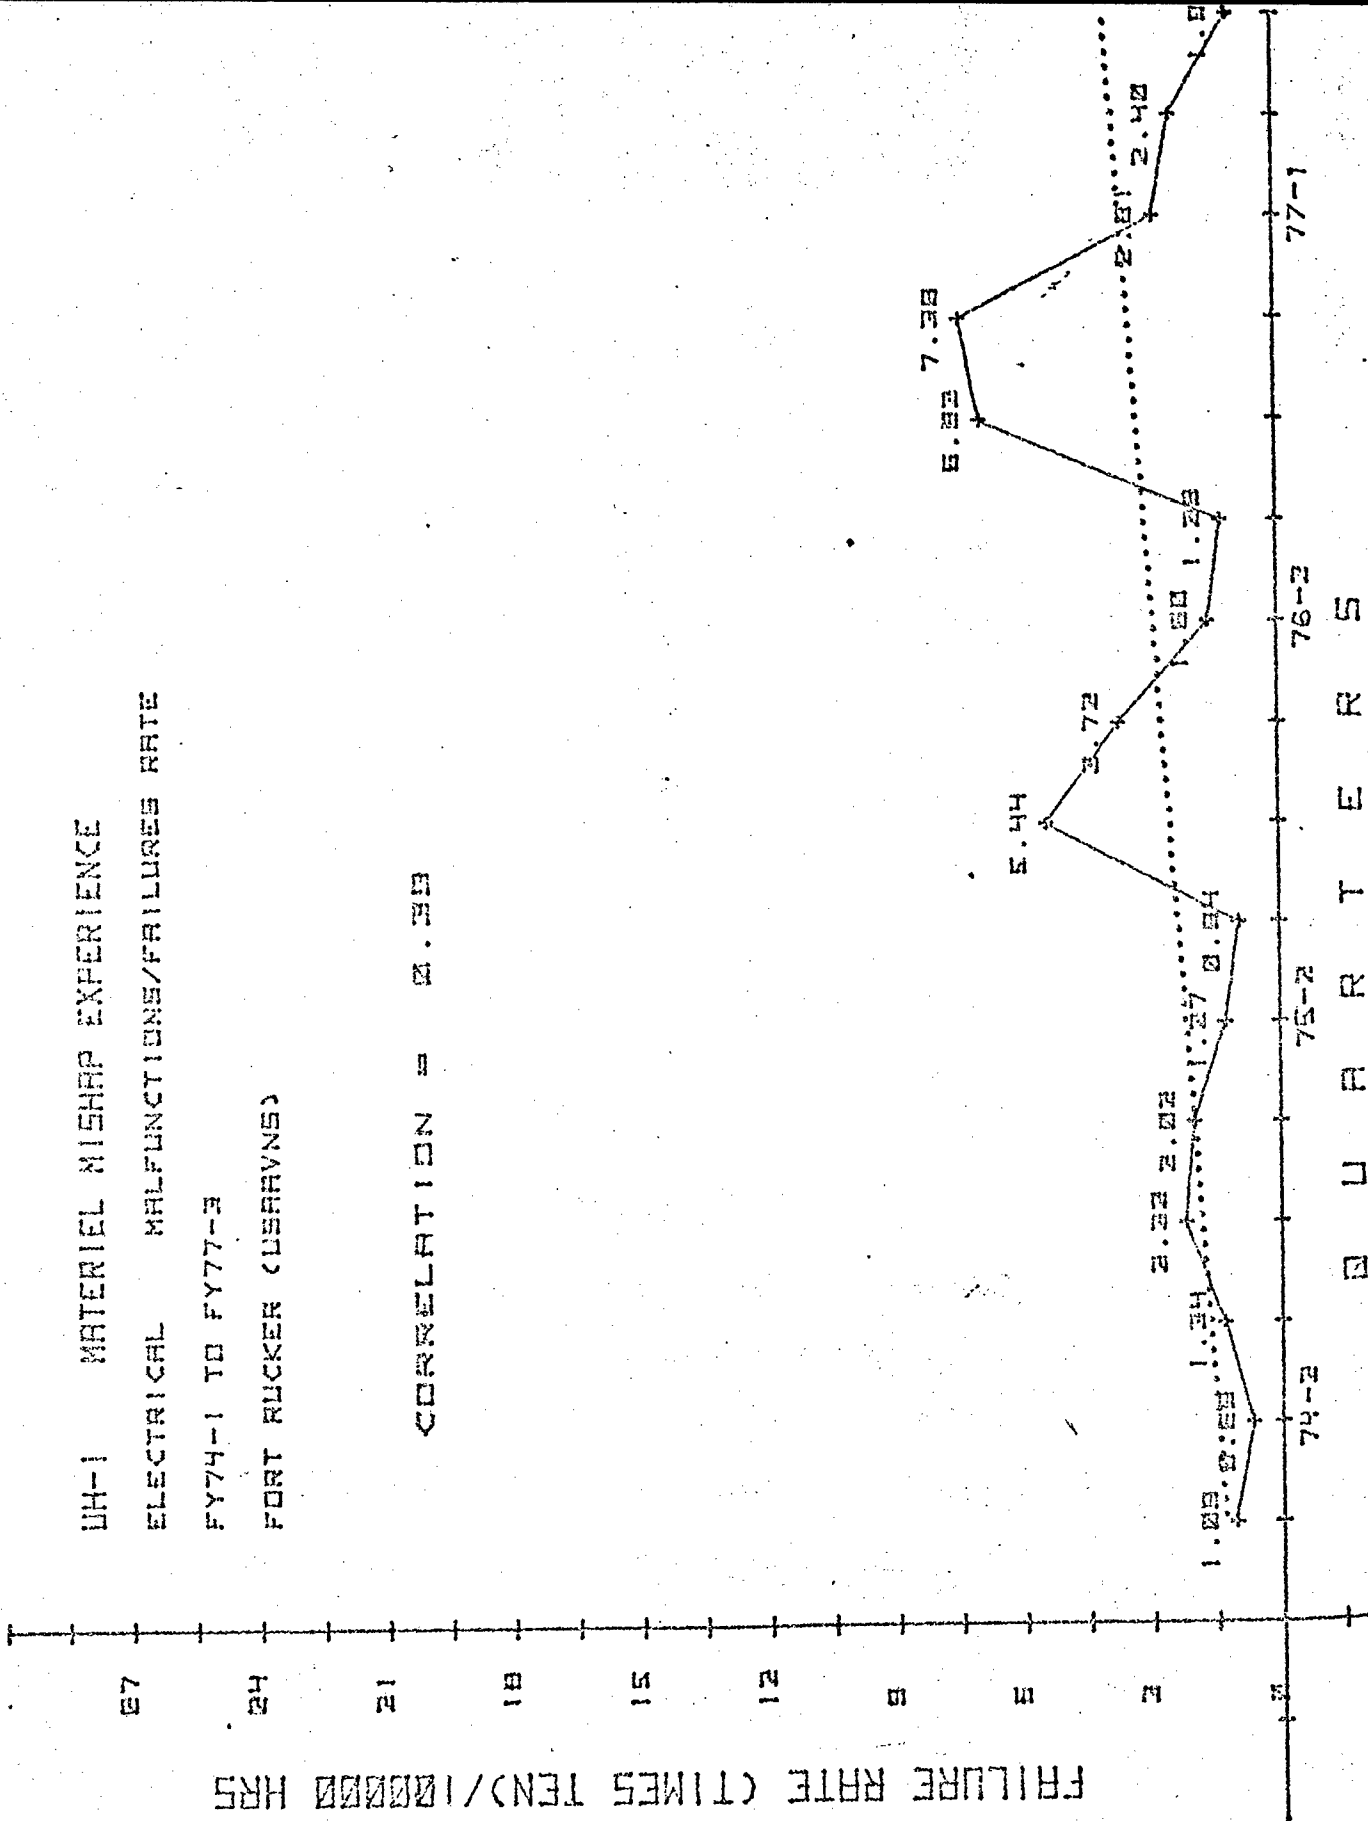
The electrical system malfunctions/failures were the cause of 126 or 17% of UH-1 materiel caused malfunctions. Figure 7 shows a significant increasing trend over the study period despite the last three quarters declining. The highest rate of 73.8/100,000 hours occurred in FY 7T quarter. The lowest rate of 6.9/100,000 was achieved in 2nd quarter FY 74. Electrical system materiel caused mishap for the entire period occurred at a rate of 24.8/100,000 hours. All the mishaps were precautionary landings.

FY 74-4 and FY 7T of Figure 7 indicates a sharp increase which also raises the total rate. This is due to the aircraft battery. In both of these quarters Fort Rucker experienced 14 battery malfunctions/failures. The other quarters in the study period only had 0 to 4 battery malfunctions/failures.

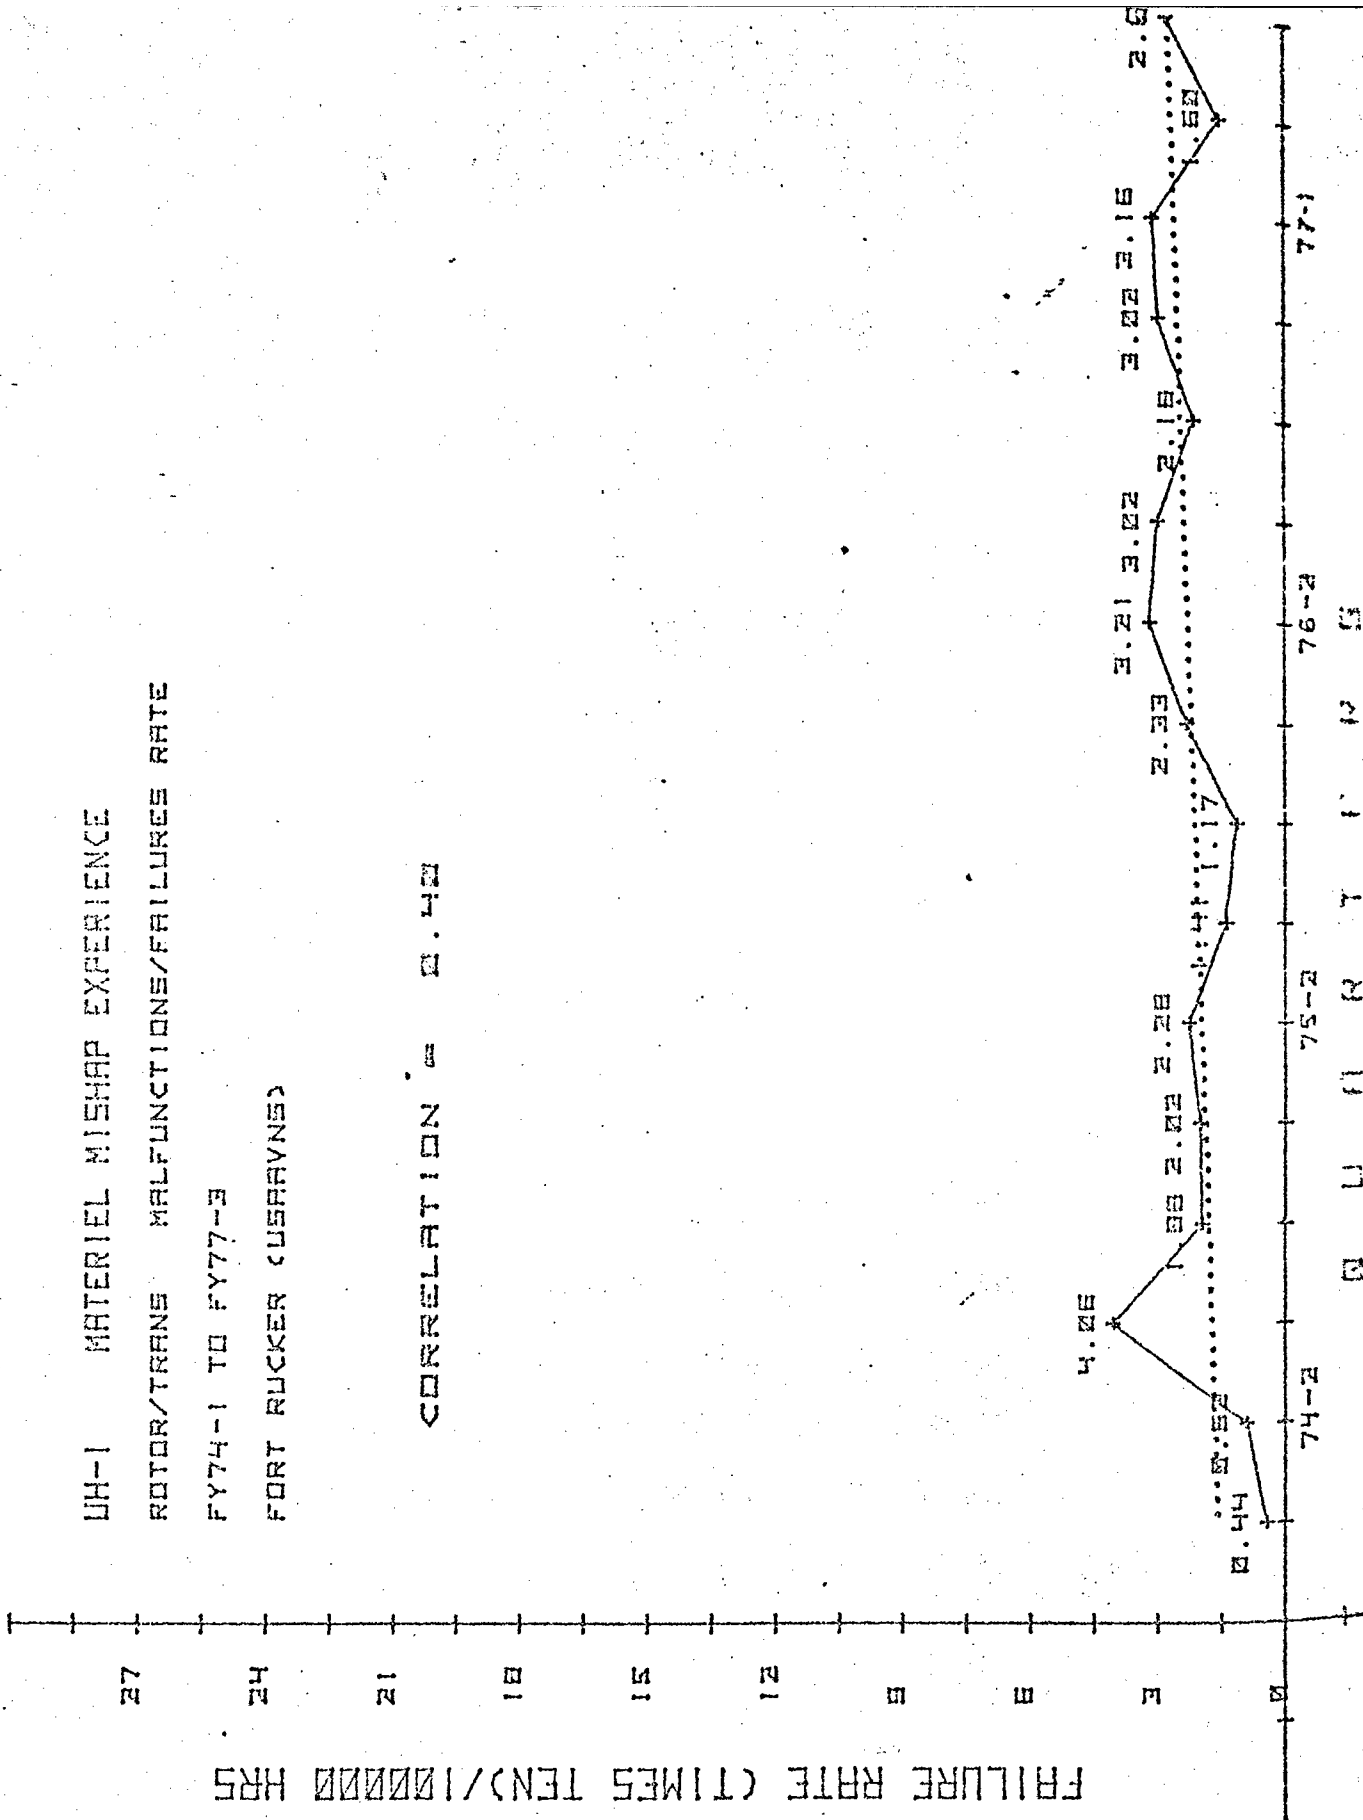
The rotor/transmission system malfunctions/failures were the cause of 112 or 15% of the 746 UH-1 materiel caused mishaps. Figure 8 showed

a slight increasing trend. The highest rate, 40.6/100,000 hours, was obtained in 3d quarter, FY 74. A 4.4 rate was obtained in 1st quarter, FY 74. Rotor/transmission materiel caused mishaps for the entire period occurred at a rate of 22.0/100,000 hours.

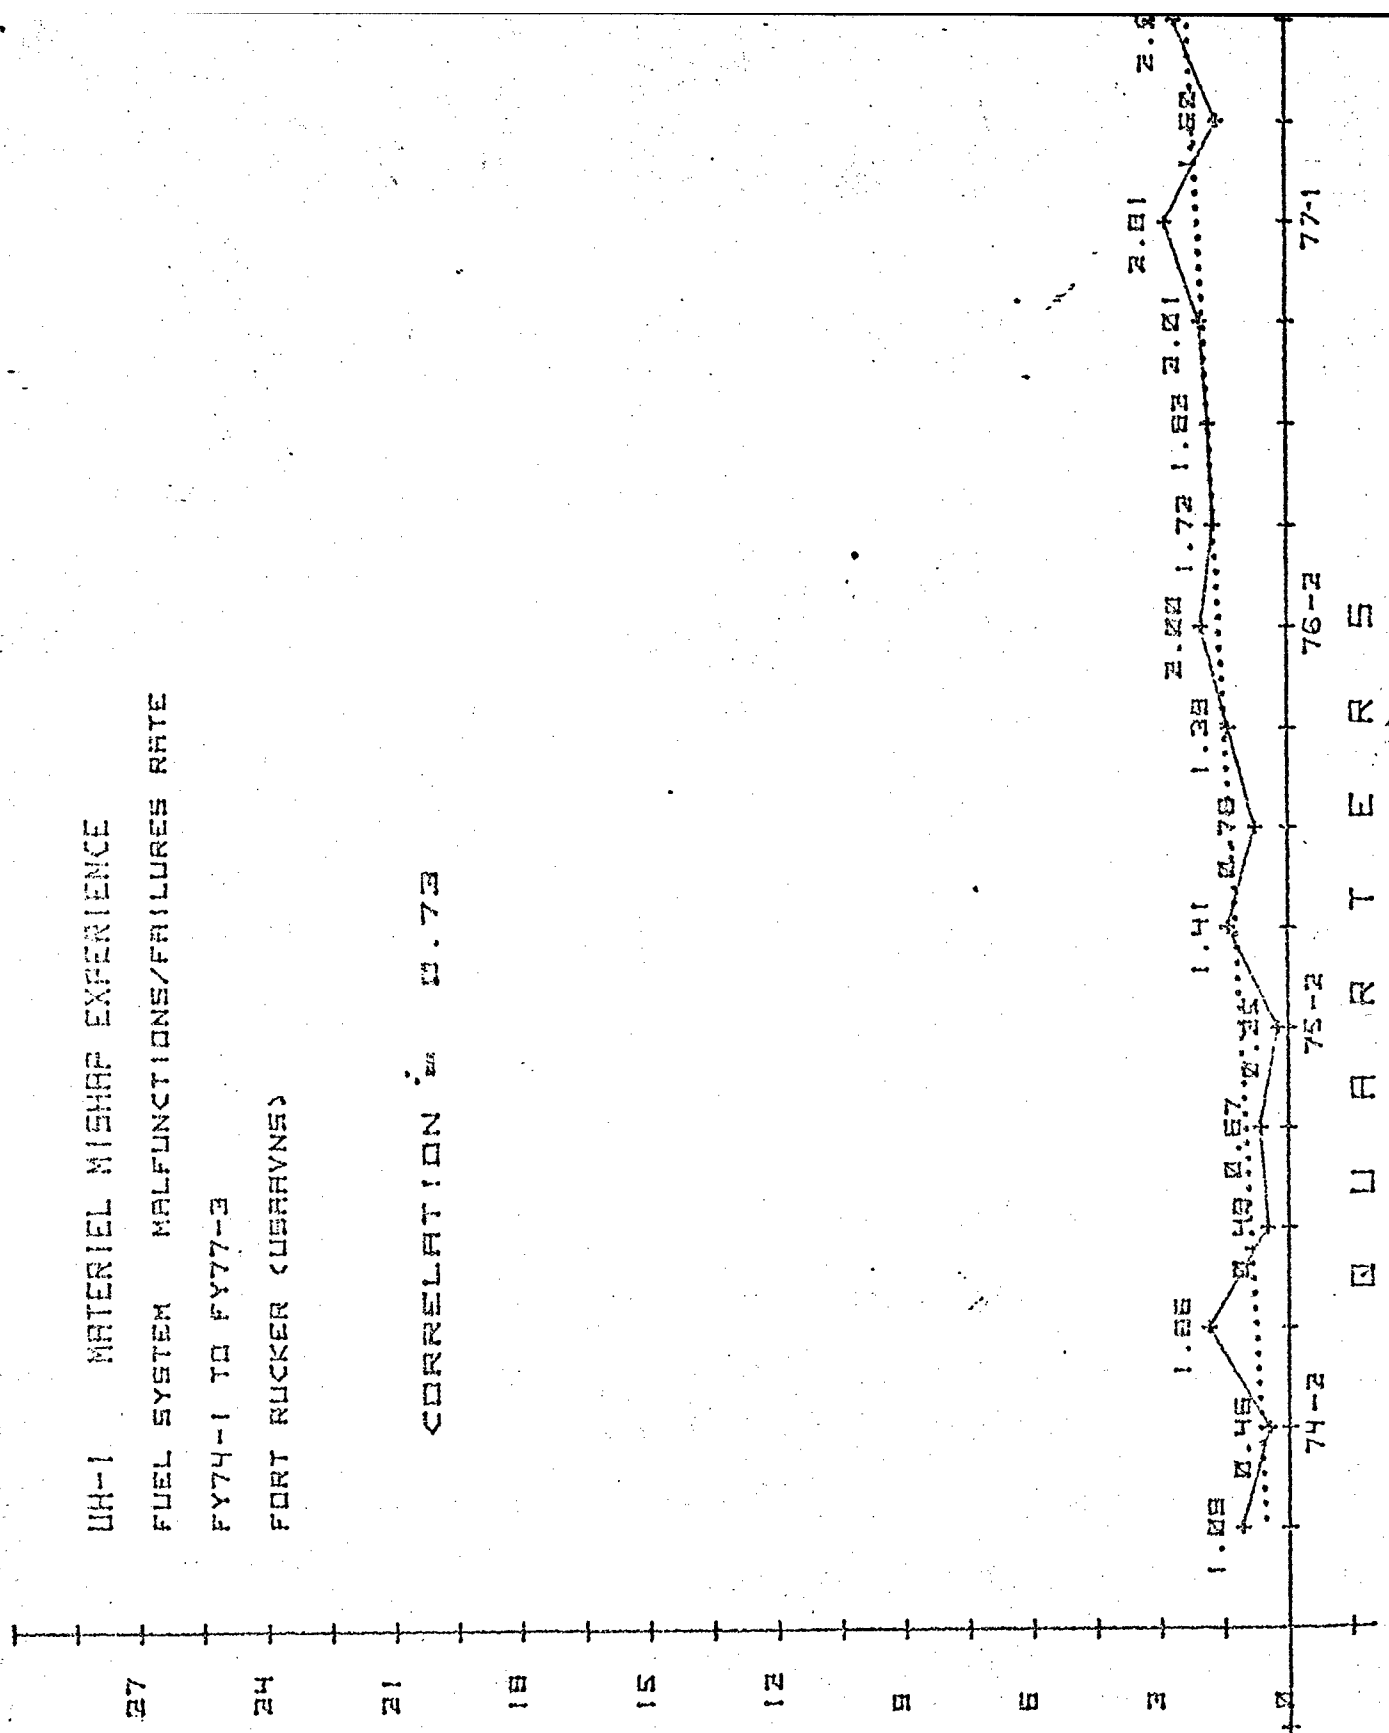
The fuel system malfunctions/failures were the cause of 70 or 9% of the 746 UH-1 materiel caused mishaps. Figure 9 shows a steady increasing trend. The highest rate of 28.1/100,000 occurred in 1st quarter FY 77. The lowest rate of 2.5/100,000 hours was achieved the 2nd quarter FY 75. Fuel system materiel caused mishaps for the entire period occurred at a rate of 13.8/100,000 hours.
