# Study of Army Aircraft Maintenance-Related Mishap Experience

November 1981

DOC 81-11

## **1 October 1976 through 31 December 1980**

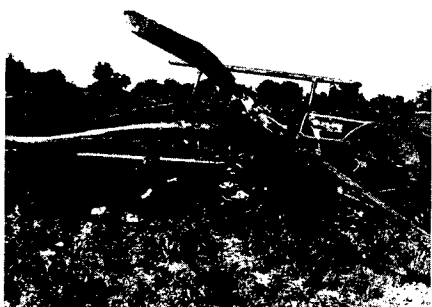
With one passenger on board, the pilot of an OH-58 attempted a left hovering turn when he noted that the left control pedal bottomed out prematurely. The aircraft then began spinning uncontrollably to the right. The pilot increased collective and attempted to fly out of the spin. This spin was unsuccessful and when the low rpm audio sounded, the pilot decreased collective to set the spinning aircraft on the ground.

During the landing attempt, the main rotor struck the ground and the aircraft rolled on its right side. Both occupants exited through the left crew door without injury. The aircraft was destroyed.

Investigation revealed that maintenance personnel used improper procedures during the installation of the tail rotor pitch change control tube, P/N 206-011-724-1. This resulted in one roller becoming dislodged from the control housing roller bearing, P/N 206-011-731-1. During flight, the dislodged roller became trapped between the pitch key, P/N 206-011-704-1, and the end of the key slot, restricting left pedal movement of the pitch control tube by approximately 7/16 inch. This resulted in insufficient antitorque control. ■
