NASA CR-425

## INVESTIGATION OF THE SONIC FATIGUE CHARACTERISTICS OF RANDOMLY EXCITED ALUMINUM VISCOELASTIC PANELS AT AMBIENT TEMPERATURES

Prepared under Contract No. NAS 1-4728 by  
NORTH AMERICAN AVIATION, INC.

NATIONAL AERONAUTICS AND SPACE ADMINISTRATION • WASHINGTON, D. C. • APRIL 1966

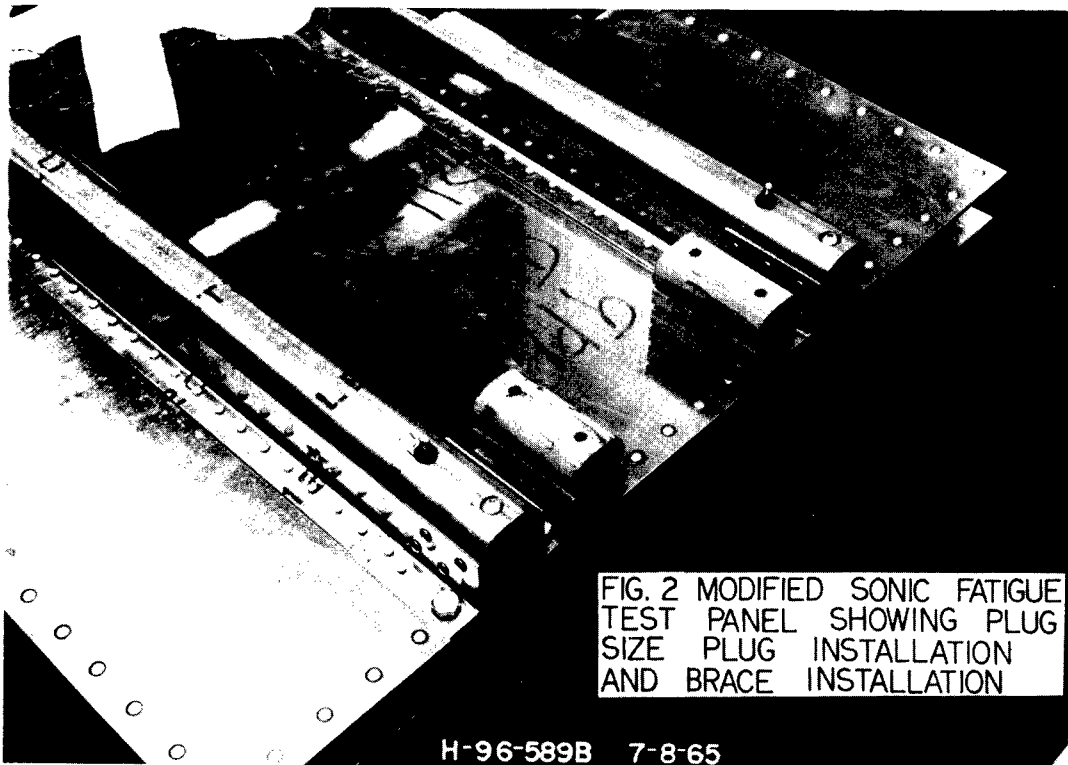
FIG. 2 MODIFIED SONIC FATIGUE  
TEST PANEL SHOWING PLUG  
SIZE PLUG INSTALLATION  
AND BRACE INSTALLATION

The original panel design incorporated four braces located in the center bay area. The purpose of these braces was to strengthen the stiffeners and prevent stiffener failure. During the preliminary testing phase, stiffener failure was experienced prior to panel fatigue in the areas where the braces were not used. This type of failure obviously necessitated a modification to the panel. Three possible fixes were considered, namely: (1) adding aluminum braces to the other sides of the hat section stiffeners, (2) replacing the aluminum braces with steel braces, and (3) plugging the ends of the stiffeners with wood or metal plugs. The final fix included the addition of .051 inch aluminum braces and the insertion of wood plugs into the ends of the hat sections. With this modification, failure to the stiffeners did not occur. The wood plugs were made from hard maple, measured 2-1/2 inches in length, and weighed approximately 16 ounces. The total weight of each viscoelastic and control panel was  $9.5 \pm 0.3$  pounds. Figure 2 gives the modified panel configuration and shows the plug size, plug installation and brace attachment.

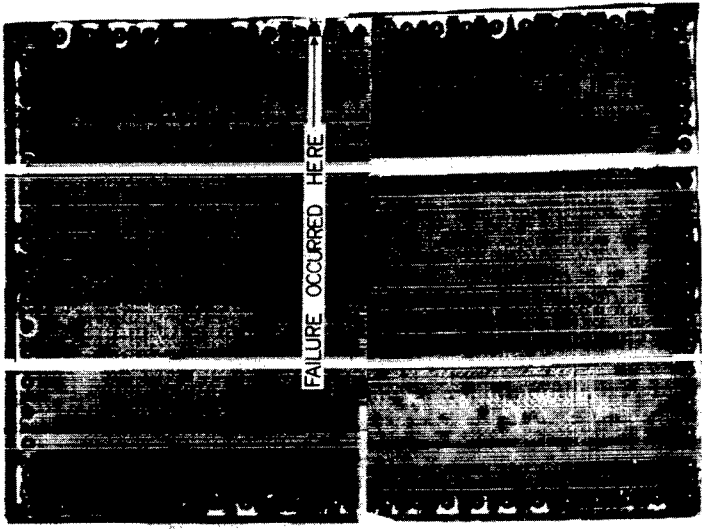
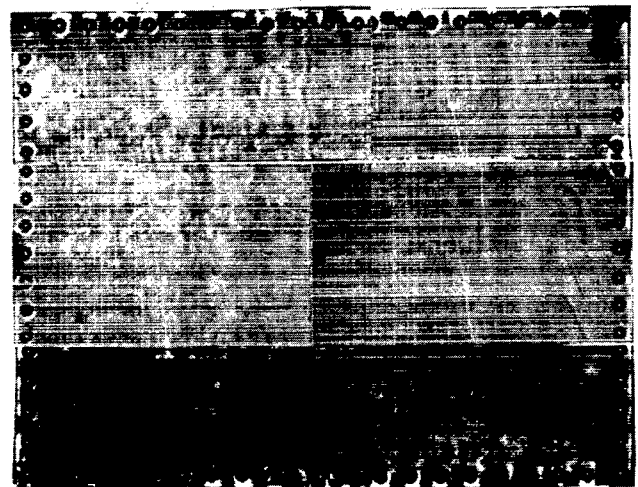
FIG. 7 TYPICAL SONOFAX RECORDS OF VISCOELASTIC PANEL

Three assembled panels, designated as NAS-8V, -9V, and -10V, were subjected to pre-and post-test inspection. The post-test results showed that no damage had developed to the bond during acoustic excitation. Pre-test results indicated some unbonding occurred during the riveting operation. The amount depended upon the degree of panel dimple.

The results of the sonofax records on the bare v-e sheet, a pre-test panel and a post-test panel are illustrated in figure 7. In the post-test panel illustration, the vertical blank areas are indications of stiffener locations and do not represent void areas.

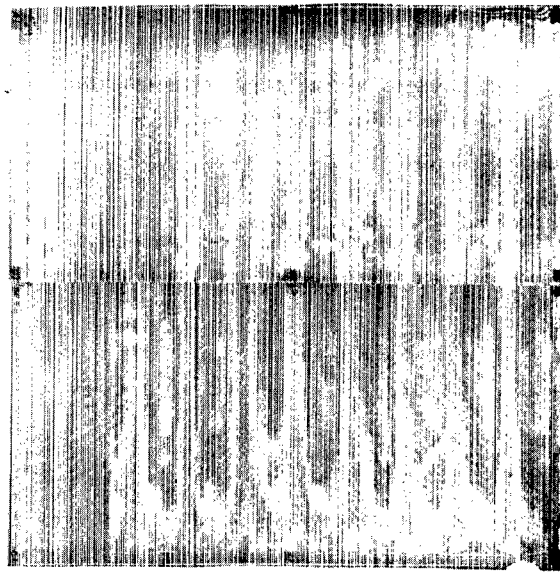
SLIGHTLY RIPPLED AL. SHEET

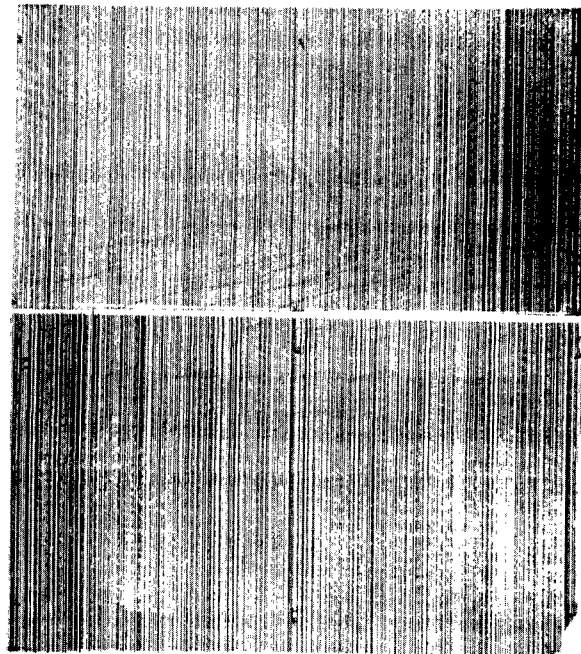
FIG. 7a: SONOFAX RECORDS OF VISCOELASTIC SHEETS

All of the viscoelastic sheets procured from the manufacturer were examined for unbonded and void areas with a sonofax machine. The general bond condition of these sheets was good with the exception of a small unbonded region near the edges on three of the specimens. Table III gives a description of the condition of the v-e sheets as observed from sonofax records.

GOOD BOND

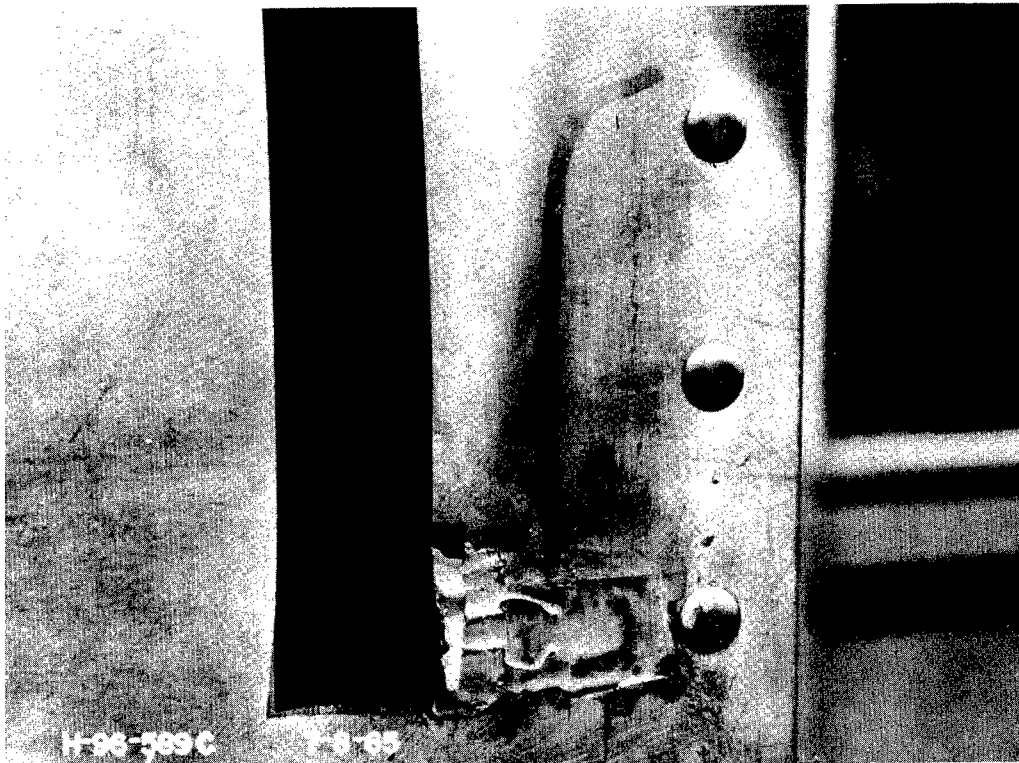
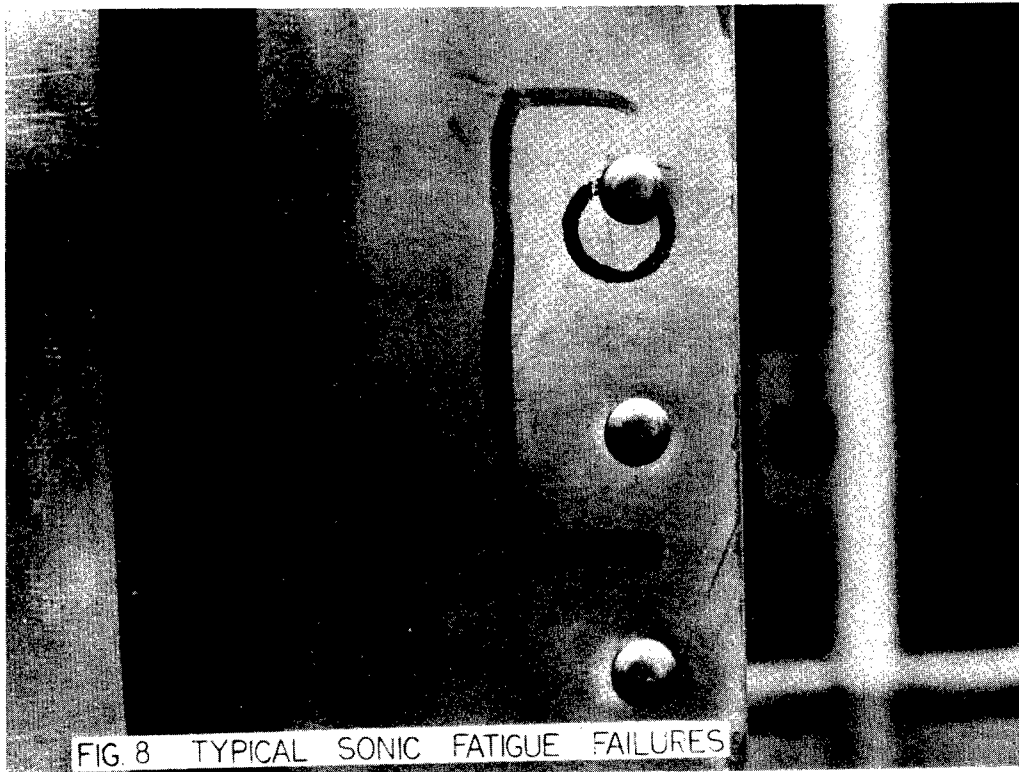
FIG. 8 TYPICAL SONIC FATIGUE FAILURES

For the aluminum control panel, the three primary frequencies were 170 cps, 242 cps, and 308 cps at a test level of 154 db as seen at strain gage position #5. As the SPL was increased, the 170 cps mode, which was identified as the fundamental frequency of the center bay area from modal mapping, increased to 185 cps and 200 cps at SPL's of 157 db and 160 db, respectively. No significant changes were noted at the other two frequencies. However, a variation of  $\pm 10$  cps was noted from the above listed frequencies at the other strain gage locations. The primary response frequency and the point of maximum stress concentration was measured at 308 cps in bay area #3. This was the area where sonic fatigue failure occurred in all panels. Failures were characterized by minute cracks propagating along the downstream flange rivet line on the back side of the panel. The majority of the failures occurred approximately 1 - 2 inches above and/or below strain gage #5. Two of the control panels exhibited failures 6 inches above the stated reference position. The cracks would generally emanate from the rivet and progress in a downward or upward direction. Several cracks had developed 1/4" to 3/8" from the rivet center line as seen in figure 8.

The character of fatigue failure of the v-e panel is similar to that of the control panel. Failure occurred in bay area #3 and 1 - 2 inches above or below gage #5. A representative panel crack is displayed in figure 8.

4. All of the fatigue failures occurred on the back side of the panel (away from the sound field) near the flange rivet line in bay area #3 (bay area #3 is downstream from the sound source). The cracks would generally emanate from the rivet and progress in a downward or upward direction. Several cracks had developed 1/4" to 3/8" from the rivet center line as seen in figure 8.
