ERDC/CHL TR-00-1

## **Demonstration Erosion Control Project Monitoring Program**

### **Fiscal Year 1995 Report**

David S. Biedenharn, Nolan K. Raphelt,  
and Chester C. Watson

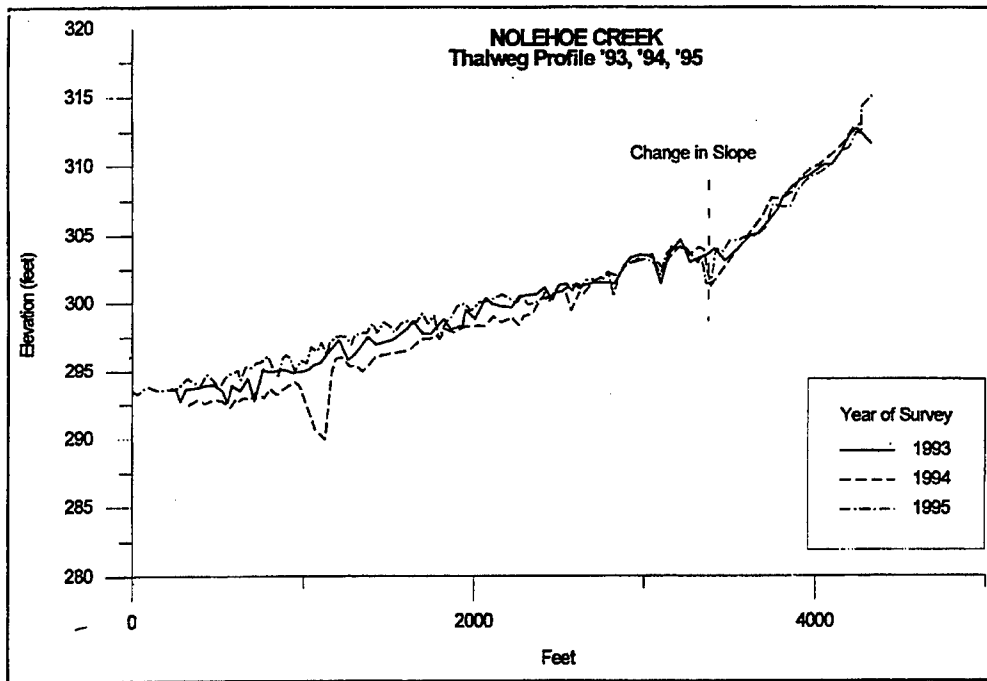
Figure 39. Thalweg profiles for Nolehoe Creek, site #7

The thalweg profile indicates that the lower Segment 1 has aggraded slightly and that the upper portion of the segment has changed little (Figure 39). Segment 1 has been classified as CEM 4, Segment 2 is classified as CEM 2. Segment 2, upstream of the break in slope, is very steep and dynamic. Segment 2 concentration is more than 4 time Segment 1, and continuing urbanization will accelerate the upstream degradation, which will place the upstream box culverts at risk. Channelization of Segment 2 to include grade control, and similar treatment for the tributary entering from the north a the break in slope should be considered. Property owner permission may be a major impediment to any future work.

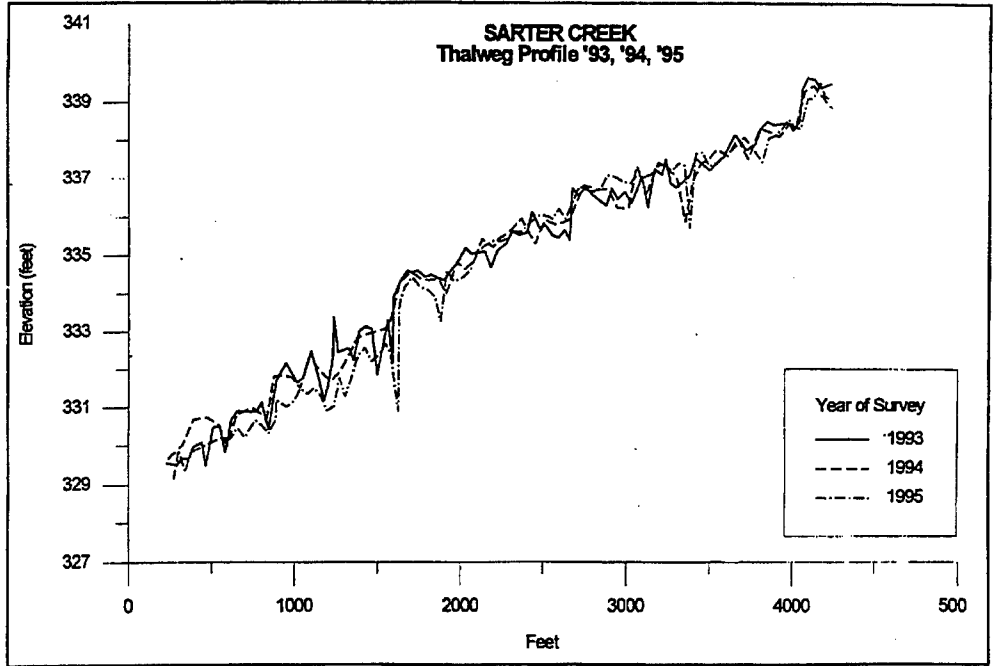
Figure 47. Thalweg profiles for Sarter Creek, site #15

The 1995 profile indicates continuing incision. Field inspection in November, 1995 confirmed several headcuts, and that numerous beaver dams are playing an important role in maintaining the stability of the channel. The channel ranges from a CEM 4 at the downstream extent to CEM 2 upstream, and has been given a CEM 3 designation overall. Riprap grade control should be considered for the site.

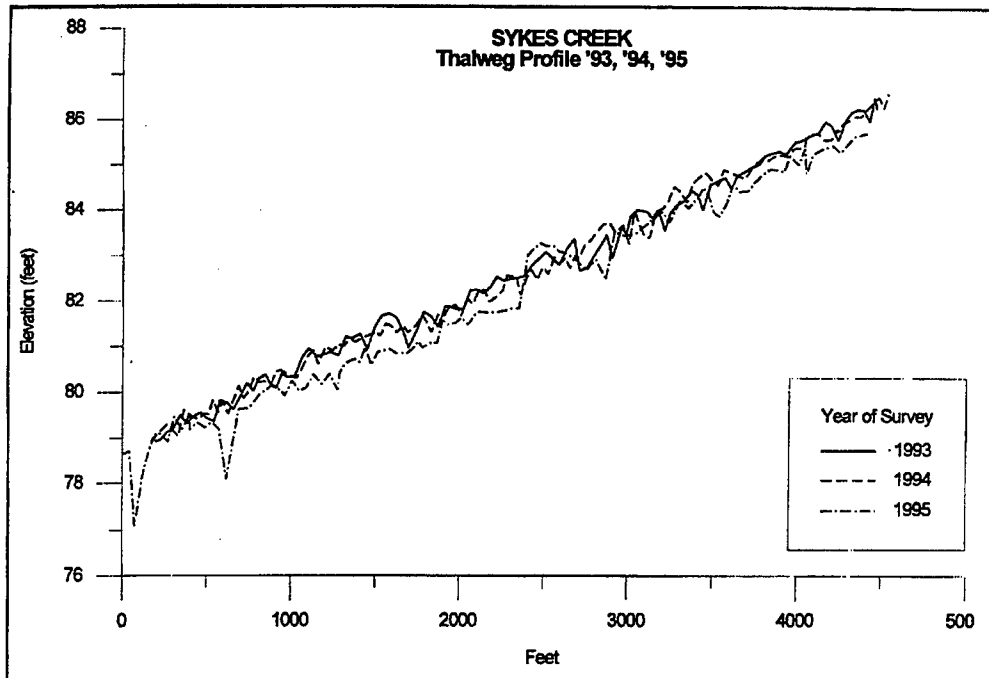
Figure 49. Thalweg profiles for Sykes Creek, site #17

The accompanying thalweg profile, shown in Figure 49, indicates that little change has occurred during the three year period, and by many indicators such as berm formation, depth of sand in the bed, and by thalweg comparison, the channel could be considered in quasi-equilibrium. However, comparison of the existing conditions to the slope and width required at minimum stream power for transport of 1000 mg/l indicates that the reach is transporting a high sediment load. The 1995, 2-year water surface slope is 211% of the minimum slope and the width is 71% of the width at minimum slope. In addition, BURBANK analysis indicates that approximately 40% of the channel banks are unstable if degradation occurs and the zero friction angle assumption is valid.

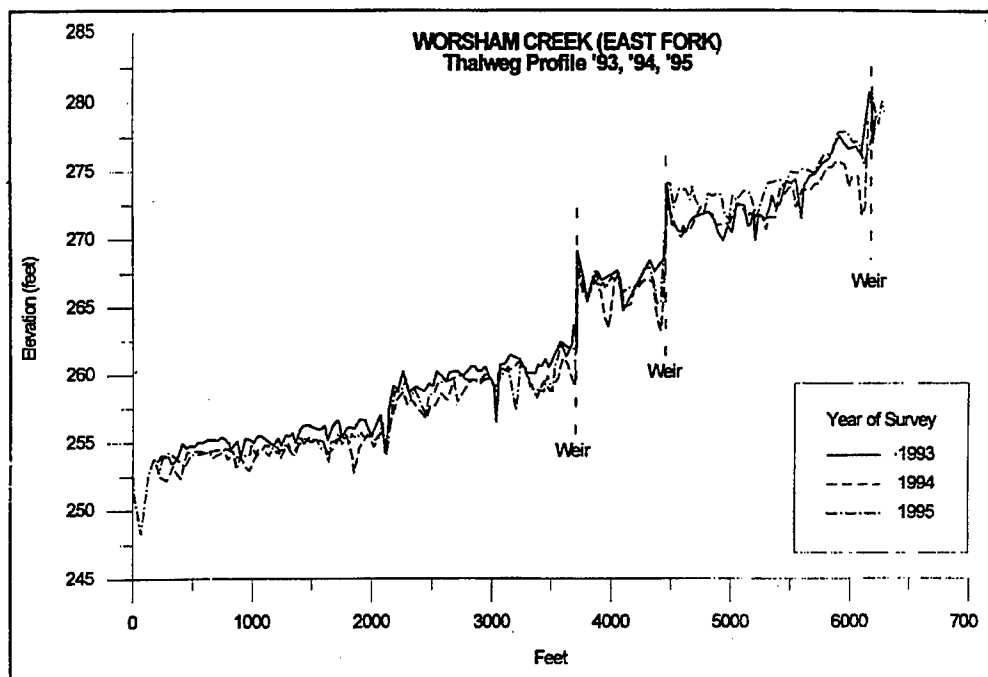
Figure 51. Thalweg Profiles for East Worsham Creek, site 18a

Upstream of No. 2 structure, in Segment 3, the 1995 survey indicates that significant aggradation has occurred. The upper portion of Segment 3 is a hard, erosion resistant clay that has changed little in the past four years. A beneficial effect of the upstream grade control structures can be realized by comparing the BURBANK analysis of the percentage of bank at risk for the zero friction angle condition in 1995. Grade control has raised the channel bed to reduce the percentage of bank unstable from 100% in Segment 1 to 5% in Segment 3. This is a significant improvement. However, the SAM results indicate that the 2-year slope in all segments remains very high at approximately 250% of the 1000 mg/l minimum slope. See Table 22 for summary results and Figure 51 for thalweg profiles of site 18a.
