OFFICE OF THE INSPECTOR GENERAL

AIRCRAFT FUEL CELL PROCUREMENTS

Report No. 94-001

October 13, 1993

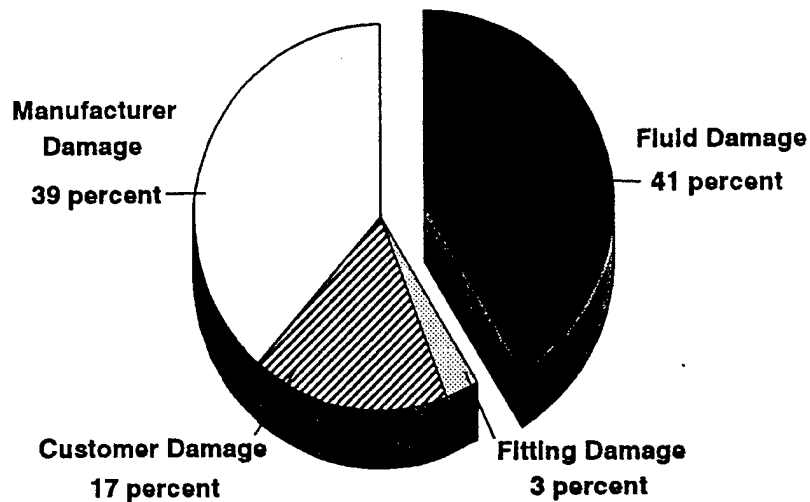
Figure 2. Quality Deficiencies Reported on AH-64 Helicopter Fuel Cells

AH-64 Helicopter Fuel Cell Evaluation. Evaluation of 79 AH-64 helicopter fuel cells stored at the Corpus Christi and Letterkenny Army Depots and Fort Hood showed that 71 fuel cells prematurely failed (Appendix E). Of the 71 fuel cells, 39 cells were manufactured by EFC and 32 fuel cells were manufactured by AMFUEL. Of the 39 EFC fuel cells, 26 (67 percent) failed because of the previously discussed blistering found in the EFC repair material. For the remaining 45 fuel cells, we determined that the most common cause of fuel cell failures, besides customer-caused failures (storing and handling, fitting damage, and activation), was inadequate design specifications that resulted in delamination of the outside wall of the fuel cell. The outside wall of a fuel cell is made by bonding nitrile or polyurethane rubber to the woven nylon or polyester cords. Delamination occurs when the outside wall of the fuel cell comes into contact with fuel or other similar fluids causing the woven materials contained in the exterior cell wall to separate. Outside delamination of the fuel cell generally is not repairable and requires the fuel cell to be replaced.

Scope of AH-64 Helicopter Fuel Cell Problem. We took additional steps to determine whether Army users reported the outside delamination problem and whether ATCOM took any corrective action to prevent recurrence. We reviewed a total of 70 QDRs submitted to ATCOM on AH-64 helicopter fuel cell failures between 1986 and 1992. Of the 70 QDRs, 29 (41 percent) of the QDRs were for outside delaminations. An analysis of the QDRs and causes listed for premature failures of the AH-64 helicopter fuel cells is shown in Figure 2.

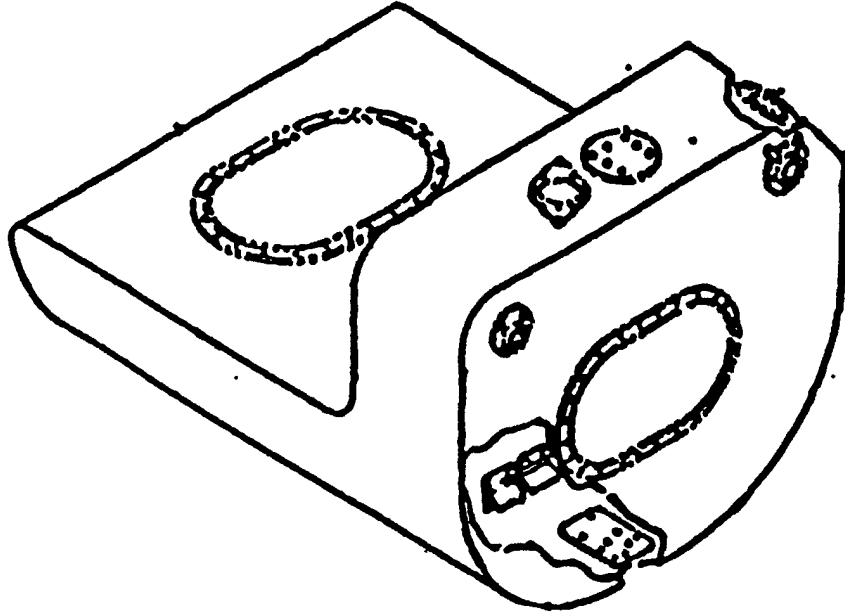
Figure 3. AH-64 Helicopter Forward Fuel Cell

Review of 146 fuel cells located at 4 Army sites showed that 42 were damaged because of improper storage and handling (Appendixes C and E). Of the 146 fuel cells, 21 were damaged beyond repair. The most significant problem occurred at Letterkenny Army Depot with the AH-64 helicopter forward fuel cell. The forward fuel cell collapses more easily because of its "L" shape, as seen in Figure 3. Fifteen of the forward fuel cells at Letterkenny Army Depot collapsed in their shipping containers and could not be straightened out. When the cells remain collapsed over a period of time, the self-sealing material migrates away from the creases in the fuel cell wall, leaving no self-sealing ability in the area and causing separation between plies.
