# Metallurgical Examination of a Failed Blade Lag Shock Absorber (Part No. 114H6802) From a CH-47D Chinook Cargo Helicopter

ARL-TR-2191

March 2000

**Marc S. Pepi, Scott M. Grendahl, and Victor K. Champagne**  
Weapons and Materials Research Directorate, ARL

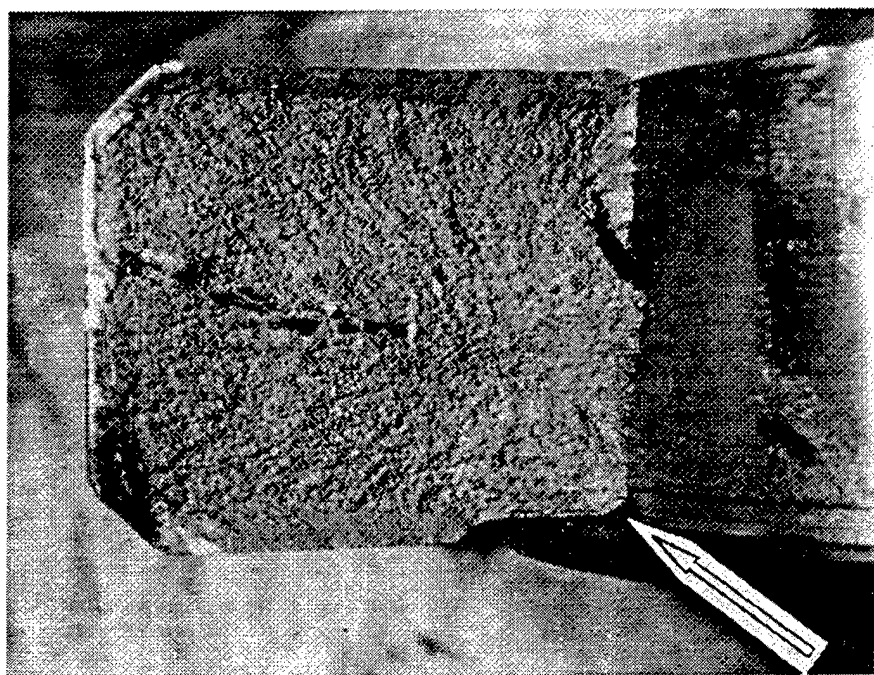
Fluorescent penetrant inspection performed by Boeing revealed no additional cracks. Figures 10 and 11 [1] show the primary and secondary fracture surfaces, respectively. The primary fracture (labeled as Fracture A within the context of this report) exhibited features consistent with a fatigue failure; the topography was relatively flat and smooth, with evidence of beach marks. The fatigue crack traversed approximately 95% of the fracture surface through the lead portion of the lug, while ductile shear lips comprised the remaining fracture surface. This was considered the primary fracture surface due to the extent of fatigue. The origin was determined to be located at the top of the 0.040-in, 45° chamfer. The secondary fracture (Fracture B) contained only approximately 20% fatigue through the lag region of the part, with the remainder exhibiting a ductile dimpled morphology. The origin of this fracture was determined to be located along the bore, approximately 0.05 in from the spot face of the lug. In addition, a dark-gold coating was observed along the exterior of the part. This coating was the typical color of a part that had been chromic-acid-anodized (as required in accordance with the engineering drawing). A blackish-green coating was observed on the bore surface, which was atypical of the chromic acid anodize. Finally, many axial score marks were noted on the bore surface. Some markings were shiny, while others contained the blackish-green coating. These markings were determined to be consistent with the prior removal of the bushing. The blackish-green coating and the axial score marks were evidence that the bore had been reworked.

**Figure 11. Optical Macrograph of the Secondary Fracture (Photo Courtesy of CCAD).**

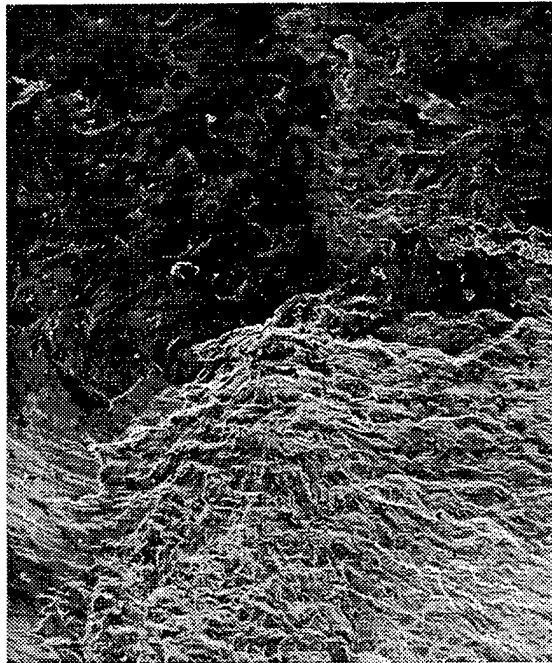
**Figure 19. SEM of the Fracture Origin of the Primary Fracture, Tilted at an Angle to Reveal the Surface of the Bore; Magnification 50x.**

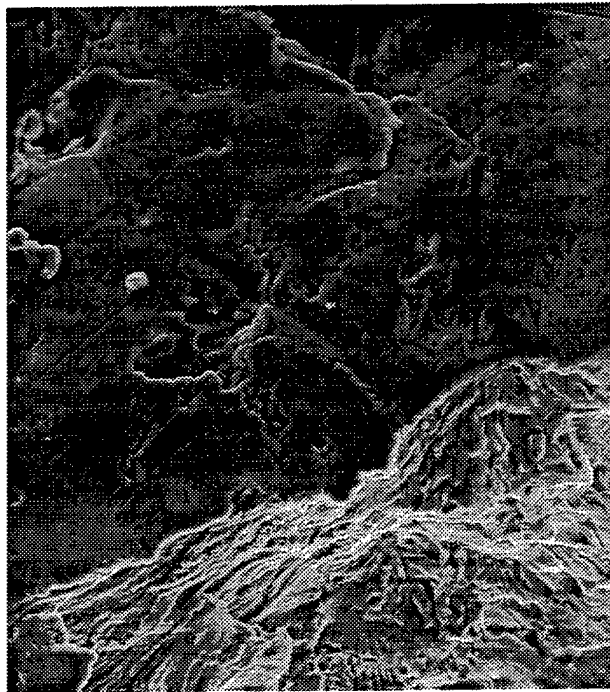
while Figure 20 is a magnification of this area showing intergranular surface attack adjacent to the origin. Beyond the fracture region, a small shear lip consisting of ductile dimples was observed, which represented final fracture. No inherent defects or gross inclusions were noted at the origin of the primary fracture. The topography of the secondary fracture was characterized by a smaller region of fatigue, with the remainder of the surface typical of overload. The fatigue morphology was characterized by a shiny appearance, in contrast to the overload region that displayed a dull texture. A shear lip encompassed the outer periphery of the fracture surface, except for the bushing wall. An intergranular morphology was evident at the fracture origin. Figure 21 shows the origin of the secondary fracture. The origin at an angle is shown in Figure 22. Figure 23 shows intergranular surface attack adjacent to the origin. EDS examination of the dark golden colored coating at Boeing revealed a level of chromium consistent with a chromic acid anodize.

**Figure 20. Magnified SEM of Figure 19, Showing Intergranular Attack on the Surface of the Bore Adjacent to the Primary Fracture Origin; Magnification 200 $\times$ .**

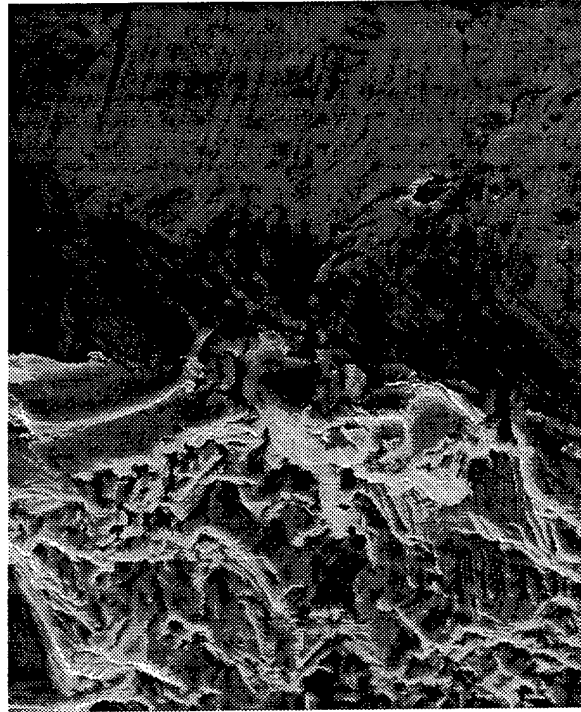
**Figure 23. Magnified SEM of Figure 22 Showing Intergranular Attack on the Surface of the Bore Adjacent to the Secondary Fracture Origin; Magnification 500 $\times$ .**

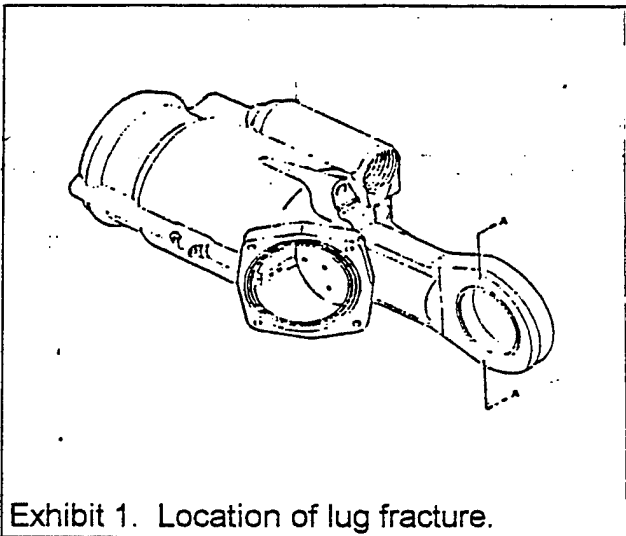
Exhibit 1. Location of lug fracture.

1. The lug fracture occurred essentially perpendicular to the longitudinal axis of the blade lag shock absorber (Exhibit 1, Arrows A-A).

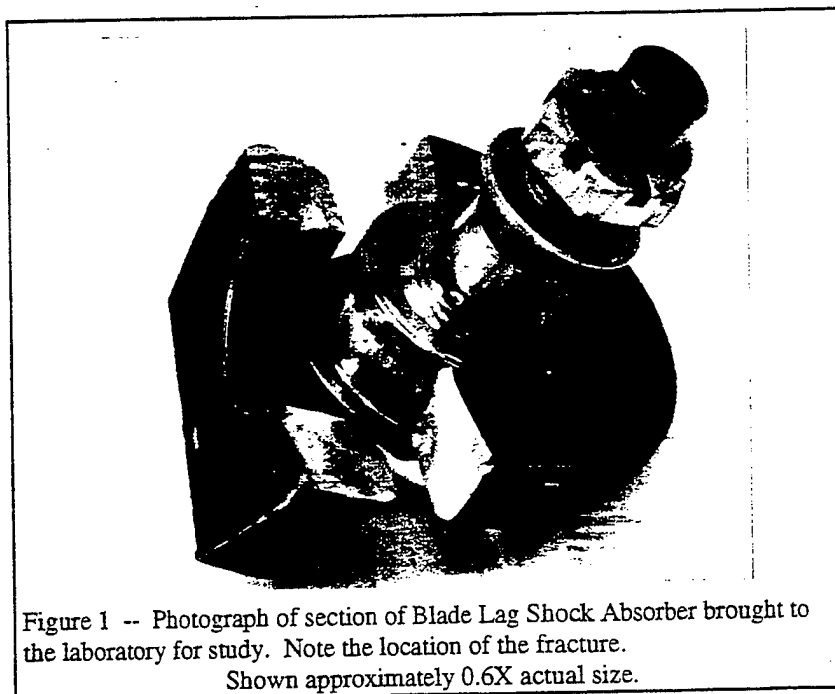
The portion of the Blade Lag Shock Absorber housing where fracture occurred was removed from the remainder of the part and brought to the laboratory for study. Fracture occurred approximately one eighth inch from the center line of the bore containing the uniball bearing (where the Shock Absorber is attached to the Rotary Head) and was approximately 90° to the length of the housing. The bearing, with attached hardware (bushing, bolt, etc.) remained attached to the larger section which fractured from the housing. See Figure 1.

Figure 1 -- Photograph of section of Blade Lag Shock Absorber brought to the laboratory for study. Note the location of the fracture.  
Shown approximately 0.6X actual size.

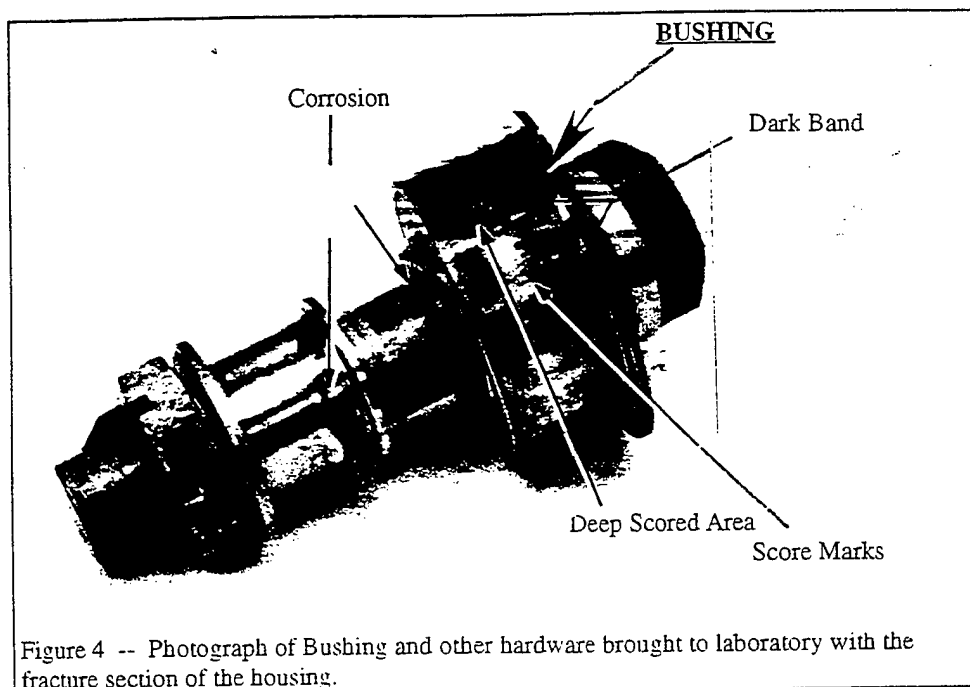
The outer surface of the bushing (which mates with the bore in the housing) was also inspected at magnifications to 30X. See Figure 4. These inspections revealed the following.

\*\*\* Evidence of corrosion to the other associated hardware (bolt, nut, etc.).

Figure 4 -- Photograph of Bushing and other hardware brought to laboratory with the fracture section of the housing.

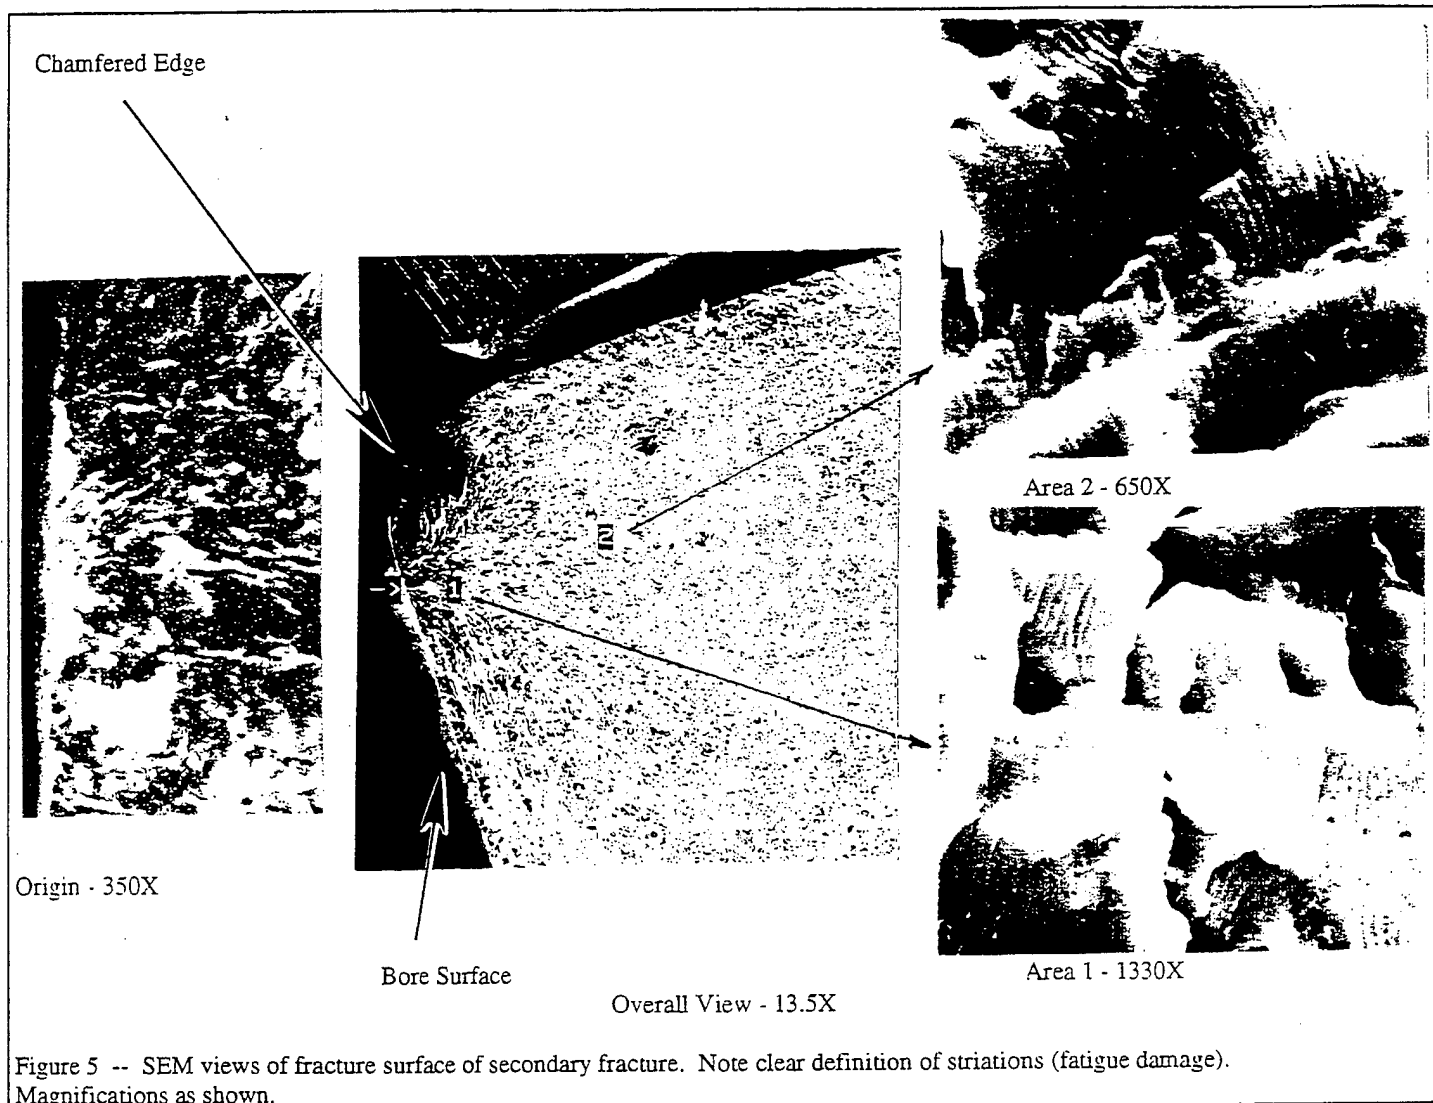
\*\*\* Striations were visible to approximately one-fourth inch from the chamfered edge defining that the cracking was propagated due to cyclic stress. The remainder of the fracture topography was indicative of that resulting from overstress.

Figure 5 -- SEM views of fracture surface of secondary fracture. Note clear definition of striations (fatigue damage). Magnifications as shown.

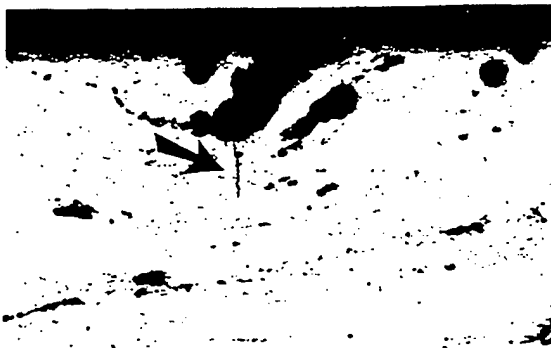
10a - 1/2" from fracture, 400X

Sections were also removed approximately 10° and 90° (around the circumference of the bore) to the primary fracture. Pitting corrosion was present at both locations. A few (3), very shallow, transgranular cracking was present in the section remove one-half inch from the primary fracture but none were present in the section removed 90° from the fracture (See Figures 10a and 10b). The grain orientation 90° from the fracture was nearly longitudinal to the part length thus should have favored intergranular cracking if the hoop stress resulting from installation of the uniball bearing were the stress which caused the failure; however, no cracking was observed. It appeared very probable that cyclic tensile stress imparted at the location of the failure during operation provided the stress necessary to cause the fracture.

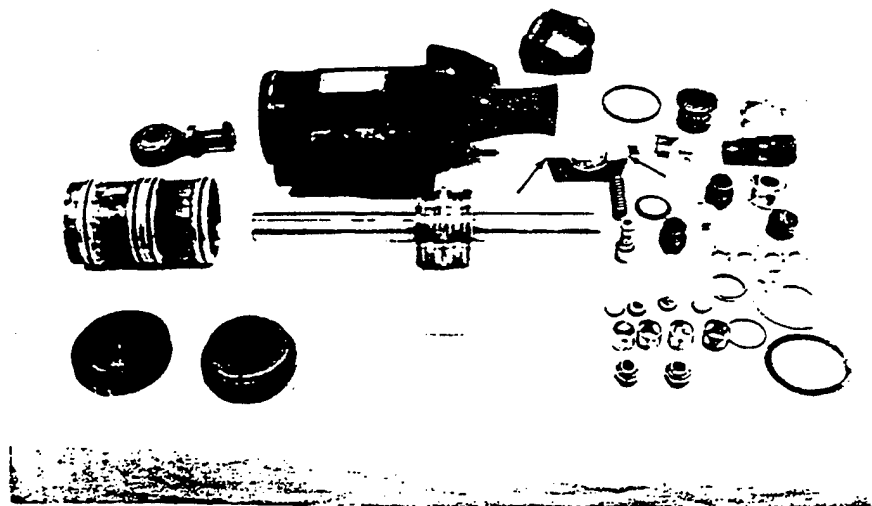
Figure 2  
As-received photograph of the Blade Lag Shock Absorber, P/N 114H6800-5, S/N VY1313. Arrows denote inboard lug fracture surfaces.

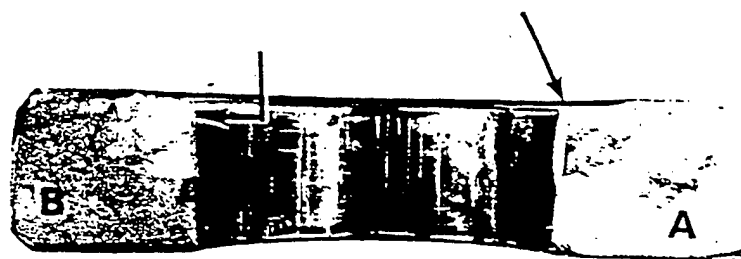
Figure 3 1X  
Photograph of the through fractured inboard lug displaying fatigue fracture surfaces A (primary) and B (secondary). Arrows indicate approximate origin locations.

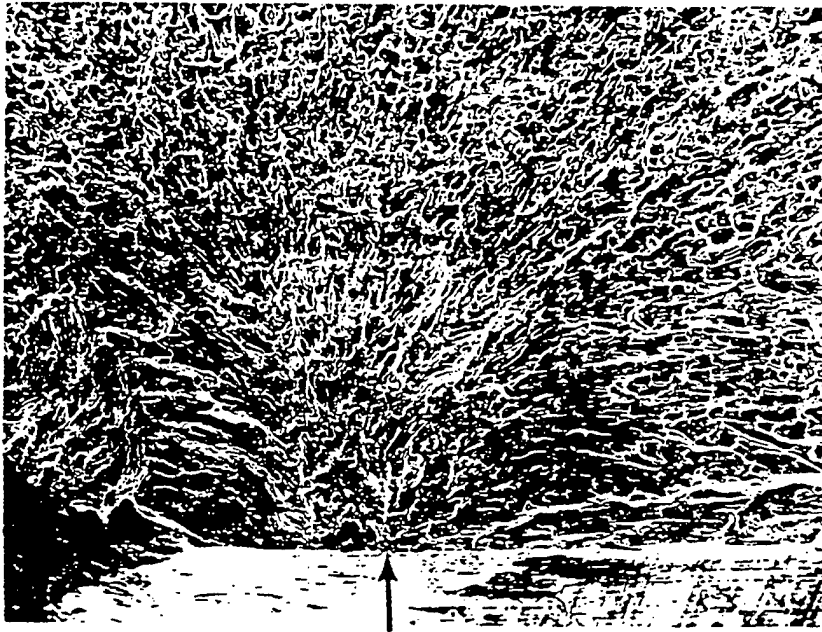
Figure 8 50X  
SEM photograph of the secondary fracture surface B . Arrow denotes the origin location.

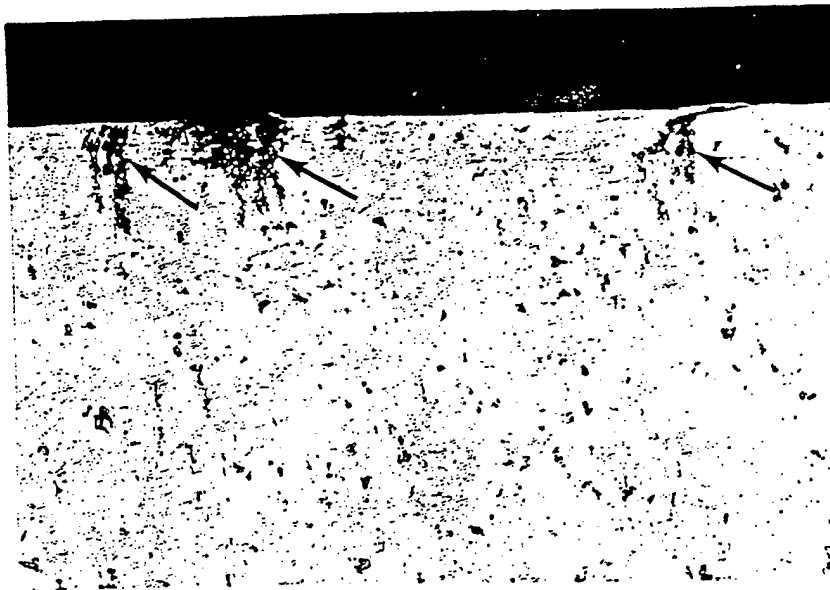
Figure 12 100X  
Photomicrograph of a cross-section through the lug approximately 90°  
from the primary origin, revealing intergranular corrosive attack (arrows)  
extending from the bore surface.

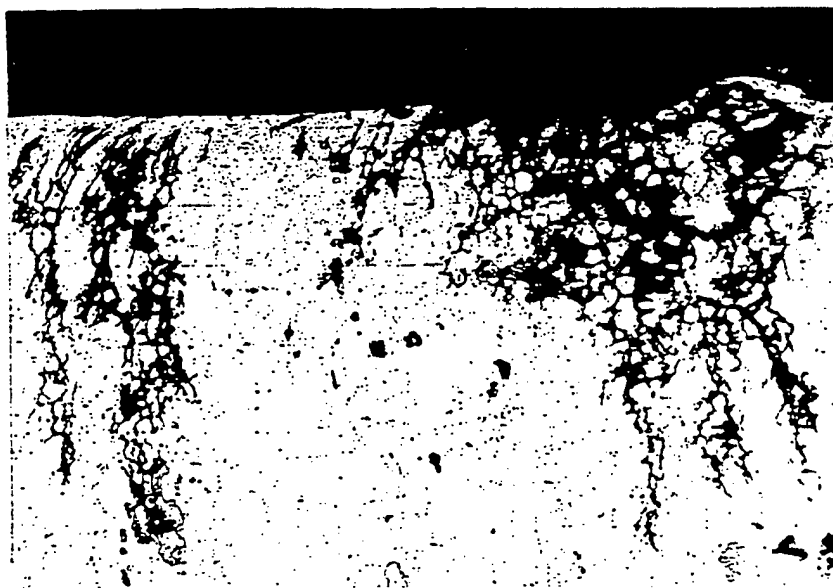
Figure 13 400X  
Magnified view of the cross-section through the lug bore revealing  
intergranular attack extending to an approximate depth of 0.006 inch.
