PB00-910401  
NTSB/AAR-00/01  
DCA97MA058

# NATIONAL TRANSPORTATION SAFETY BOARD

## AIRCRAFT ACCIDENT REPORT

CONTROLLED FLIGHT INTO TERRAIN  
KOREAN AIR FLIGHT 801  
BOEING 747-300, HL7468  
NIMITZ HILL, GUAM  
AUGUST 6, 1997

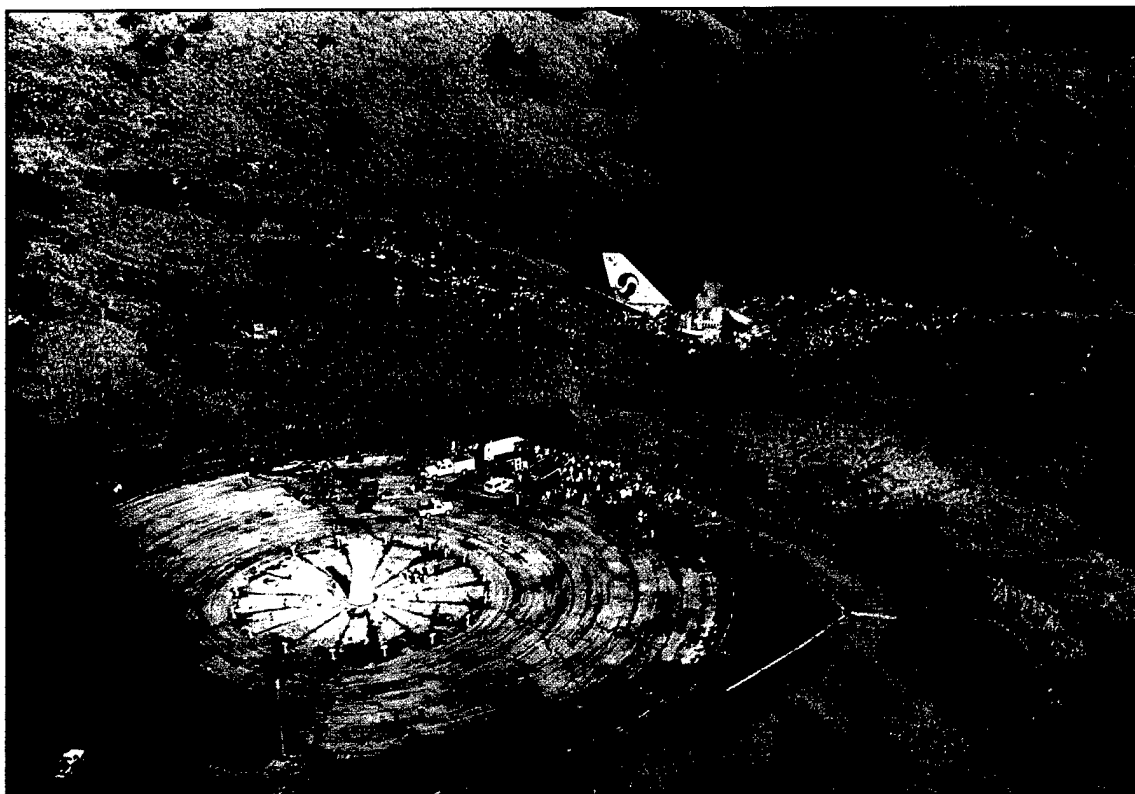
**Figure 8b.** Closer view of the wreckage from Korean Air flight 801 and the NIMITZ VOR.
