National Transportation Safety Board

Safety Recommendation

Date: April 7, 2000

In reply refer to: A-00-23 through -27

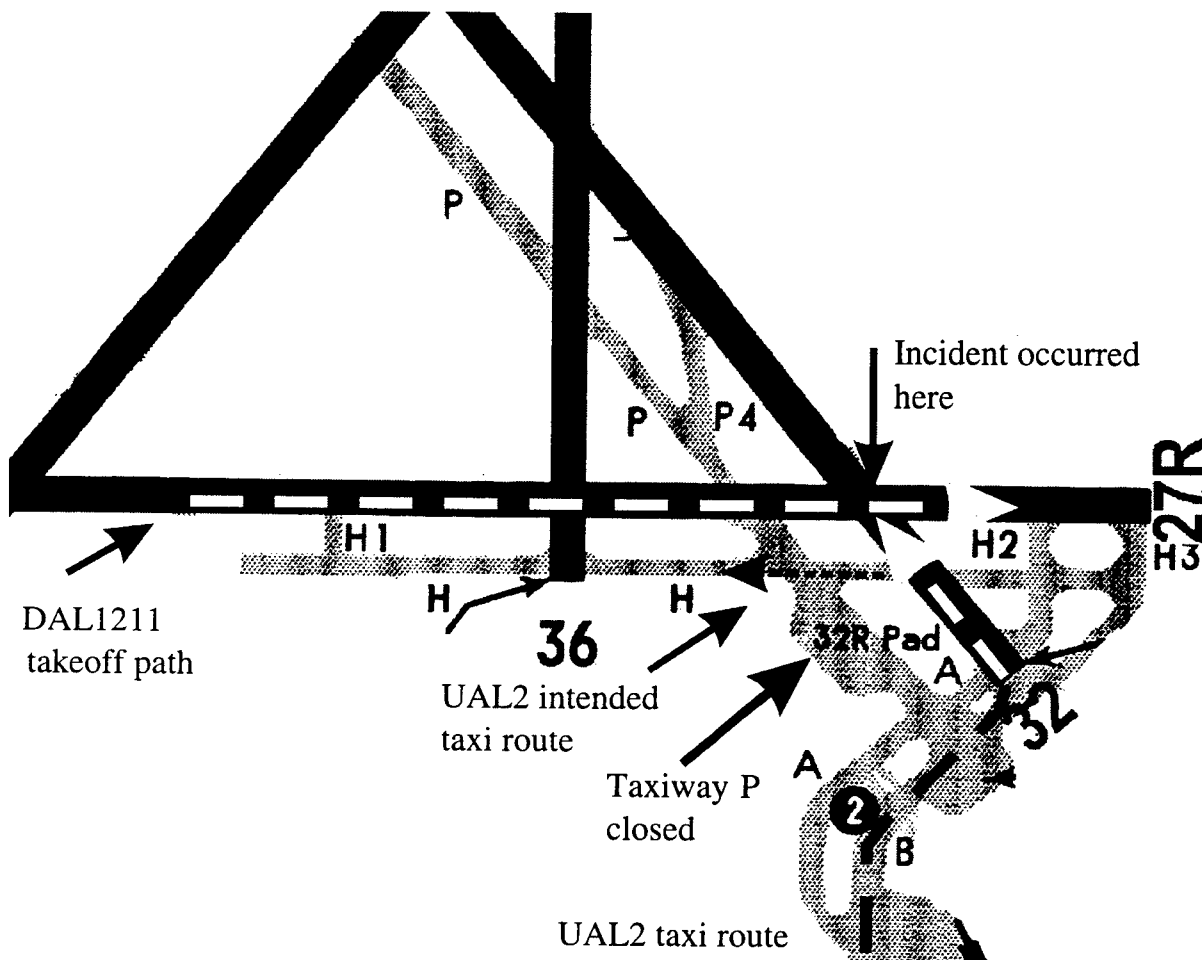
Figure 1. ORD Airport Diagram

Safety Board investigators found that the taxi route assigned for use between taxiways B and H at the time of the incident was not the taxi route usually assigned. Aircraft taxiing between taxiways B and H would normally follow taxiway P; however, a section of taxiway P had been closed for several weeks for reconstruction. The tower controllers elected to use runway 32R as a taxiway to bypass the closed section of taxiway P. The UAL2 crew was not familiar with that part of the route, and no signage identified taxiway H at its intersection with runway 32R.

Investigation revealed that the ORD airport certification manual approved by the Federal Aviation Administration (FAA), pursuant to 14 Code of Federal Regulations Part 139, does not require a sign at the intersection of taxiway H and runway 32R because it is close to the threshold of runway 32R and aircraft do not normally turn off there. However, when the tower controllers

elected to use runway 32R to bypass the unusable segment of taxiway P, the intersection of runway 32R and taxiway H became a frequently used taxi route for aircraft crossing the airport from west to east. The tower controllers involved in this incident reported that they were not aware that the intersection was unmarked, and airport management staff stated that they had not been informed of the tower's plan to route aircraft on runway 32R to taxiway H during the construction period. Following the incident, airport management constructed a temporary sign and installed it at the runway 32R/taxiway H intersection.

The mechanic who was taxiing UAL2 stated that he was looking for a sign identifying taxiway H. Both crewmembers stated that the area was very dark and that they did not see any signs or lights identifying taxiway H. Thus, the absence of appropriate signage and markings at the runway 32R/taxiway H intersection apparently contributed to the loss of situational awareness experienced by the UAL2 crew, causing them to miss the turn onto taxiway H. This potential problem might have been detected and addressed if ORD's ATC managers had informed airport management about its alternate taxi plan and asked that the route be checked for adequate signage and markings. Detection and correction of such problems is important because, especially in unfamiliar situations, flight and ground crews depend on proper signs and surface markings to maintain situational awareness and avoid runway incursions. Therefore, the Safety Board believes that the FAA should amend FAA Order 7210.3, "Facility Operation and Administration," to require tower ATC managers to monitor planned airport construction projects or other activities that may require significant use of nonstandard taxi routes and coordinate with airport management to ensure that such routes are inspected for adequate signage and markings.

Amend Federal Aviation Administration Order 7210.3, "Facility Operation and Administration," to require tower air traffic control managers to monitor planned airport construction projects or other activities that may require significant use of nonstandard taxi routes and coordinate with airport management to ensure that such routes are inspected for adequate signage and markings. (A-00-28)

Publish a flight standards handbook bulletin to its principal operations inspectors describing the September 11, 1999, runway incident between Delta Air Lines flight 211 and United Airlines 2 and recommending that carriers review the adequacy of their procedures for ensuring that personnel assigned to move aircraft have received sufficient training and information to do so safely. (A-00-29)
